A Novel Method for the Non-Destructive Assessment of Strength Degradation and Re-Use Potential of Weathered Float Glass From Facades: A Proof of Concept Study

Abstract: Lack of knowledge about the properties of weathered (used) glass is currently a major barrier to glass reuse. This results in probably unnecessary recycling or down-cycling of architectural glass at the end of life. Avoiding this creates a significant opportunity to reduce resource depletion and decarbonize the built environment. This can be done by developing an optical non-destructive test method that estimates the strength of naturally weathered glass by characterizing surface flaws. This allows excessively damaged glass panels to be removed for surface repair or recycling. Specimens were made from 50⁺-year-old monolithic flat glass taken from a façade in the Hague, Netherlands, where it was exposed to salt in the air, water, cleaning, and abrasion from wind-driven dust and sand particles. The specimens were examined using a microscope and a handheld optical profilometer to determine surface flaw characteristics. The glass specimens were then tested using a ring-on-ring (coaxial double ring) setup. Similar tests

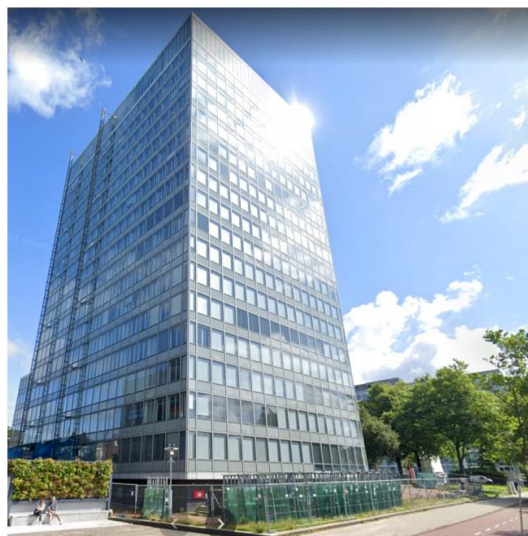
Fig. 1: The office building at Koningskade 4 in the Hague from which the glass was sourced

The weathered glass became available with the renovation of the office building at Koningskade 4 in The Hague, shown in Fig. 1. This building was designed in 1967 and built-in 1969 with a double skin façade. The outer skin was composed of large glass panels of 2.5×2.5 m of 10 mm thick monolithic float (soda lime silica) glass which were 50+ years old when they were carefully removed from the building in 2022 and taken away for storage. The location is 4 km from the sea and close to major roads. Pollution is thus more than average in the Hague region with the height of the building exposing the glass to higher wind and thus more abrasion. This could thus be considered a relatively severe exposure for a European location and therefore a reasonable worst-case example from the point of view of the research goals. A single panel was used to cut samples for this research. Two sample sizes, 250×250 and 450×450 mm, were used to compare side effects. The size was determined by the size of the available ring on ring testing equipment. At least 40 samples of each size were produced for both the weathered and the new glass. All specimens were cut by a commercial glazing firm using standard industrial glass cutting tables to ensure quality and consistency. Most of the glass was re-used to build IGUs for the Floriade natural pavilion.

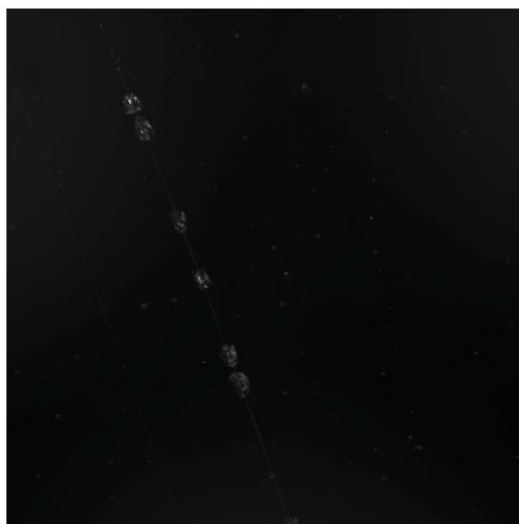
Fig. 3: TRACEiT image of weathered glass, left top lighting, right transmitted lighting

An optical profile scanner (TRACEiT manufactured by Innowep) was used in this study. It is an optical system that measures surface profiles by combining a lighting source, an optical camera, and software to make an accurate 3D assessment of a surface. The device was not specifically developed for scanning glass surfaces and no references could be found for using it on glass, so the settings had to be determined with support from the manufacturer and by trial and error, a full description is given in Sofokleous (2022). No physical changes were made to the scanner, only the software options were optimized for glass. The new glass specimens and the interior face of the weathered specimens showed no significant response to the optical profile scanner indicating that any defects present are smaller than the resolution of the scanner. Thus only the specimens with the weathered outside face in tension during the co-axial ring-on-ring test were fully scanned within the area of the loading ring. Figure 3 shows examples of images obtained from the optical profile scanner. The transmitted light image shows a linear scratch and localized damage zones along the scratch. To improve the image quality, the optical profile images were post-processed in PAINT.Net software or using MATLAB image processing algorithms. The results are shown in Fig. 4.

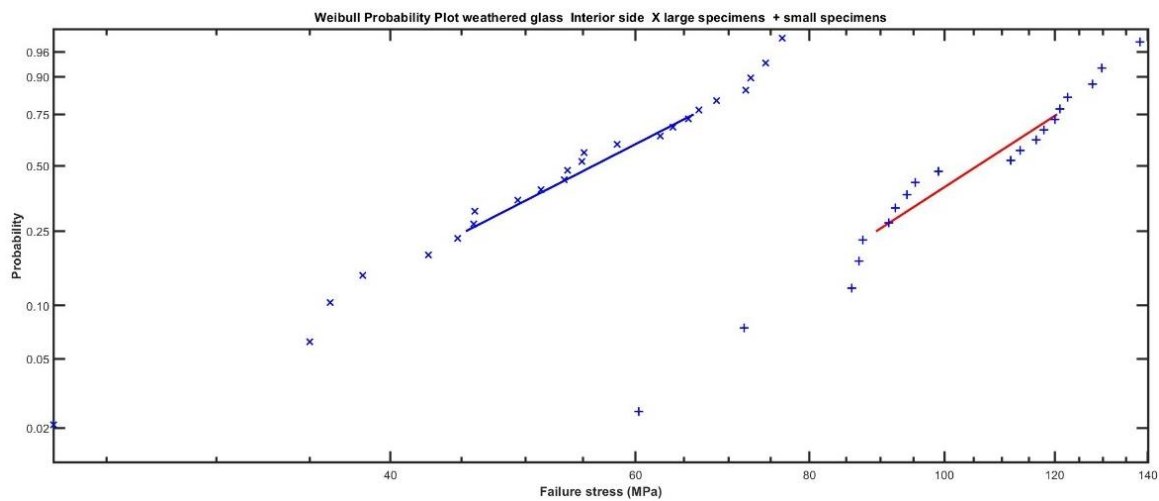
Fig. 9: Weibull plot of weathered specimens with the interior face in tension

Conversely, Fig. 9 shows that there is a significant size effect in the surface strength of the interior surface of the weathered glass. Here, larger specimens are significantly weaker than smaller specimens. The same can be observed for the new glass specimens with the Tin side in tension (Fig. 10). For these specimens apparently the defect density is much lower and more singular in nature, which means that a larger area has a greater probability of containing a critical defect.

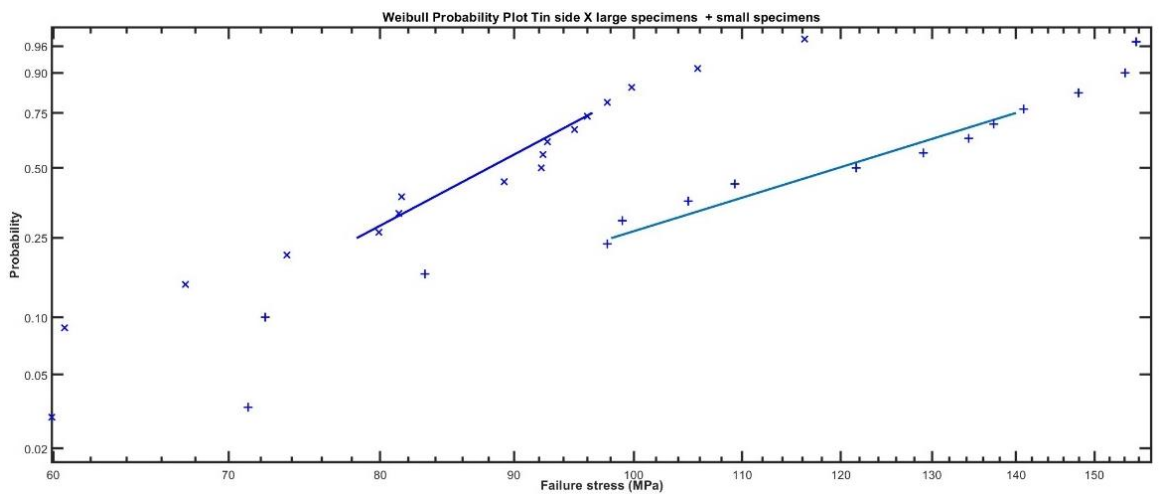
Fig. 10: Weibull plot of new glass, tin side in tension

Figures 8-11 provide a direct comparison between the small specimen tests and the large specimen tests. Figure 8 reveals that there is no significant size effect for the weathered surface strength. Effectively the large and small specimens seem to form a single statistical group. This implies that the surface damage density is so high and relatively uniformly distributed across the whole surface that the probability of finding a critical defect is not significantly dependent on the size of the stressed area being tested.

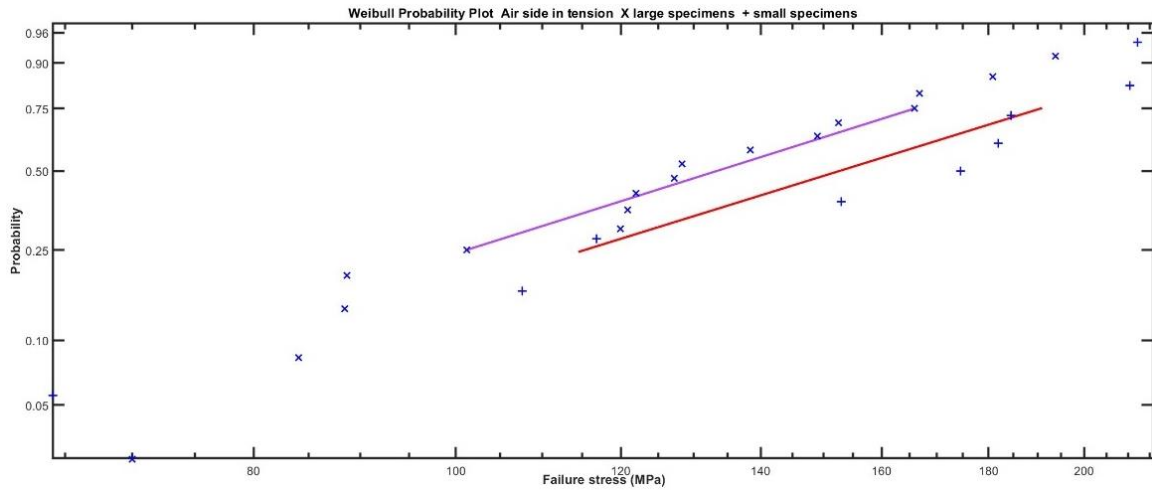
Fig. 11: Weibull plot of new glass, airside in tension

In what initially seems a paradox, the new glass specimens with the air side in tension, Fig. 11, have very little size dependency. However as the air side was not in contact with the rollers during the annealing phase of float glass production it is also the least damaged side, which is confirmed by the higher strength. A pristine glass surface should show no size effects. The new glass specimens with the air side in tension thus approximate such an “undamaged” surface.

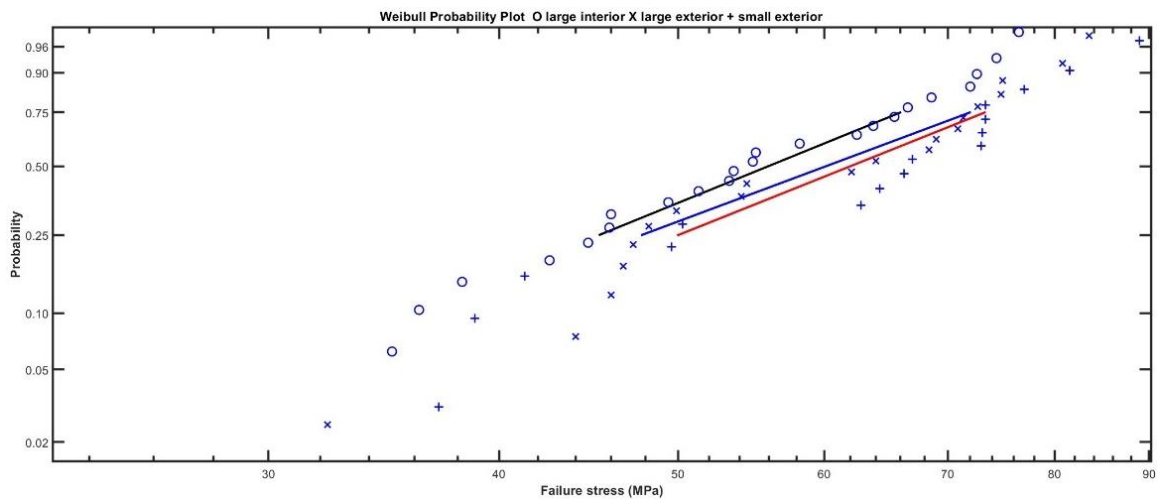
Fig. 12: Weibull plot of large interior, large exterior, and small exterior specimens

The Weibull plots of the large interior, large exterior, and small exterior weathered glass specimens in a single graph (Fig. 12) show a reasonable coincidence, except for the lower outlier of the large interior data set. This would suggest that large surfaces of weathered glass both interior and exterior, excepting the occasional outlier, converge to a minimum strength of around 30 MPa. For a probability of failure of 2-5%. It should be noted that due
