Automatic settlement analysis of single-layer armour layers

Proceedings of the 6th International Conference on the Application of Physical Modelling in Coastal and Port Engineering and Science

AUTOMATIC SETTLEMENT ANALYSIS OF SINGLE-LAYER ARMOUR LAYERS

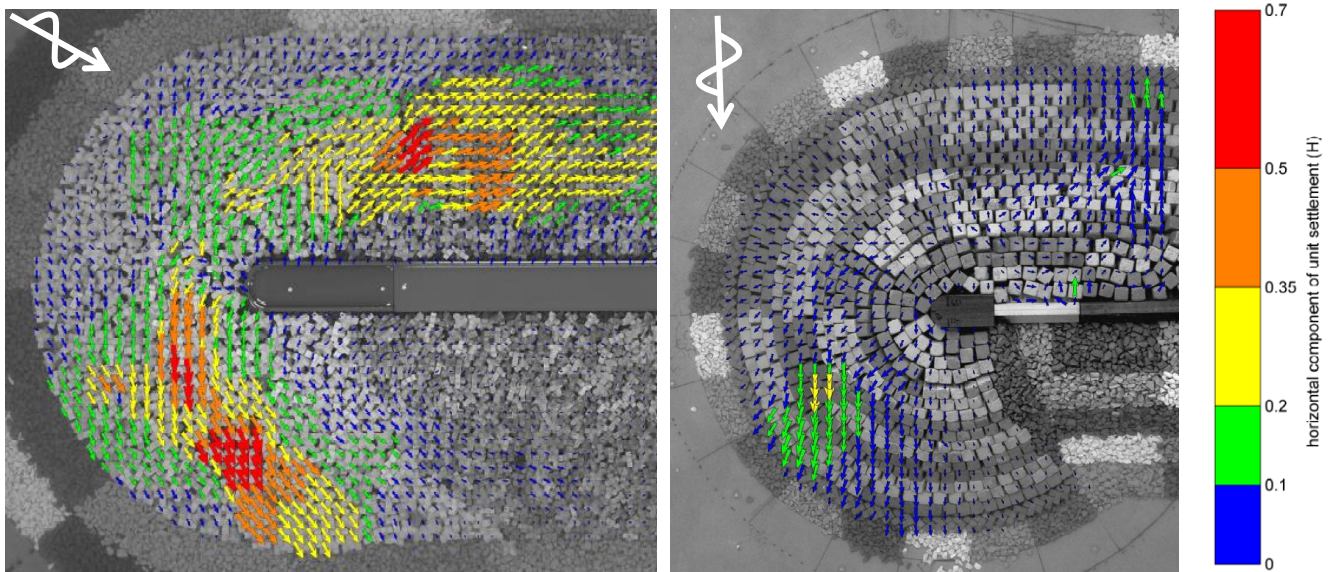
Figure 1. Settlement analysis on breakwater roundheads. Left: with two sizes of model XBloc[®]. Right: with single-layer cubes.

settlement is to be determined). Two examples of the results of this technique applied to breakwater roundheads in a wave basin of Deltares, where the magnitude and direction of the settlement are obtained, are given in Figure 1. The colour of the arrows indicates the quantitative displacement (in units of element height H , where $S=1$ corresponds to a displacement over a distance of one H).

In Figure 1 two results of tests on rubble mound breakwater roundheads are shown. Two different types of single layer armour are used. Some observations can be made from these figures. All settlements are lower than the unit height H , with the settlements on the cube layer being lower (different hydraulic conditions were used). The direction of settlement is usually in between the wave direction, and the direction down the slope. In both graphs the largest settlement is seen to take place at roughly 135° from the wave direction. This is the location that is usually mentioned as the location where most damage occurs on a roundhead. The toe structure was displaced somewhat in both cases. It seems that the settlement originates there.

In the roundhead depicted in the left picture of Figure 1 two sizes of XBloc® model units were tested, with a larger (lighter coloured) unit on the roundhead. In this particular design a berm was applied in the slope at the middle of the cross section, in order to realize a gentle slope that was needed for geotechnical reasons. Note that the settlements in this picture were normalized by the size H of the larger unit, and the horizontal component of the settlement, s_x , is displaced. Large displacements S of $0.5H$ to $0.7H$ occurred on the roundhead and near the seaward transition of unit sizes. These displacements are strikingly larger than those that were observed in the trunk cases with interlocking units, where unit extraction occurred when the displacements were larger than about $0.2H$. The displacements on the roundhead are seen to be originating near the seaside of the roundhead where the toe was pushed aside (bottom of picture). From here a band of large settlements can be seen to go up to the centre of the roundhead. This implies that the movement of the toe possibly weakened a large part of the armour layer on the roundhead. These conclusions were not drawn by using conventional overlay techniques where the information of the direction of settlement is not determined.

Along the oblique transition between the two unit sizes that is present in the top of the picture, an increased settlement of the smaller type of can be observed. This indicates the lower stability of the smaller unit type, and the lower degree of interlocking at the transition between the unit sizes.

In the right picture of Figure 1 a roundhead with a single layer cube armour layer is shown. At first sight no damage has occurred to the armour layer. Here also the settlement analysis indicates the largest settlements over $S = 0.2H$ on the roundhead around 135° from the wave direction. On the trunk section with normal wave attack the settlements are larger than on the largest part of the roundhead with settlements over $0.1H$.

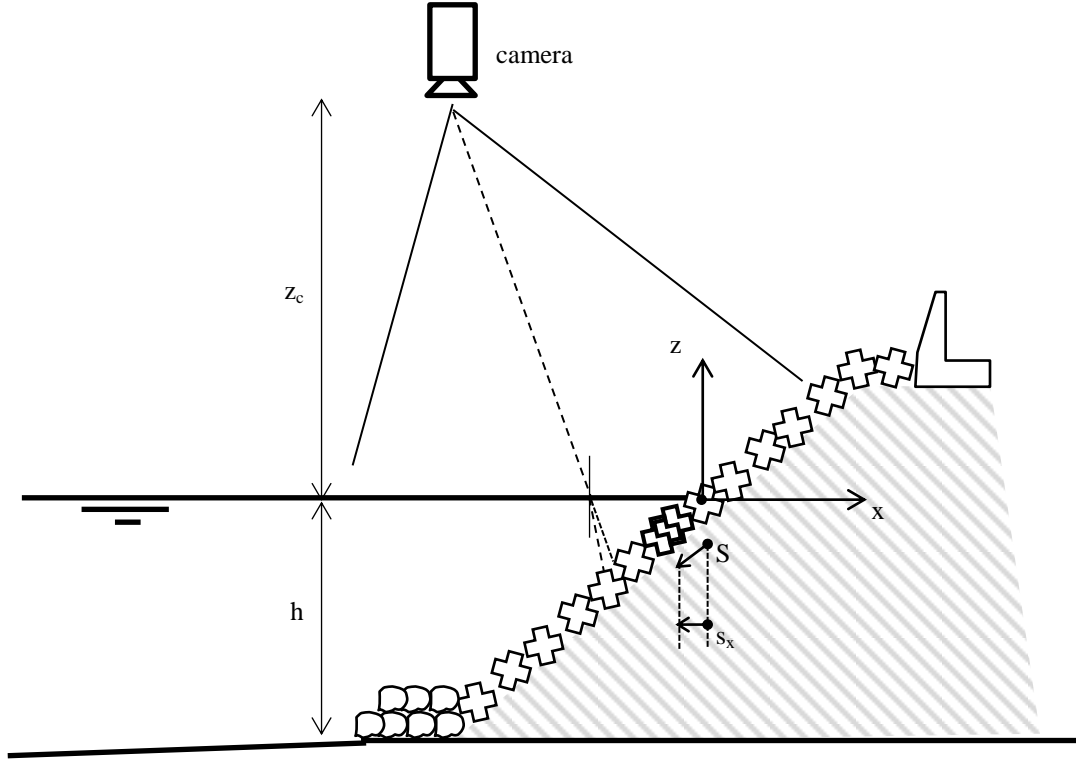
The technique is based on single pictures of the slope before and after a test (series). The typical setup is sketched in Figure 2. The camera remains at exactly the same position during the tests, or is placed back after the tests. The water level is the same before and after the test. If the camera orientation or zoom has been slightly altered during the tests, the picture is rectified such that the image as taken with identical camera pose is obtained. When using a high camera position a sufficient accuracy of the measurement can be obtained (order 1%) without elaborate calibration procedures.

Figure 2. Setup of measurement and definition of symbols.

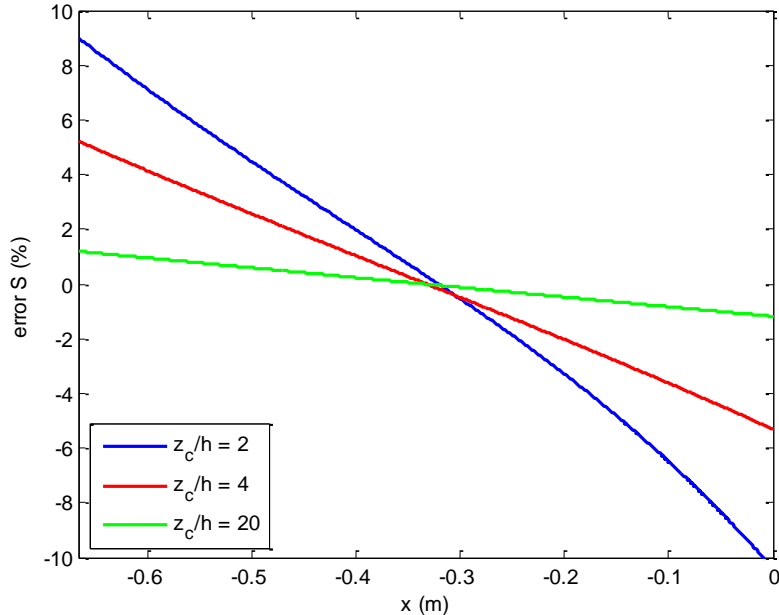
It is preferable not to drain the flume or basin after each test, to enable efficient testing. The presence of a still water level can influence the positions of armour unit under water that is seen on the camera image due to the refraction of light. The camera is positioned in such a manner that the refraction of light due to the water surface does not significantly influence the settlements that are observed, such that no rectification is necessary. In the tests the same water level is used to record the image before and after the test, so the distortion for an unaltered point below water will be equal before and after the test. Moreover, the distance of the camera is made very large compared to the water depth. Due to this fact both the camera lens distortion, the change of calibration factor with elevation, as well as the refraction of the light at the water surface, can have very limited influence on the results (order 1%). Similar analyses can be made to see whether the images before and after the test can be taken with a somewhat different water level. In Figure 3 the result of applying Snell's law on the determined settlement from the pictures, when neglecting the light refraction due to the water surface, is shown. This graph holds when the two images are made with exactly the same camera pose and water level, and a 3:4 slope. If refraction does influence the results, the images have to be corrected for the refraction, or the images should be recorded after draining the flume.

Figure 3. Accuracy of the settlement determination for various camera levels, z_c , based on a setup as indicated in Figure 2.

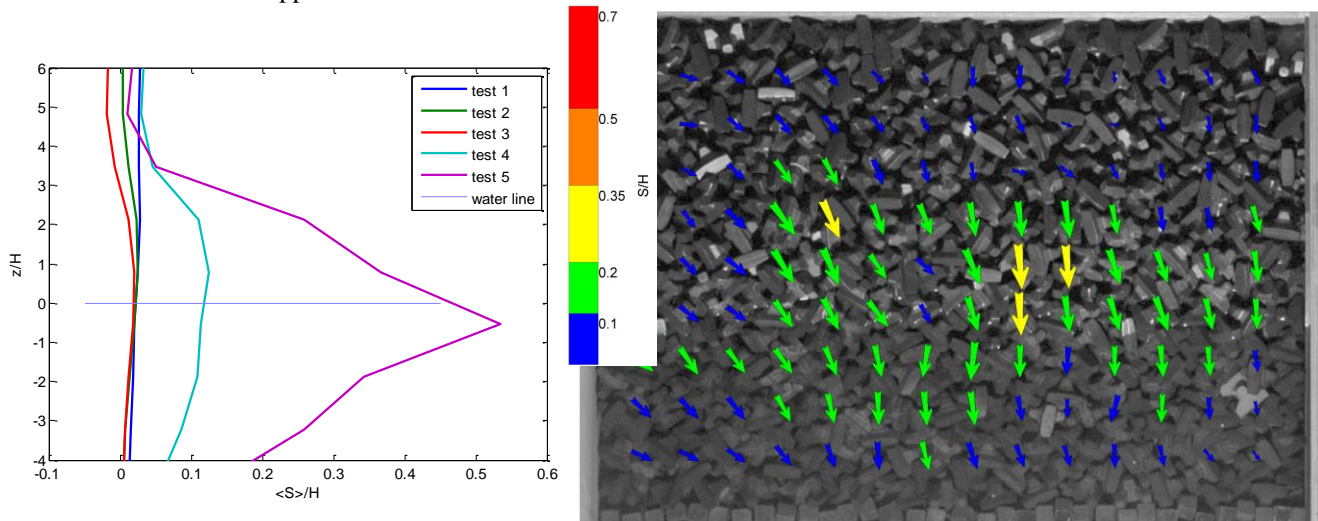
First a test series (Series A) on a model Accropode™ slope is treated. A top view of the slope is given in the right graph of Figure 4, with the crest at the top of the figure and the toe beginning at the bottom of the figure. The units are

Figure 4. Left: vertical profile of cumulative $\langle S \rangle$ for a slope with model AccropodeTM units for five tests with increasing wave heights. Right: displacement pattern for 4th test.

In the left plot in Figure 4 the cumulative mean settlement profile as function of height is shown for the series of tests with increasing wave height. The levels in this graph correspond to the levels on the picture on the right. In the first three tests only small settlements occurred, with some negative settlements (up-slope) for the top few rows. Settlements were clearly increasing in the 4th test. Around the water line most settlement occurs, such that the largest settlement gradients occur higher up at the slope, where the placement density has declined. The toe is still stable, but the downward movement of the entire layer indicates that the load of the armour layer on the toe is probably being mobilized. In the 5th test the settlement increases much more. Also the toe slides seaward. In the 5th test many units were extracted, such that the displacements that are presented in Figure 4 are determined only for the units that are still part of the slope.

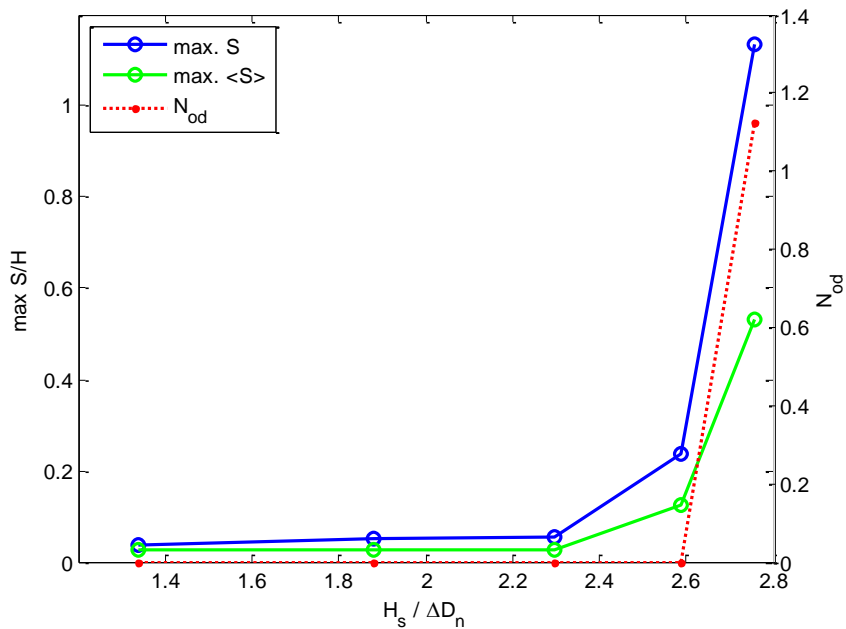
Figure 5. Measured settlement (maximum of local value S and of width- averaged value $\langle S \rangle$) for trunk section with model AccropodeTM units, together with damage number for displaced units.

In Figure 5 the settlement as function of stability number is shown for the same Test Series A. Two definitions for the settlement are given. One is the average settlement over the width of the structure according to eq. (2), $\langle S \rangle_{\max}$, the other is the maximum local settlement on the slope S_{\max} . Often only the information on the number of displaced units (N_{od}) is reported, so that until damage or failure occurs, here at the 5th test, no quantitative information about the state of the layer is available. It can be seen that the displacements on the slope have become significantly larger in the 4th test, which is a sign that the layer is weakened. The damage after Test 5, the first test where unit extraction occurred, is regarded as too severe ($N_{od} = 1.5$). For reference, often extraction of a single unit, or $N_{od} \approx 0.2$ is already considered to be failure. This is in consequence of the typical ‘brittle’ damage behaviour of single-layer armour layers, where after initial damage the damage progression is very rapid. In the pattern and quantity of the settlements (and its gradients) signs of the weakening of the armour layer are observed one test earlier. The damage to this layer occurred at a relatively low $H_s/\Delta D_n$ value, which was due the fact that the toe was not stable and did not support the slope constantly. Moreover, the breaking wave attack on the slope might be increased, due to the steep and shallow foreshore.

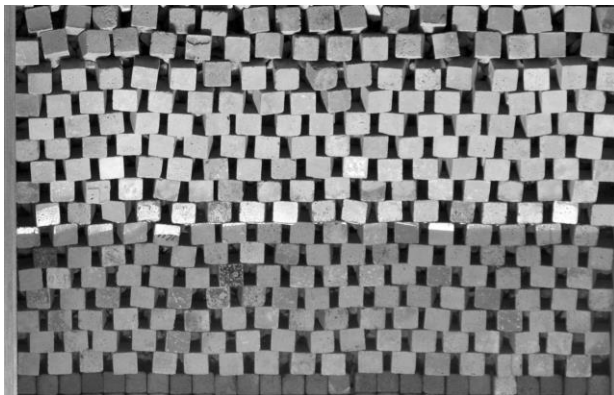
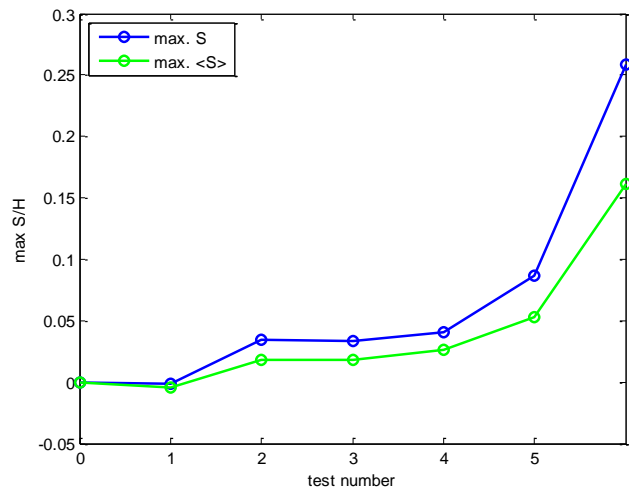
Now an armour layer made up of cubes that are placed in a single layer is treated. In Figure 6 the top view of a slope with cubes is shown. The cubes are placed regularly on a 2:3 slope and have a 25% porosity, or $1/3D$ spacing of the cubes. The crest is located at the top, where the upper two rows are placed horizontally, and at the bottom of the picture the start of the toe is visible.

Figure 6. Left: initial situation of breakwater trunk with single-layer cubes. Right: maximum settlement per test.

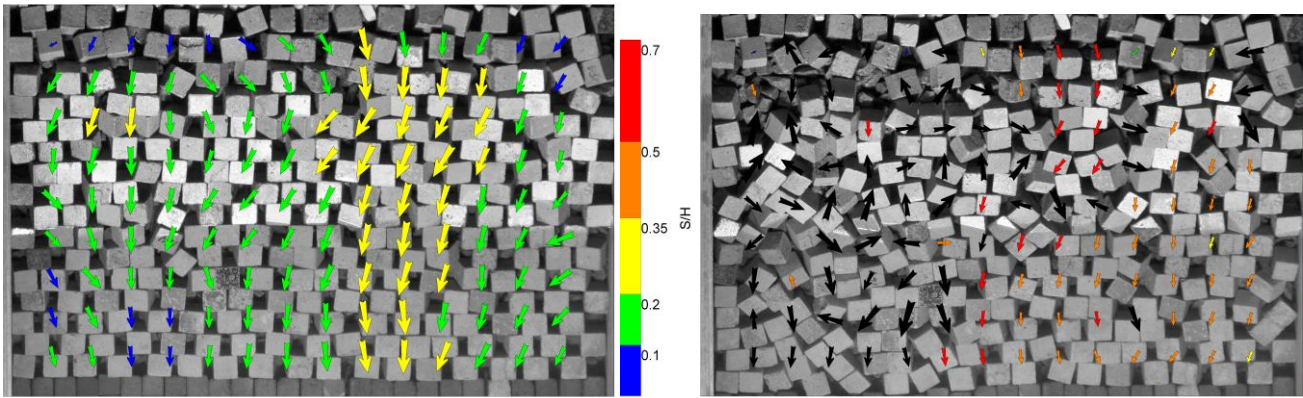
The slope was tested with a series of 7 tests. The wave height was increased up to Test 5. The wave height in Tests 6 and 7 are the same as in Tests 4 and 5, but with a larger wave period. The settlement after the 6th test became significantly larger when the toe at the right side of the slope slid somewhat seaward, see left image of Figure 7.

Figure 7. Left: settlement analysis on breakwater trunk with single-layer cube after 6th tests. Right: situation after 7th test, where determination of full displacement field becomes difficult.

After Test 7 the toe slid further, especially at the left side, causing larger settlements of the single layer cubes. The orientation of the cubes was so chaotic that the settlement could not be determined for the entire slope, as can be seen the figure where the black vectors ($S > 1H$) are not reliable. In all these tests on this cube slope no extraction of units occurred, even though the gap at the outer crest line, in the top left of the picture, had become rather large, and the underlayer was visible over a large surface area. In certain places settlement in the order of more than 1D can be observed.

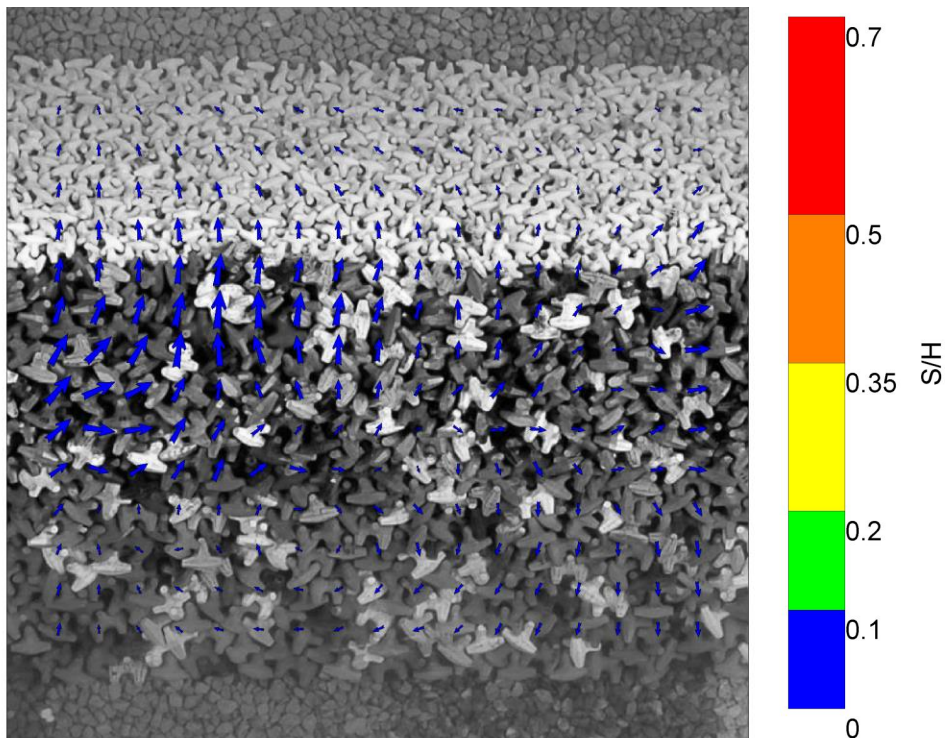
Figure 8 shows a top view of a low-crested breakwater with model Core-LocTM armour layer. The port side with smaller units is located at the top of the figure, and the sea side at the bottom of the figure. The figure shows the structure after being loaded by an extensive test series, including overload conditions. The minimum crest freeboard of all tests was $R_c/H_{m0} = 0.64$, so quite some overtopping occurred. No units were extracted during all tests. It can be seen that lower on the slopes hardly any settlements occurred. The units at the crest moved most, but still not much, with maximum displacements up to $0.04H$. So even though the layer is very stable, the first motions of the armour layer on the crest can be observed and reported.

Figure 8. Settlement analysis on low-crested breakwater trunk with Core-LocTM units.

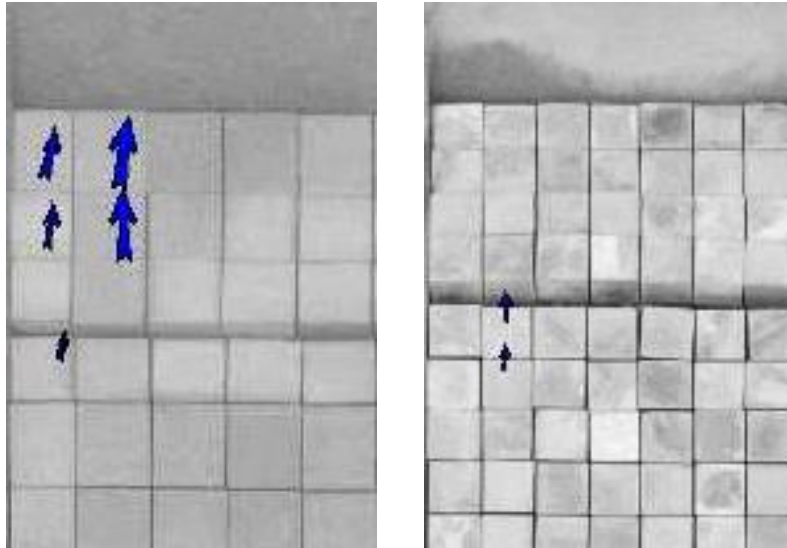
The image processing technique has also been applied to bed protections consisting of regularly placed concrete units. Versions with wide thin slabs and cubes were tested. The armour layers were very stable, with very small displacements that were hardly noticeable by eye. By using the displacement technique motions between 0 and 2 mm (model scale) could be detected and reported. A part of the two alternatives is depicted in Figure 9.

Figure 9. Settlement analysis on two bed protection layers.

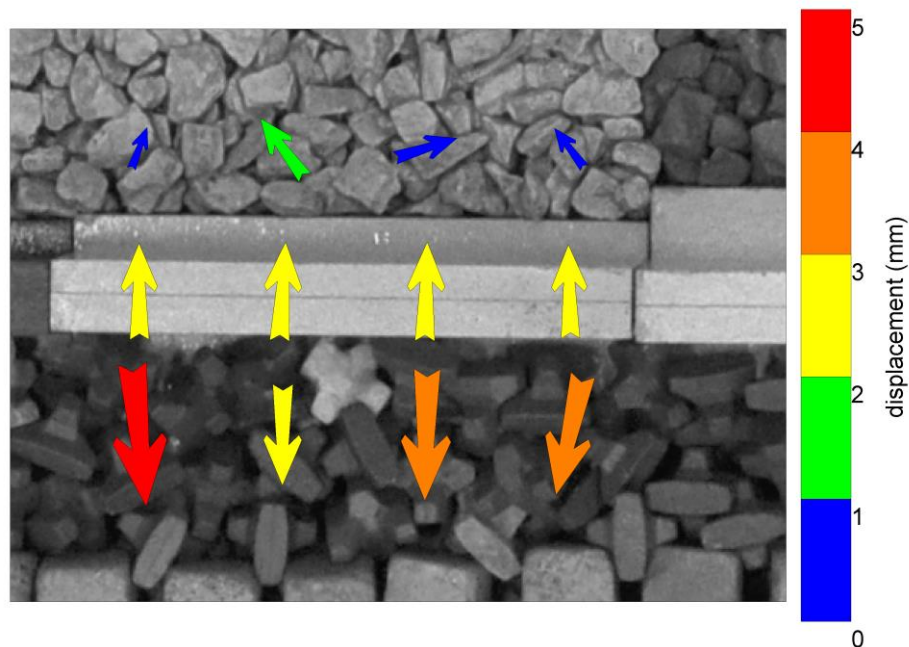
The settlement technique has also been applied to the displacements of crest elements (crown walls). The technique cannot detect the uniform colour of concrete very well. It works better when the concrete is given a random pattern. However, as can be seen in Figure 10, also on normal concrete the element can be recognized, and the displacement can be obtained from the settlement analysis. Note that the armour units in front of the crest element were displaced seaward

Of course, a displacement of a crest element can also be easily obtained from pictures taken before and after a test (series) by regarding the movement from a modelled crest element relative to a fixed point like the fixed model crest element next to the modelled element. However, when a row of crest elements is placed besides each other, only the relative displacements of the elements can be obtained in this manner. A global calibration of the images, as required for the settlement analysis, can be used to obtain the displacement of the crest element relative to a fixed earth point. Moreover the rotation in the horizontal plane can be seen from the transverse gradient of the vectors. In Figure 10 this rotation is limited.

Figure 10. Displacement analysis of crest element.
