12th International Conference on Structural Analysis of Historical Constructions

INTEGRATED CONSERVATION STRATEGIES IN THE NETHERLANDS

SILVIA NALDINI¹, ROB VAN HEES² AND ERNST VAN DER GRIJP³

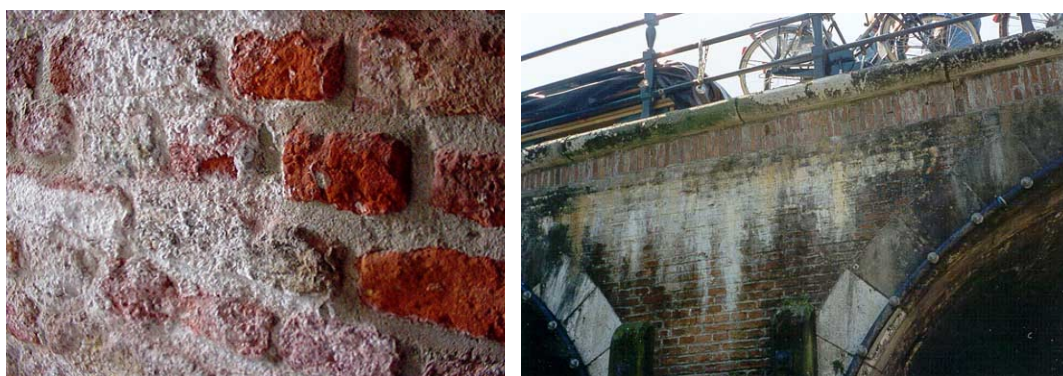
An example is the difference between salt efflorescence and encrustation. Both are clearly defined and explained in MDCS and illustrated with photos. Salt efflorescence is the result of transport of water and soluble salts via the pore system of a material; encrustation is the result of a process of percolation of water through voids and cracks, in combination with leaching of mortar constituents such as lime, which is subsequently deposited at the surface [figure 2].

Figure 2: Salt efflorescence (l) and encrustation due to leaching of mortar constituents (r)

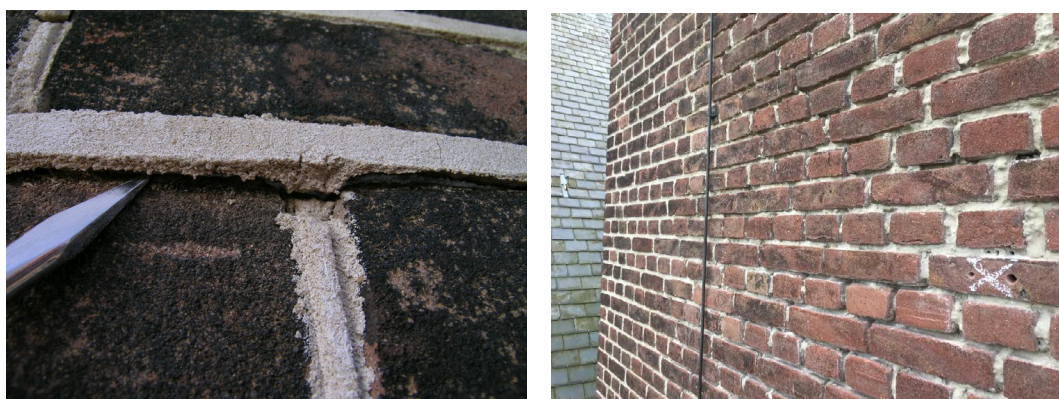
A passage of a MW report made before the adoption of the new terminology has been selected to show a description of damaged pointing. No reference to the source is given for privacy reasons. The description of the type of damage rises questions: ‘especially in the higher part (of the masonry) the pointing is damaged, cracked, has lost adhesion, is detached or washed out’. It is clear for the reader that the pointing is damaged and gone, but in which way? In one piece or through e.g. erosion? It is fundamental to identify the phenomenon in order to better understand the mechanism behind it: for example, in the case of push out, the pointing maintains its cohesion and is indeed pushed by e.g. the formation of a swelling compound or frost action; in the case of erosion the pointing loses particles [figures 3].

Figure 3 Examples of push out of pointing(l) and erosion (r)

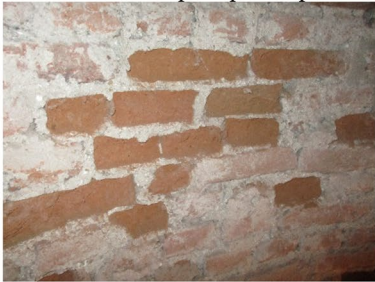
Figure 4: Passage of a MW report. The masonry is in a good state (G), with the exception of some moisture penetration and powdering of the stones. (No reference to the source is given for privacy reasons).

The passage of a MW report made before the course concerning a certain location in a building is compared to the passage on the same location based on the MDCS methodology [figures 4, 5].

In the first example the state of conservation of the masonry of a staircase is described as ‘good’, with the exception of some moisture penetration and powdering of the bricks. In the following report, MDCS terminology and methodology presented in the course (Monumentenwacht moves) are implemented. The identification of damage and its context is more complete and clear. Although the general state of conservation is rated as good, locally

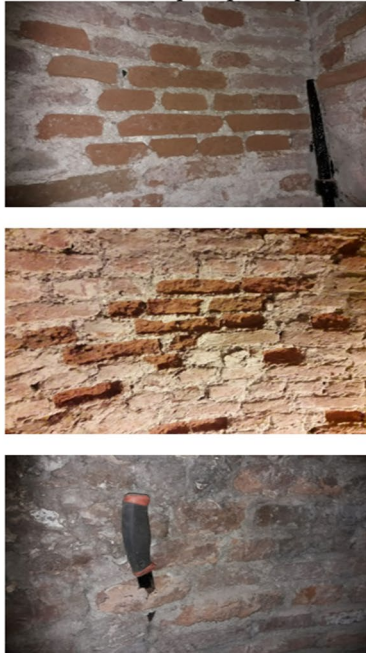
Figure 5: Passage of a MW report concerning the same masonry as in fig. 4, but written on the basis of the MDCS terminology and methodology. The damage is better identified and the damage mechanism explained. (No reference to the source is given for privacy reasons).

occurring damage is reported at the west side. The damage is identified as powdering, and moisture penetration is assessed. The mechanism is also explained: due to the moisture penetrated in the wall (soluble) salt is transported and deposited at the surface of the masonry, where it crystallizes causing damage to the ‘softer’ bricks in the first place. The specific damage found at different locations is disintegration → powdering (second picture) or layering and spalling (third picture). This way of reporting and explaining damage - based on visual assessment, which is inherent to the way of operating of MW – provides the inspector with a basis for planning further investigations (e.g. moisture and salt distribution) or else monitoring the extension and severity of the damage. MW Gelderland is presently developing a tool facilitating the storage of the information on the damage types and interventions. Such a tool would be easy to manage and could be used during (MW) inspections; it is deemed important for recording data, which are presently not always traceable, i.e. data concerning interventions.
