Monitoring Shear Behavior of Prestressed Concrete Bridge Girders Using Acoustic Emission and Digital Image Correlation

Sensors

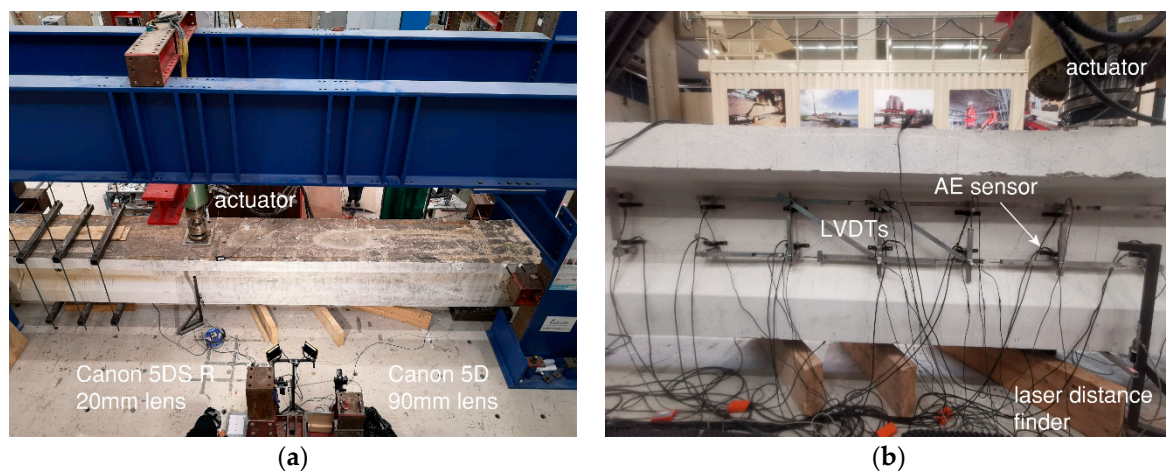
Figure 1. Overview of test setup: (a) At DIC side, and (b) at sensor side.

Figure 1a shows an overview of the test setup, including the girder, the steel frame used for applying the loading, one of the supports, and the actuator. The girders were simply supported with a span of 9.6 m. A single concentrated load was applied through a loading plate of 300 mm × 300 mm. The center of the load was at 2903 mm from the center of the support in HPZ01 and HPZ02, and at 4400 mm in HPZ03 and HPZ04. The purpose was to investigate the influence of load position on shear capacity. Detailed analysis can be found in a companion paper [4]. To avoid failure on the unwanted side, slipping of the prestressing strands and a possible spalling failure during the test, vertical prestressing was applied near the other support.

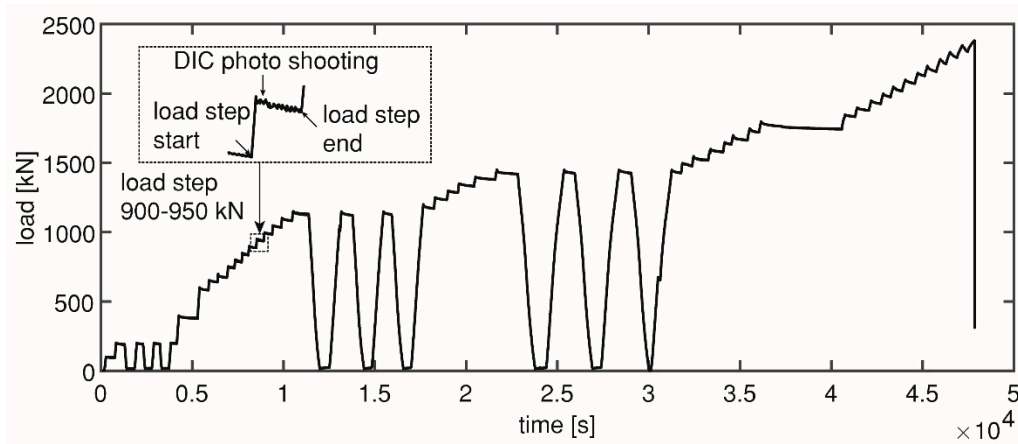
Figure 2. Loading history of HPZ04.

The load was applied in cycles of loading and unloading to predefined load levels, instead of monotonically to failure (Figure 2). For each beam, four load levels were chosen based on the expected structural responses during the test. At the first load level, no cracks occurred. By the second load level, a first flexural crack was expected. By the third load level shear cracks were expected. After the fourth load level, the specimen failed. The first three load levels are composed of three load cycles each. Small load steps of 50 kN were taken when loading to the load level for the first time. With these load cycles, crack opening and closing can be followed.

Local cumulative AE events within each load step was calculated. The start and end point of each load step are marked in Figure 2. In this way, we can track the change of local cumulative AE events with increasing load. As the number of AE events is related to the cracking activities [34], the change of local cumulative AE events was expected to indicate the local crack development.

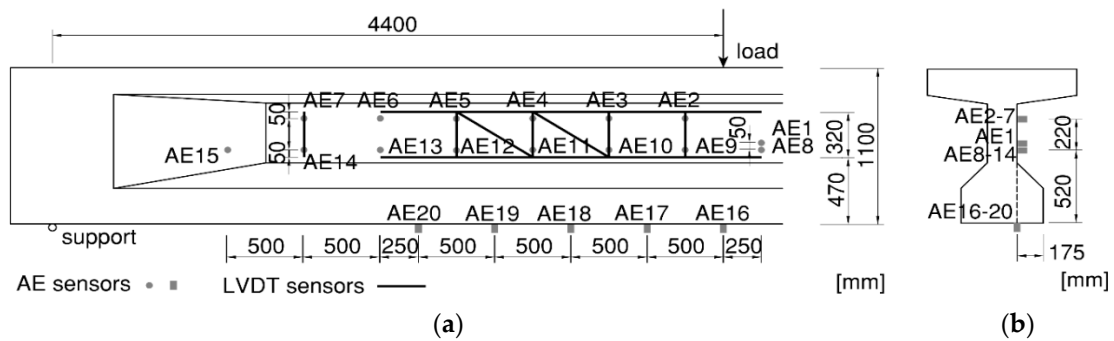
Figure 3. Sensor plan for beam HPZ04 showing LVDTs and AE sensors: (a) Side view; (b) cross-section.

In each experiment, similar sensor layout was used to cover the interesting measuring area. Figure 3 shows the sensor layout as used for HPZ04, including LVDTs and the AE sensors which are discussed in the next section. The other face of the girder was used for the DIC measurements, as also shown in Figure 1a.

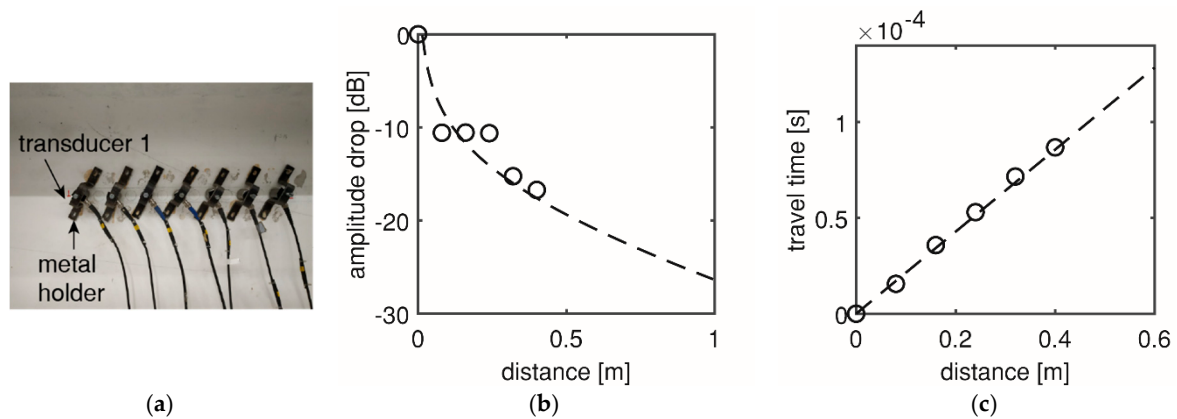
Figure 4. Baseline measurement in HPZ03: (a) Setup, (b) amplitude drop, and (c) wave speed.

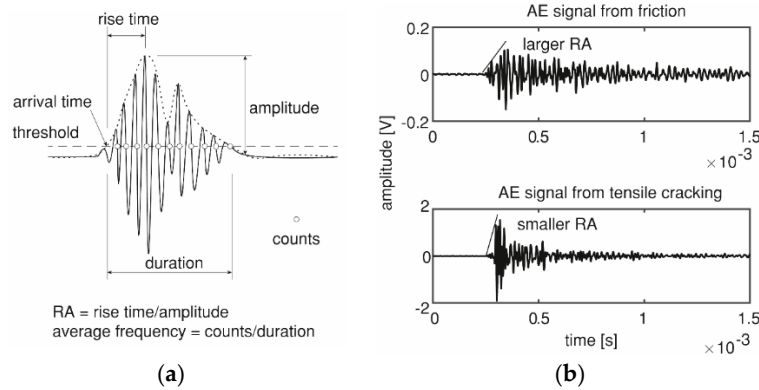
Figure 5. (a) Illustration of AE parameters and (b) AE signals from friction and tensile cracking. Based on the recorded signal arrival times, grid search method was used to estimate the source location [33]. The grid point, of which the calculated arrival times at the sensors were best matched with the recorded arrival times, was determined as the source location [7]. In this paper, the measuring area was discretized into a grid with size 5×5 mm. The mathematical formulation used in source localization can be found in our previous paper [6].

Based on the features of the received signals, one can classify the source types into tensile cracking and friction [8]. Four parameters derived from the signal are relevant: rise time, amplitude, counts, and duration, as defined in Figure 5a. Based on these four parameters, two widely-applied features in source classification are RA value, which is the ratio of rise time and amplitude, and average frequency,

which is the ratio of counts and duration [8]. Generally, signals from tensile cracking have a larger average frequency and a smaller RA value than those from friction [9,10]. These features were observed from two typical signals in our tests (Figure 5b). The counts are not marked in the typical signals because of their large number.

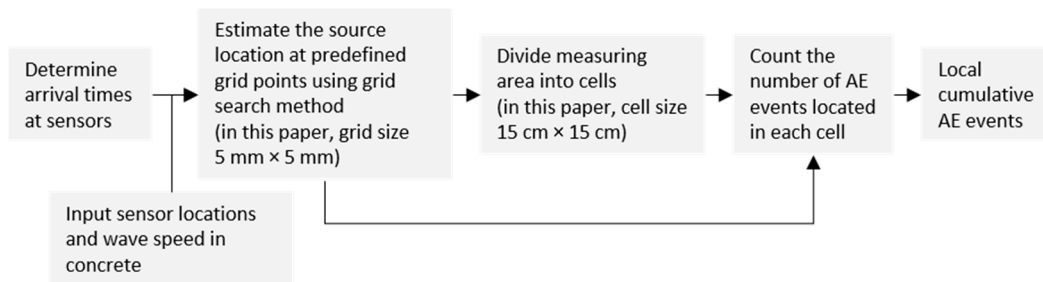
Figure 6. Approach of calculating local cumulative AE events.

To quantify the spatial distribution of the located AE events, we divided the measuring area into cells, and counted the number of AE events located in each cell, which was referred to as local cumulative AE events. This approach has been described in detail in [29]. The cell dimension is limited by the source localization error, and was taken as 15×15 cm in this paper. The approach of calculating the local cumulative AE events is illustrated in Figure 6.

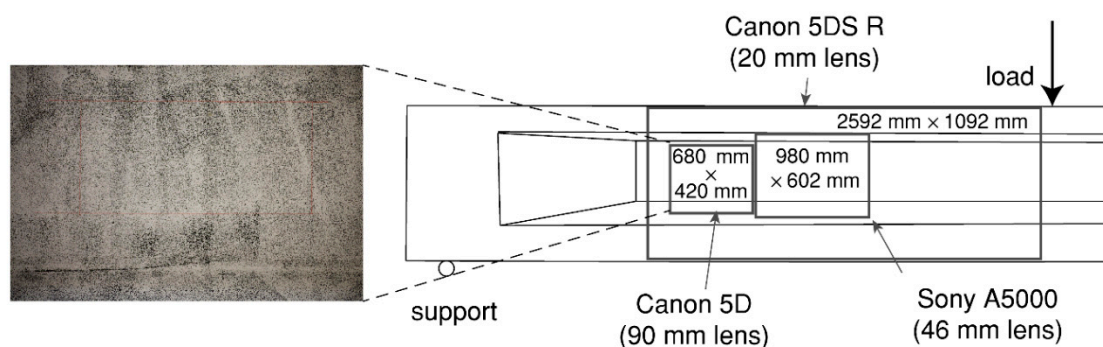
Figure 7. DIC setup for beam HZP04 showing the random pattern, and the position of the 20 mm wide angle lens, the 90 mm lens and the SONY A5000 camera.

At each load step, photos were taken of the DIC side. Figure 2 shows an example of one load step. For the four girders, a Canon 5DS R camera with 50.6 Megapixels resolution and a wide-angle lens (20 mm F1.4 fixed focus lens) were used on one side of the girder to capture the deformation in the web of the shear span. For HPZ02, HPZ03, and HPZ04, two extra cameras were used to capture the development of shear cracks in the web: a Canon 5D with 21 Megapixels with a macro lens (90 mm F/2.8 fixed focus lens) and a Sony A5000 (16–50 mm zoom lens at focal length of 46 mm) with 19.8 Megapixels. The camera-specimen distance for the Canon 5DS R was fixed to cover an area of 2590×1092 mm with a resulting pixel size equal to 0.31 mm. The Sony A5000 covered an area in the web equal to 980×602 mm with a pixel size of 0.19 mm. The measuring area of the Canon 5D was of 680×420 mm and the resulting pixel size was 0.13 mm. A scheme of the DIC setup with the areas of interest is shown in Figure 7.

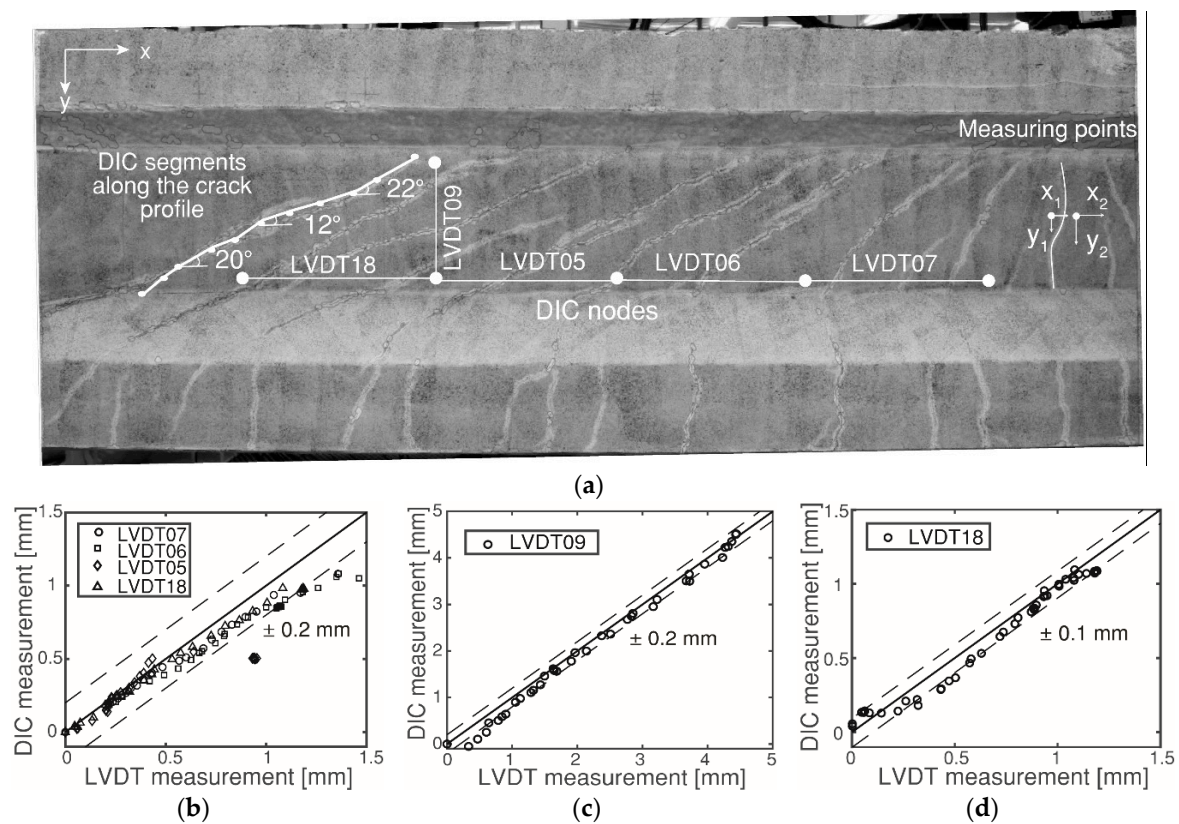
Figure 8. Calibration of DIC with LVDT in HPZ04: (a) location of DIC nodes and LVDTs 05–07, LVDT09, and LVDT18, together with the segmental division in one crack; (b) LVDTs 05–07 and LVDT18 measurements and DIC with Canon 5DS R (20 mm lens); (c) LVDT09 measurement and DIC with Sony A5000; and (d) LVDT18 measurement and DIC with Canon 5D (90 mm lens).

First, the accuracy of the displacement measurement from the DIC analysis was evaluated with the LVDT readings. The wide-angle lens distortion was corrected following the procedure described in [37]. The locations of the mounting nodes of LVDT 5, LVDT 6, LVDT 7, LVDT 9 and LVDT18 were determined on the DIC side. Figure 8a shows the location of the nodes on HPZ04. At these locations, the relative displacement differences in the horizontal or vertical direction of the nodes were compared with the measurements of the LVDTs. The comparisons between the DIC and LVDT measurements are given in Figure 8b,d. This figure shows that the difference between the two methods is within 0.2 mm and 0.1 mm depending on the resolution of the camera and the lens. Considering that the crack pattern and the displacement field were not completely equal for both sides of the specimen, the difference was acceptable. Similar results were found for the remaining girders in the experimental program. In general, the accuracy of DIC is dependent on the quality of the pattern, the subset size, the resolution of the camera and the lens [38,39].

The cracks obtained from the strain distribution were manually approximated to ten linear segments, from which the crack angles were calculated as shown in Figure 8a. The simplified crack pattern and crack angle were used for further analysis.

For each crack, two measuring points on both sides of the crack profile were determined. The displacement difference in the x -direction was defined as W (crack opening in the longitudinal direction), and the displacement difference in the y -direction was defined as Δ (crack opening in the transverse direction). An example of the measuring points is given in Figure 8a as x_i and y_i .

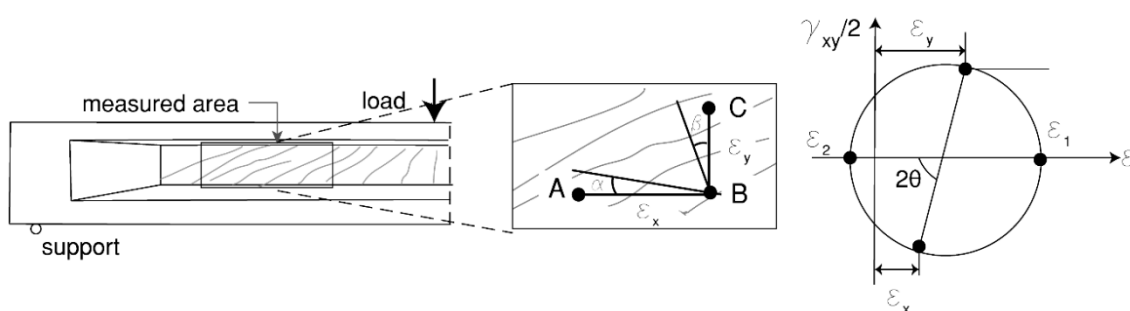
Figure 9. Scheme of measured area for HPZ04 and Mohr's circle for average strains.

An algorithm was developed to select the area of interest and to calculate the average strains (ε_x , ε_y , and γ_{xy}) from the displacement measurements of the DIC results. The normal strain in the y -direction (ε_y) was calculated from the average displacements along the vertical line \overline{BC} removing the outliers. For the normal strain in the x -direction (ε_x), a linear strain distribution was assumed along the height direction with the strain at the top side of the web being zero. When AB is located at the bottom of the web, the assumed distribution result in $\varepsilon_x = \varepsilon_{x\overline{AB}}/2$ with $\varepsilon_{x\overline{AB}}$ as the average strains along the horizontal line \overline{AB} located at the bottom of the web. The shear strain (γ_{xy}) was computed as the change of the angle between the lines \overline{AB} and \overline{BC} , thus $\gamma_{xy} = \alpha + \beta$, with α and β as shown in Figure 9.

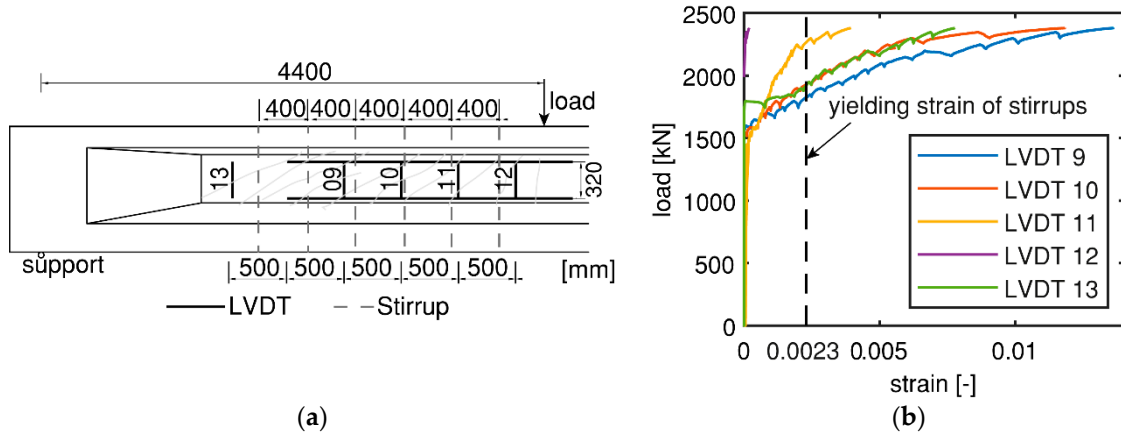
Figure 10. Measurement of yielding stirrups from LVDTs for HPZ04: (a) Position of the stirrups and LVDTs; and (b) Vertical deformation results of LVDTs.

Vertical web deformations measured by the LVDTs can help identify yielding of the stirrups. For example, Figure 10a shows the position of the stirrups and the vertical LVDTs in HPZ04. The results from the LVDTs are given in Figure 10b in which the yielding strain of the reinforcement (0.0023) is indicated with a dashed line. We can observe that strains at LVDTs 9–11 and 13 exceeded the yielding strain with increasing loading, but not for LVDT12. This could be because that LVDT12 was not in the shear cracking zone. An initial conclusion was that the stirrup next to LVDT12 was not yielded,

while the other five stirrups near LVDTs 9–11 and 13 possibly yielded. However, the information from LVDTs was not sufficient to determine the number of stirrups that yielded. Further study on the angle of compression field is needed which is discussed in Section 3.2.3.

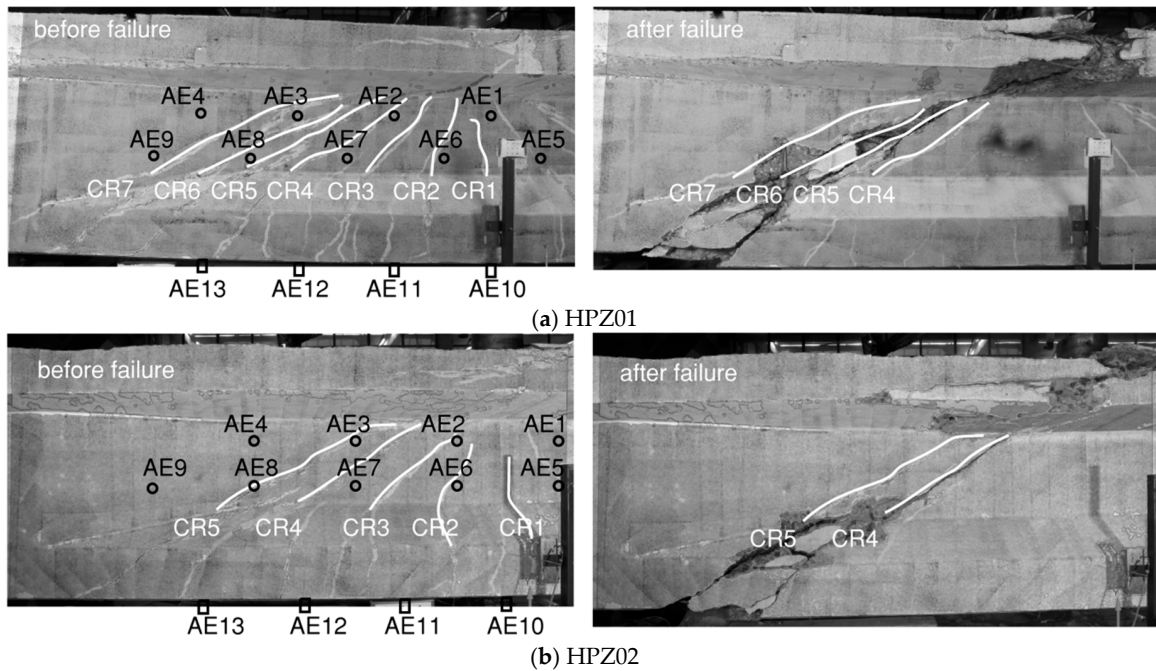
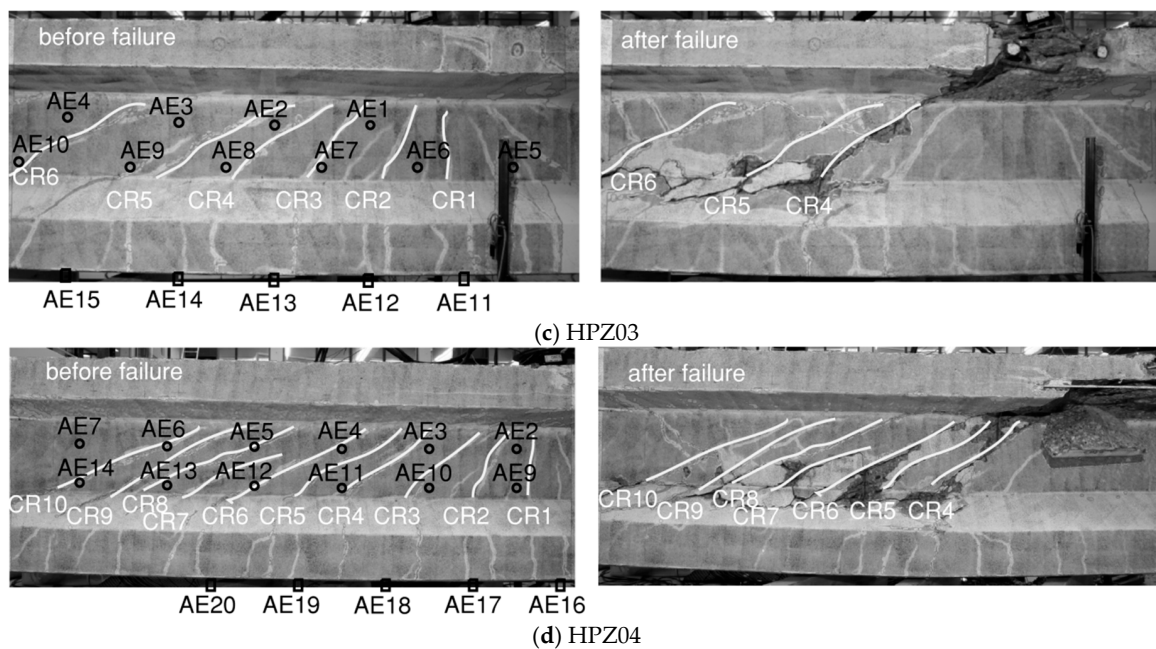
Figure 11. Crack patterns in the four girders from DIC results before and after failure, with the locations of AE sensors: (a) HPZ01, (b) HPZ02, (c) HPZ03, (d) HPZ04.

Figure 11 shows the DIC visualization of the cracks with numbering from smaller to larger according to their opening sequence. First, flexural cracks developed (e.g., CR1 in HPZ01), then flexure-shear cracks (e.g., CR3 in HPZ01), then shear-tension cracks (e.g., CR7 in HPZ01), and finally the failure of the specimen occurred (shown on the right-hand side in Figure 11).

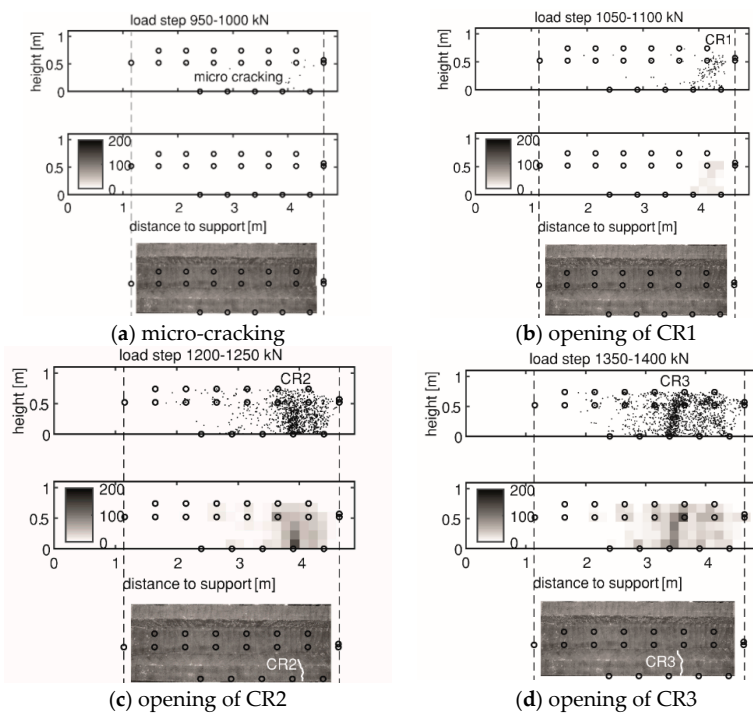
Figure 12. Opening of flexural cracks in HPZ04: (a) Microcracking; (b) CR1; (c) CR2; and (d) CR3. At each subfigure, from top to bottom: the first plot is the estimated location of AE events, the second plot shows the local cumulative AE events, and the third plot shows the incremental crack opening from DIC. The DIC results are edited to help the reader identify the important cracks.

Figures 12 and 13 indicate the gradually opening of flexural cracks and shear cracks in HPZ04 in the measuring area of AE and DIC. For each load step, three types of plots are included: the first one is the estimated location of AE events that occurred in this load step, the second one shows the local cumulative AE events, and the third one is the incremental crack opening from DIC. The interval of each load step is 50 kN.

When microcracking and the first crack CR1 were detected by AE, DIC did not show a clear crack pattern. For the other cracks like CR2 and CR3, DIC can detect the cracking at the same load step as AE. The main reason was that small crack widths can be masked by the noise in the DIC measurements. The difference in crack width was also reflected by the local cumulative AE events, as in CR1 the value was less than 50, while in CR2 the value was over 100. This meant the opening of CR2 was wider with more released energy. The drawback of AE was a lower resolution compared to DIC due to the source localization error.

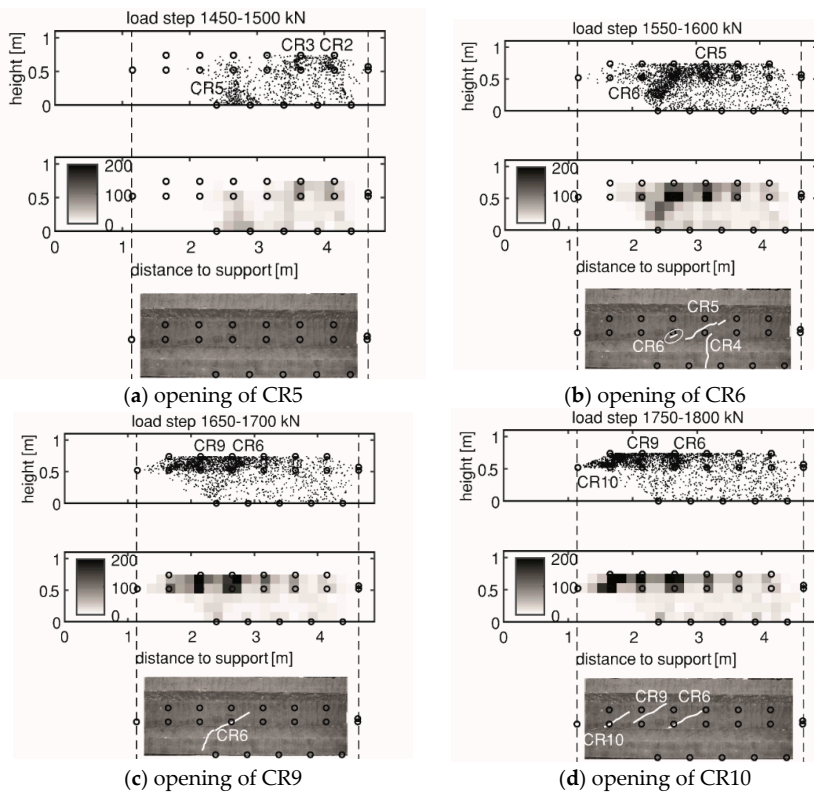
Figure 13. Opening of shear cracks in HPZ04: (a) CR5; (b) CR6; (c) CR9; and (d) CR10. At each subfigure, from top to bottom: the first plot is the estimated location of AE events, the second plot shows the local cumulative AE events, and the third plot shows the incremental crack opening from DIC. The DIC results are edited to help the reader identify the important cracks.

At a later stage, when more cracks opened, AE again detected cracks earlier than DIC. DIC was not able to detect the opening of CR5, further crack tip opening of CR2 and CR3 at 1450–1500 kN, when AE detected these activities (Figure 13a). AE can also detect opening of CR6 and CR9 earlier than DIC as can be seen in Figure 13b,c, respectively. However, AE was not sufficient to distinguish the actual crack pattern. More cracks between source and receiver delayed the wave arrival time and increased the source localization error, leading to unclear crack detection from AE at a later stage in the experiment.

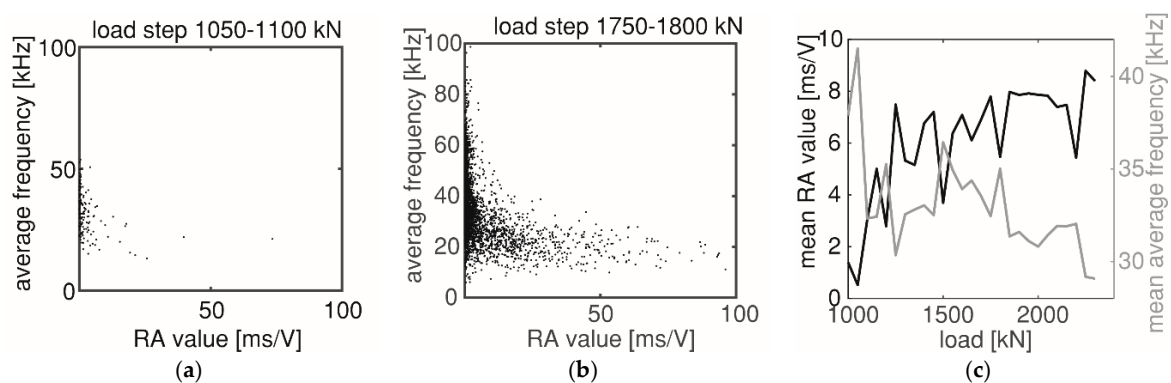
Figure 14. (a,b): Average frequency and RA value of each AE event at load steps 1050–1100 kN and 1750–1800 kN, respectively, and (c): Changing of mean average frequency and mean RA value with loading.

Figure 14 shows the AE crack classification results. Two parameters, the RA value and average frequency, are plotted for AE events occurring in an earlier load step (1050–1100 kN) and later load step (1750–1800 kN). The former load step was when the first flexural crack CR1 was detected (see Figure 12b), and the latter was when the last shear crack CR10 was detected (see Figure 13d).

Comparing Figure 14a,b, more AE events tended to have lower average frequency and higher RA value in the later load step of 1750–1800 kN. This observation means that more friction events happened in the later load step when the shear crack CR10 opened. This result agreed with the expectation that friction between crack surfaces occurred more in a structural member with more shear cracks than flexural cracks. Figure 14c compares the change of mean RA value and mean average frequency obtained in each load step with the applied load level, showing the trend of decreasing average frequency and increasing RA value when the load increased.

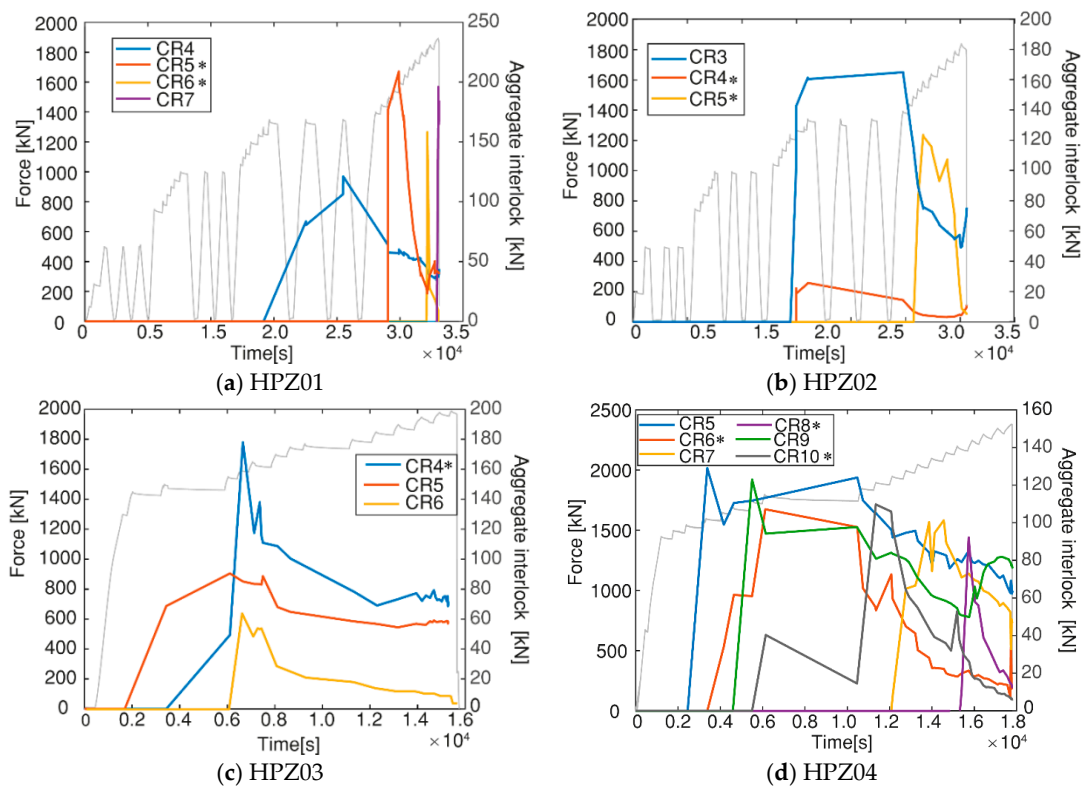
Figure 15. Aggregate interlock contribution during loading analyzed over time for all the experiments: (a) HPZ01; (b) HPZ02; (c) HPZ03; and (d) HPZ04. * indicates the critical shear cracks.

The aggregate interlock distribution was computed for all the experiments using the detailed results of crack kinematics and the crack profiles as introduced in Section 2.3.2. The results of aggregate interlock are given in Figure 15. For comparison, the loading scheme was also plotted in the same figure. The results for HPZ03 and HPZ04 considered only the last part of the loading scheme since flexure-shear and shear-tension cracks developed at this stage.

The general tendency shown in Figure 14 is that the aggregate interlock contribution was higher when the crack opening was smaller since larger contact areas were expected. The shear forces that were transferred through aggregate interlock of the cracks reduces with the increase of the applied load. The loss of aggregate interlock corresponded to an increase of the crack opening. For HPZ01, CR5 and CR6 merged into the critical shear crack which finally led to failure (see Figure 11a). A similar observation was found for HPZ02: CR4 and a secondary crack merged into the critical shear crack as shown in Figure 11b. Regarding HPZ03, the aggregate interlock could not be computed for the last load step due to a technical problem with the camera. However, the tendency indicates that there was a decrease of the contribution for CR4, CR5, and CR6. Figure 15d shows the results of the contribution of aggregate interlock for HPZ04. CR8, and CR10 present a decrease of aggregate interlock after the opening and development of CR8 at the load of 2145 kN. The shear stresses that were transferred through aggregate interlock in these cracks were almost zero at the moment before failure. CR9 presented an increase of aggregate interlock due to the compression of the cracked surface as a result of opening of the adjacent cracks. From these observations, we can conclude that aggregate interlock was not the governing shear-transfer mechanism. It became ineffective as the cracks widened and slid. The shear was transferred through the other actions, such as the stirrups and the direct strut from the load to the support.

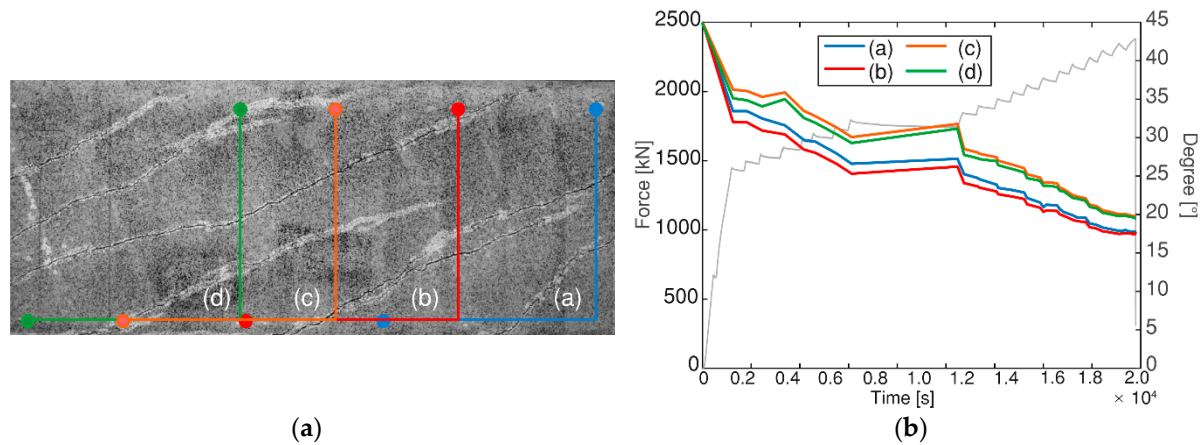
Figure 16. (a) Evaluated areas for HPZ04, and (b) Rotation of the principal strain direction during loading for HPZ04.

The angle of the compression field θ was calculated from the strain measurements as a function of the load. Figure 16a shows the four areas that were analyzed with the DIC algorithm and Figure 16b presents the resulting angle as a function of time and the applied load for HPZ04. The general tendency was that before cracking the principal strain direction was approximately 45° . Then, after the development of the first inclined crack, the stiffness changes and the principal strain direction rotated to a lower angle. The angle tended to increase slightly when the load was held for a considerable

amount of time as a result of the sustained loading. The results of the angle of the principal strain direction indicated that there was continuous rotation until failure, thus confirming that the angle of the compressive strut can be variable, as stated in the VATM.

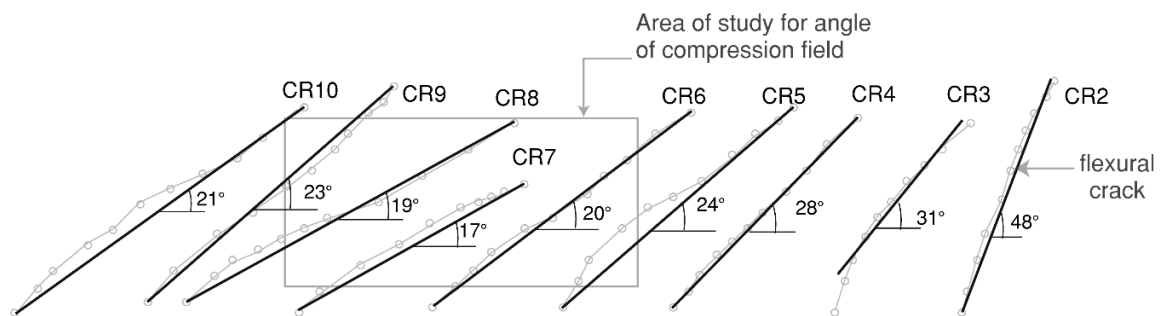
Figure 17. Crack pattern and crack angle from DIC results of HPZ04.
