Proceedings of the 4th European Regional Conference of IAEG (EUROENGE0 2024)

SOIL INVESTIGATIONS AS A CORNERSTONE FOR GEOTECHNICAL DESIGN OF LIQUEFACTION MITIGATION MEASURES BELOW LEVEES

liquefaction, levee, soil investigation works, remediation design, LeveeLiq project

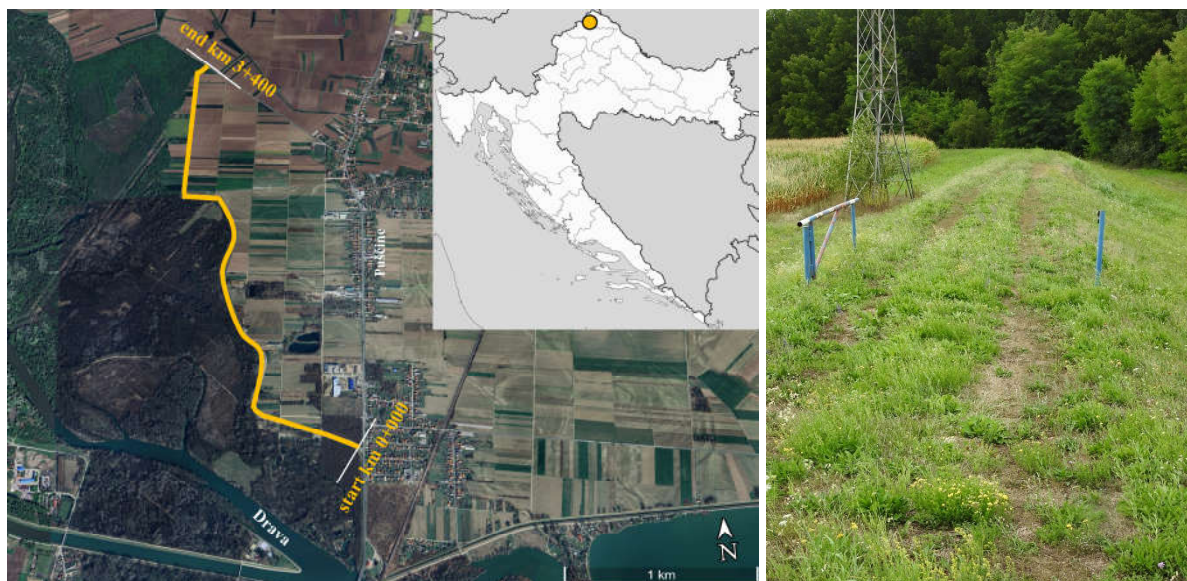
Figure 3. The layout and the current condition of the Pušćine levee

The Pušćine levee is located on the left bank of the Drava River in northern Croatia, Međimurje County, Figure 3, and is 3.4 km long. Initially built in 1966 to protect the settlements of Pušćina and Gornji Hrašćan from flooding, the levee does not have a sufficient safety height. This was demonstrated in November 2012, when the largest recorded water wave led to severe flooding in the area. It was decided to reconstruct the levee so that it meets the flow rate requirements of 2900 m³/s, which in turn means an increase of up to 1.5 m compared to the existing crest level. However, the raising and construction of the access road will shift the levee 12 to 20 m towards the water side to fit into the existing Croatian Waters' cadastral parcel.

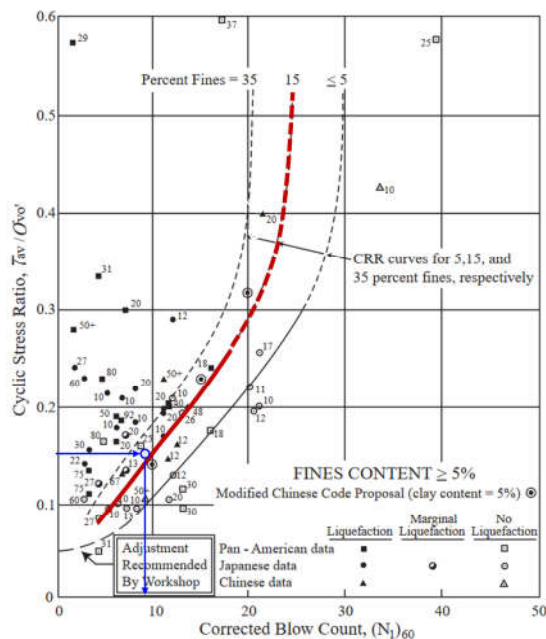
Figure 4. An SPT-based soil liquefaction chart, modified from Seed et al. (1984)

where the r_d is stress reduction factor, a_{max} is the peak horizontal ground acceleration, while σ_{v0} and σ'_{v0} represent total and effective vertical stress, respectively. The liquefaction resistance CRR parameter is the CSR value required to activate liquefaction, which happens when $CSR \geq CRR$. Using the a_{max} of 0.14g which corresponds to the seismic event of 475-year return period, and applying the stress-reduction, the calculated CSR is 0.156. For the silty sands with 15% of fines, which form soil just below the levee, the critical SPT blow number is 9 (without groundwater) to 11 (with groundwater), Figure 4. Therefore, main design identifies two criteria which should be fulfilled in order to consider the liquefaction mitigation measures: (1) the material of the surface soils are uniformly to poorly graded sand or silty sand; (2) SPT blow number in sand or silty sand should be lower than 9 or 11. When the obtained DPL blow numbers (Premur, 2022) are correlated with the SPT values, the associated SPT values range from 2 to 7 in sandy formations, followed by the significant increase in number of blows in lower gravel layers.

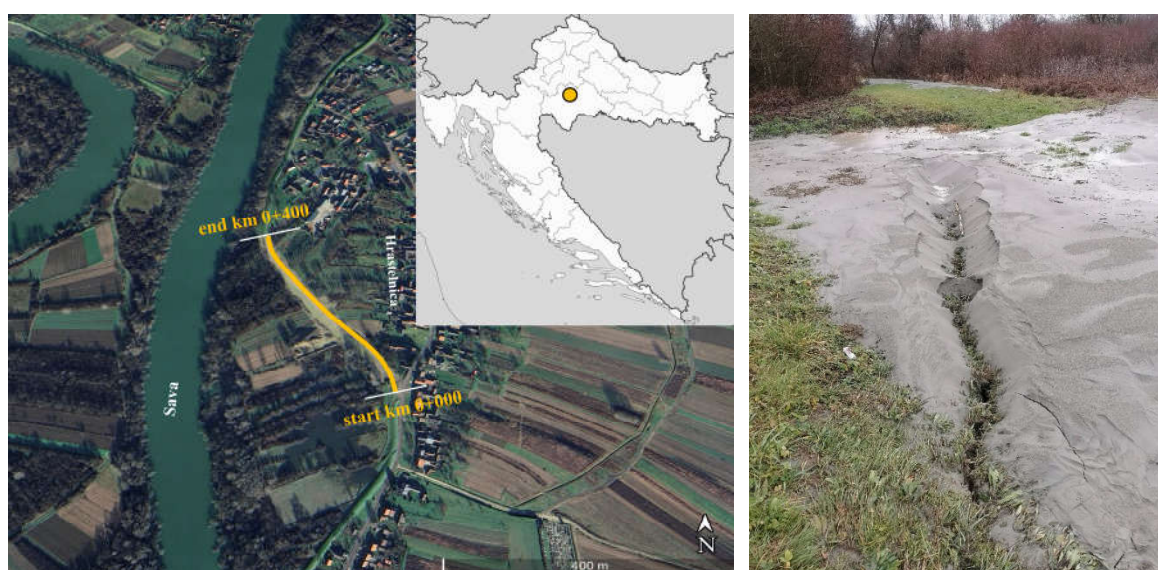
Figure 6. The layout of the damaged section of Hrastelnica levee with observed sand ejecta

As a result of the 2020 Petrinja earthquake, a levee on the left bank of the Sava River in Hrastelnica, Sisak-Moslavina County, showed significant deformations and cracks on the crest, slopes and surrounding soil. The length of the damaged section is 400 m, from km 106+200 to km 106+600 (Figure 6). The damage is largely due to liquefaction, with a large amount of sand ejecta observed.
