## Collapse test of prestressed concrete slab-between-girder bridge

# Collapse test of prestressed concrete slab-between-girder bridge

## 2 DESCRIPTION OF VECHT BRIDGE

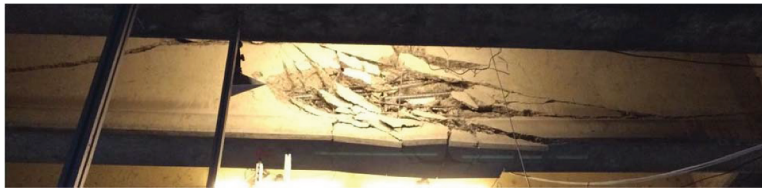
Figure 6. Shear failure of T-girder in test 1. The diaphragm is located on the left side and the end support on the right side.

The table also gives the Failure mode. For tests 1 and 2, Figure 6 illustrates the failure in the girder and Figure 7 illustrates the failure in the deck, which is the initial failure. Test 3 was an experiment on an edge girder. As there were safety concerns regarding the stability of the tower of counterweight upon failure of the edge girder, this experiment was limited to a maximum load of 250 tons. All experiments on the disconnected T-beams resulted in a flexural shear failure, see Figure 8. The load-deflection diagram of the connected girders is shown in Figure 9 and of the disconnected girders in Figure 10.

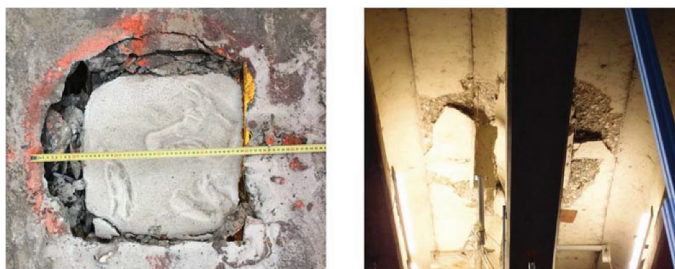
Figure 7. Punching failure of the deck slab in test 1, showing top view and measurements in cm (left) and bottom view (right).

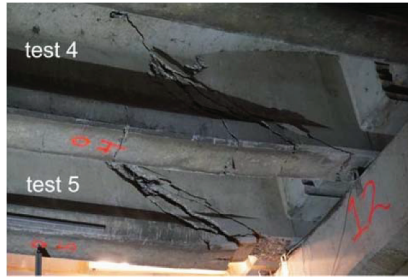
Figure 8. Flexural shear failures in test 4 and 5.
