## AN INTEGRAL APPROACH FOR THE ASSESSMENT OF TIMBER PILE FOUNDATIONS

Jan Willem van de Kuilen<sup>1,2</sup>, Olga Beketova-Hummel<sup>3</sup>, Giorgio Pagella<sup>4</sup>, Geert Ravenshorst<sup>5</sup>, Wolfgang Gard<sup>6</sup>

**ABSTRACT:** Timber pile foundations are widespread in many areas around Europe and North-America. Especially in areas with weak soils, timber pile foundations have been a very good and economic solution. However, aging of the foundations can become a problem, as physical, biological and/or chemical degradation may occur over time. Now, that foundations can be up to 500 years in cities like Venice, Amsterdam, Hamburg, Boston and many others, questions arise about the reliability and which assessment methods can be used in order to estimate the current load carrying capacity and their residual service life. Residual service life is depending both on the time-to-failure behaviour of wood, as well as, the dead and live loads on the piles below buildings, quay walls and bridges. The approach taken integrates degradation models with a reaction kinetics based damage model. For wood that remains consistently below the waterline, the combination of bacterial de

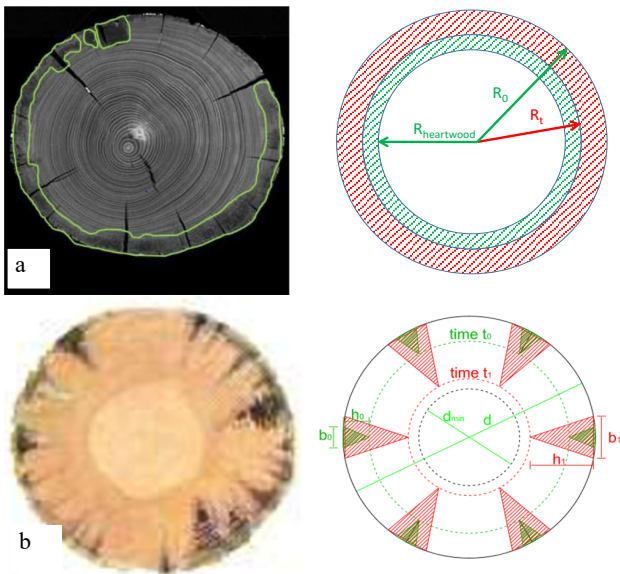
**Figure 4:** Cross section with decay profiles. a) Radial decay, b) Triangular decay, Left: Kleindienst et al, [8], Right: Gentner, N. [10].

For fungal decay, also other patterns can be identified, such as the one given in Ibach [8] and Kleindienst [9], which shows a pie shaped pattern, see Figure 3b. The expectation is that fungal decay grows radially into the wood, and then gradually spreads out in the tangential direction. Schematically, both types of decay can be represented in an idealized manner as shown in Figure 4. More recently, CT-scanning was used to get a better insight in how decay may be distributed over the cross section. In figure 4a, a non-uniform pattern of decay along the circumference is shown, similar to that of figure 3. This makes it possible to better understand how the rate and shape of the decay is reducing the structural safety and the remaining service life of a foundation. The rate of decay depends on many different factors, but wood species and type of decay are among the most prominent.

especially then, the low density of decayed wood becomes clearly distinguishable from the sound wood. In Fig.4 a CT image of a dried specimen is shown, where the outer (sapwood) zone is decayed over almost the full circumference. From the greyscale, this is clearly identifiable.

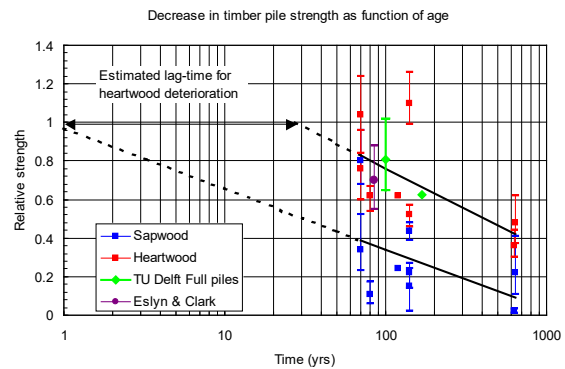
**Figure 5:** Relative strength of sap- and heartwood as a function of age [6].

Extrapolation of the line for sapwood confirms the finding of [3], that degradation of softwood starts relatively early after completion. For heartwood, additional data was presented in Zelada et al. [20], confirming its location in the graph, and a delay time for heartwood degradation of about 30 years can be expected. The estimated lag-time for heartwood deterioration, is comparable to the lag-time for decay initiation as presented in Wang et al. [22]. It must be mentioned that this is only a very rough assumption. The scatter is large and, as the thickness of the sapwood layer is different for different wood species, also the delay time will show a large scatter. On the other hand, there are also strong indications that progress of bacterial decay in for instance pine as very much reduced, as soon as the decay front has reached the heartwood. That indicates that there is kind of a natural maximum reduction of the cross section possible and the remaining cross section would continue to function for much longer, depending on the mechanical load level.

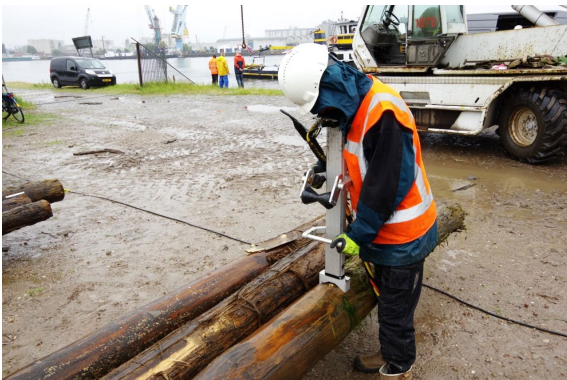
Figure 6: Microdrill in use on an excavated pile.

One of a few non-destructive and in-situ methods that is available for wood inspection is micro-drilling, such as IML-RESI PD. An IML-Resi for underwater use, is currently in a trial stage. In [17] an extensive analysis of microdrilling resistance and some of the pros and cons of the technology have been presented. The drill is equipped with a needle, which is injected through the cross section of the wooden trunk in question. As the needle passes through the material, the amount of energy needed to drive the needle through the medium is recorded/captured as drilling resistance. In case of IML-RESI PD, the needle is 3mm diameter at a tip and 1.5 mm diameter at its shaft. Resulting data is plotted as resistances vs distance, and shows a wave plot in which amplitude displacements coincide with changes in density and moisture content [19].

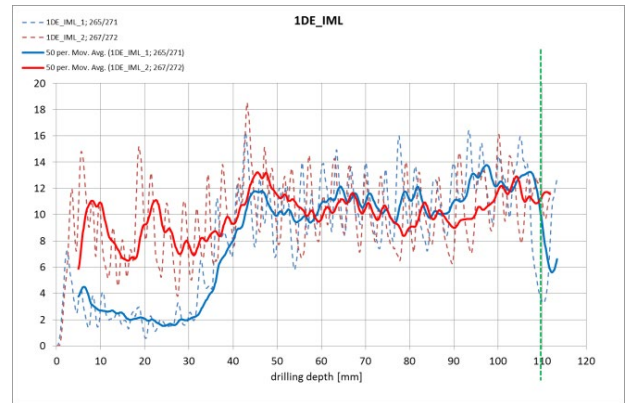
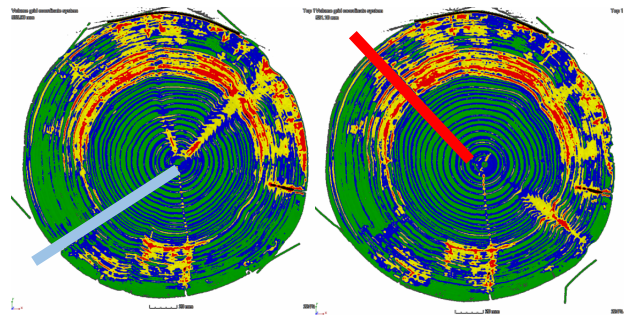
Figure 7: Top: drilling resistance profile created from micro drill test data. Bottom: CT-cross sectional image with location of micro-drill profile from the top graph.

Figure 7 gives a fundamental difficulty in measuring on-site with penetrating devices like a microdrill. As these devices give only a local result, it may happen that an area with no decay is hit (Red), or an area with high decay (Blue). In practice, only a limited number of measurements can be done, so there is no guarantee to obtain a tomographic image of the state of the wood through the entire cross section. Complicating aspects are areas within the pile with low natural density or strength. Low natural density can have similar drill resistance values as high density wood with a light level of decay. As a consequence, the assumed compression strength capacity as related to the drilling resistance shows quite a high scatter, see indicatively in figure 8, modified from Schreurs [21]. Red, yellow and green areas are indicative. A considerable overlap between Resistance values and Compression strength values can be identified, making classification of piles for strength a difficult exercise.

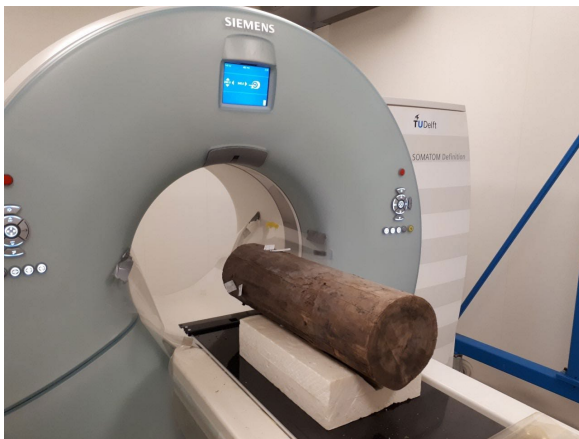
**Figure 9:** CT scanning test of retrieved timber pile

Another in-depth method of wood quality analysis is done with Computer Tomography (CT) scanning. This non-destructive method has been used for wood testing since the 80s [18]. It since has been used to determine density, wood quality and moisture content. Extracted old piles have been analyzed using a commercial CT-Scanner to determine wood quality as well as wood decay in the cross section, see Figure 9.

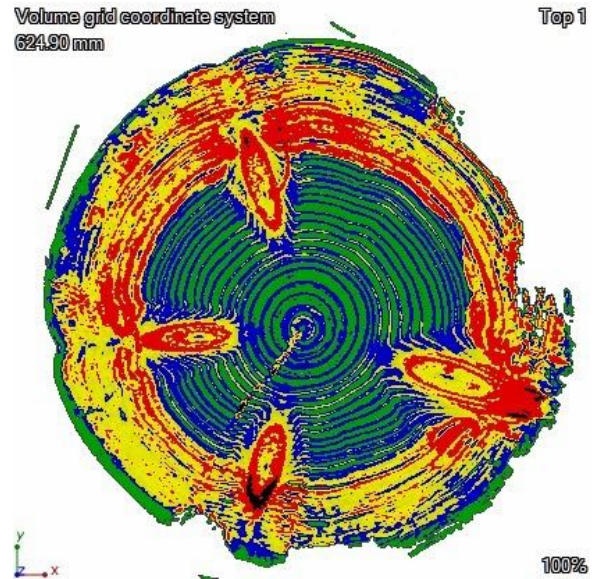
**Figure 10:** High density knots and sapwood with high moisture content (yellow/red) and juvenile and heartwood in the center (green/blue).

CT scans can provide highly detailed 3D images with features such as knots, cracks, heartwood and sapwood identifiable. A complicating issue is the moisture content during scanning. An example is given in Figure 10.

It can be seen that denser sapwood with high moisture content has a similar density level as the high density knots. Cleaning for moisture content allows for clear identification of the wood quality, including whorls that are generally governing the compression strength. Such a weak spot can be governing when verifying the load carrying capacity of a pile.

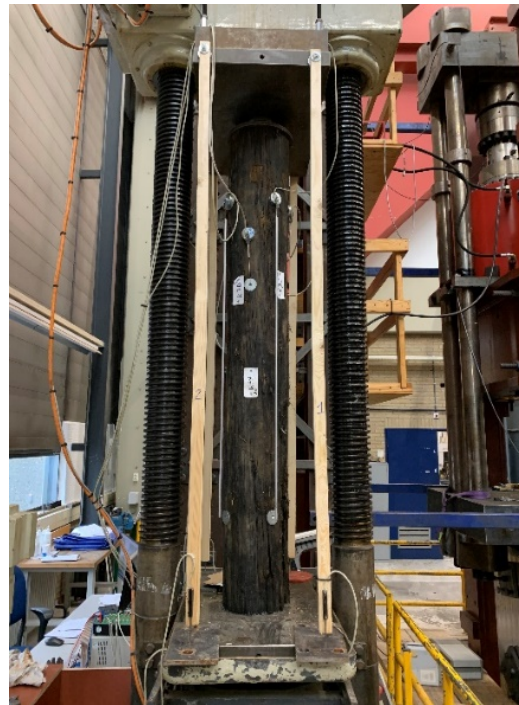
Figure 12: Large scale compression test set-up.

Mechanical testing on full scale pile sections is performed to determine (residual) compression strength and the static modulus of elasticity. For that, extracted piles are divided in three pieces (head, middle part and tail), debarked and prepared for the compression test. Depending on the diameter, the piles are cut in three different lengths (900 mm, 1350 mm, 1800 mm) according to the standards EN 408 and EN 14251 which prescribe an axial length of six times the smaller diameter of the cross section for a cylindrical pile. Before testing, the piles are submerged to reach the wet condition for the compression test, which means a moisture content higher than 70%. Figure 12 and 13 show the compression test set-up with pile sections up to 1800 mm length. LVDT sensors are placed between the plate heads and on the piles itself to determine the static modulus of elasticity. In order to obtain both global and local strength and stiffness information, LVDT measurement devices are placed over the length of the section, over the section with the largest knots or the section that is expected to fail in compression first. When testing full scale sections with decay, this will be more difficult to address, as sections with decay may still have a load carrying capacity of similar order as section with high knottiness values. Figure 14 shows a actual failure pattern with crushing wood in and around areas with many knots. Because of eccentricities of knots in the cross section, failure may concentrate on one side of the pile only. Apart from compression wrinkles, longitudinal cracks also develop at later stages,

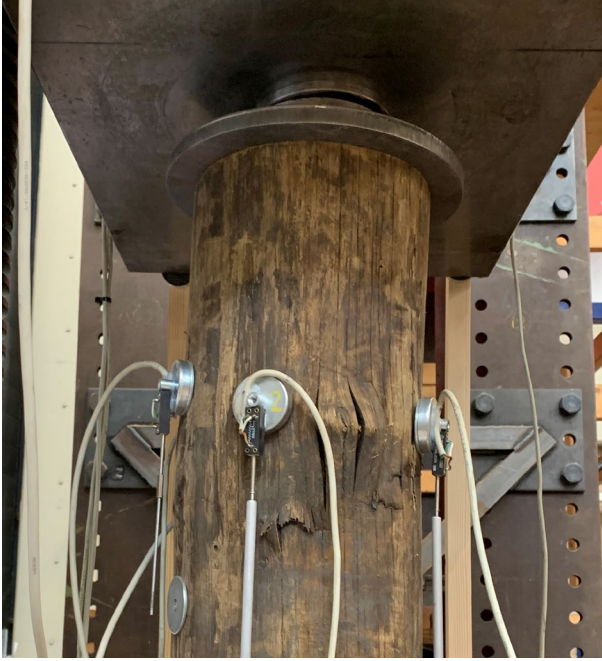
Figure 14: Failure in compression around knots
