Numerical investigation into the effects of corrosion on the shear performance of pretensioned bridge girders with cast-in-place slabs

Jadwiga Osmolska, Magdalena; Kanstad, Terje; Hendriks, Max A.N.; Markeset, Gro

Structures

Corrosion and shear cracking are frequently observed near supports of pretensioned bridge girders in coastal climates, so non-linear finite element analysis was used to study the effect of corrosion on shear performance in a real case study. Varying degrees of corrosion and various locations (top strands, bottom strands, vertical stirrups and girder-slab interface) were considered. The analyses included construction phases, concrete creep and shrinkage, and the effects of corrosion on the properties of prestressing and reinforcing steel, concrete, and the bond between concrete and reinforcement. The study shows that high (20%) corrosion in the bottom layer of strands can modify the failure mode from concrete crushing in the web to strand slippage or crushing of concrete in the support zone with limited cracking. Although severe strand corrosion significantly compromises girder capacity and ductility, failure occurs only when there is overloading. The predict

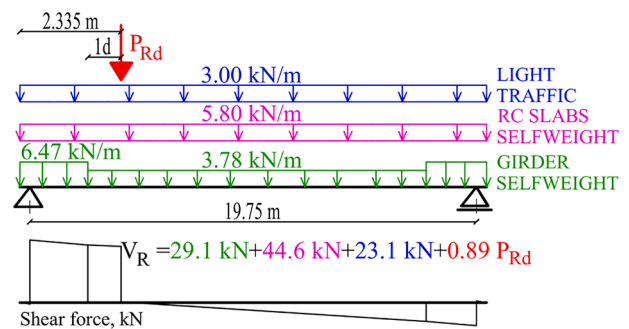
Fig. 4. Shear resistance expressed in terms of applied loads.

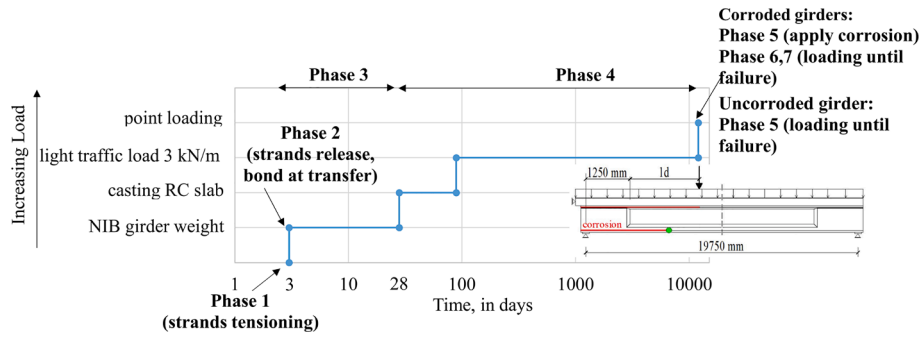
Fig. 8. Sequence of the NLFE phased analysis.

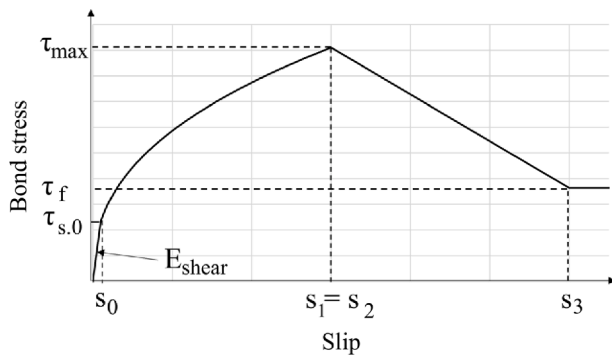
Fig. 11. Schematic view of the bond-slip model for the strands.

strands. To simulate the bond-slip behaviour of the pretensioned reinforcement, line interface elements for each strand layer were modelled as embedded in the plane stress concrete elements.

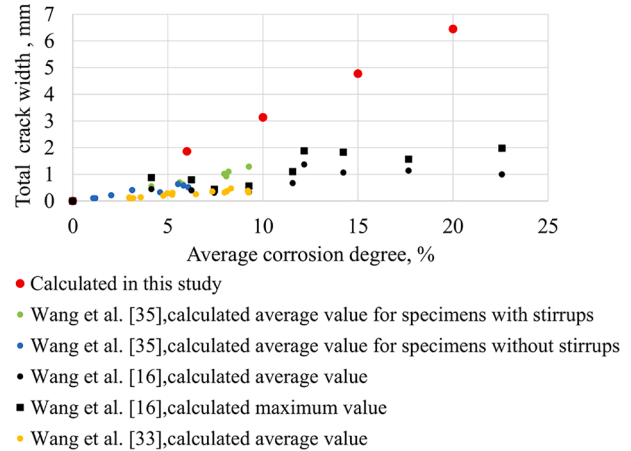
Fig. 14. Total corrosion-induced crack widths in pretensioned elements recorded from experiments.

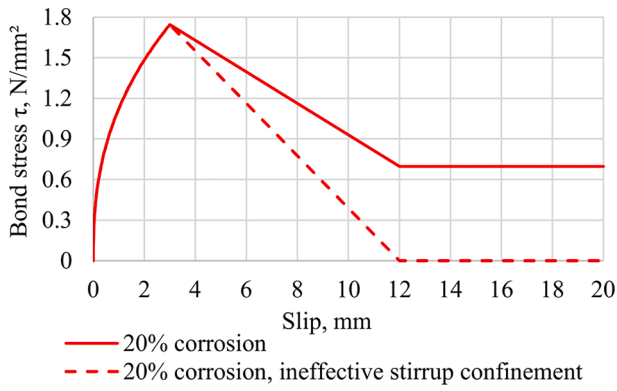
Fig. 15. Bond-slip model for strands with 20% corrosion assuming effective and ineffective stirrup confinement.

a residual friction stress τ_f equal to zero to simulate ineffective stirrups. The comparison of bond-slip curves for 20 % corrosion with and without effective stirrup confinement is shown in Fig. 15.

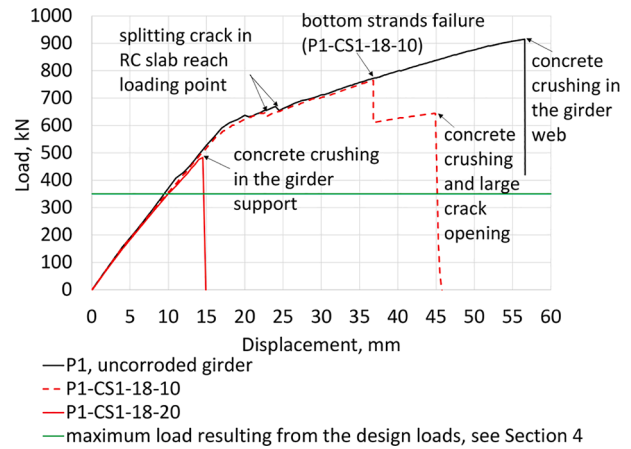
Fig. 19. Load-displacement curves obtained for the uncorroded girder (P1) and the girders with corroded bottom layer of strands (P1-CS1-18).

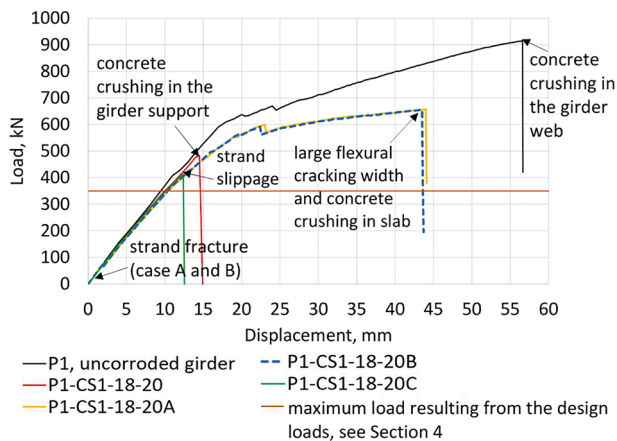
Fig. 25. Load-displacement curves obtained for the uncorroded girder (P1) and the girders with 20% corrosion in the bottom layer of strands assuming varying concrete or bond parameters as described in Table 6.

The structural behaviour of girders P1-CS1-18-20A and B are similar. Detailed results are therefore shown only for the girder with slightly lower capacity (Girder 20B). Fig. 26a shows that the bottom layer of the strands fractured at the assumed location (1.8 m from girder end) immediately after applying 20 % corrosion. Consequently, the girder stiffness was reduced as shown previously in Fig. 25. Despite the fracture

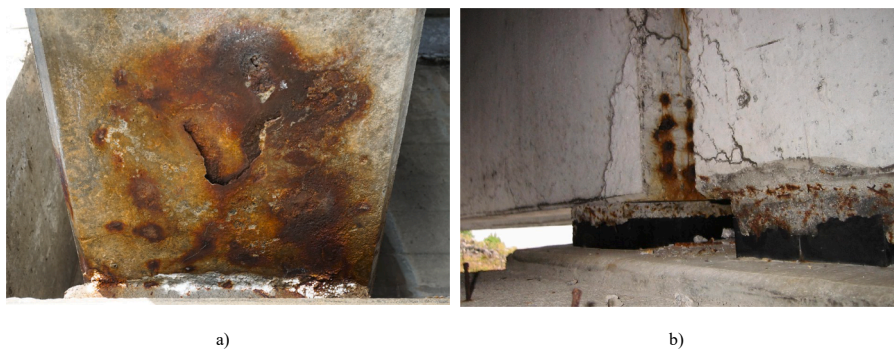
Fig. 30. Corrosion cracking in bottom of pretensioned girders: a) significant corrosion cracking in the NIB girder bottom flange near support, bridge close to Kristiansund; and b) corrosion cracking and spalling in the NIB girder-ends, photo by NPRA [7].

The development of cracking in the case with failure in the anchorage zone may show some similarity to the cracks observed in the field, particularly those propagating from the top of the web for a load lower than the maximum load of 350 kN estimated in Section 4 from the design loads, cf. Fig. 31 and Fig. 1c. Those types of crack, however, also
