Switch Panel wear loading—a parametric study regarding governing train operational factors

Hiensch, E. J.M.; Burgelman, N.

Vehicle System Dynamics: international journal of vehicle mechanics and mobility

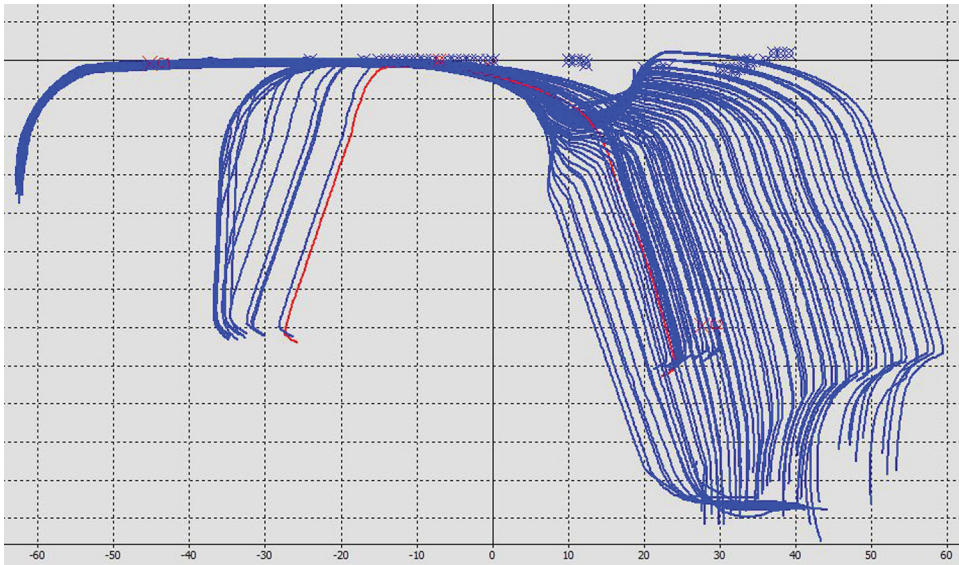
Figure 4. Overview of Miniprof rail cross sectional profiles measured at a section of the switch panel: the combined stock and switch rail serving the diverging route.

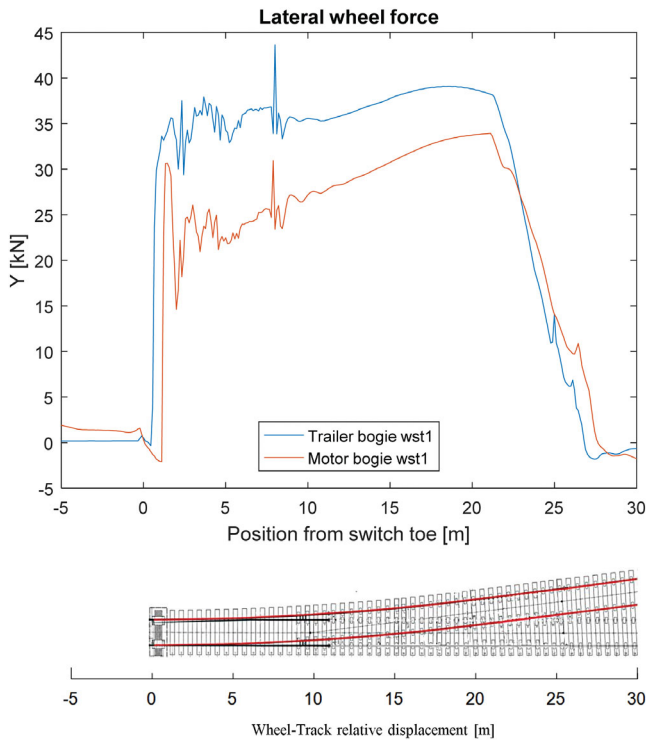
Figure 6. Lateral wheel force of at the leading wheel of the front bogie (trailer) and second bogie (motor).

To illustrate the overall dynamics at play for the modelled vehicle negotiating the 1:9 switch, the resulting lateral and vertical forces for the reference situation are presented in Figures 6 and 7. For the leading wheel of each bogie almost directly after entering the

switch flange contact occurs, resulting in a sharp increase in lateral wheel force. Throughout the switch panel and crossing panel the wheels remain in flange contact, showing a rather irregular behaviour during the first 8 m.

The irregular lateral and vertical wheel force values corresponding to the first 8 meters into the switch panel are caused by discontinuities in the wheel–rail contact conditions. The use of measured rail profiles at the switch panel, especially those combining stock and switch rail, will involve small alignment deviations between the successive measurement locations. These deviations and resulting changes of the wheelset relative to the rail cause the wheel–rail contact position to jump between switch rail and stock rail. This leads to abrupt changes in contact pressure, rolling radius and slip levels and is reflected in the observed sudden changes in Y and Q values, the overall development however remains clear. Beyond these first 8 m, the rail is described by a single measured profile, resulting in a steadier wheel–rail contact behaviour.

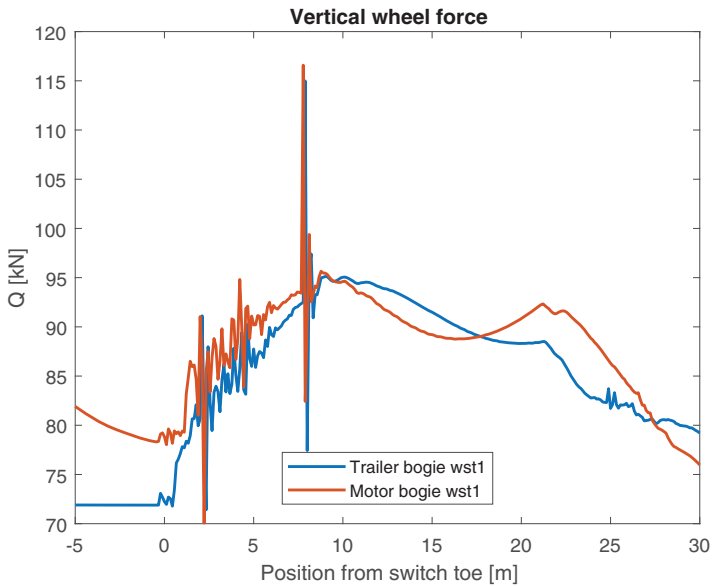
Figure 7. Vertical wheel force of at the leading wheel of the front bogie (trailer) and second bogie (motor).

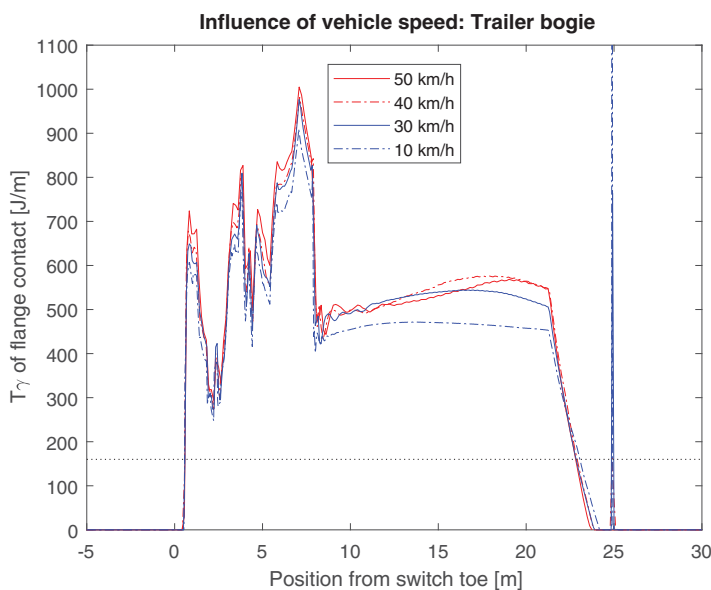
Figure 8. Wear loading for different train speeds. T_γ development at leading wheel of leading bogie.

Figure 8 presents the effect of train speed in relation to flange contact T_γ development at the leading wheel of the leading bogie. When negotiating the switch panel, three distinct peaks for T_γ are seen to arise. These occur from changes in contact position and corresponding changes in locations and orientations of contact forces and slip. Upon entering the switch, a first peak for T_γ arises due to the appearing flange contact. A second peak occurs when the wheel load fully transfer from stock rail to switch rail. A third peak arises

at the end of the switch rail: at the transition of the machined switch rail profile to the nominal profile.

Figure 8 clearly shows the influence of train speed to be rather small. This observation is in accordance with the findings of the parametric study reported in [3] concluding that, for a give combination of wheel profile and axle load, the influence of train speed on contact pressure is small. Similar VAMPIRE[®] simulation results are reported in [19], presenting a modelled 1:9 turnout and container wagon (22.5 tons axle load). For the presented vehicle speed range of 5–50 km/h, it can be observed that the influence on wear energy development at the flange contact is very limited, this again in correspondence with the present study.

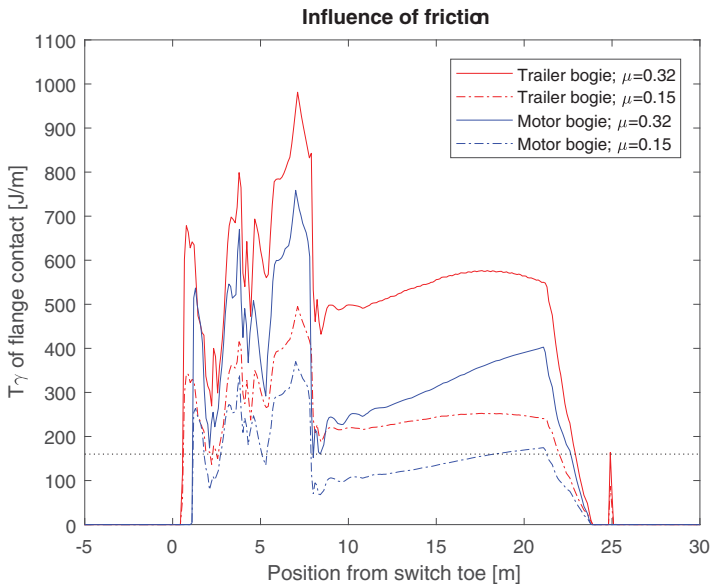
Figure 9. Wear loading in dependency on friction coefficient. $T\gamma$ development at the leading wheel of trailer and motor bogie.

The effect of the wheel–rail friction coefficient within the flange contact is presented in Figure 9.

The friction coefficient is seen to have a significant effect on the level of $T\gamma$ and the corresponding wear loading of switch and closure panel. Decreasing the friction coefficient from $f = 0.32$ to $f = 0.15$ will halve the lateral wear loading at the switch rail gauge face. For the lubricated (low friction) condition, the resulting $T\gamma$ values of 300 J/m for the leading trailer bogie and 200 J/m for the motor bogie indicate the switch rail to operate within the regime of full wear. The expected wear rate however is much lower compared to the non-lubricated (high friction) condition. From the resulting $T\gamma$ values in lubricated condition ($T\gamma \approx 200$ J/m), operation of the closure rails can be expected to be within the regime of mild wear for the leading bogie. For the motor bogie, with $T\gamma$ values for the reviewed configuration varying from 100 to 180 J/m, locally a shift into the RCF/wear regime is to be expected.

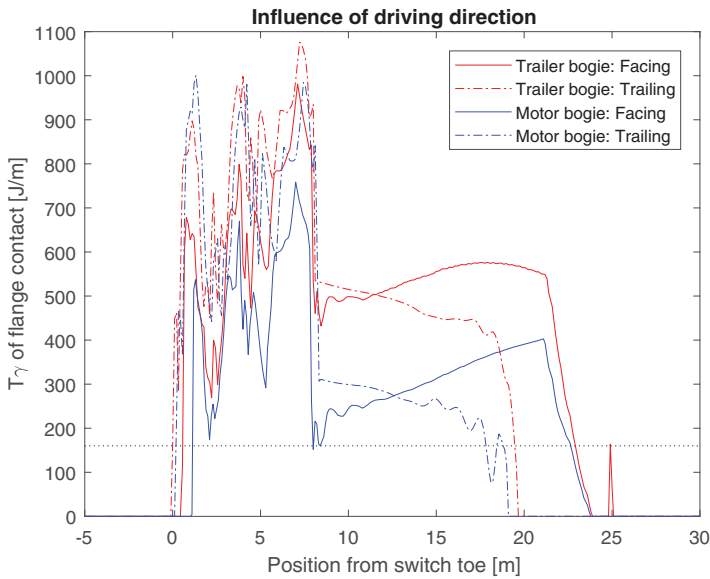
Figure 10. Wear loading for different directions of traffic (trailing/facing). T_{γ} development at the leading wheel of motor and trailer bogie.

Figure 10 shows the effect of direction of travel at the diverging route, presenting the T_{γ} development for the leading wheels of first (trailer) and second bogie (motor). When travelling in the trailing direction (running along the point), the wear loading at the switch rail is seen to be 30% higher compared to the facing direction (running towards the point), as can be seen in Figure 10. The wear loading at the closure rail on the other hand is seen to decrease when travelling the diverging route in trailing direction. *Remark:* in both trailing and facing direction the applied vehicle orientation is equal with respect to the direction of traffic: the front coach is followed by intermediate coach.

This effect in wear loading can be explained by the relatively short curved section for this type of switch. When the leading bogie enters the curved section of the turnout, the second bogie will still be in the tangent track section. When going further down the curve the coach will start to rotate with respect to the second bogie, addressing the rotational resistance between these two. The resulting torque will increase the lateral (Y) force at the flange contact of the leading wheelset. When the leading wheelset has passed the switch curve, a similar however less pronounced effect will occur at the flange contact for the second bogie. This effect is illustrated in Figure 11, presenting the lateral (Y) forces when negotiating a curve with radius 195 m, curve length 20 m, without transition curves. It can be observed that for both the leading (trailer) bogie and second (motor) bogie the lateral forces at the leading wheel are gradually increasing.

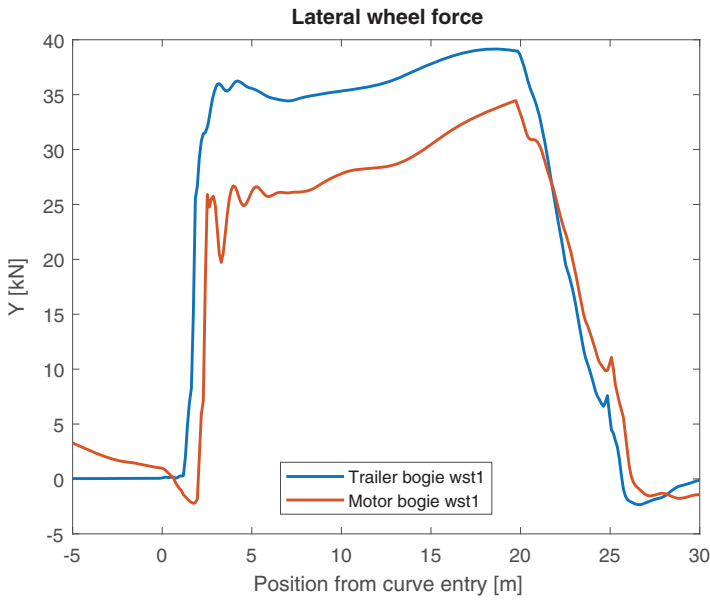
Figure 11. Development of the lateral (Y) forces when negotiating a curve with limited length (20 m).

The effect of the track layout has been considered by connecting the left-hand switch to a right hand curve with 195 m radius without cant, creating an S-shaped curve. The influence of this alignment set-up seems to be small. After negotiating the curve the lateral

position of the wheels is out of centre. This has an influence on the position where the wheel flange makes first contact with the switch rail, it however has no significant influence on the level of the wear loading. Increasing the gauge to 1445 mm does not show to have a significant influence on the level of wear loading, nor does traction show a notable effect.

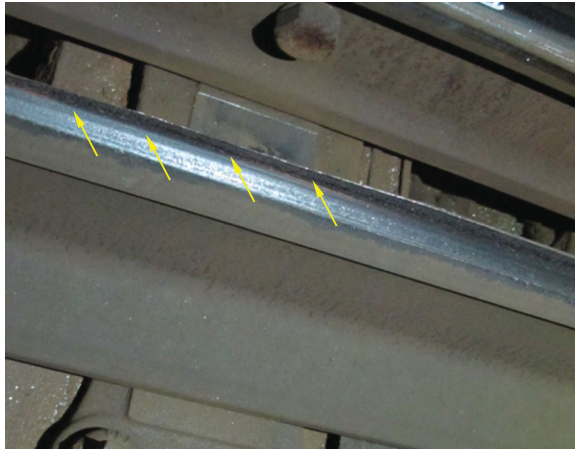
Figure 12. Severely worn switch rail (inspection December 2014).

An opportunity to expand the scope of this parametric study occurred when issues with severe switch rail wear were reported at a large number of 1:9 turnouts installed at the ProRail railway yard of Amsterdam Central Station (see Figure 12).

The most extreme case that was reported, was 1 mm of side wear within nine days, resulting in a significant increase in maintenance pressure and related cost for repair and renewal. A corresponding increase in side wear was also reported for the high rail of a number of narrow curves near the station. This abrupt increase in wear behaviour offered the opportunity to study the effect of possible changes in operational parameters to which modelling results can be cross-checked.

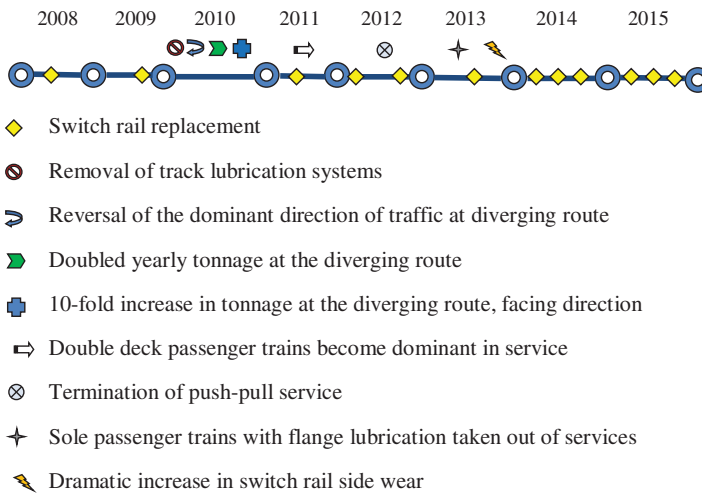
Figure 13. Switch rail replacement dates for one of the ‘severe’ wearing switches (left switch rail, serving the diverging route). Period August 2008 – September 2015.

The switch rail lifetime development of the selected switches was analysed from the contractor’s maintenance logs. Figure 13 shows how the time interval between replacements has decreased for one of the ‘severe’ wearing switches, illustrating the effect of the increasing wear rate on rail lifetime. Around 2010 several changes occurred, as indicated in Figure 13. These changes are reflected by the replacement interval. During the period 2008 up to and including 2010 the average switch rail life is approx. 17 months. The involved maintenance specialists consider this life span as ‘to be expected’ given the extreme conditions at the Amsterdam CS yard. During the years 2011–2013, after the mentioned change in switch loading and routing in 2010, the average switch rail life is seen to decrease to approx. nine months. From 2014 the average switch rail life suddenly further decreases to approx. three months. For comparison: the in March 2011 installed left switch rail at one of the ‘mild’ wearing switches was to be replaced only in September 2015, after a life span of 53 months. Although over this period, the average annual tonnage in the diverging route for this switch is about 2/3 of that for switch illustrated in Figure 13, the observed difference in switch rail life is still significant.

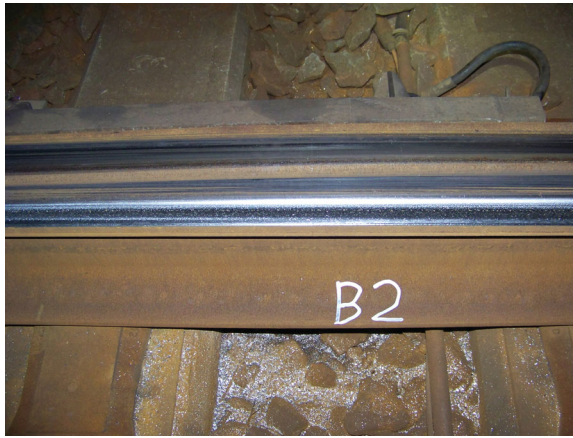
Figure 14. Switch panel of ‘severely’ wearing switch (left switch and stock rail). Wear debris present, high roughness of gauge face. No lubrication marks.

Following the selection of 'severe' and 'mild' wearing turnouts, track inspections were carried out at the selected turnouts. Transverse profile, track gauge and roughness measurements were performed at several positions, together with visual inspections of the running band to assess the presence of RCF damage and lubrication. These results served as further input to the problem analysis. At the date of inspection (4 September 2015), the operational performance time of the inspected four left switch rails was, respectively, 1, 3, 6 and 52 months. During the track inspection, a distinct difference in visual appearance was observed between 'severely' and 'normal' wearing switches. Wear debris were clearly present at the switches with reported 'severe' wear, together with plastic deformation and spalling of the switch rail tip and high roughness of the gauge corner (Figure 14). The gauge corner of the switch with reported low wear rate, possesses a smooth running

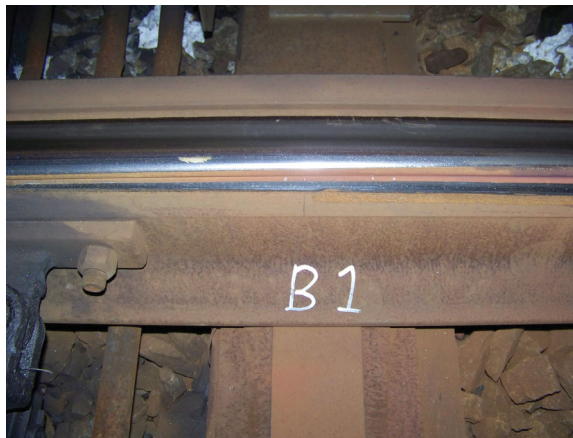
Figure 15. Switch panel of ‘mild’ wearing switch (left switch and stock rail). No wear debris observed. At the gauge face remains of lubrication are present.

surface with no debris particles on site. At the switch rail gauge corner of this ‘mild’ wearing switch remains of flange lubrication were observed (Figure 15); the other inspected ‘severe’ wearing switches did not show any traces of flange lubrication.
