Experimental research on salt contamination procedures and methods for assessment of the salt distribution

Construction and Building Materials

The RILEM TC ASC-271 is developing a new laboratory test to assess the durability of porous building materials to salt crystallisation. The test encompasses two phases: salt accumulation and damage propagation. This paper focuses on designing a procedure for the accumulation phase; this is considered successful when salts crystallise at the material's evaporative surface (common situation observed on site) without the occurrence of damage. Two procedures were developed and tested on two limestones with different porosity: (1) capillary absorption of a salt solution followed by drying, and (2) continuous capillary absorption. Sodium chloride or sodium sulphate solutions were used. Several methods for assessing the salt distribution were employed: ultrasonic pulse velocity, drilling/scratching resistance, hygroscopic moisture content, ion chromatography, scanning electron microscopy, and micro X-ray fluorescence. The results enabled the selection of the most effective protocol for the salt accumulation phase.

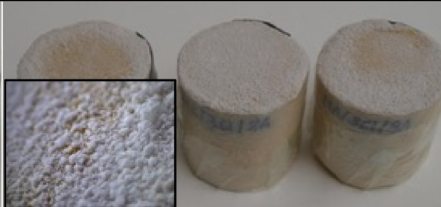
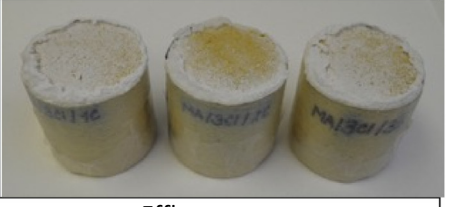
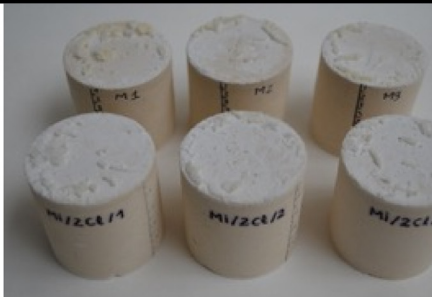
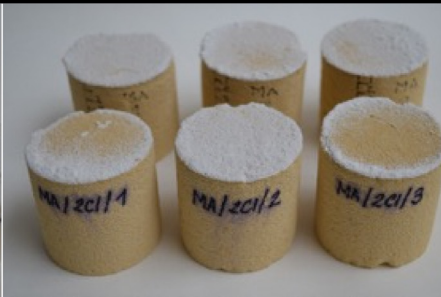
Damage/alteration	Efflorescence	Efflorescence
	Salt efflorescence	Powdery	(micro) cauliflower
	Damage severity	No damage	No damage
	Damage extension	-	-
P1-1W	Photo

Damage/alteration	Efflorescence	Efflorescence
	Salt efflorescence	Powdery (surface) and hollow crust	Powdery
	Damage severity	No damage	No damage
	Damage extension	-	-
P2-2W	Photo

Damage/alteration	Efflorescence	Efflorescence
	Salt efflorescence	Powdery	Powdery
	Damage severity	No damage	No damage
	Damage extension	-	-

Fig. 4. Summary of the macroscopic visual observations on the specimens contaminated with NaCl. Scores of severity of damage: low (+) to high (++++). Scores of extension of damage: small (+) to large (++++ surface area.

Samples contaminated with NaCl with both procedures developed only salt efflorescence, and no visible damage was detected (Fig. 4). The type and amount of salt efflorescence (Fig. 6a) varied according to the procedure followed and type of stone used: a lower amount of NaCl efflorescence developed in the less porous stone (Migné) with procedures P1-1S and P2, but the amount was still slightly higher than for the more porous stone (Maastricht) with procedures P1-1 W and P1-2 W. The results of mass loss (Fig. 7a) can be considered negligible (lower than 0.05 wt%) and confirm the visual observations.

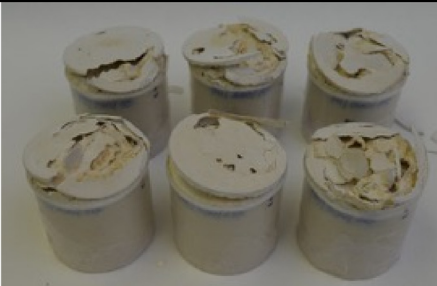
Damage/alteration	Scaling with subflorescence		Efflorescence, granular disintegration, and scaling with subflorescence	
	Salt efflorescence	Powdery		Powdery	
	Damage severity	++		++	
	Damage extension	++		++	
P1-1W	Photo

Damage/alteration	Bursting with subflorescence		Granular disintegration with subflorescence	
	Salt efflorescence	Crust		Crust	
	Damage severity	++++		++	
	Damage extension	++++		++++	
P2	Photo

Damage/alteration	Efflorescence		Contour scaling with subflorescence	
	Salt efflorescence	Cauliflower		Powdery	
	Damage severity	+		++	
	Damage extension	+		++

Fig. 5. Summary of the macroscopic visual observations on the specimens contaminated with Na₂SO₄. Scores of severity of damage: low (+) to high (++++). Scores of extension of damage: small (+) to large (++++) surface area.

Both types of stones contaminated with Na_2SO_4 showed damage with all procedures (Fig. 5). Minor damage was observed in Migné after Na_2SO_4 contamination with procedure P1-1S, leading to ca. 1 wt% of mass loss (Fig. 7b); the amount of salt efflorescence observed was very low and concentrated close to the evaporative surface. After one rewetting, Na_2SO_4 contaminated Migné specimens (P1-1 W) suffered rapid and severe damage (within 24 h of drying). For this reason, the planned second rewetting was not performed, and these specimens were not subjected to the analysis of salt distribution.

In the case of the more porous stone (Maastricht), samples contaminated with Na_2SO_4 with procedure **P1-1S** developed slight granular disintegration and scaling, leading to 0.7 ± 0.4 wt% mass loss (Fig. 7b). After one rewetting (**P1-1 W**), the amount of salt efflorescence increased significantly; the amount of efflorescence reached almost 90 wt% of the salt introduced, whereas mass loss was ca. 1.1 wt%. The 2nd rewetting step (**P1-2 W**) induced more damage (ca. 2 wt% of mass loss) and slightly more salt efflorescence. In contrast with Migné, damage occurred in Maastricht samples contaminated with Na_2SO_4 with procedure **P2**.

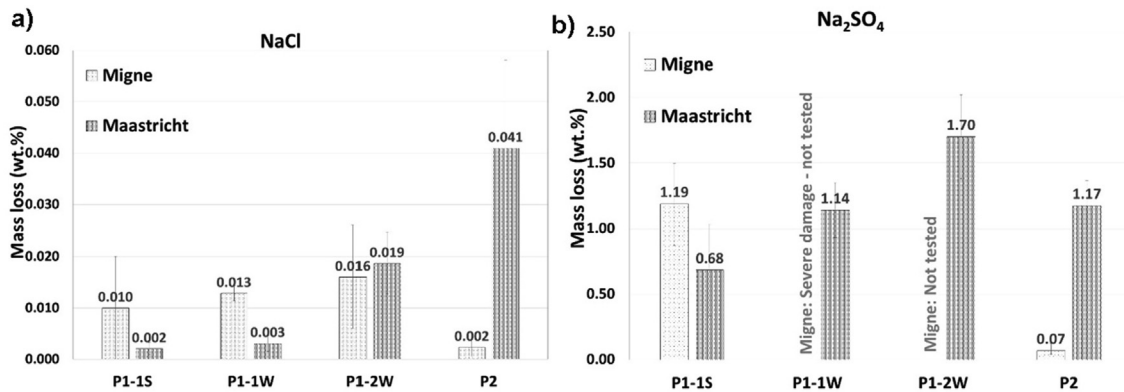
Fig. 7. Mass loss of stone material registered after the salt accumulation test with procedures P1 and P2, expressed as the percentage relative to the dry weight of the specimens: (a) stones contaminated with NaCl, (b) stones contaminated with Na₂SO₄.

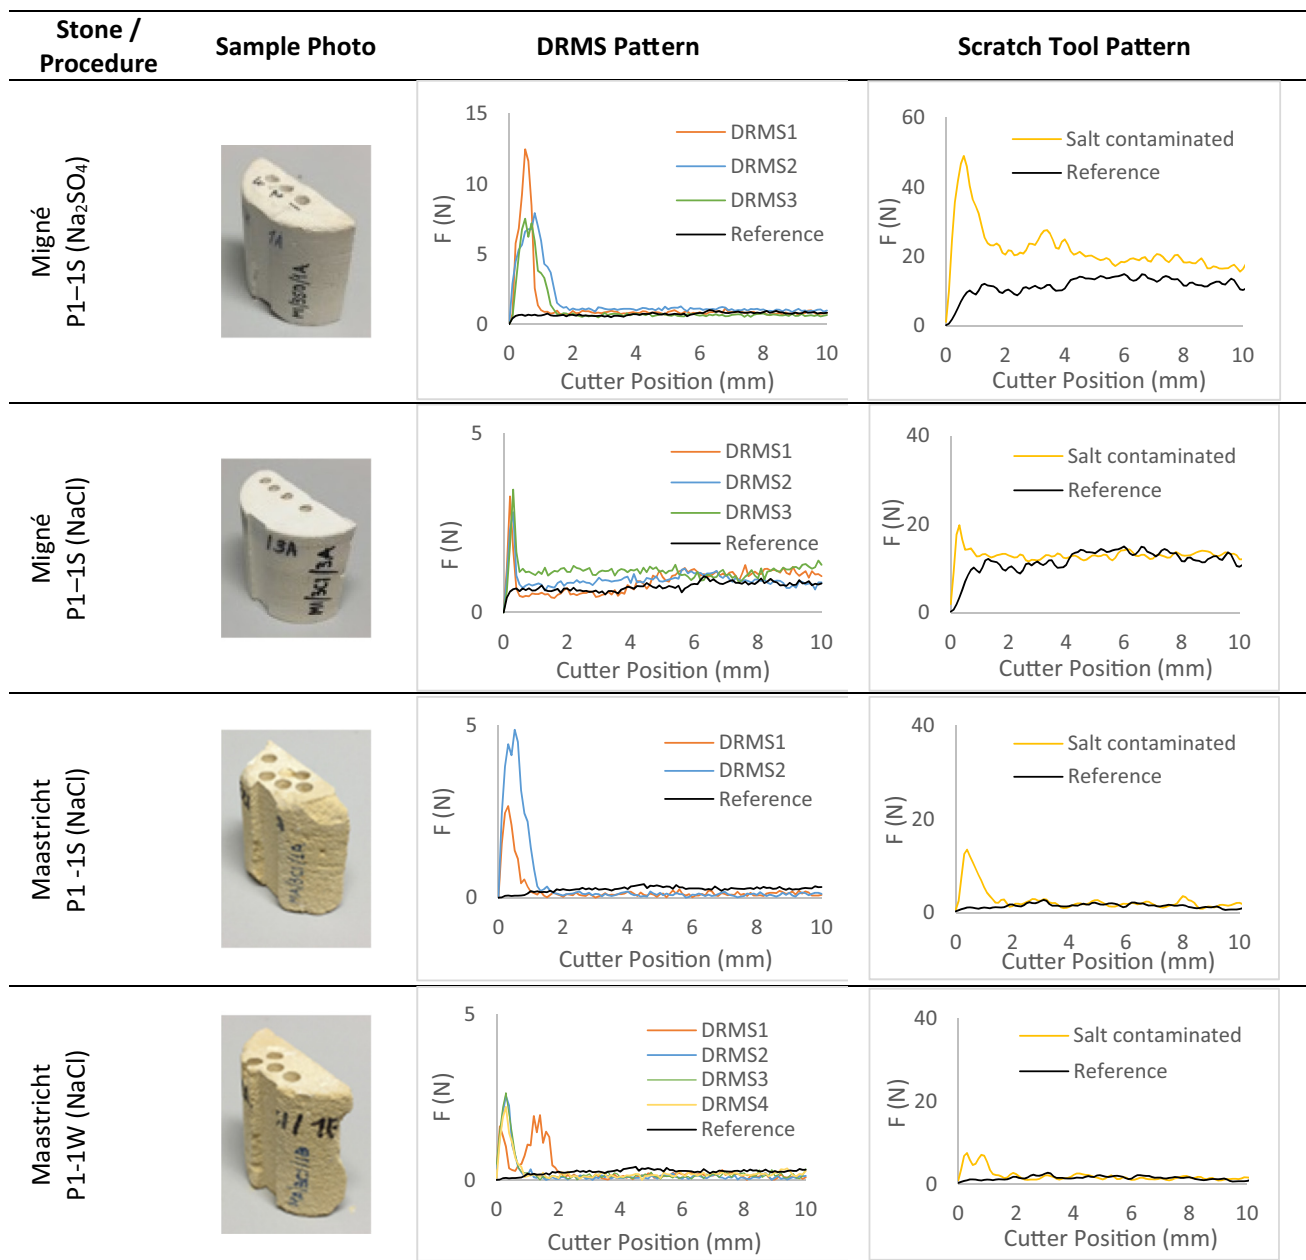
Fig. 17. DRMS and average ST patterns for samples contaminated according to procedure P1 (coloured lines) and reference samples (black lines).

The scratching and drilling force (*F*) patterns versus the cutter position (depth of the sample) are provided in Fig. 17. From these, evident changes in the microstructure of the salt contaminated samples (i.e., pore clogging resulting in increased cutting resistance areas) can be observed. In particular, in all the patterns derived after salt contamination and drying, localized peaks in material resistance to cutting were recorded very close to the evaporative surface (ca. 0–2 mm). These peaks, which are not observed in the reference specimens, are prominent both in the ST and the DRMS patterns and suggest pore filling by the salts.

The position of the peaks in cutting resistance is nearly identical for each sample, irrespective of the mapping technique used, indicating that both methods are detecting pore clogging due to salt crystallisation at more or less the same location. This is in line with previous applications of the ST and the DRMS [21,28] and confirms the reliability of both techniques and their potential in detecting the position of the salt crystallisation front in limestone.

The peak cutting resistance recorded in the case of Migné contaminated with Na₂SO₄ with procedure **P1-1S** is much higher, compared to the corresponding sample contaminated with NaCl. This is in line with the μ-XRF and SEM results (Table 3), which suggest that Na₂SO₄ has a tendency to crystallise more locally, closer to the evaporative surface, as opposed to NaCl which shows higher dispersion. The localised crystallisation of Na₂SO₄ usually leads to more damage [16], as was indeed the case in the visual observations hereby reported (Figs. 4 and 5). In the case of the much weaker and porous Maastricht stone, the peak resistance recorded for the sample contaminated once (**P1-1S**) with NaCl was again rather low. Upon rewetting with water (**P1-1W**), the peak resistance was further reduced. In contrast, the thickness of the salt-rich layer (i.e., increased cutting resistance area) appears broader, albeit not as broad as in the optimised μ-XRF map, suggesting some redistribution of the salt content with water absorption and possibly some salt escaping the sample as efflorescence; this
