Chloride-induced corrosion of steel in concrete—insights from bimodal neutron and X-ray microtomography combined with ex-situ microscopy

2024

Materials and Structures/Materiaux et Constructions

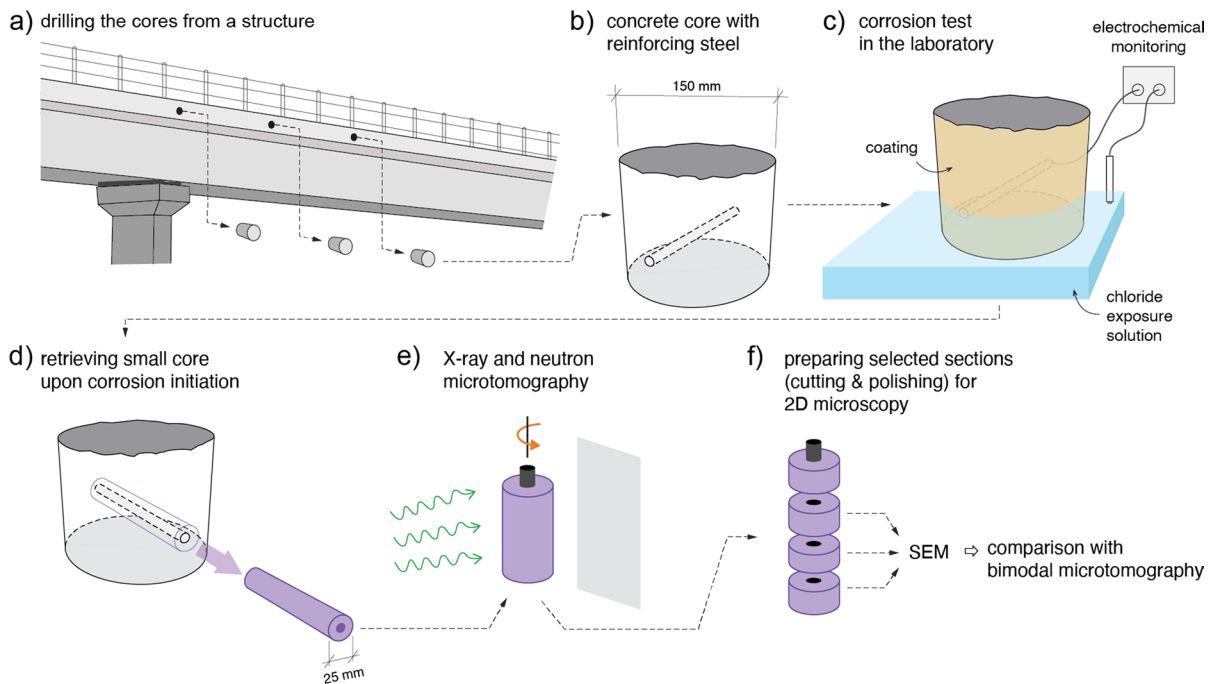
Fig. 1 Sequence of experiments from retrieving samples from a reinforced concrete bridge (**a, b**) over corrosion testing in the laboratory (**b**) to the in-situ study of the samples in an early

stage of corrosion by means of X-ray and neutron microtomography (**d, e**) and comparison with classical ex-situ microscopy (**f**)

Four concrete cores were retrieved from the edge beam (top side) of a reinforced concrete bridge in Switzerland (labelled as B1-E1), the construction of which was completed in 2004 (Fig. 1a).

At the time of sampling, the age of the structure was ~15 years. The diameter of each concrete core was 150 mm, and it contained a ribbed reinforcing steel bar of diameter 10 mm (Fig. 1b). The rebar was oriented horizontally in the structure (first reinforcing steel layer). No sample was corroding at the time of coring, as evidenced by potential measurements [30] on the structure prior to sampling. More

To induce corrosion of the embedded reinforcement, the reinforced concrete samples were placed in a 10% sodium chloride solution to allow for chlorides to diffuse into the concrete and to trigger corrosion of the steel bar (Fig. 1c). The electrochemical potential of the embedded steel bar was continuously monitored with the help of a reference electrode and a data-logger (multimeter with input impedance > 1 MOhm), until a drop of the potential indicated initiation of corrosion, which occurred after around 2 years from the start of the exposure of the cores to the sodium chloride solution (Supplementary Figure S1). A more detailed description of the sample preparation protocol and the corrosion test can be found in Ref. [32].

After corrosion initiation, a core of 25 mm diameter was extracted from the tested specimen, such that the entire 150 mm long rebar was centrally located in the 25 mm core (Fig. 1d). A total of four such cores were obtained, labelled as B1-E1-H-1 to B1-E1-H-4. From that moment onwards, the specimens were generally (apart from the shipping time) kept in laboratory conditions (approx. 20 °C, 50% RH), which significantly limits corrosion and transport processes, that is, largely preserved the state after terminating the laboratory corrosion test described above. The cores were transferred to the facilities for neutron

and X-ray microtomography at the TU Delft (X-Ray microCT: Civil Engineering and Geosciences, neutron microCT: Reactor Institute Delft) as soon as corrosion initiated, so that the mechanism of corrosion of steel in concrete could be studied in a very early stage (shortly upon chloride-induced corrosion onset) and in-situ, that is, in a largely undisturbed state (Fig. 1e).

After tomographic in-situ imaging (Fig. 1e), the samples were transferred back to ETH Zurich, where selected sections were studied by conventional microscopy (Fig. 1f). These sections were selected based on the results of the segmentation of the bimodal microtomography to study sections with features of particular interest such as locations where corrosion initiated or where air voids were found close to the SCI. With the knowledge about the coordinates of these features within the sample, sections were cut with a water-cooled diamond saw. After sawing, the surface of the sections was firstly ground and then polished to further optimize the

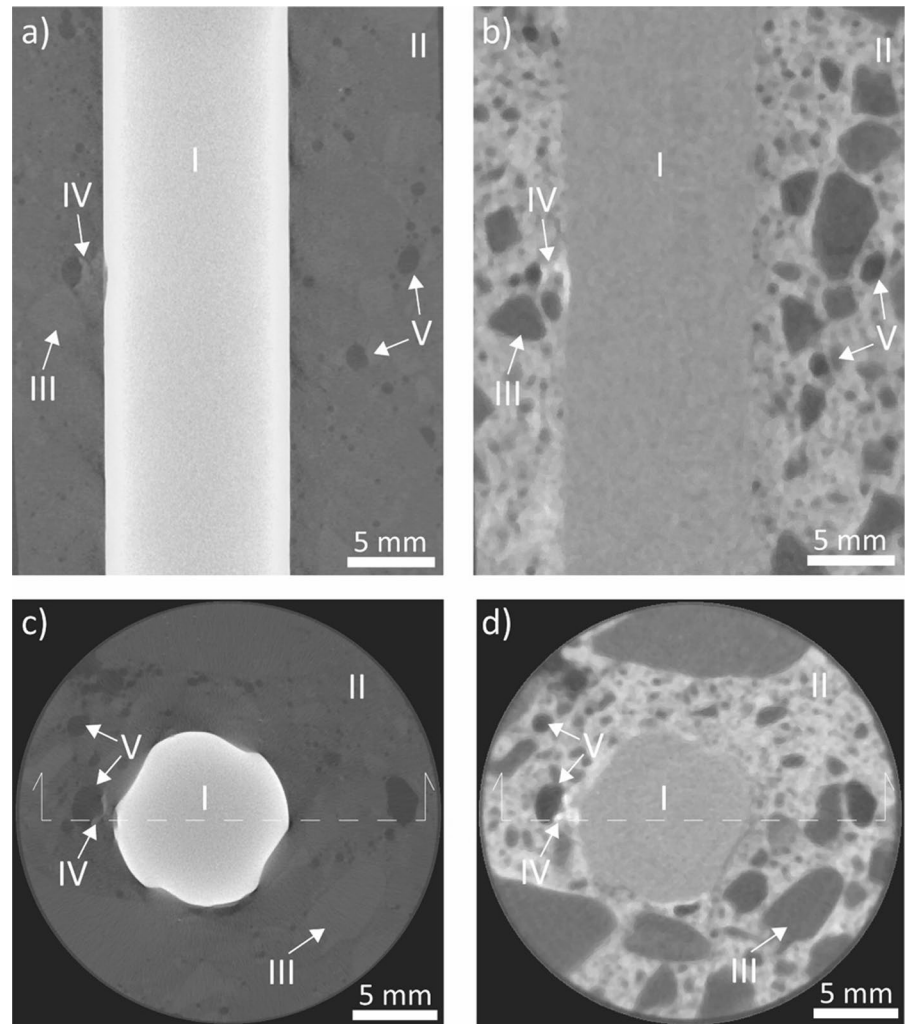
Fig. 2 Comparison of reconstructed sections of the two imaging modes X-ray (**a, c**) and neutrons (**b, d**), illustrating the pronounced differences in attenuation (grey level) between the two modes for different phases, such as the rebar (I), cementitious phases (II), aggregates (III), corrosion products (IV), and voids (V). The dotted lines visible in the horizontal slices of X-rays and neutron images, respectively, indicate the cross-section lines of the respective vertical images. Image analysis and detection of components were conducted on high-resolution data, of which image quality may differ from the one herein visible

while the neutron imaging mode is largely free from such artifacts.

It should be noted that the visual distinction of the different features based on grey values and shape may in Fig. 2 as shown here, namely in the form of a converted and compressed image format, possibly even printed on paper, not work as well as this was possible when the original images were viewed on a high-quality computer screen and with specialized software (VG studio).

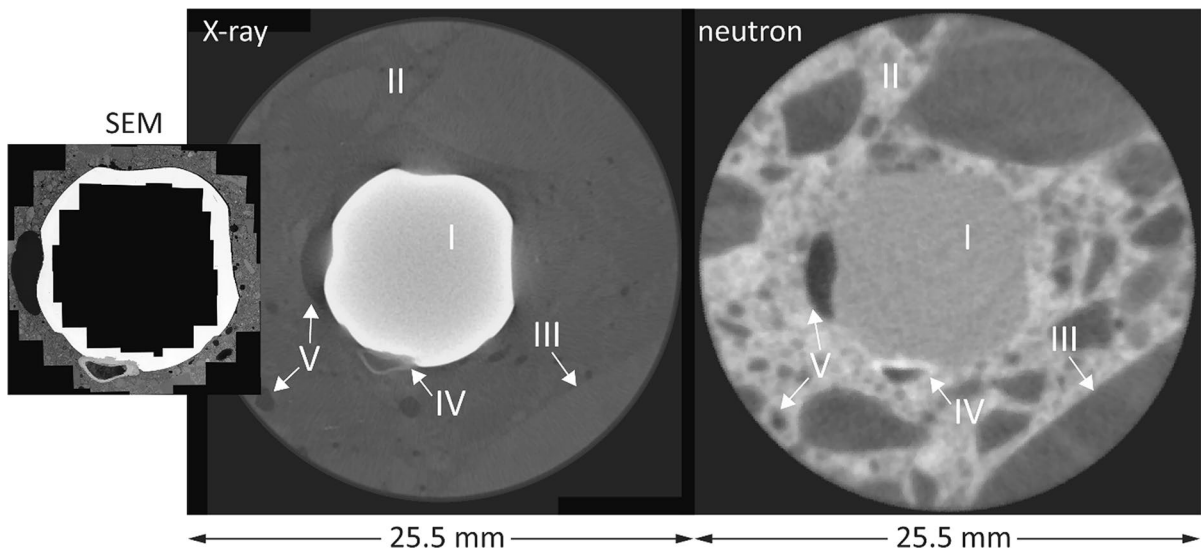
Fig. 3 Comparison (at identical size and orientation) of cut and polished section viewed in SEM (stitched image) with the corresponding reconstructed sections from X-ray and neutron imaging modalities, illustrating the different specimen phases such as the rebar (I), cementitious phases (II), aggregates (III), corrosion products (IV), and voids (V). Note that through SEM only the steel–concrete interfacial region was imaged, while in both X-rays and neutron images the concrete matrix of the

core is fully visible. To better observe the characteristics of the SCI as well as the occurrence of corrosion pits, the SEM micrograph with higher magnification is also visible in Fig. 8a. Note that the orientation of the reinforcement in the images may be different from the actual orientation of the steel when it was embedded in concrete, of which no information could be obtained

Figure 3 shows an example of one inspected horizontal section where conventional ex-situ scanning electron microscopy was compared to the corresponding section as reconstructed from the X-ray and neutron tomography, respectively. The SEM micrograph shown here was composed by image

stitching (from recording numerous high-resolution images along the SCI region). The SEM image in Fig. 3 was adjusted to ensure identical size and orientation of the rebar and the features in the concrete matrix between all three imaging modes. It becomes apparent that the resolution of the images differs considerably. SEM yields the highest resolution of the different imaging modes, clearly in the submicron range. The pixel size of the microtomography was 25 and 49 μm for X-ray and neutron imaging modalities, respectively. By directly comparing the reference images acquired through X-ray and neutron microtomography and the respective SEM micrograph representative of the same specimen portion, a number of observations can be made based on the geometry of the specimen herein

- X-ray shows considerable artefacts surrounding the rebar, where both darker and brighter regions are clearly apparent, which are absent in the SEM and neutron images. These artefacts are more pronounced than those observed in similar studies where cylindrical steel bars were used [15, 26, 36, 37] because of the ribbed geometry of the reinforcement embedded in the specimen herein investigated. Nevertheless, the availability of neutron images and SEM micrographs allows for a precise distinction of the constituents of the SCI. For specimens with similar geometry and characteristics, the calibration of X-ray images with complementary techniques is therefore advised.

- Through both X-ray and neutron imaging, macro-air voids (overall larger than around 80–200 μm) and corrosion product build-up at the SCI can be detected. However, the volume of corrosion products may be mis-estimated due to the interfacial artifacts in the case of X-ray imaging and by the similar gray scale value to that of hydrogen-rich components (e.g., cement hydration products) in the case of neutron imaging. Corrosion attacks at the reinforcement can also be reliably detected, especially in X-rays images. The extend at which this detection can occur mainly depends on the resolution (i.e., voxel size) of the image stack. In the present case, the smallest corrosion attacks that could be detected were around 50 μm deep.

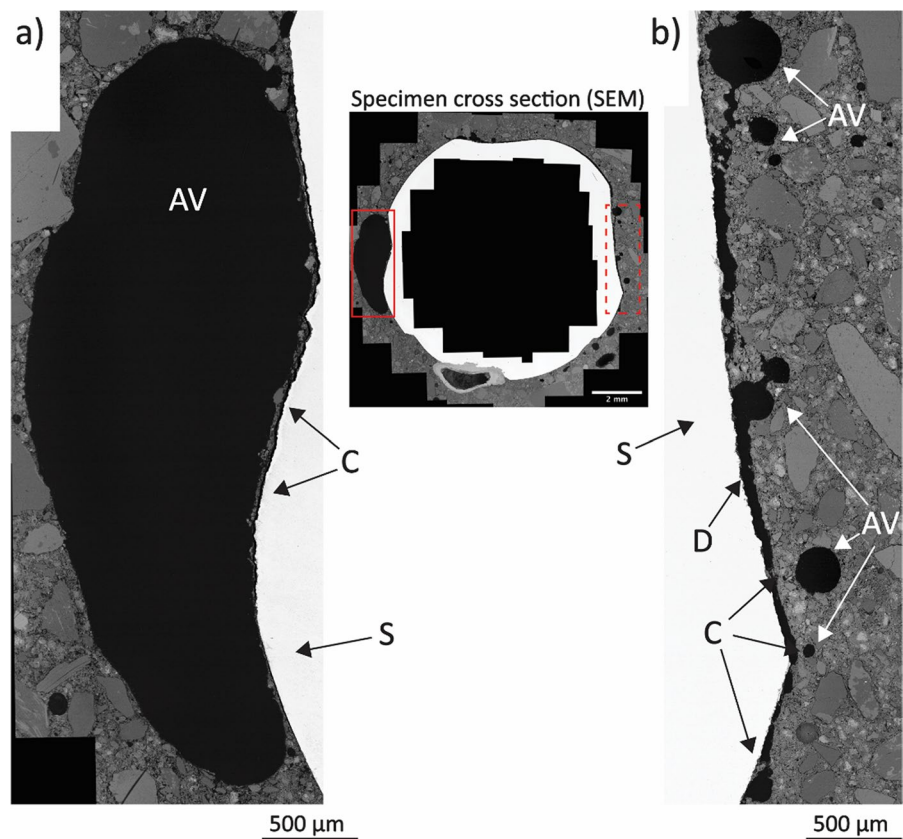
Fig. 4 SEM image of the specimen cross section (center) with areas where interfacial air voids are found at higher magnification, showing the different phases (S = steel; C = cement paste; AV = air void; D = debonding between steel and concrete; the solid and dotted red boxes highlight the portions reported at higher magnification in (a) and (b), respectively); **a** interfacial macro-air void, separated from the steel by a thin layer of cement paste of around 20 μm thickness; **b** multiple small interfacial voids separated from the steel by a layer of cement paste with variable thickness

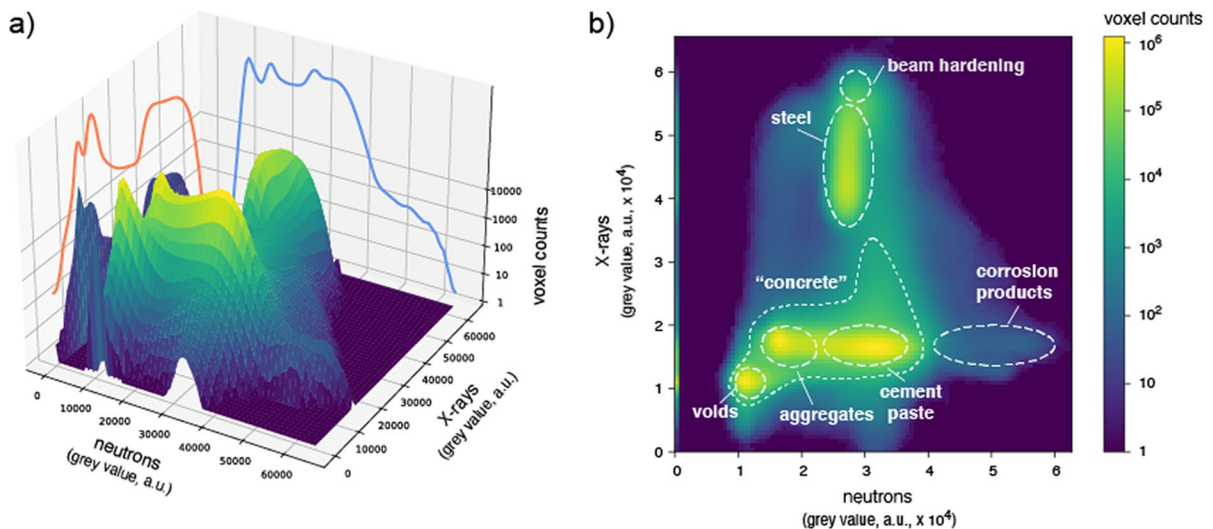
Fig. 5 Bivariate histogram displaying the number of voxels associated with certain X-ray and neutron attenuation intensities of the whole image stack (representative of the whole specimen); **a** three-dimensional visualization, **b** two-dimensional

plot with indicated interpretations of the combined X-ray and neutron attenuation behavior in terms of features encountered

In Fig. 5 a bivariate histogram of the number of voxels associated with certain X-ray and neutron attenuation coefficients is visible for the whole image stack of a here imaged specimen. A three-dimensional visualization of the two X-ray and neutron attenuation coefficient histograms is visible in Fig. 5a, while the respective two-dimensional plot is reported in Fig. 5b. In this latter case, it is possible to identify areas that belong to certain components of the specimen based on the behavior observed when simultaneously

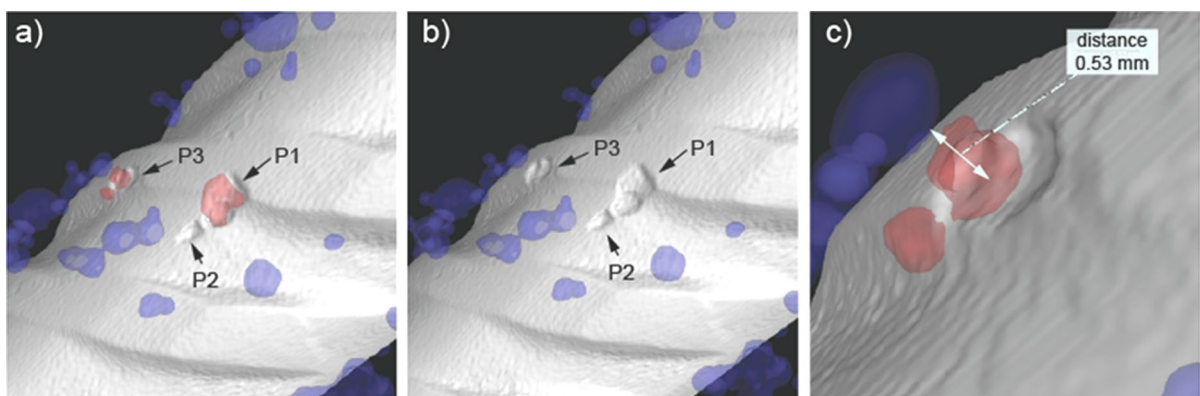
Fig. 6 Examples of segmented 3D renders illustrating interesting features at the steel–concrete interface (cementitious matrix and aggregates suppressed in the displaying mode for clarity): **a** corrosion initiation pits in the rebar and presence of corrosion products (red) and macroscopic concrete voids

(blue); **b** same but without displaying the corrosion products, to better reveal the pits; **c** illustration of a measurement of the distance between a macroscopic concrete void and a pit (higher magnification than **a** and **b**). Rebar diameter = 10 mm

500 μm), as visible in Fig. 6c. The influence of air voids will be discussed in Sect. 3.3.2. Here, we will discuss features related to the size and geometry as well as the distance between individual corrosion attacks.

Figure 6 shows relatively flat and shallow “pits” (in the range of 50–100 μm depth and 200–600 μm width and length). The here apparent morphology of the localized corrosion attack was representative of the numerous other pits observed in the other specimens. The ratio pit width:depth and pit length:depth were generally clearly larger than 1. It may be questioned whether so shallow localized corrosion attacks may still be termed “pits”, considering classical pitting corrosion theory. According to the theory underlying pitting corrosion of passive metals, the stability of newly formed pits is significantly affected by the geometry of the pits. When the local conditions to depassivate the steel are present (e.g., the necessary chloride concentration in relation to hydroxyl ions), metastable pits form and grow at a rate that depends on various factors, including metal composition, pit electrolyte concentration, and pit bottom potential [39]. While autocatalytically growing, the anodic and cathodic corrosion reactions separate spatially during pitting. The local pit environment becomes depleted in oxygen, which shifts most of the cathodic reaction to the exposed surface where there is higher availability of this reactant. A consequence of this classical pitting corrosion mechanism is the in-depth growth of a corrosion pit while the rest of the metal surface remains passive [40]. Transport processes between pit bottom (where ferrous ions are released) and the outside areas (where cathodic reaction occurs) are an important factor in pit growth, which is markedly affected by the geometry of the pit (depth, width) [41]. Moreover, the availability of negatively charged ions different from hydroxyl ions (such as chloride ions) is crucial in order to maintain stable pit growth, as the migration of hydroxyl ions into the pit may lead to repassivation [42, 43].

The occurrence of corrosion “pits” close to each other as shown in Fig. 6 may raise further interesting points of discussion. Admittedly, it is unclear from the available in-situ images, which were taken at one point in time, whether the different visible corrosion “pits” had formed in a sequence (the first one forming, then repassivating, followed by formation of another one, etc.) or whether they occurred simultaneously. Additional information on this question is available from the electrochemical monitoring of the corrosion process, especially the transition from passive state to active corrosion. The potential of the rebars was continuously monitored during chloride exposure. According to the experimental protocol, a decrease of at least 150 mV, maintained over at least 10 days, was used as the criterion to determine stable corrosion initiation [32]. Supplementary Figure S1 shows the potential vs. time during this corrosion initiation period for the different specimens. These data show a clear drop in potential (by 200–300 mV). Moreover, in 3 out of the 4 specimens, it was clearly apparent from the potential measurements that no repassivation events occurred over the following approx. 10 days; in one case (B1-E1-H-1), some slight potential variations were visible, however, no full repassivation was apparent. This electrochemical data thus suggests that a sequence of initiation of

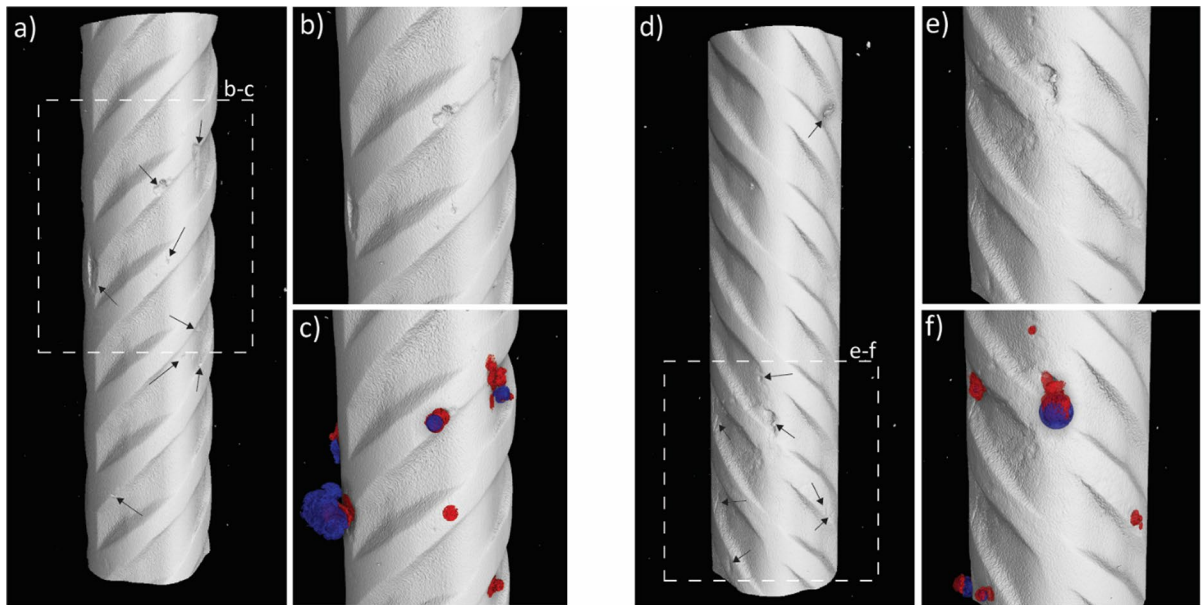
Fig. 7 Examples of segmented 3D renders illustrating interesting features at the steel–concrete interface (cementitious matrix and aggregates suppressed in the displaying mode for clarity): **a** render of pristine steel of specimen B1-E1-H-2, indicating corrosion attacks with black arrows (the dotted square is the magnified portion of the specimen); **b** higher magnification portion of the corrosion attacks of B1-E1-H-2; **c** higher magnification portion of the corrosion attacks of B1-E1-H-2 showing corrosion products (red) and interfacial

voids (blue) in the proximity of the corrosion attacks; **d** render of pristine steel of B1-E1-H-3, indicating corrosion attacks with black arrows (the dotted square is the magnified portion of the specimen); **e** higher magnification portion of the corrosion attacks of B1-E1-H-3; **f** higher magnification portion of the corrosion attacks of B1-E1-H-3 showing corrosion products (red) and interfacial voids (blue) in the proximity of the corrosion attacks

From Fig. 7 and Table 3, relevant information about the factors influencing the mechanism of corrosion initiation of steel in concrete can be obtained. First, in every specimen several initiation spots were observed, on average between 6 and 11 per imaged

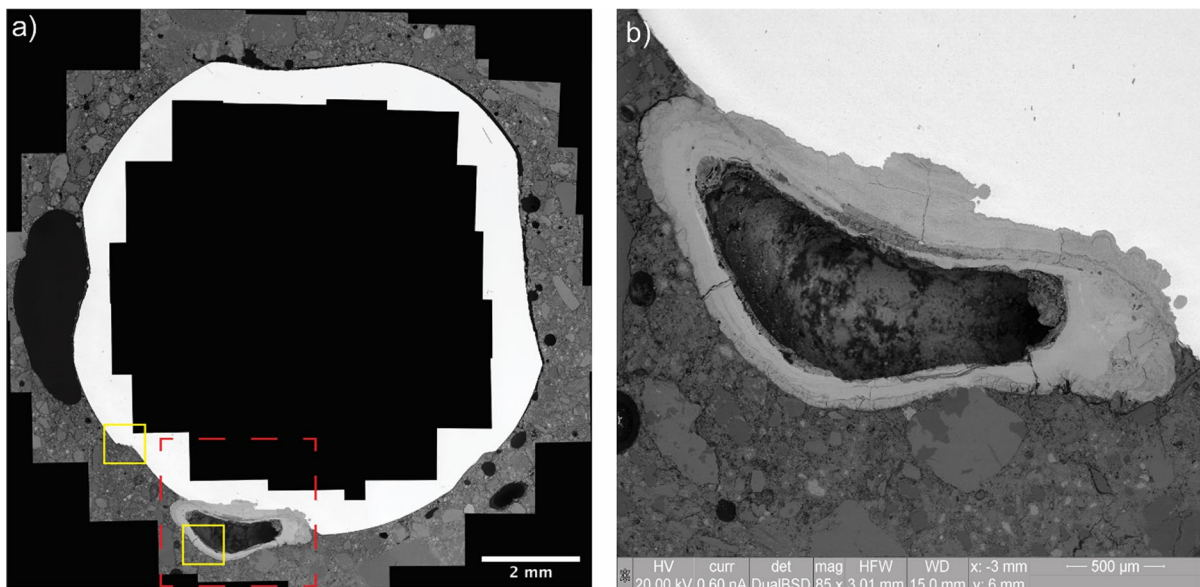
Fig. 8 SEM micrograph of a corroding section (BSE detector, acquired at 20 kV and 85 \times magnification): **a** overview of the corroding section made by stitching together the micrographs collected at the SCI, where the rebar is visible in white, the corrosion products in light gray, the concrete matrix in dark gray and the air voids in black (the red dotted-line box is representative of the zoomed-in area reported in Fig. 8b,

while the yellow boxes are areas shown at higher magnification in Fig. 9a–b); **b** Corrosion site in proximity to an interfacial air void, which is partially filled by corrosion products. Note that the orientation of the reinforcement herein reported may be different from the actual orientation of the steel when it was embedded in concrete, of which no information could be obtained

The results reported in Table 3 are in line with the findings related to the observations arising from the SEM observations reported below. In Fig. 8 the SEM micrograph of a corroding section is visible, highlighting some regions of interest (ROIs) at higher magnification reported in Fig. 9.

As it is visible from Fig. 8, different air voids are found at the SCI. Microscopic air voids with a diameter ranging between 50 and 200 μm are visible at the right and top-right side of the steel bar, often separated by a thin layer of cement paste (10–20 μm thick). A few small air voids are also visible at the bottom side of the steel. In the proximity of these interfacial microscopic voids, no corrosion sites can be observed. More interestingly, two macroscopic air voids are clearly visible at the left and

bottom side of the bar, both significantly bigger than 1 mm. While the latter one is partially filled by corrosion products that precipitated into it from a corrosion pit in its vicinity, the former one is completely empty, and it is not in proximity of any corrosion pit. These observations are in line with the results reported in Table 3, according to which most microscopic and macroscopic air voids at the SCI did not per se create the most sensitive locations for corrosion to occur. Nevertheless, Fig. 8 may suggest interesting points that need further analysis and experimental evidence to be clarified. Among others, an important reflection relates to the moisture conditions of the SCI. The growth of a corrosion site at one specific location and the lack of any corrosion attack where other interfacial voids are visible Fig. 8 may suggest that the moisture conditions at the SCI may significantly vary around the steel cross section, regardless the exposure of the bigger scale specimen. Variations in moisture state of the concrete at the steel concrete interface upon capillary water uptake may occur depending on variability in pore structure [24].

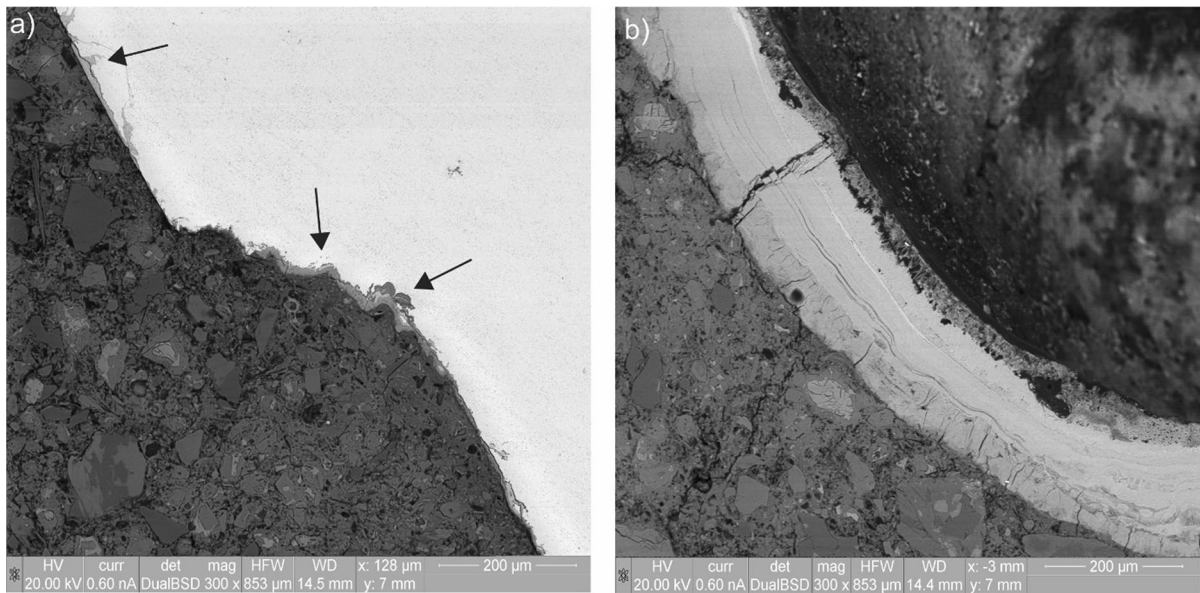
Fig. 9 SEM micrographs of corrosion pits at the SCI of a corroding rebar: **a** small corrosion pits formed at the SCI without any macro defect present; **b** layered morphology of corrosion products precipitated at the edges of an interfacial air void
