Measurements Vechtdijk

D.1. Introduction

This appendix treats the results of the grass pull tests that are executed on the Vechtdijk. Measurements were performed at two locations, the first being located at coordinates 52°30'32.8"N 6°14'24.6"E and the second being located at coordinates 52°31'21.2"N 6°11'23.8"E. The dike is characterised by a sandy subsoil. In deep layers, sometimes clay lumps were found during the tests. Four different types of tests have been conducted:

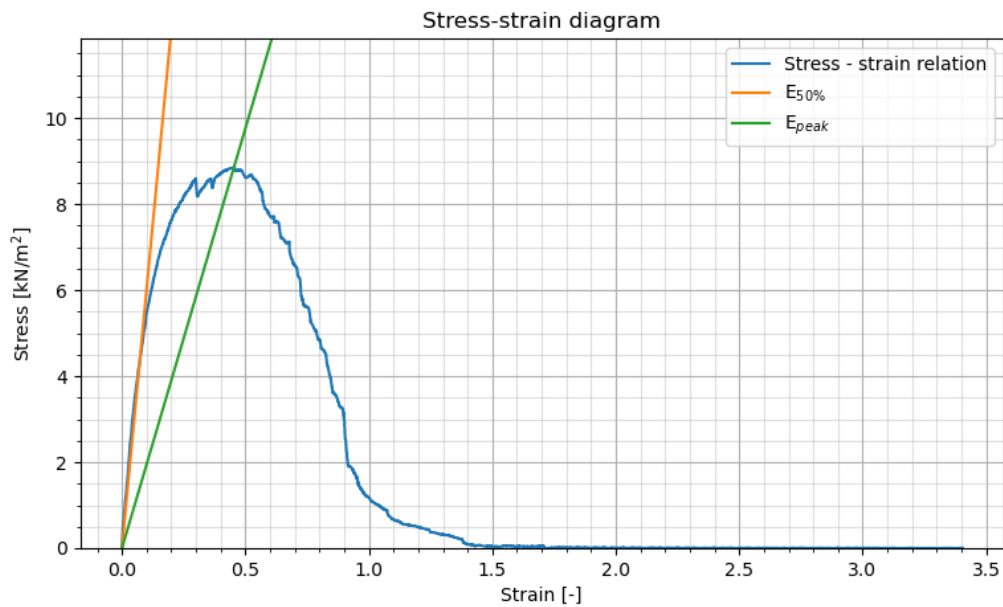
Stress-strain relation

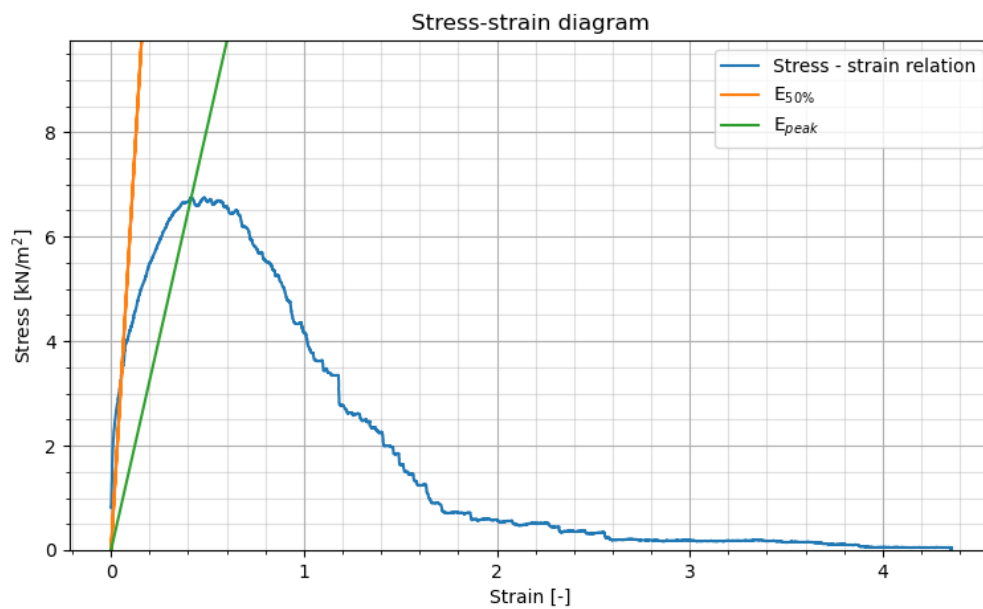
Stress-strain relation

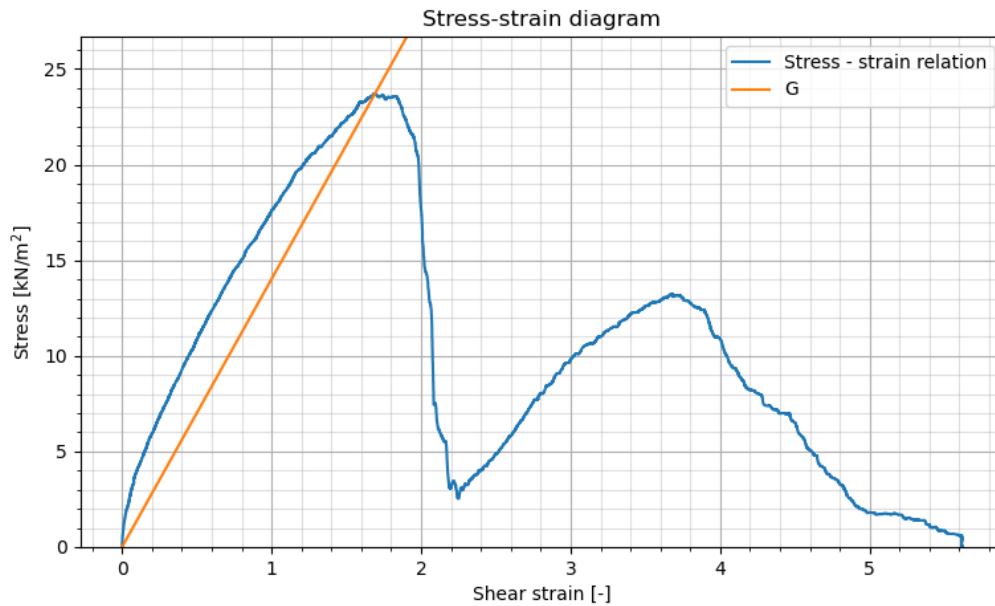
Stress-strain relation

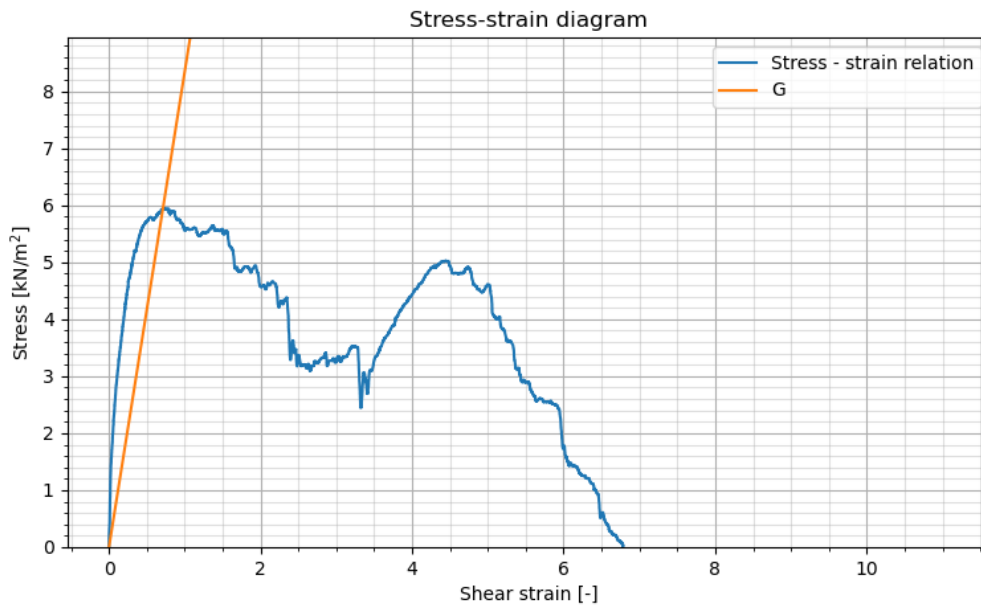
Stress-strain relation

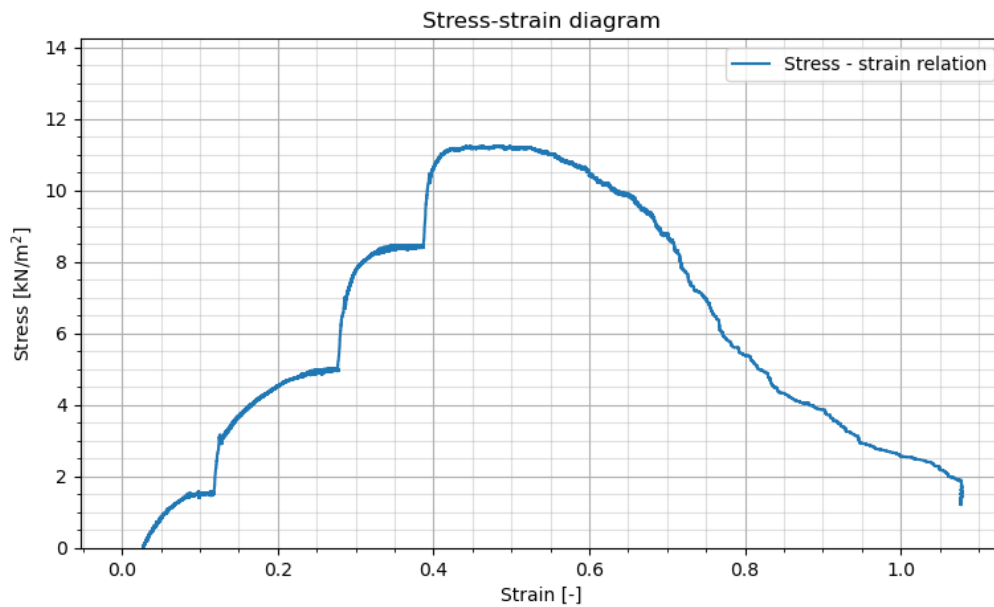
Stress-strain relation

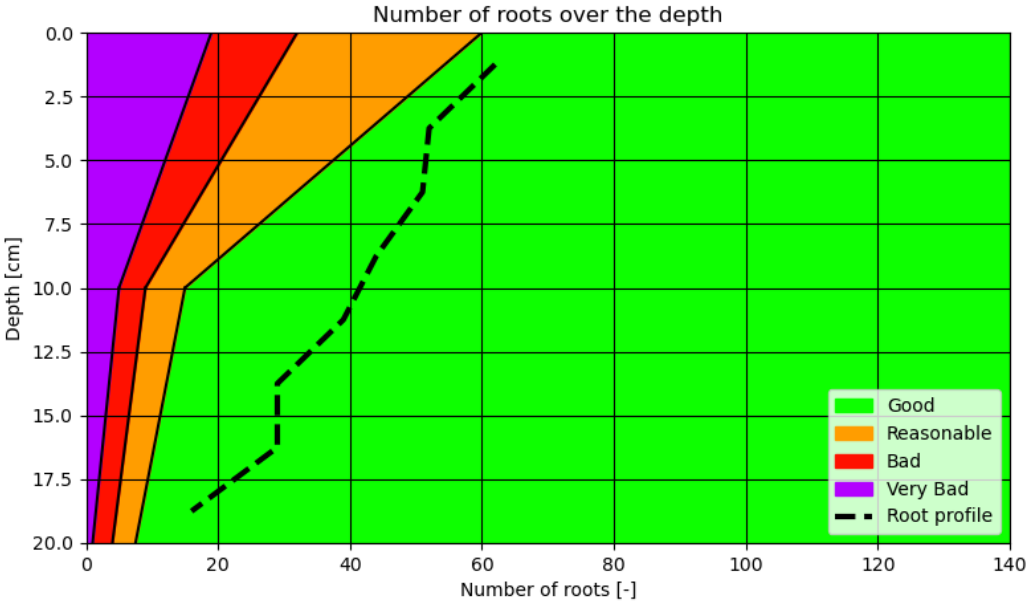
Root profile

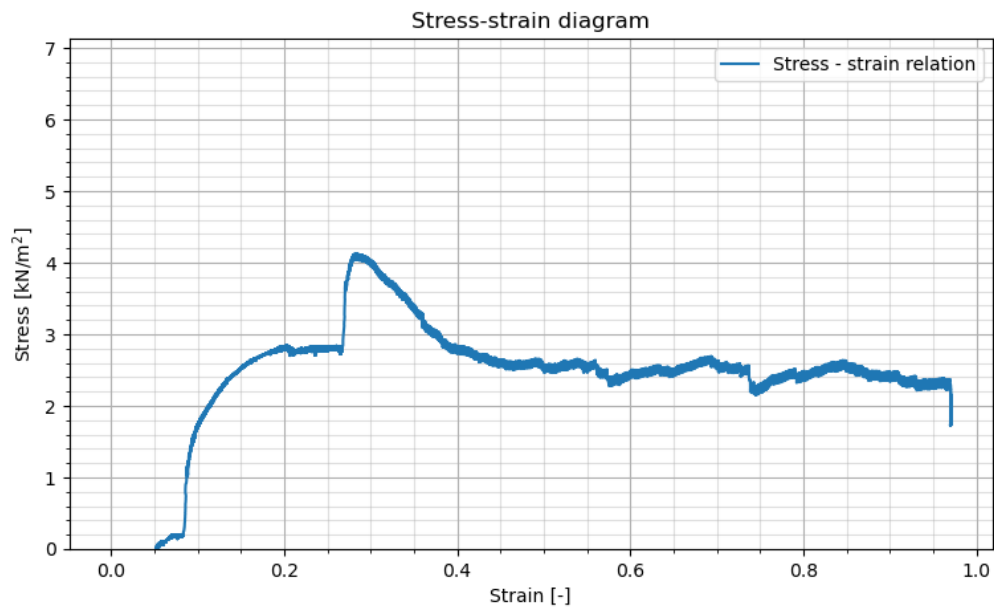
Stress-strain relation

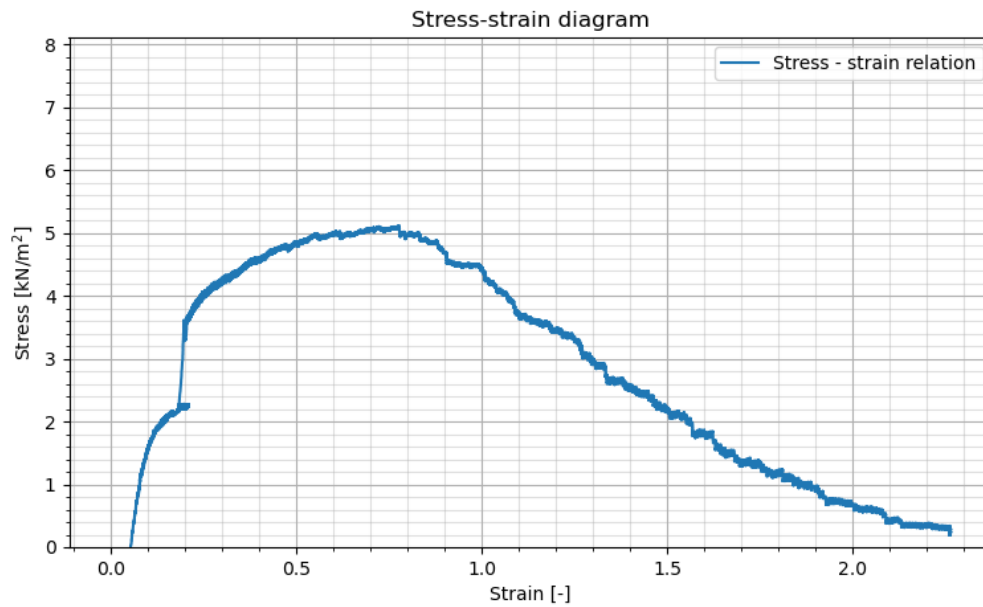
Stress-strain relation

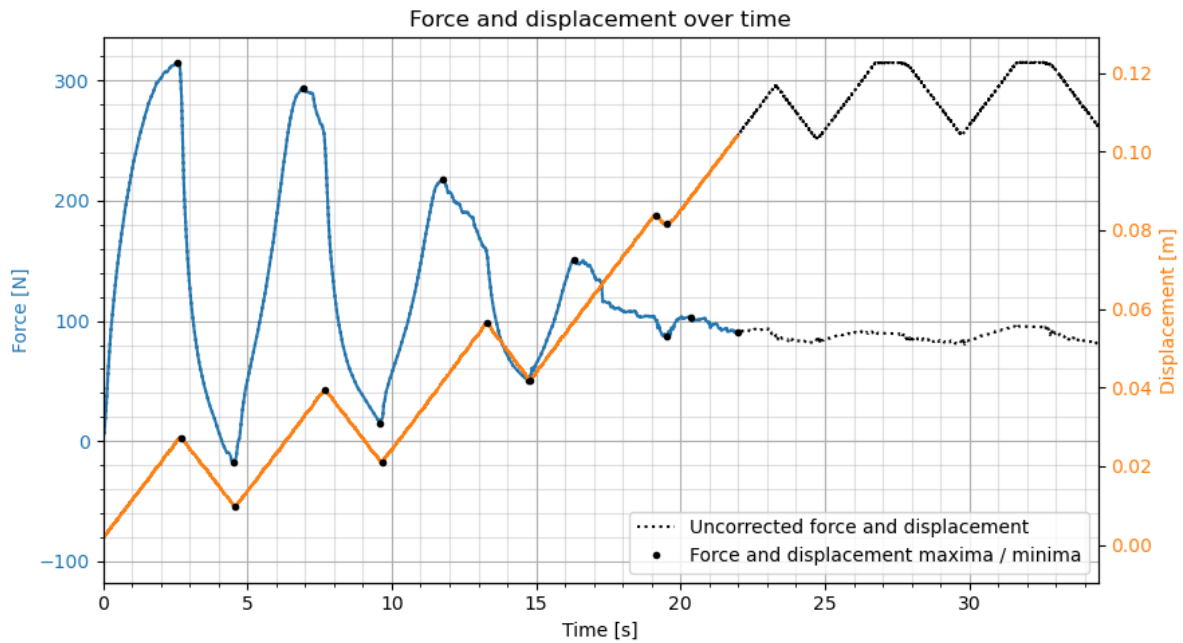
Force and displacement over time

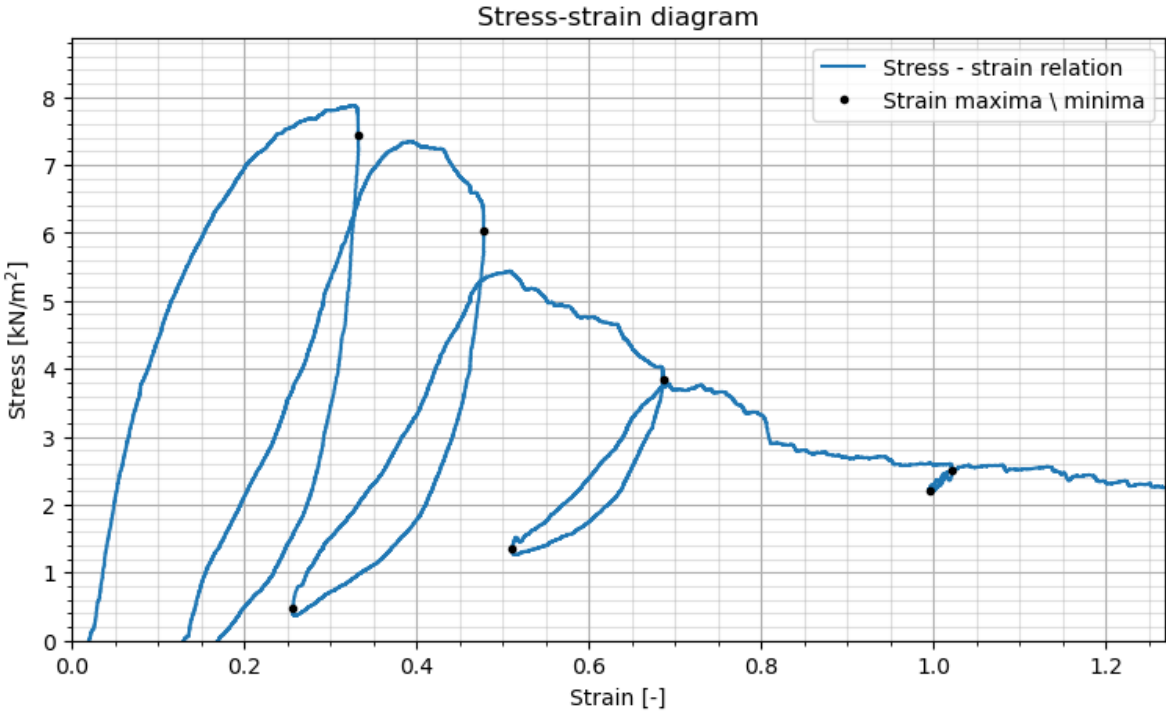
Stress-strain relation

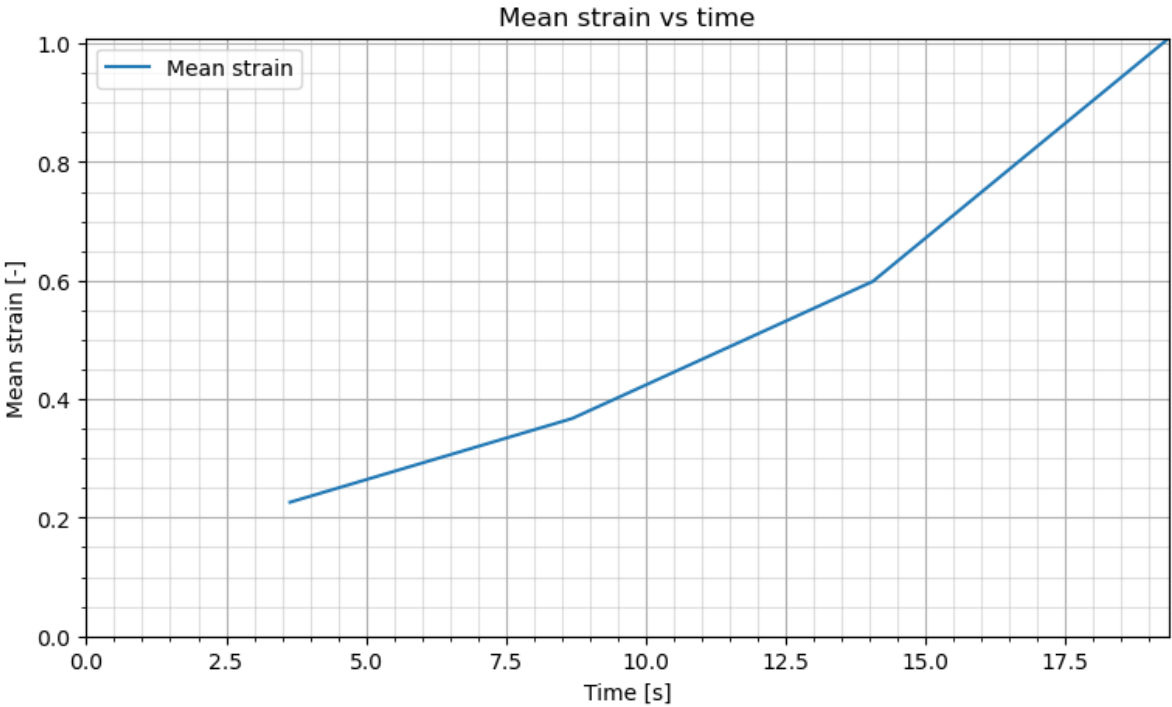
Mean strain over time

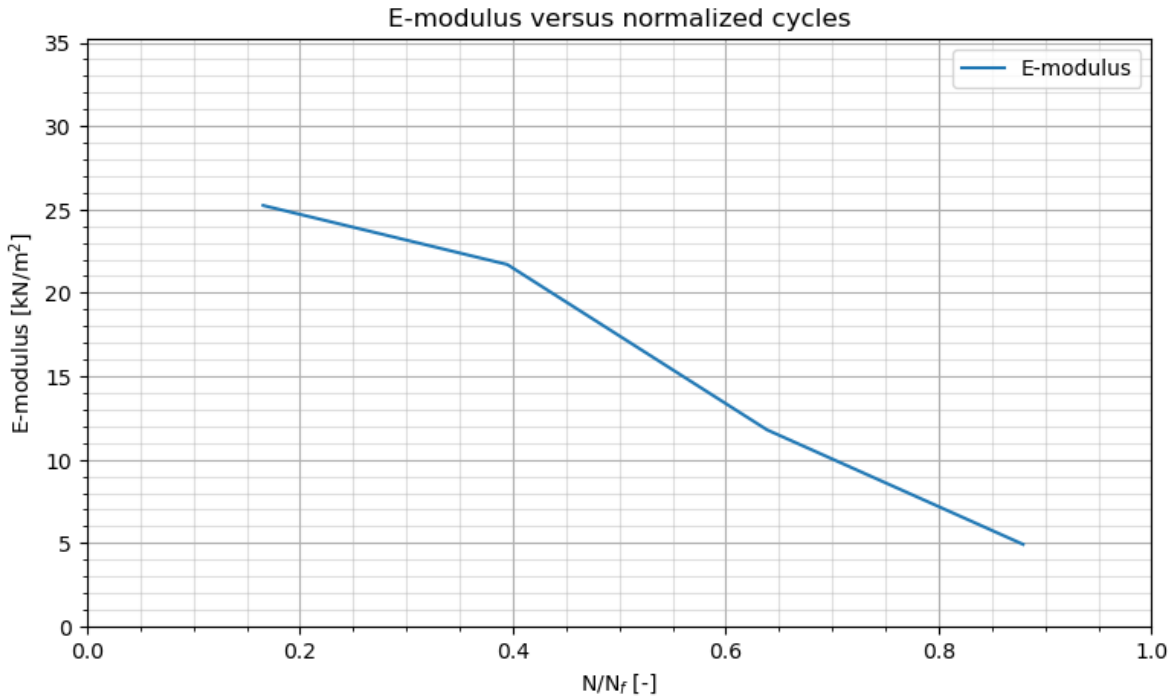
E-modulus over time

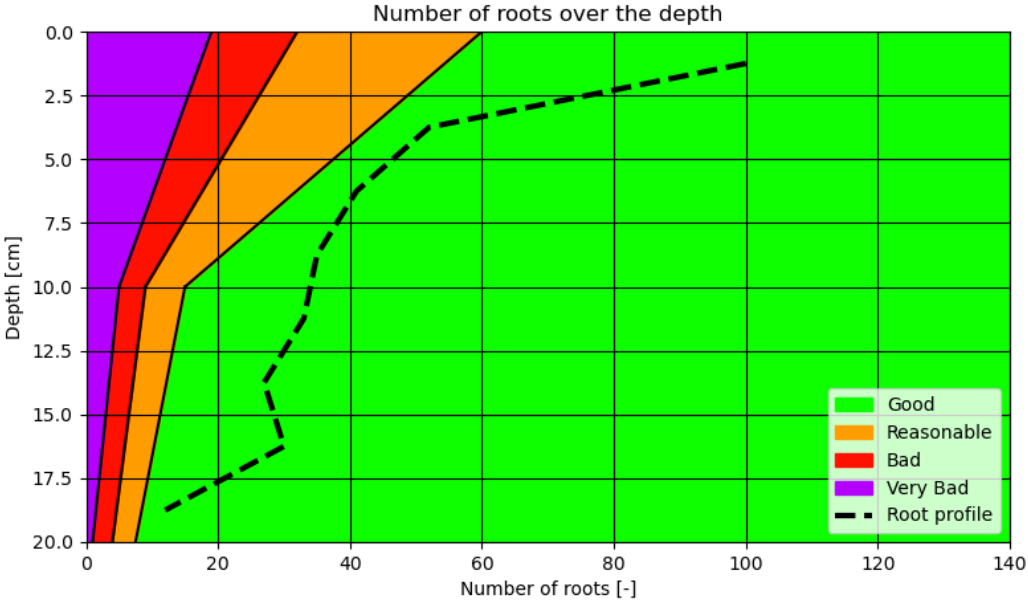
Root profile

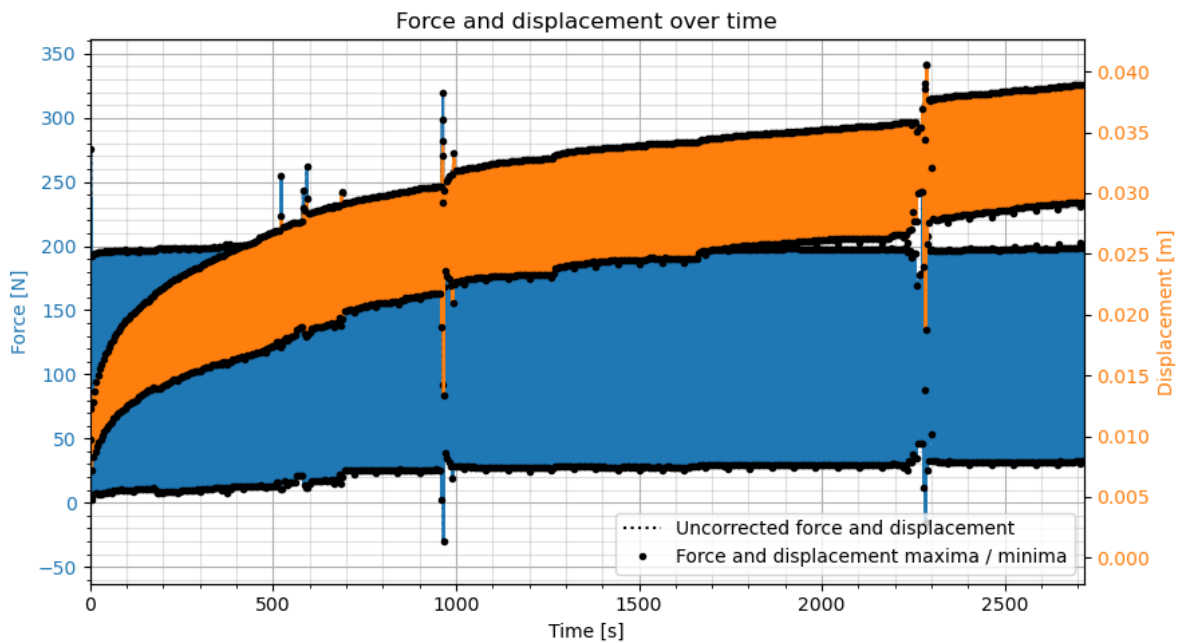
Force and displacement over time

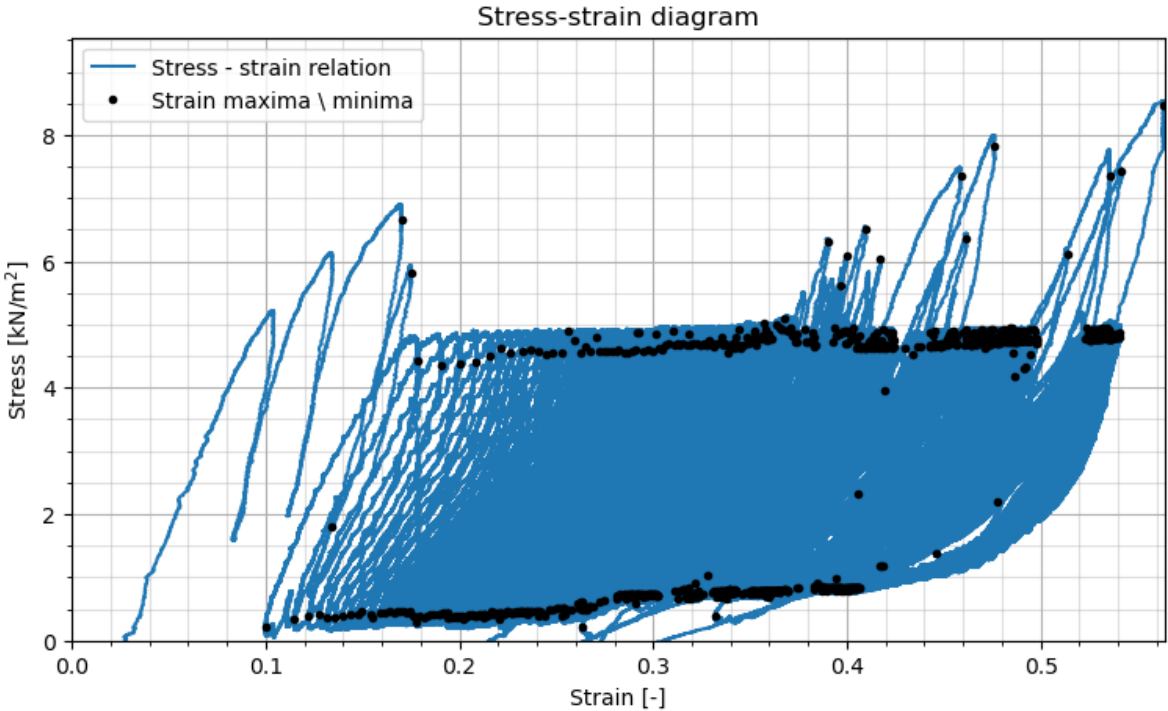
Stress-strain relation

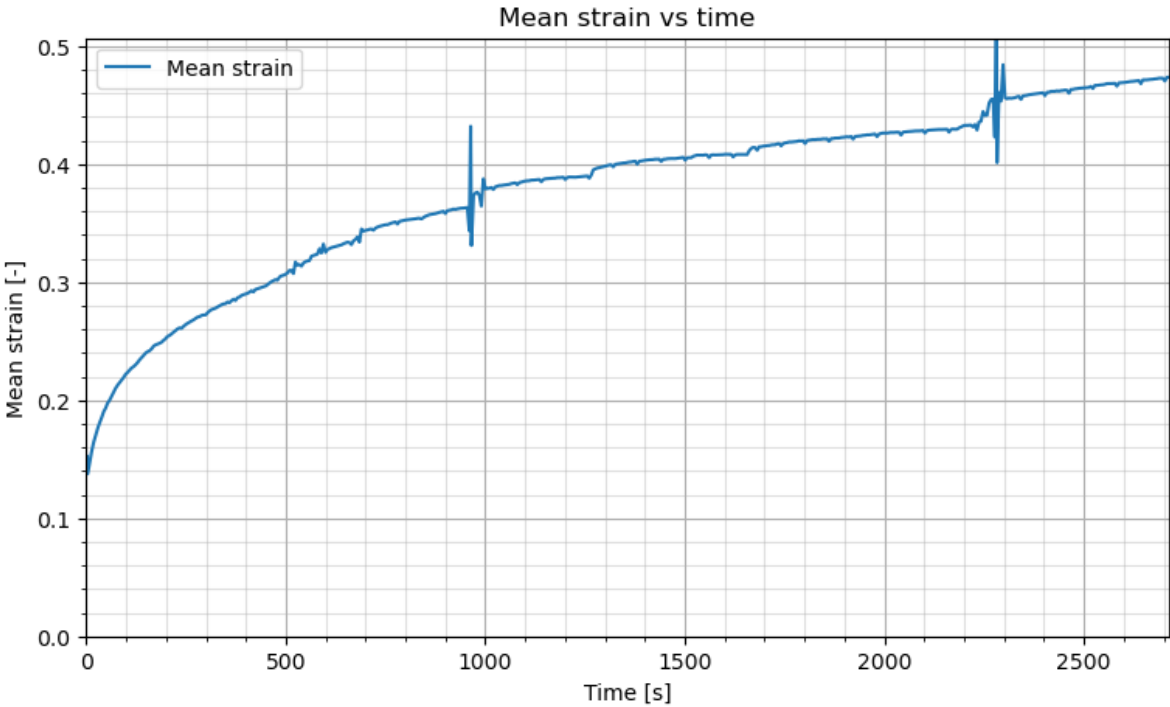
Mean strain over time

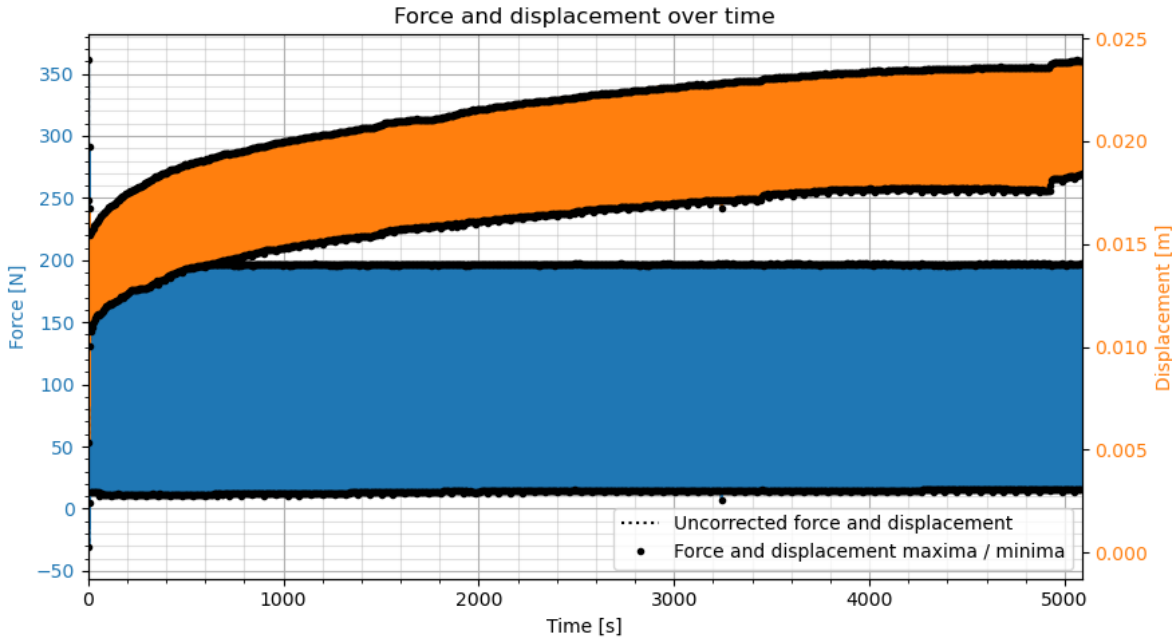
Force and displacement over time

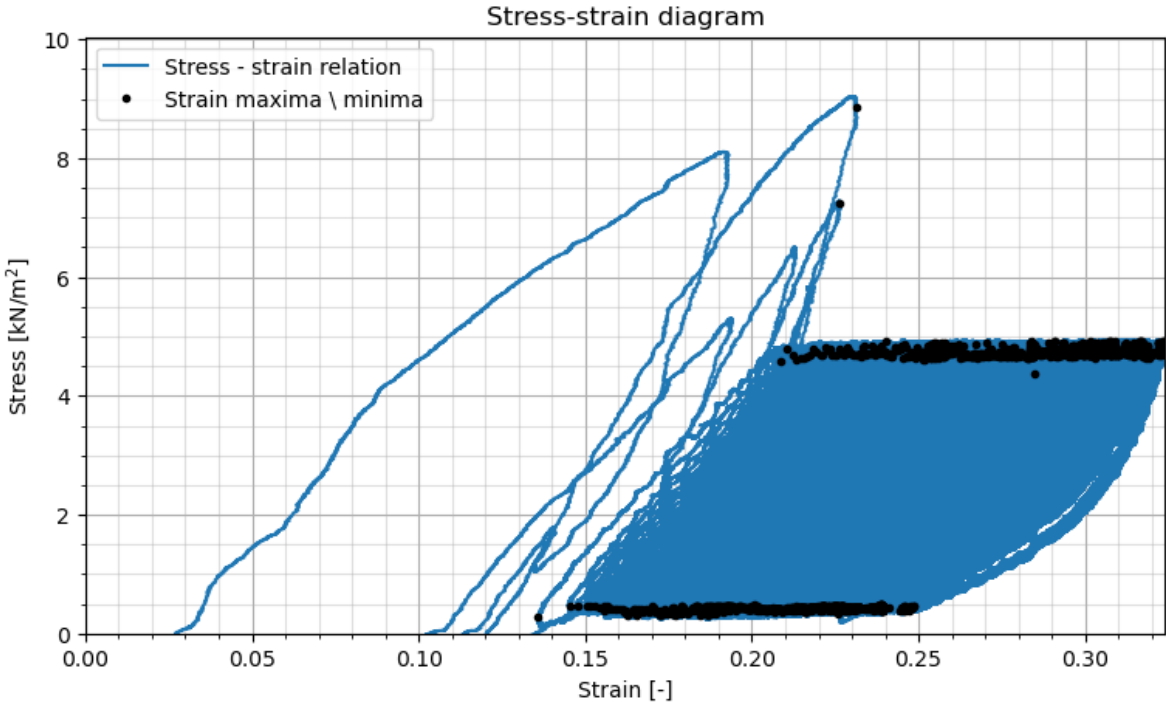
Stress-strain relation

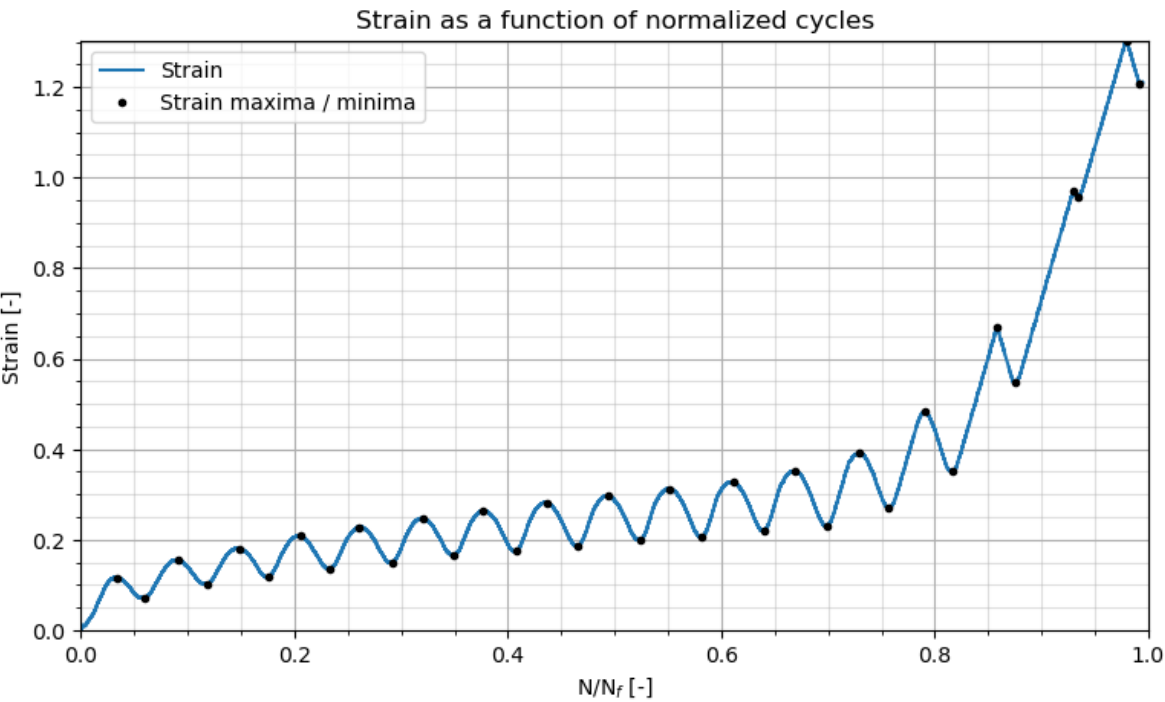
Strain over normalized cycles

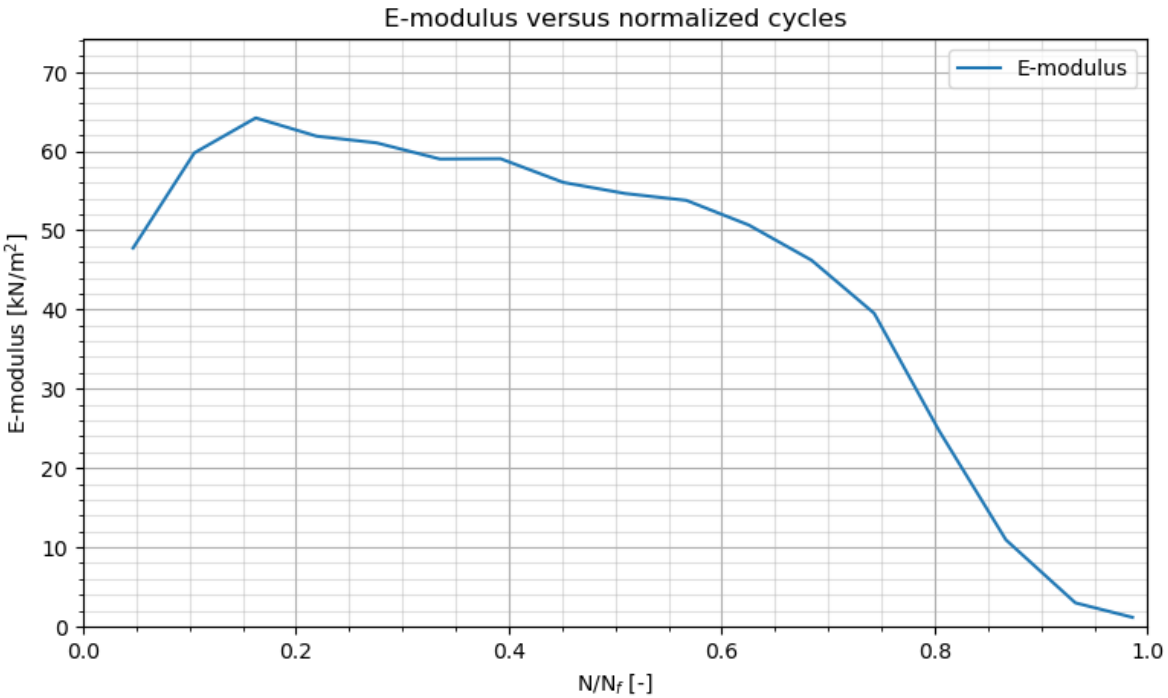
E-modulus over time

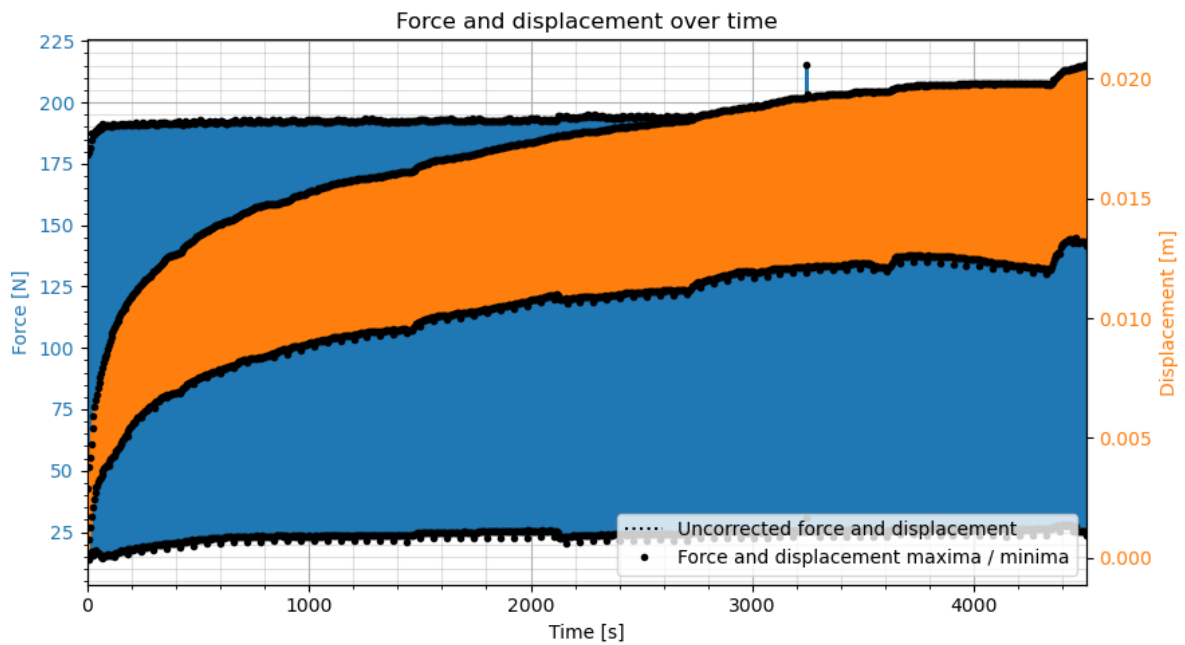
Force and displacement over time

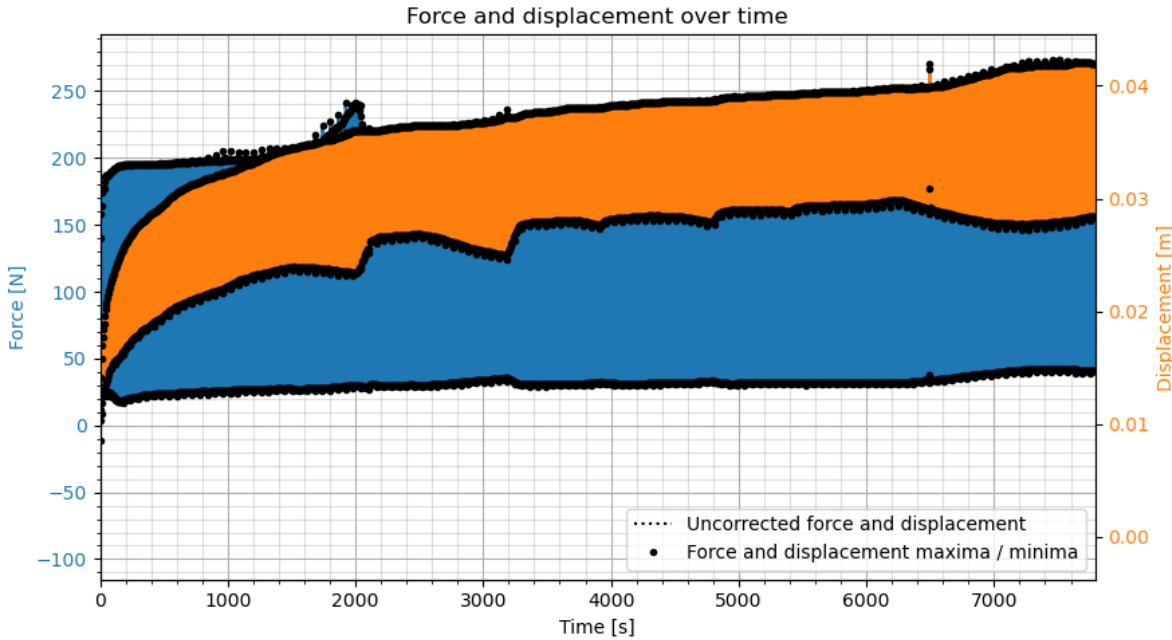
Force and displacement over time

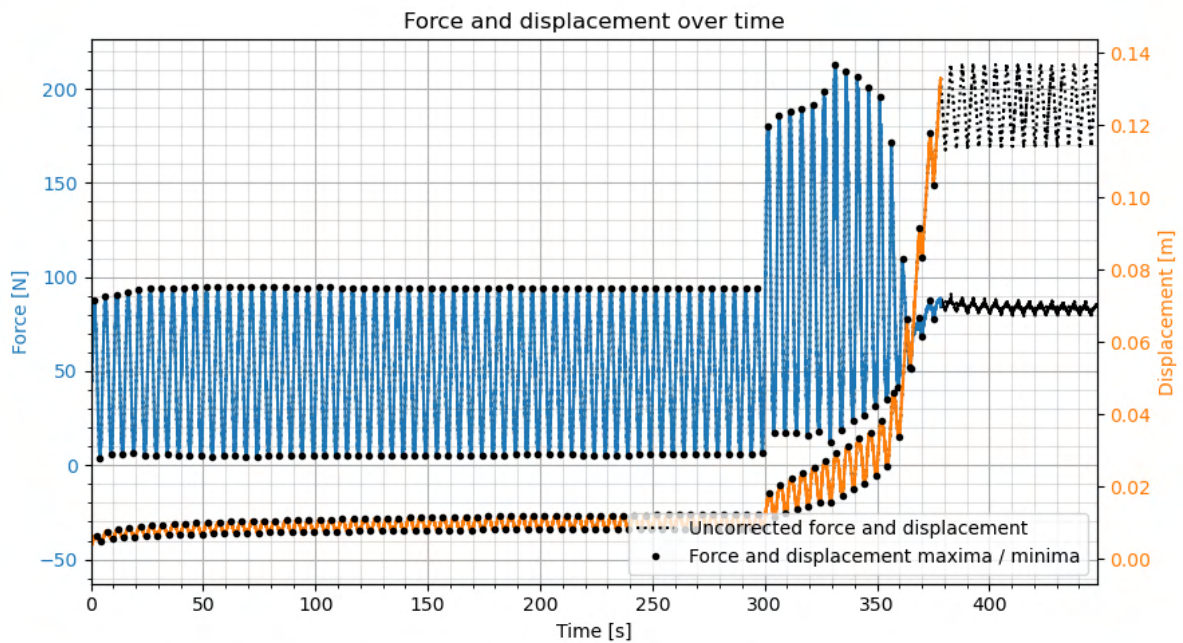
Force and displacement over time

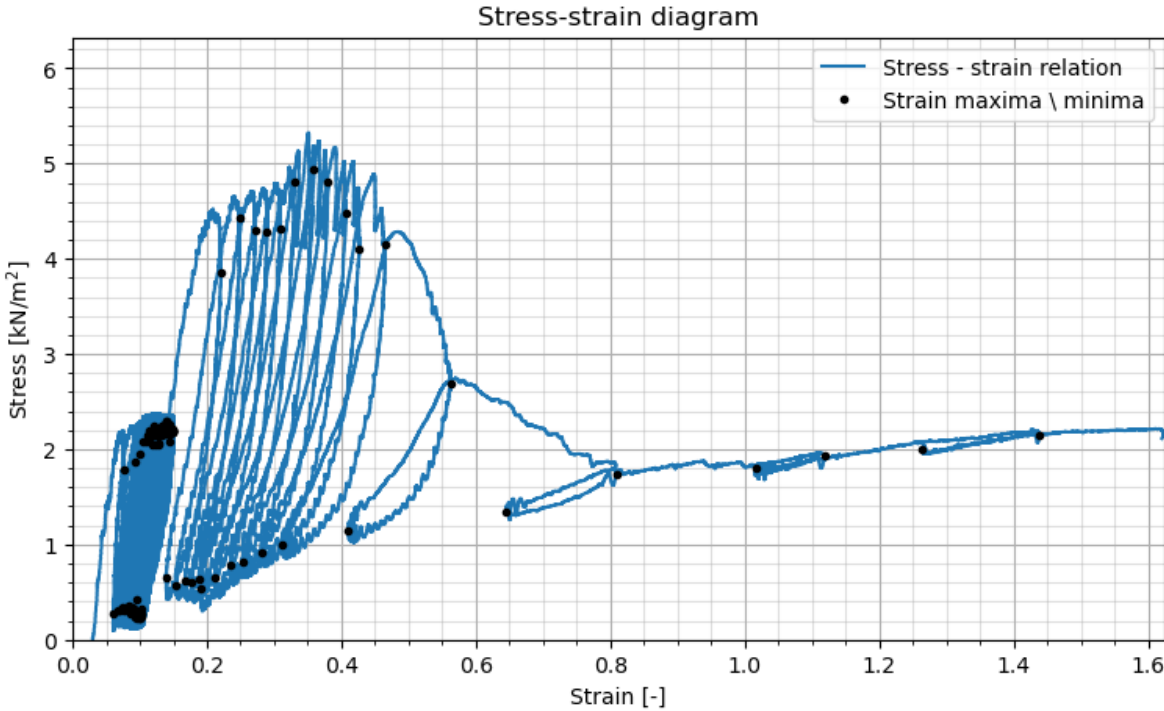
Stress-strain relation
