Pre-collapse spaceborne deformation monitoring of the Kakhovka dam, Ukraine, from 2017 to 2023

Communications Earth and Environment

The Kakhovka Dam on the Dnieper River in Kherson Oblast, Ukraine, was completed in 1956 as the final dam in the Dnieper reservoir cascade. On the morning of June 6th, 2023, a substantial portion of the dam suffered a collapse while under Russian control. This incident was documented through satellite optical and radar images, providing valuable evidence of the dam's condition. Here we present the results of multi-temporal Interferometric Synthetic Aperture Radar (MT-InSAR) monitoring of the Kakhovka dam. The dam is vital for water management and hydroelectric power generation. Utilizing multi-temporal InSAR (MT-InSAR) data, we assessed the dam deformations prior to the collapse. Our findings indicate movements of the south side, facing the Dniprovska Gulf, compatible with several possible damage mechanisms. This study highlights the significance of employing spaceborne advanced monitoring techniques to detect signs of distress and ensure the stability of critical infrastructure.

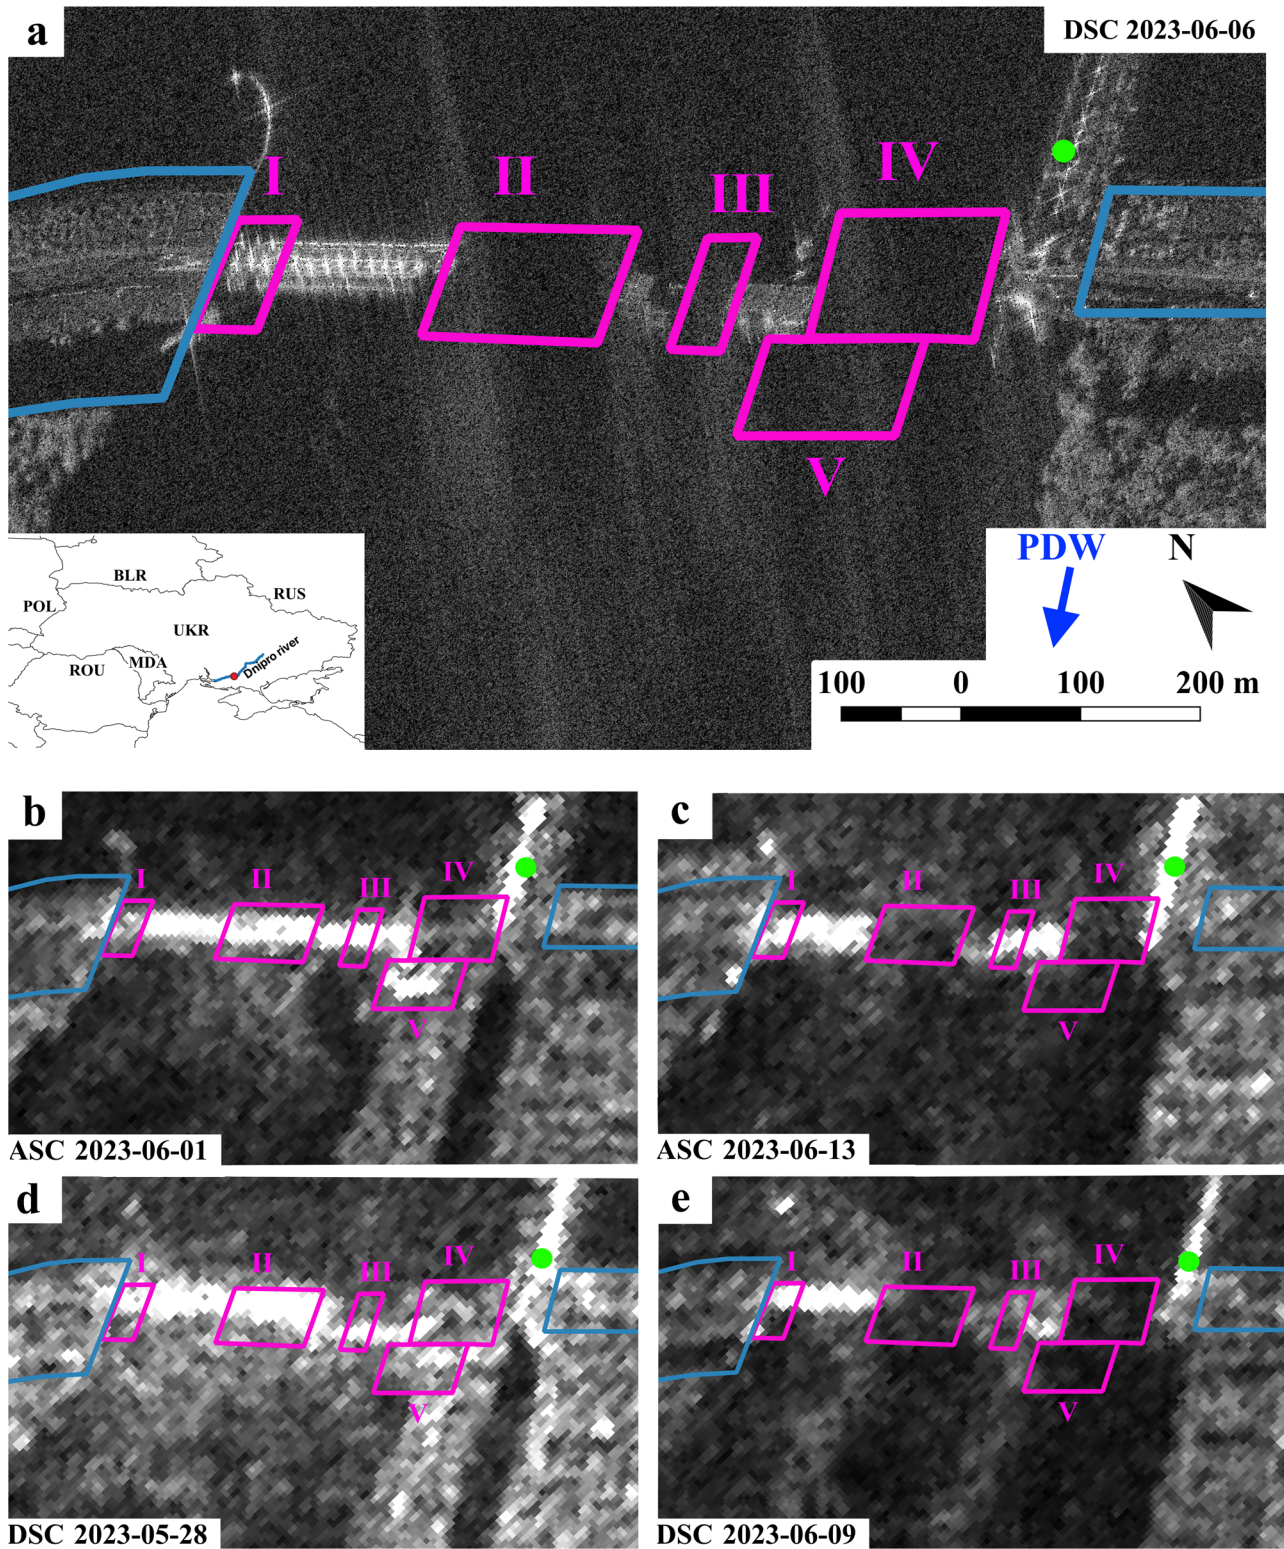
Fig. 1 | Areas of interest over the Kakhovka dam identified using Umbra HH polarized and Sentinel-1 VV polarized GRD images. a shows the Umbra descending image with the resolution of 50 by 50 cm, acquired on June 6th 2023. **b** and **c** show two Sentinel-1 SAR amplitude using ascending images acquired on June 1st 2023 and June 13th 2023 before and after the collapse, respectively. Similarly, **d** and **e** show the Sentinel-1 SAR amplitude using descending images acquired on May

28th 2023 and June 9th 2023, respectively. The purple numbered polygons represent the collapsed parts of the dam. The blue polygons indicate the dam embankments. The green marker indicates the shipping lock location. The blue arrow shows the direction of the river flows. SAR data © 2023 Umbra Lab, Inc. (Licensed under CC BY 4.0). Copernicus Sentinel data 2023, processed by ESA.

meters in length¹. Using a post-collapse image acquired by Umbra, a high-resolution X-band SAR, as well as pre- and post-collapse Sentinel-1 images, we identified two main breaches that had occurred at the dam (Fig. 1, Polygons II and IV). While polygon I has been affected by the events imaged before the damage, occurred on November 11th, 2022⁴, polygon III contains the breached part of the hydroelectric power plant and polygon V shows the location of an associated building (Fig. 1).

The cause of the collapse has been a subject of intense debate. Based on a Reuters report, which details an investigation conducted collaboratively by Ukrainian prosecutors and an international legal experts' team, explosive placed by Russia were identified as the cause of the collapse⁵. The New York Times reported that an American infrared intelligence satellite had recorded a heat signal over the dam before the collapse⁶. Moreover, seismic signals, likely from a large explosion, were recorded by sensors located in Ukraine and Romania by NORSAR^{6,7}. Based on these findings, The New York Times suggested that the explosion at the dam was caused by Russian invasion forces⁵. Chances of structural failure have been assessed as low, providing the dam was maintained properly⁸. Additional theories included the possible influence of earlier damage and of increased water levels⁹. The Conflict Intelligence Team observed that the dam was operating abnormally, with only the same spillway gates open, for eight months starting from November 15th, 2022¹⁰. During this period, gates were open only on the east side¹⁰ (Fig. 1, polygon II).

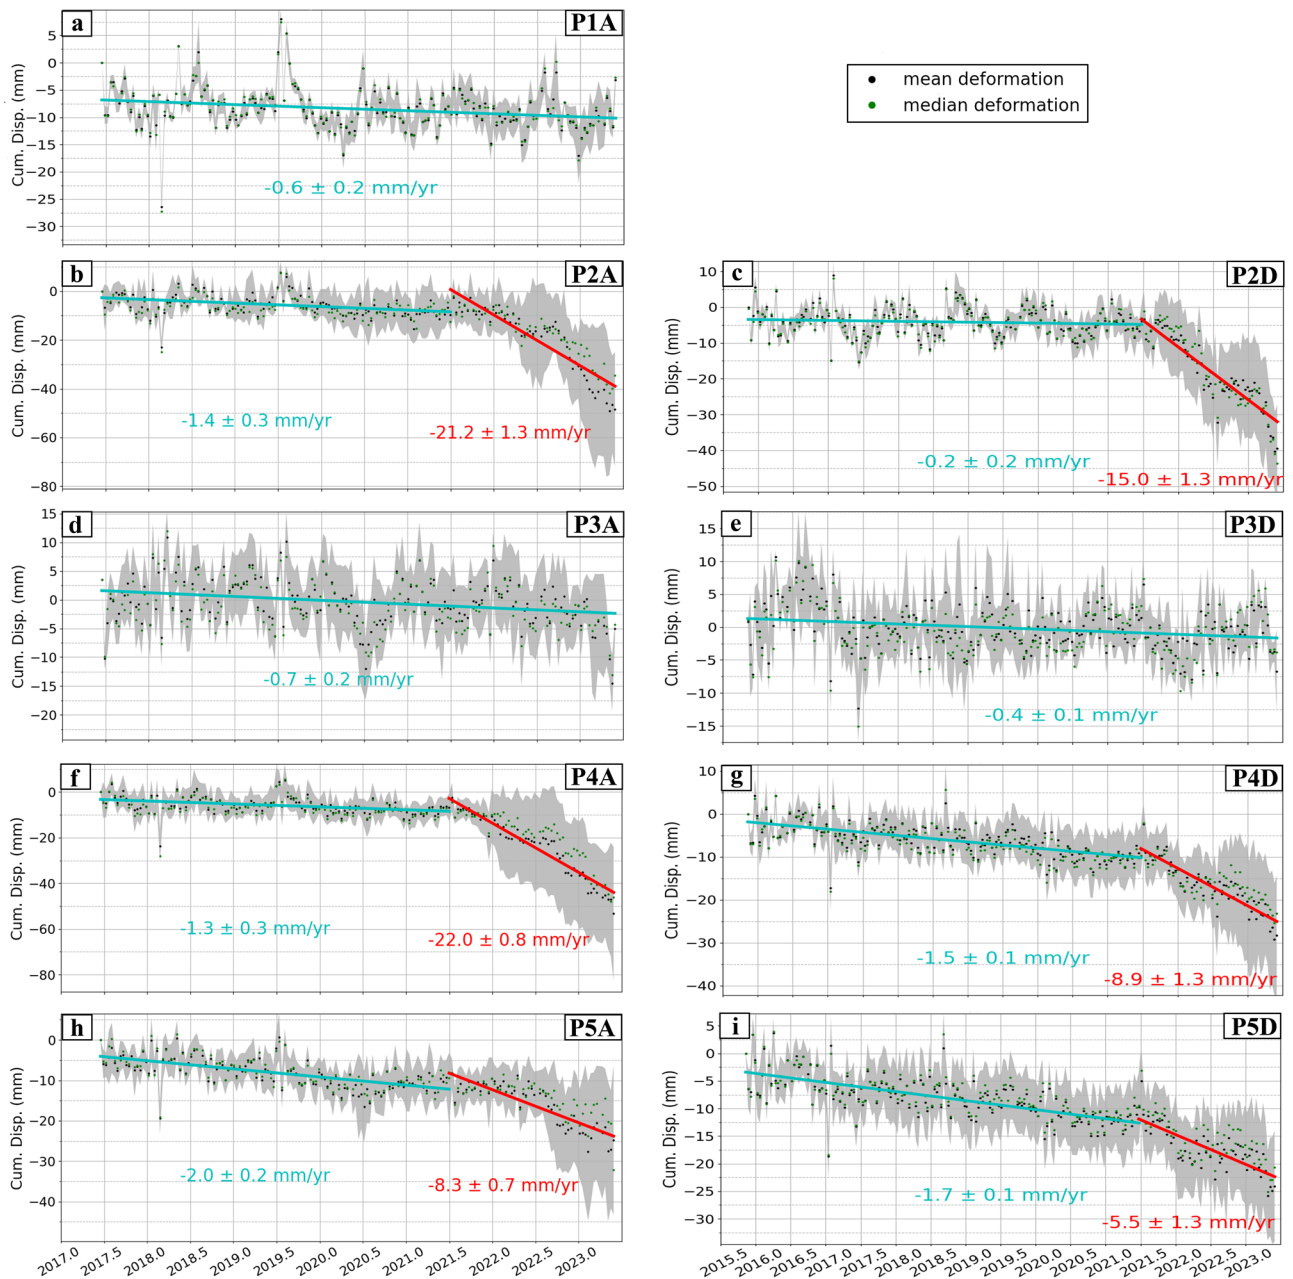
Fig. 2 | Average line of sight deformation time-series for polygons I, II, III, IV, and V extracted from Fig. 1. Images a, d, f and h represent the ascending deformation time-series and images c, e, g and i are the descending deformation time-series, respectively. Positive values point to moving toward the satellite. The Cyan line represents trends between the beginning of each time-series and June 2021 while the red lines indicate trends observed during the period July 2021–2023. Mean and median deformation is represented as black and green dots respectively. Grey

error bars represent limits indicating one standard deviation. The titles of the panels have been abbreviated for clarity, following the pattern: Px(A/D), where “P” represents “Polygon”, x is the number indicating the polygon number, and “A” or “D” stands for “ascending” or “descending” geometry, respectively. Just one measurement point has been found for polygon I descending (P1D) and therefore has not been displayed in this figure.

We used two Sentinel-1 InSAR dataset comprising both ascending and descending tracks. The ascending (ASC) track included a total of 180 images acquired by Sentinel-1A and Sentinel-1B, spanning from July 2017 to June 2023 (Table 1). Similarly, the descending (DSC) track dataset consisted of 226 images acquired by Sentinel-1A and Sentinel-1B, covering the period from November 2015 to June 2023. By analyzing the time-series of deformation over each of the five polygons (Fig. 1), five distinct patterns of deformation were observed in both the ASC and DSC geometries, indicating the presence of displacement in different directions, including vertical (up/down) and horizontal (east/west) (Fig. 2 and Table 2). It is noteworthy that upon analysing the data, it becomes apparent that polygons I and III remained remarkably stable, with no substantial deformation observed throughout the entire period. In contrast, polygons II, IV, and 5 exhibited the most pronounced changes, particularly starting from June 2021. Polygon V, which is situated above a nearby dam facility, shows a linear deformation trend starting in 2015. This trend reached a rate of nearly 2±0.2 mm per year, amounting to a cumulative displacement of 10 mm over the 5 years prior to the collapse (Fig. 2h). Starting in June 2021, the rate of deformation in polygon V accelerated by 4 times, reaching a trend of 8.3±0.7 mm year⁻¹ until the dam’s collapse (Fig. 2h). Conversely, polygons II and IV, which are positioned over the section of the dam that experienced breaches, exhibit an average deformation of 21.5±1.5 mm year⁻¹ and 12±1.8 mm year⁻¹ for the ascending and descending geometries, respectively (Fig. 2b, c, f, g). Figure 3 illustrates the distribution of selected persistent scatters (PSs) along with their respective mean velocities, including both ASC and DSC geometries. The ascending track perspective is observed from the southern side of the dam (see Fig. 2a, c), characterized by a smaller look angle compared to the descending (Table 1). Consequently, the chosen PSs are primarily located in the southern portion of the dam. Conversely, the descending track is characterized by a higher look angle, and it originates from the northern side, resulting in PSs that encompass both the northern and southern regions of the dam. Therefore, for a fair comparison, the observed deformation in these polygons is localized and confined to the southern side of the dam. The DSC dataset reveals slightly lower velocity

values and similar activation dates due to its reduced sensitivity to vertical displacements as the descending is characterized by a larger look angle, (Tables 1 and 2).

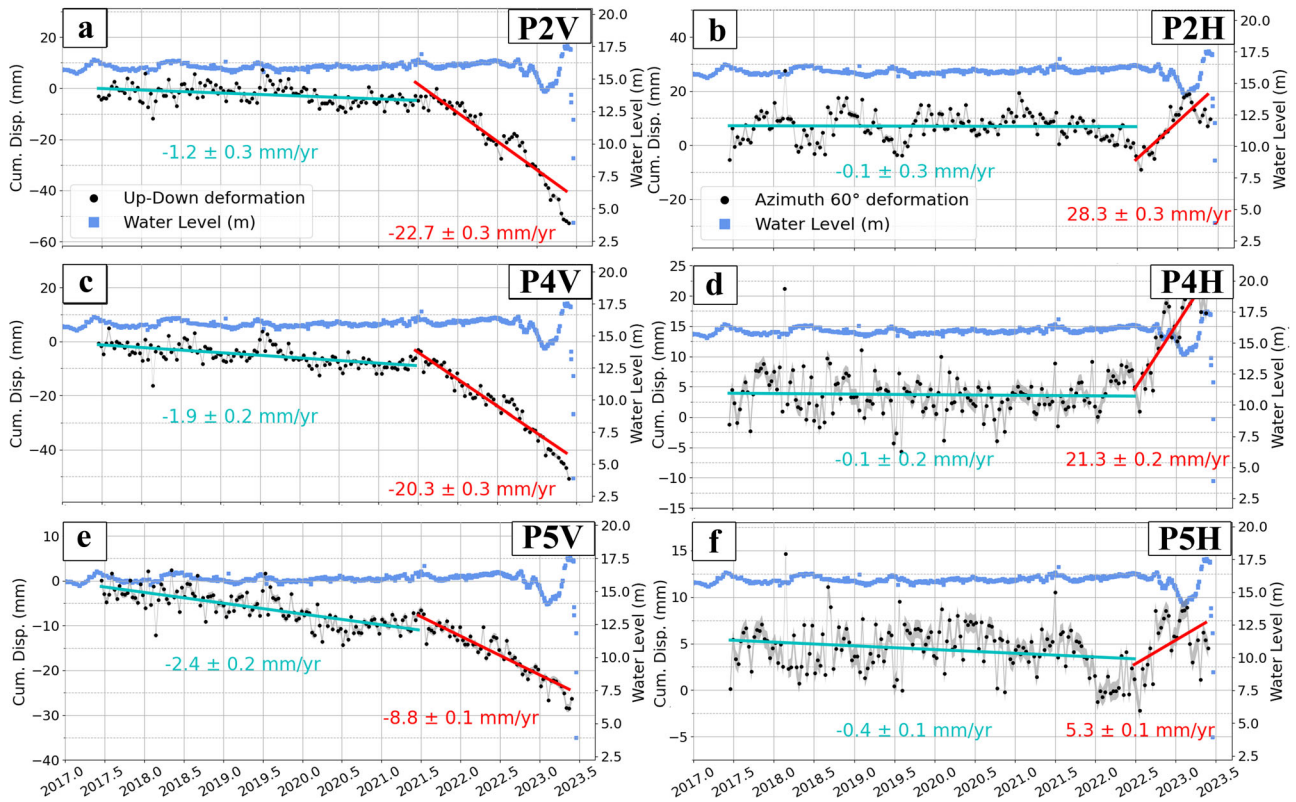
Fig. 4 | Decomposed deformation time-series for polygons II, IV and V. a and b represent the vertical and PDW deformation components for polygon II, respectively. c and d show the vertical and PDW averaged deformation time series for polygon IV, respectively. e and f show the vertical and PDW averaged deformation time series for polygon V, respectively. Positive values indicate upward motion for the vertical component and along upstream motion for the PDW

component. The titles of the panels have been abbreviated for clarity, following the pattern: Px(V/H), where “P” represents “Polygon”, x is the number indicating the polygon number, and “V” or “H” stands for “vertical” or “horizontal” (PDW) component, respectively. Blue squares show the water level of the reservoir time-series from Hydroweb²².

Ascending and descending geometries present dissimilar patterns, suggesting the presence of vertical (up/down) and horizontal (east/west) displacements. To gain a more comprehensive understanding, the average line-of-sight (LOS) deformation values were further analysed and decomposed into their vertical and perpendicular to the dam walls (PDW) components (Table 3). Specifically, over polygon II we measured a downward linear displacement of -22.7 ± 0.3 mm year⁻¹ starting from June 2021 and a 28.3 ± 0.3 mm year⁻¹ upstream PDW displacement starting from June 2022. In contrast, polygon IV exhibits a downward displacement of approximately -20.3 ± 0.3 mm year⁻¹ initiating in June 2021, and a 21.3 ± 0.2 mm year⁻¹ upstream PDW displacement, initiating in June 2022 (Table 3 and Fig. 4). Time-series of decomposed deformations along the vertical and PDW components for polygon II, polygon IV and polygon V are represented in Fig. 4. The time-series of measured water levels using the Hydroweb River Water Level products²² is also plotted as the second axis for each panel in Fig. 4.

The thermally detrended vertical and PDW displacements indicate that between 2017 and June 2021 an area located next to the Kakhovka hydroelectric power plant has been almost steady (Polygon III). This area was subsiding in the past²⁶ since compression of the clay layers underlying the infrastructure has been recorded between 1955 and 1976 at rates of 60 mm year⁻¹. A nearby facility has been subsiding from 2017 to June 2021 by an average constant rate of -2.4 ± 0.2 mm year⁻¹ (polygon V). Using the method in Raspini et al.²⁷ we identified an accelerating subsidence pattern starting June 2021. In June 2021, the facility started settling at 8.8 mm year⁻¹ rates, four times faster compared to the subsidence rate before acceleration. In June 2021, the concrete dam started showing signs of accelerating subsidence movements at maximum rates of -22.7 ± 0.3 mm year⁻¹ and -20.3 ± 0.3 mm year⁻¹, respectively, over polygons II and IV (Fig. 4). In addition to the vertical deformation, Figs. 4b and d exhibit upstream PDW movements in both polygon II and polygon IV. A comparison of Fig. 4e and f indicates that the most dominant component of deformation for polygon V was vertical.
