MSc thesis

The stability of foreland types under dike breach conditions – an experimental study

Master of Science
in Civil Engineering

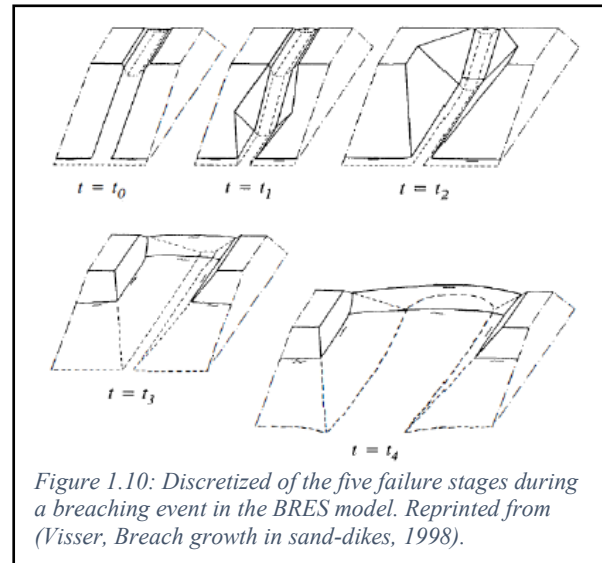
Figure 1.10: Discretized of the five failure stages during a breaching event in the BRES model. Reprinted from (Visser, Breach growth in sand-dikes, 1998).

Many mathematical and/or numerical models have been developed to predict breach growth. A well-known, often applied model, is the BRES model (BReach Erosion in Sand-dikes model), developed by (Visser, 1998). In this 1-D mathematical model the breach growth process of a sand dike is described in 5 separate phases, see Figure 1.10. In terms of sediment transport formulas, the model uses Bagnold-Visser (Visser, 1988) for the first three phases (supercritical flow), and Van Rijn (Van Rijn, 1984) for the subsequent phases. The sediment transport is only computed for non-cohesive material. The model distinguishes three types of breaches, which describe a different situation: (A) with the presence of a toe construction in front of the dike, a choice can be made between an erodible or non-erodible foundation, (B) with a relatively high foreland or (C) without any added construction.

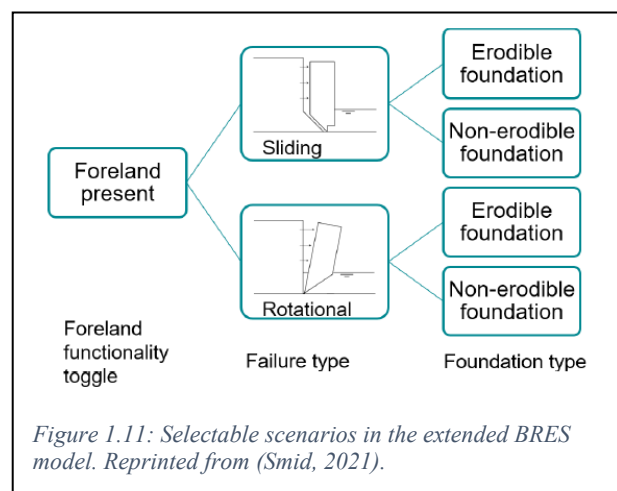
Figure 1.11: Selectable scenarios in the extended BRES model. Reprinted from (Smid, 2021).

Recently, the influence of a foreland was added as a separate module in the BRES model by (Smid, 2021). The module is activated from the moment onwards where foreland erosion occurs, which is from phase three in the original BRES model type B. With a mathematical script of the headcut erosion mechanism as described above, the amount of headcut erosion for different scenarios is calculated. Simultaneously, the shape of the foreland spillway is predicted. Four scenarios can be created by the user by selecting between either a sliding or rotating block failure mechanism during the headcut erosion process. A foundation that is or is not erodible is optional when choosing a block failure type, see Figure 1.11.

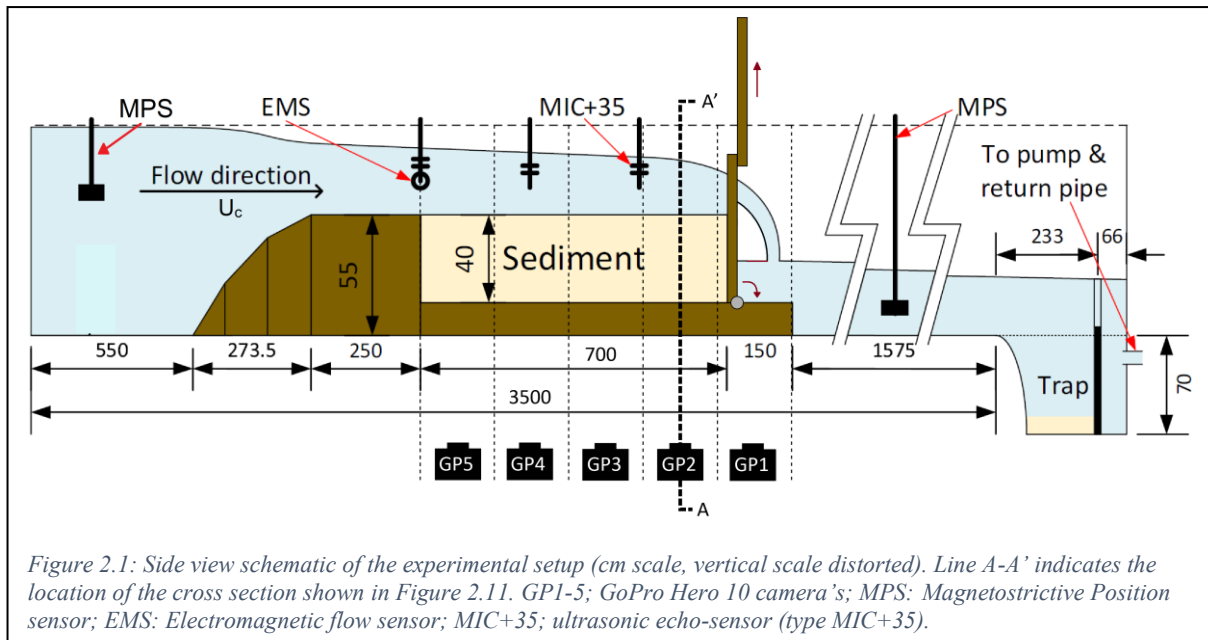
Figure 2.1 shows a schematization of the full sediment flume facility length of the experimental setup used in this study. The schematic clearly shows the overall experimental setup, measuring instruments, GoPros and the flume system which regulates the hydraulic conditions. Horizontal distances are in centimeter scale and have been added to the schematization. The vertical scale is distorted. A line is drawn to indicate cross-section A-A' at the GoPro 2 position, which will be discussed in Section 2.2.4. Additional images of the experimental setup can be found in Appendix A: Additional Images.

For the experimental setup, specific elements were applied, developed and built within and around the sediment flume facility. The elements were developed to establish foreland-dike breach conditions (high flow velocities) and to observe the sediment stability from a 2D perspective. Concrete plywood panels were used to manufacture all experimental elements. Concrete plywood is a sheet material that consists of several layers of veneer. The sheet material is provided with an epoxy layer. This hard layer forms a waterproof finish which makes it extremely suitable for constructions in humid environments. It is also very easy to treat. Below a short description is provided of the specific elements:

- A broad-crested weir (BCW) with specific characteristics (sketched in brown in Figure 2.1) was developed, constructed, and built within the sediment flume facility to imitate a foreland and the associated hydraulic conditions. Weirs have been extensively used in experimental facilities to study flow conditions in open channels (Badr & Mowla, 2014) (Osman Akan & Iyer, 2021). The essence of a broad-crested weir is that the streamlines on the crest become horizontal and parallel due to the conservation of energy (Chanson & Eraso, 2004). This flow condition also prevails on a foreland during a dike breach. Figure 2.2 shows the typical flow/energy profile over a broad-crested weir. As can be seen, the water level upstream of the weir is raised, which gives an increase in the potential energy. As a result, the discharge on the crest of the weir is maximized. If the crest is long enough (L_b in Figure 2.2), eventually a critical flow will develop on top of the weir. At the downstream end of the weir the water flow detaches from the headcut brink, resulting in an overflow jet. Sufficient space is required upstream and downstream of the weir to allow flow conditions to be set and to minimize the impact of disturbances.

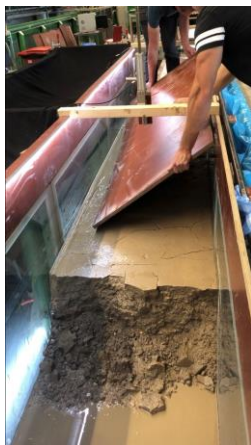
Figure 2.3: Image of placing the concrete plywood panels on top of the river clay package.

A single layer of concrete plywood panels was constructed on top of the clay package (see Figure 2.3). The panels served as an extension of the BCW concrete plywood ramp surface height all the way until the clay package headcut (see Figure 2.4). To prevent the panels from floating during experiments, they were attached to the sediment flume side walls by means of small flow-conducting panels (see Figure 2.4 and Figure 2.5). The false bottom, yellow plus-grid and two measurement devices can also be observed in the images. The name “Tompouce” is chosen because the layered structure resembles a typical Dutch pastry named Tompouce (or Tompoes), consisting of puff pastry on top of cream. Below three images are shown to give an impression of the Tompouce experimental setup.

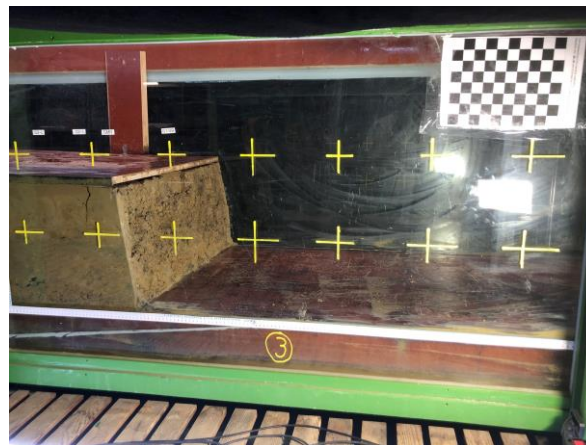
Figure 2.4: Side view image of the Tompouce experimental setup taken at the headcut location. The false bottom and yellow plus-grid can be observed as well.

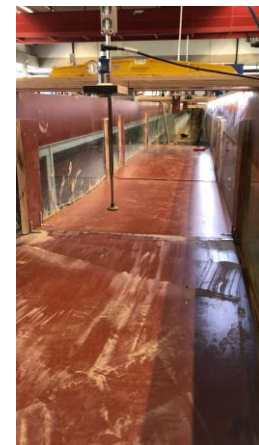
Figure 2.5: Top view image of the Tompouce experimental setup taken within the sediment flume facility. A water level sensor (MIC+35) and flow velocity sensor (EMS) can be observed as well.

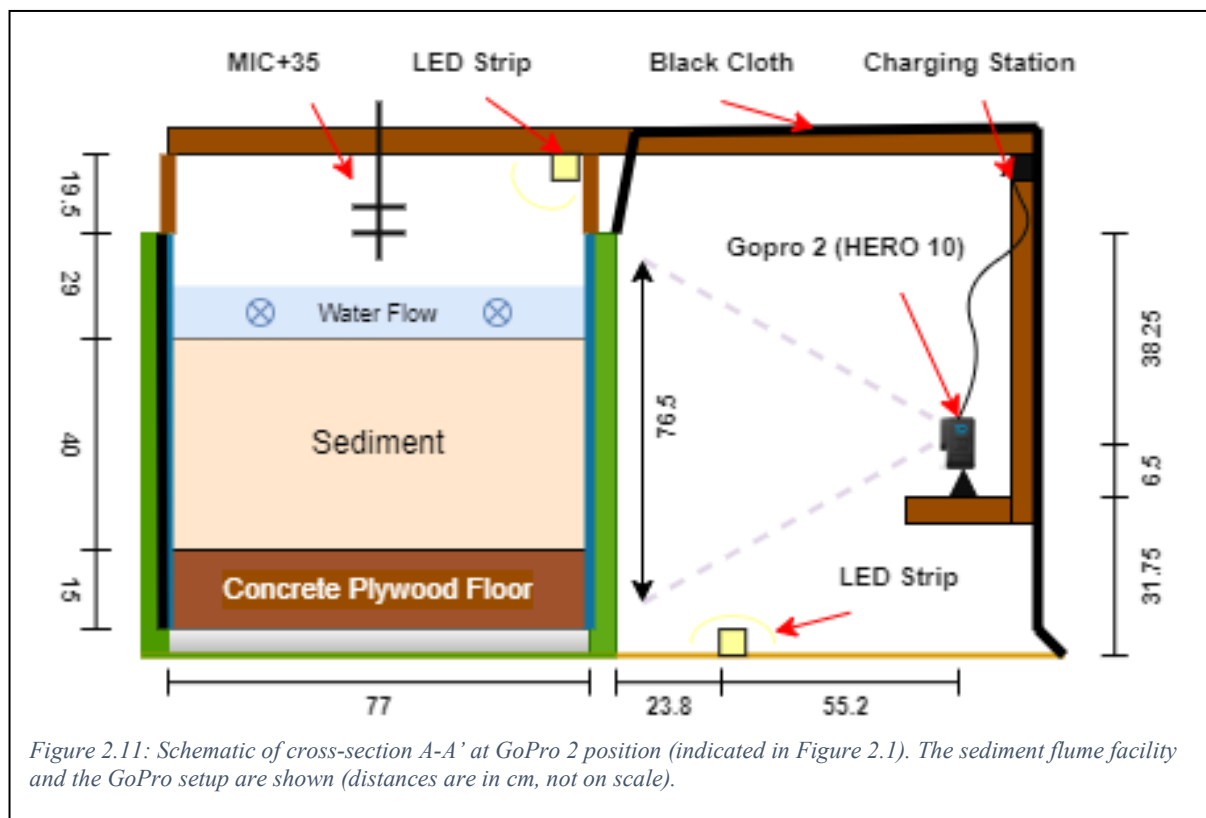
The erosion process was recorded from the side of the sediment flume facility by five GoPros, Hero 10 (see Figure 2.11). They could be started simultaneously with the help of a remote control. Each GoPro was optimal positioned in front and in the middle of a plexiglass window along the sediment test layer. In this way, the five GoPros collectively observed the entire sediment packet. A frame of wooden beams and concrete plywood panels was designed and constructed to hold the five GoPros in position.

Several measures were taken to ensure an optimal visibility for further analysis, see also Figure 2.11:

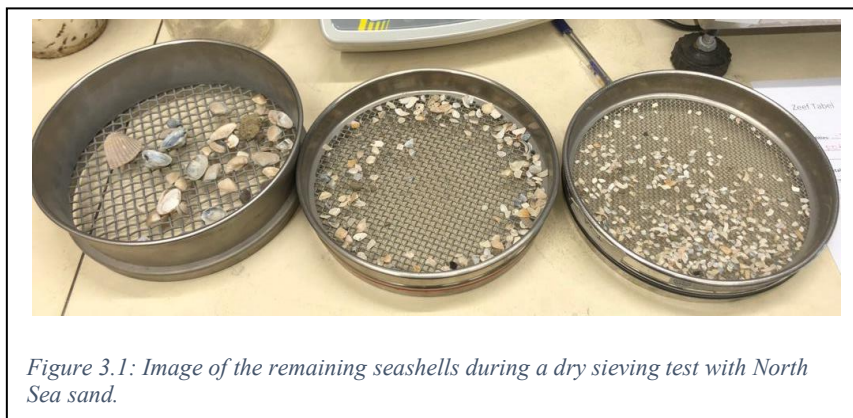
Figure 3.1: Image of the remaining seashells during a dry sieving test with North Sea sand.

Four identical dry sieving tests were performed in accordance with BS 1377:1975, Test 7(B). (Verwaal & Mulder, 2017). During the dry sieving tests, it was found that the North Sea sand samples contained seashells (see Figure 3.1). Their maximum size was 4 cm and the volume percentage was around 7%. The seashells have not been removed during the sediment package preparation before each experiment and may influenced the erosion process. (Cheng, et al., 2021).

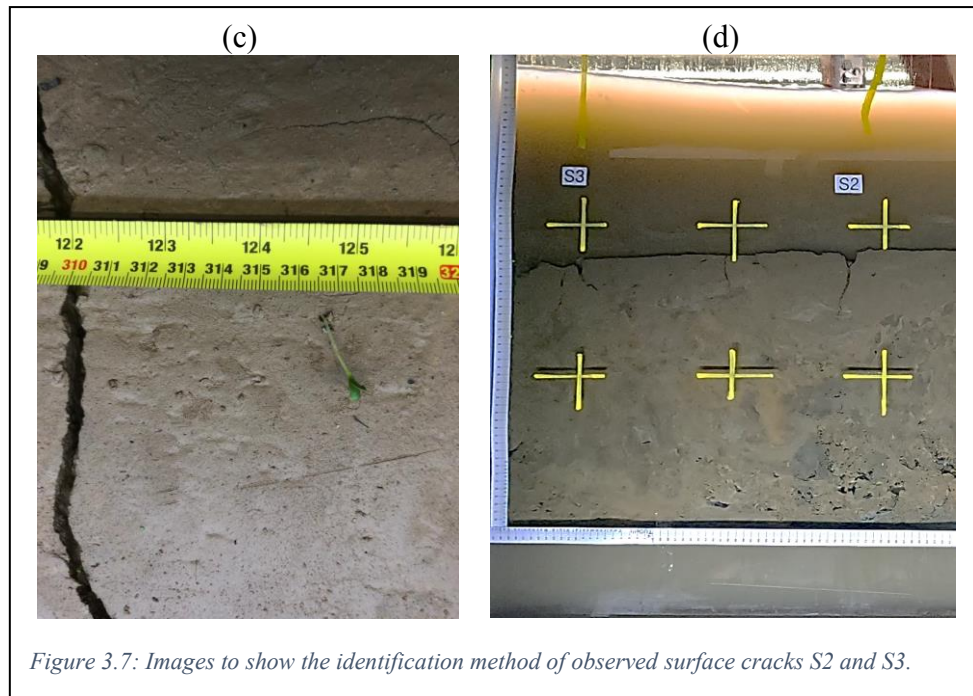
Figure 3.7: Images to show the identification method of observed surface cracks S2 and S3.

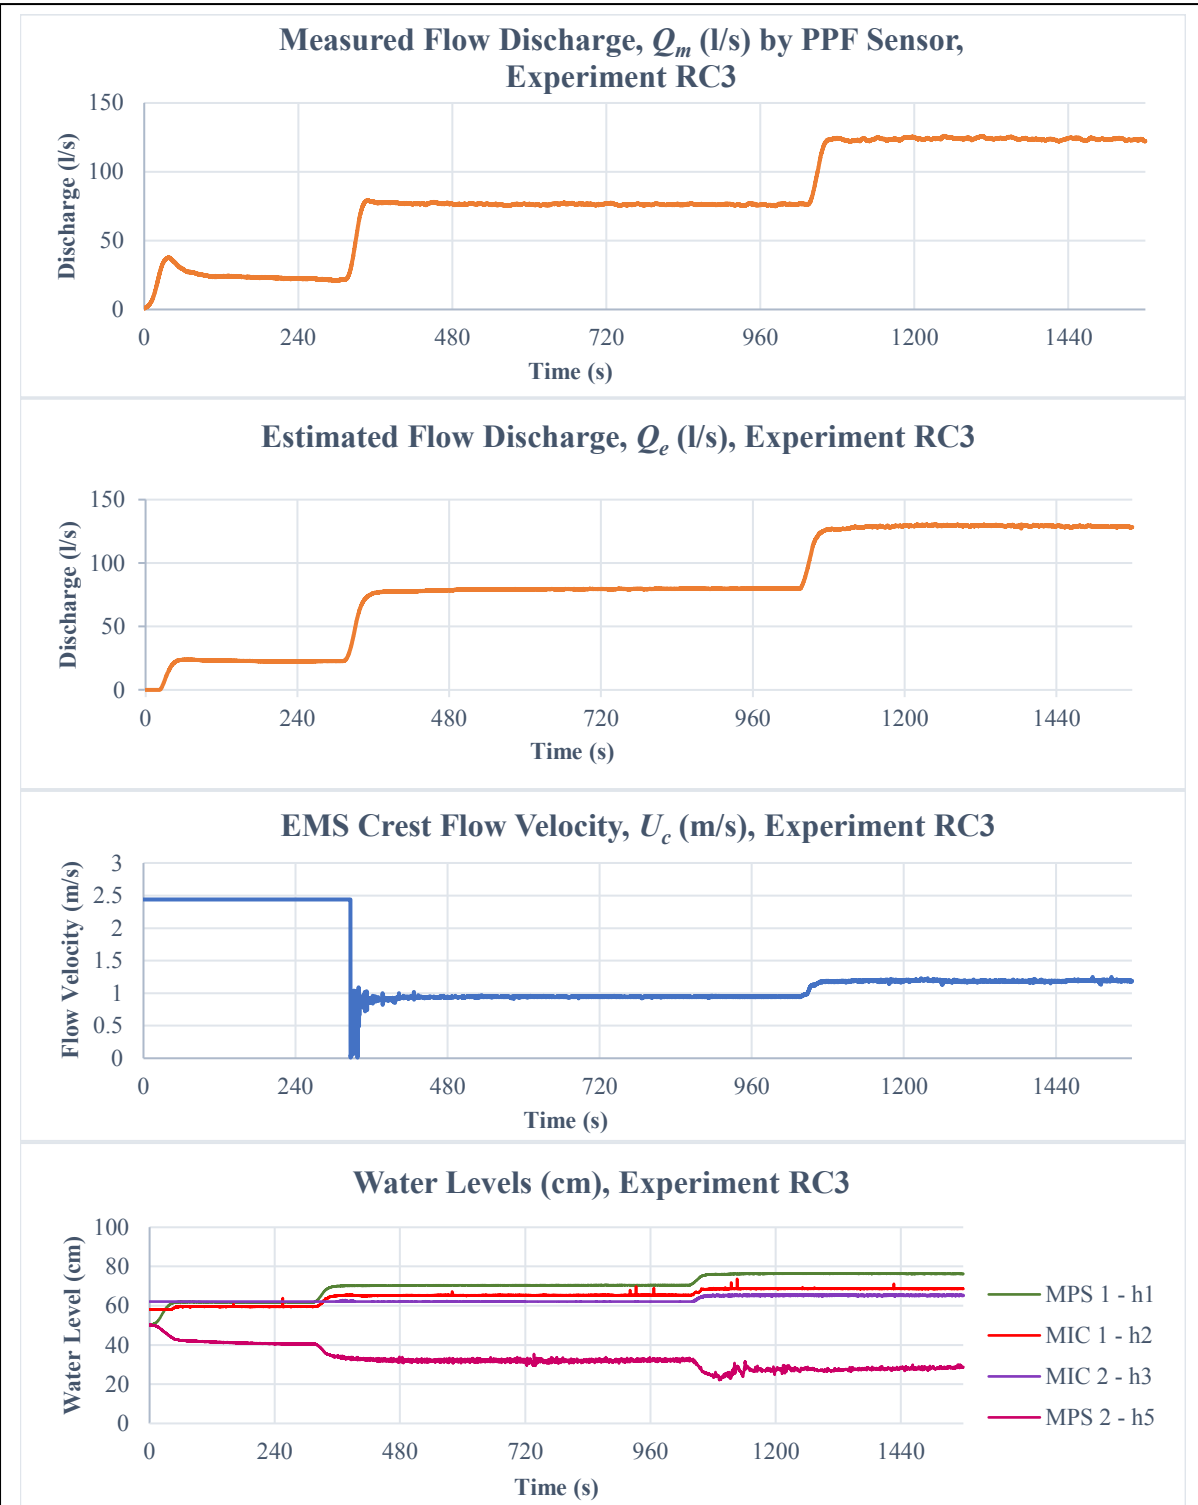
Figure 3.8: Measured flow discharge, Q_m (l/s), flow discharge, Q_e (l/s) estimated using Equation (3.1), crest flow velocity, U_c (m/s), and water levels, $h_1 - h_3$ and h_5 (cm), during river clay experiment RC3.

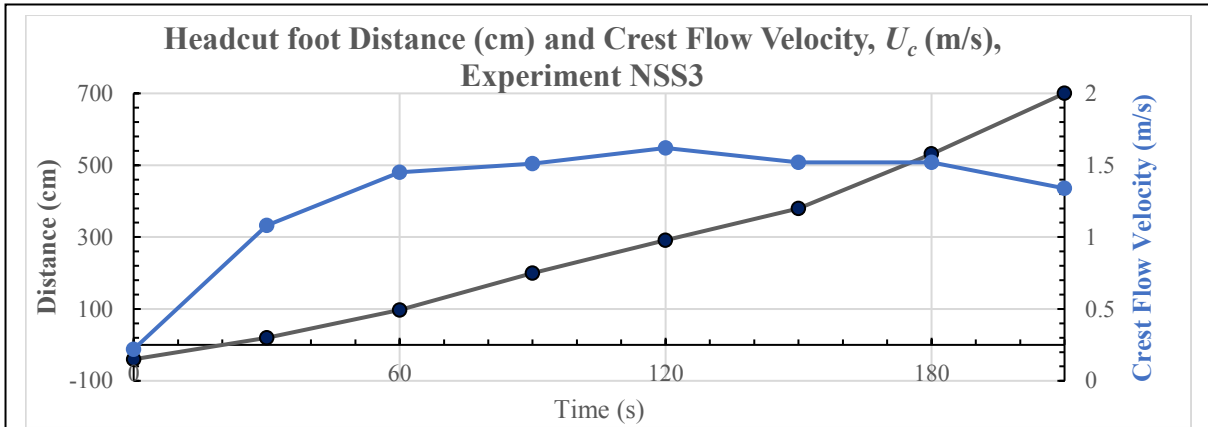
Figure 4.2: Tracked x -position of the headcut foot (the red marker in Figure 4.1) as a function of time during experiment NSS3 (North Sea sand) (black). The second y -axis presents the measured crest flow velocity, U_c (blue).

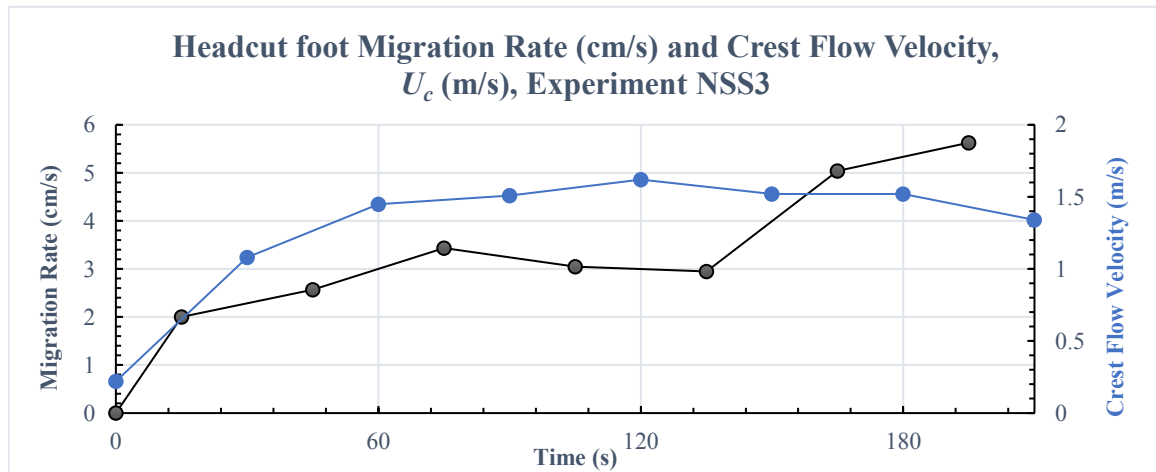
Figure 4.3: Headcut foot migration rate during experiment NSS3 (North-Sea sand) (black). The second y -axis presents the measured crest flow velocity, U_c (blue).

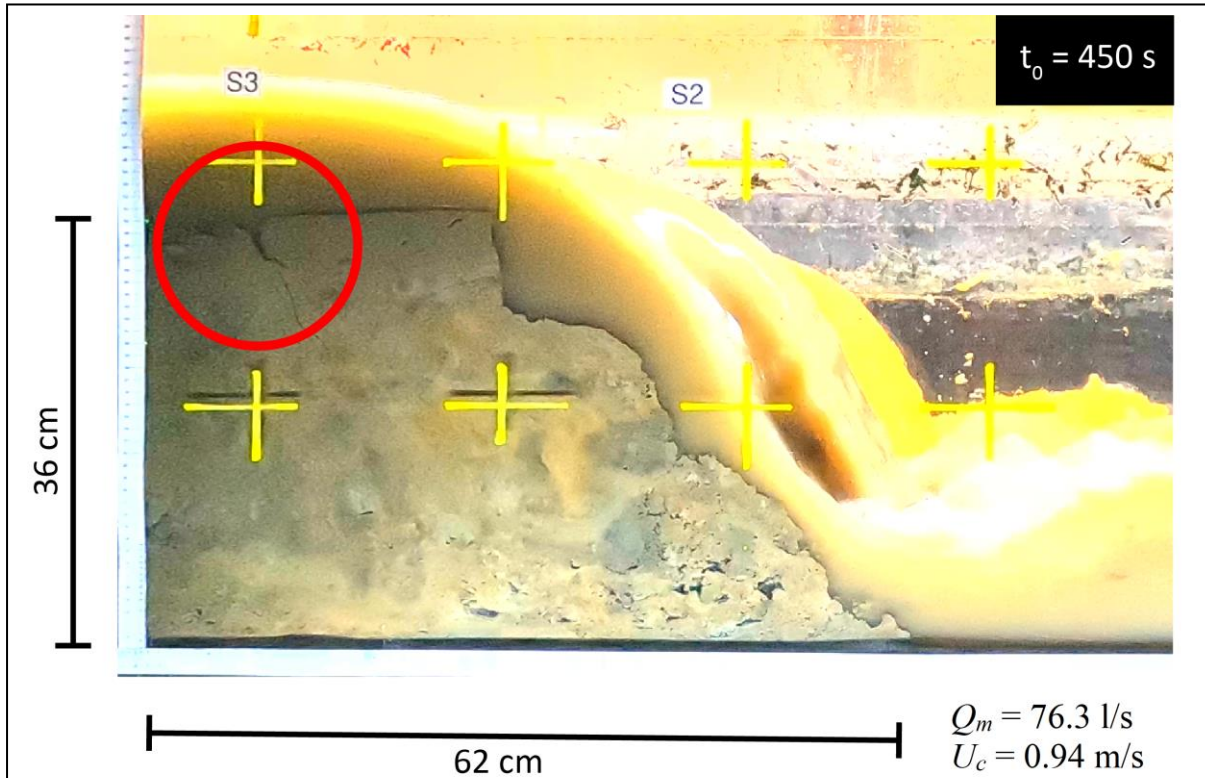
Figure 4.4: Modified GoPro snapshot during experiment RC3 at time $t_0 = 450$ seconds. Hydraulic conditions: measured flow discharge, $Q_m = 76 \text{ l/s}$ and crest flow velocity, $U_c = 0.94 \text{ m/s}$. Dimensions of the river clay section are 62 cm horizontal and 36 cm vertical. S2 and S3 indicate location of the identified surface cracks formed during soil preparation phase. The red circle indicates observed initial crack formation.

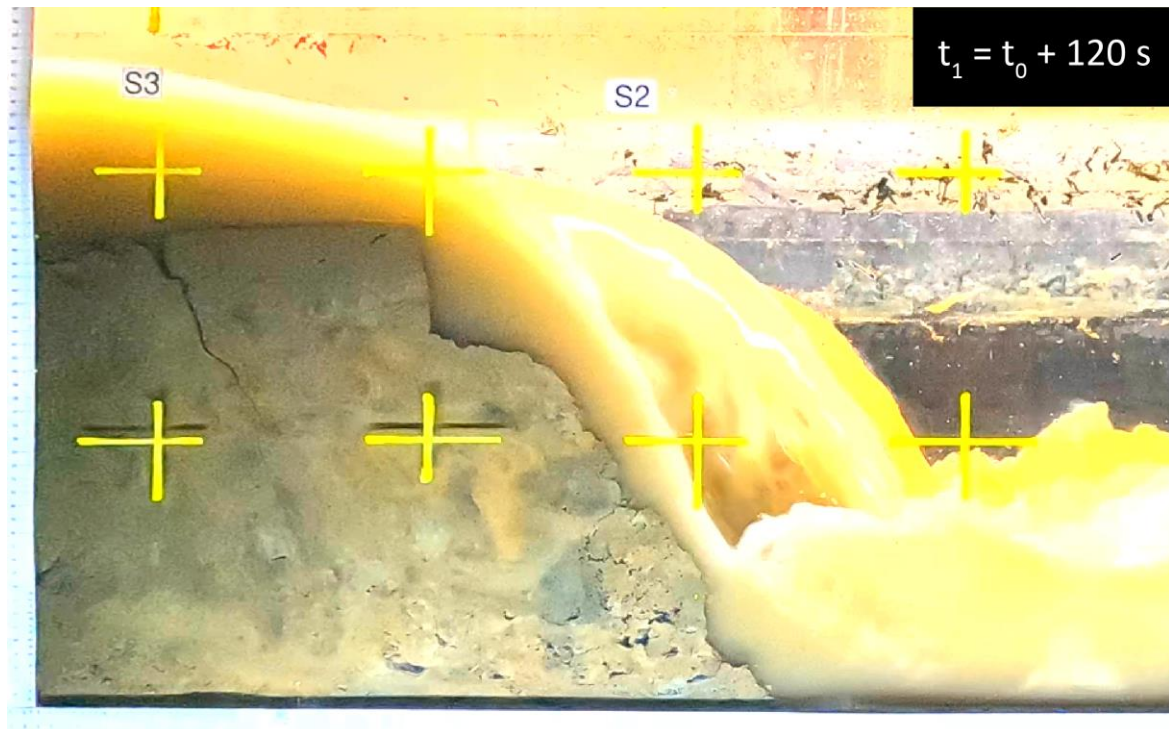
Figure 4.5: RC3 GoPro 2 snapshot at $t_1 = t_0 + 120$ seconds (2 minutes). Crack S3 formation grows due to increasing shear stress.

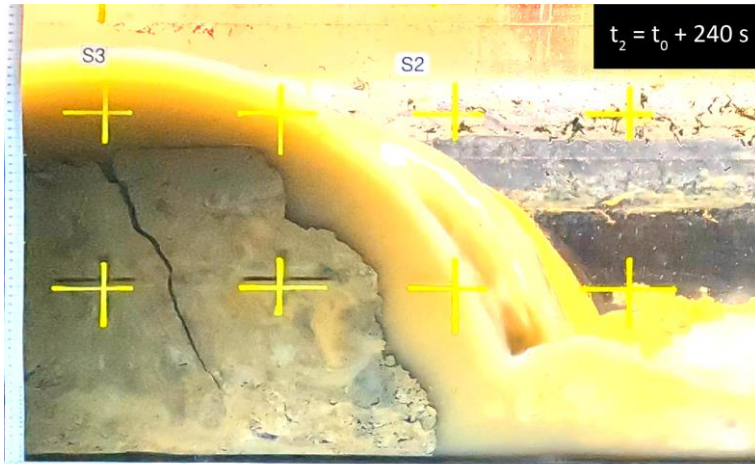
Figure 4.6: RC3 GoPro 2 snapshot at $t_2 = t_0 + 240$ seconds (4 minutes). Further growth of crack S3 formation due to increasing shear stress.

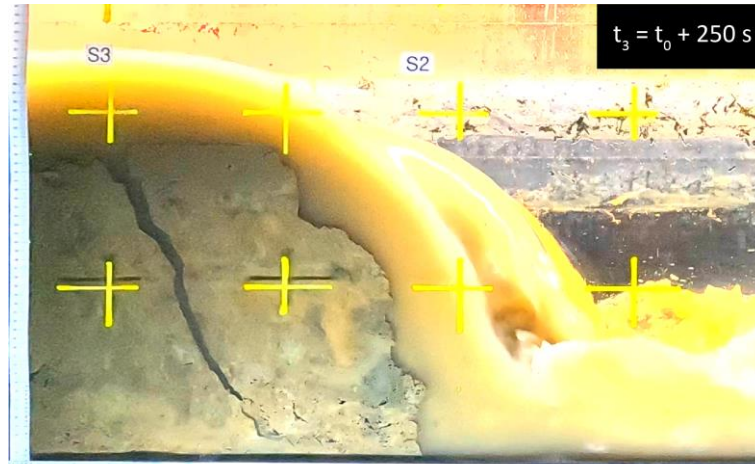
Figure 4.7: RC3 GoPro 2 snapshot at $t_3 = t_0 + 250$ seconds ($t_2 + 1$ second). Start of sliding block failure mechanism.

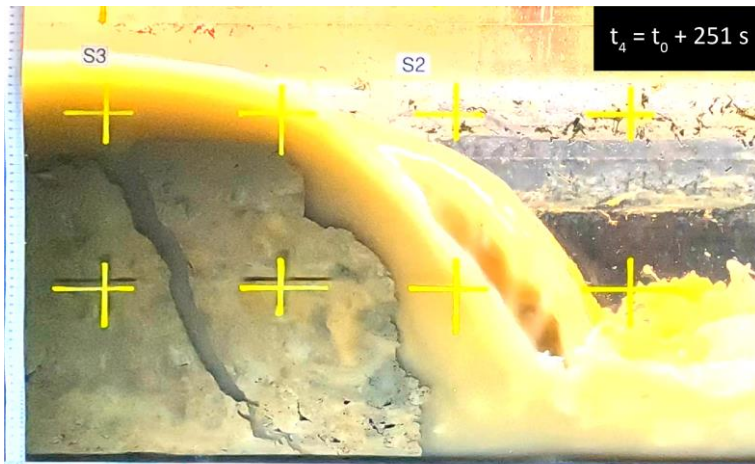
Figure 4.8: RC3 GoPro 2 snapshot at $t_4 = t_0 + 251$ seconds ($t_3 + 1$ second). Further advancement of sliding and rotational block failure mechanism.

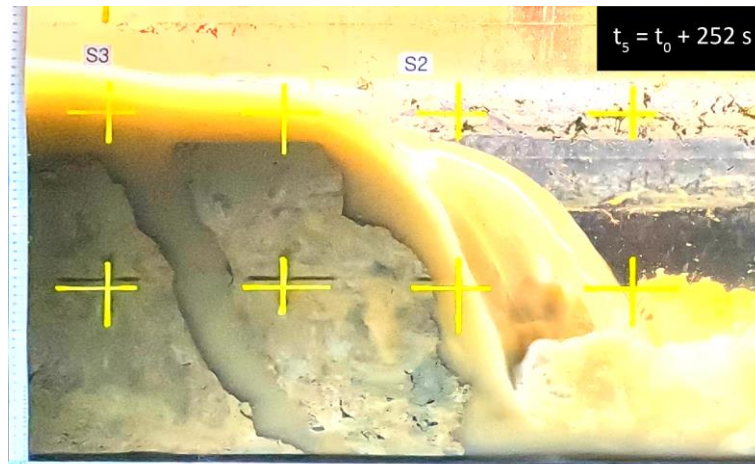
Figure 4.9: RC3 GoPro 2 snapshot at $t_5 = t_0 + 252$ seconds ($t_4 + 1$ second). Last moment before the eroded block is pushed away.

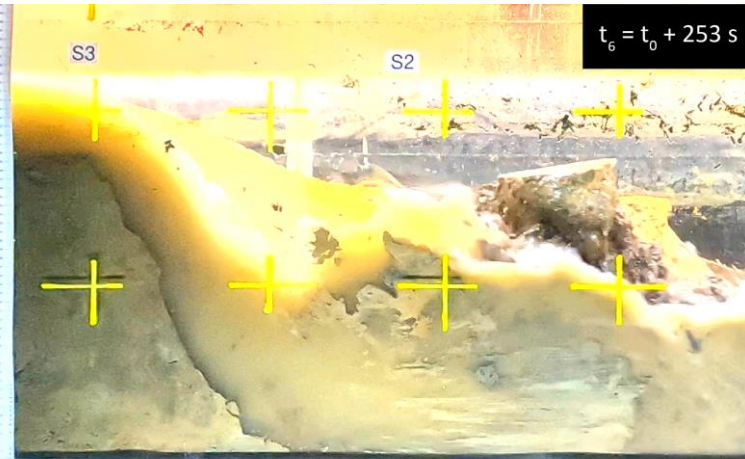
Figure 4.10: RC3 GoPro 2 snapshot at $t_6 = t_0 + 253$ seconds ($t_5 + 1$ second). The block has become completely detached and is pushed further downstream by impulses of water flow.

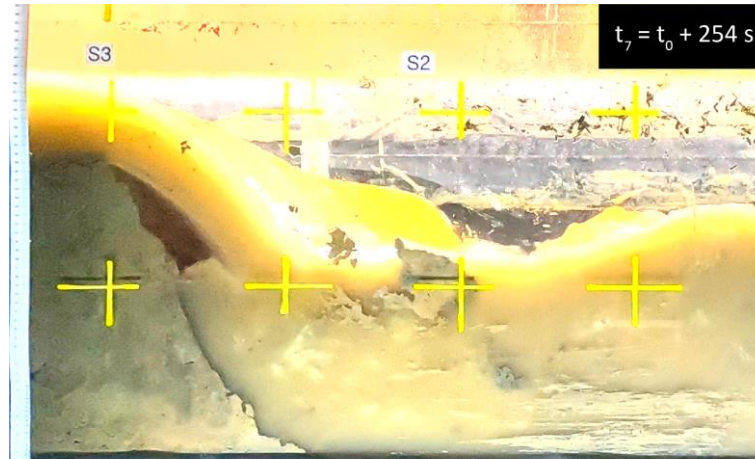
Figure 4.11: RC3 GoPro 2 snapshot at $t_7 = t_0 + 254$ seconds ($t_6 + 1$ second). The eroded block has been pushed one meter downstream. The downstream water level increases and an aerated nappe arises at the newly formed headcut.

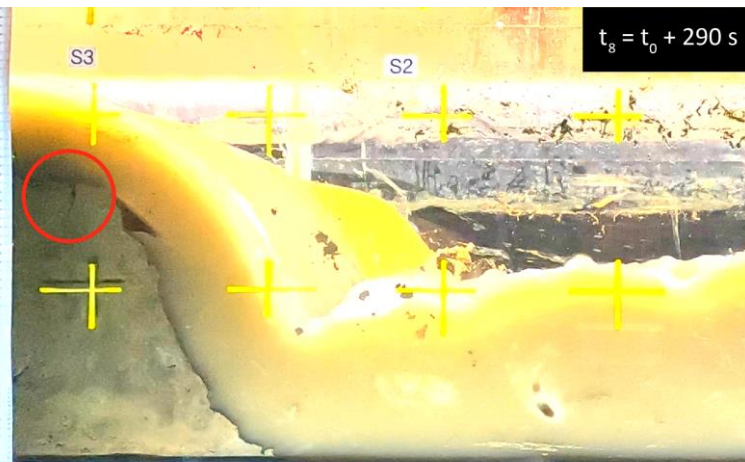
Figure 4.12: RC3 GoPro 2 snapshot at $t_8 = t_0 + 290$ seconds ($t_7 + 36$ seconds). During this time headcut erosion occurred. The eroded block is washed away and therefore the downstream water level decreases. A new crack formation is indicated with the red circle. The block erosion process repeats.

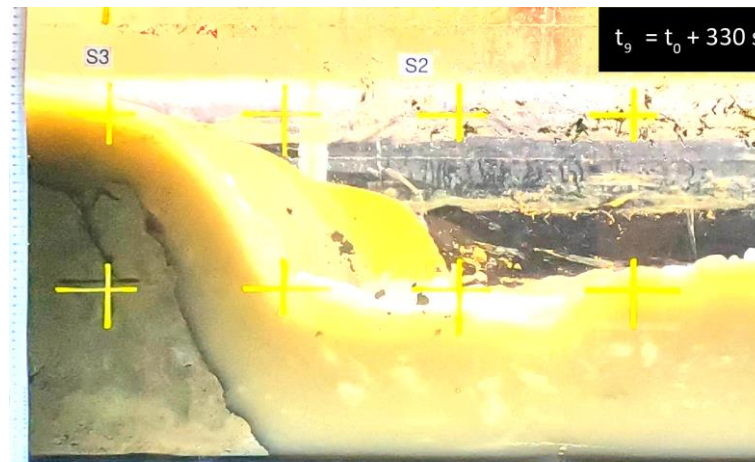
Figure 4.13: RC3 GoPro 2 snapshot at $t_9 = t_0 + 330$ seconds ($t_8 + 40$ seconds). Further growth of the new crack formation.

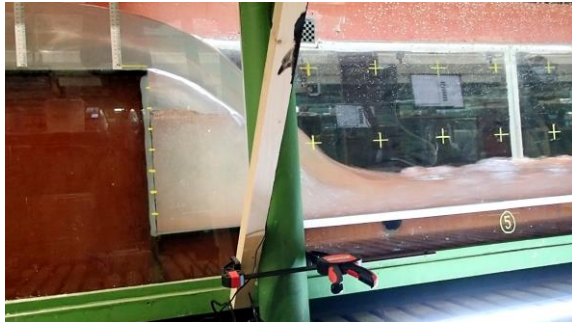
Depressed (non-aerated) nappe during experimental setup test run.

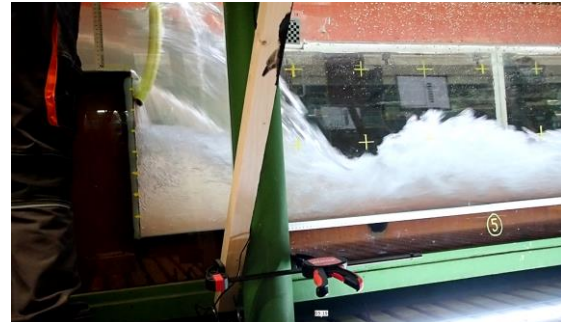
Aerating of the depressed nappe cavity through the aeration tube during the experimental setup test run.

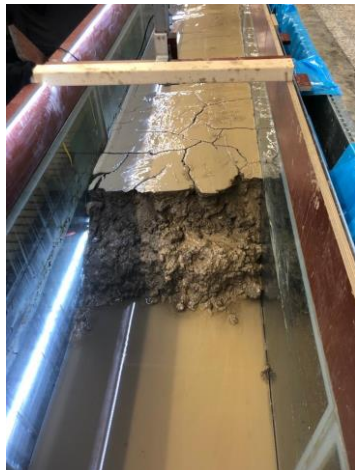
River clay headcut after removing of the Tompouce setup. The surface cracks are clearly visible.

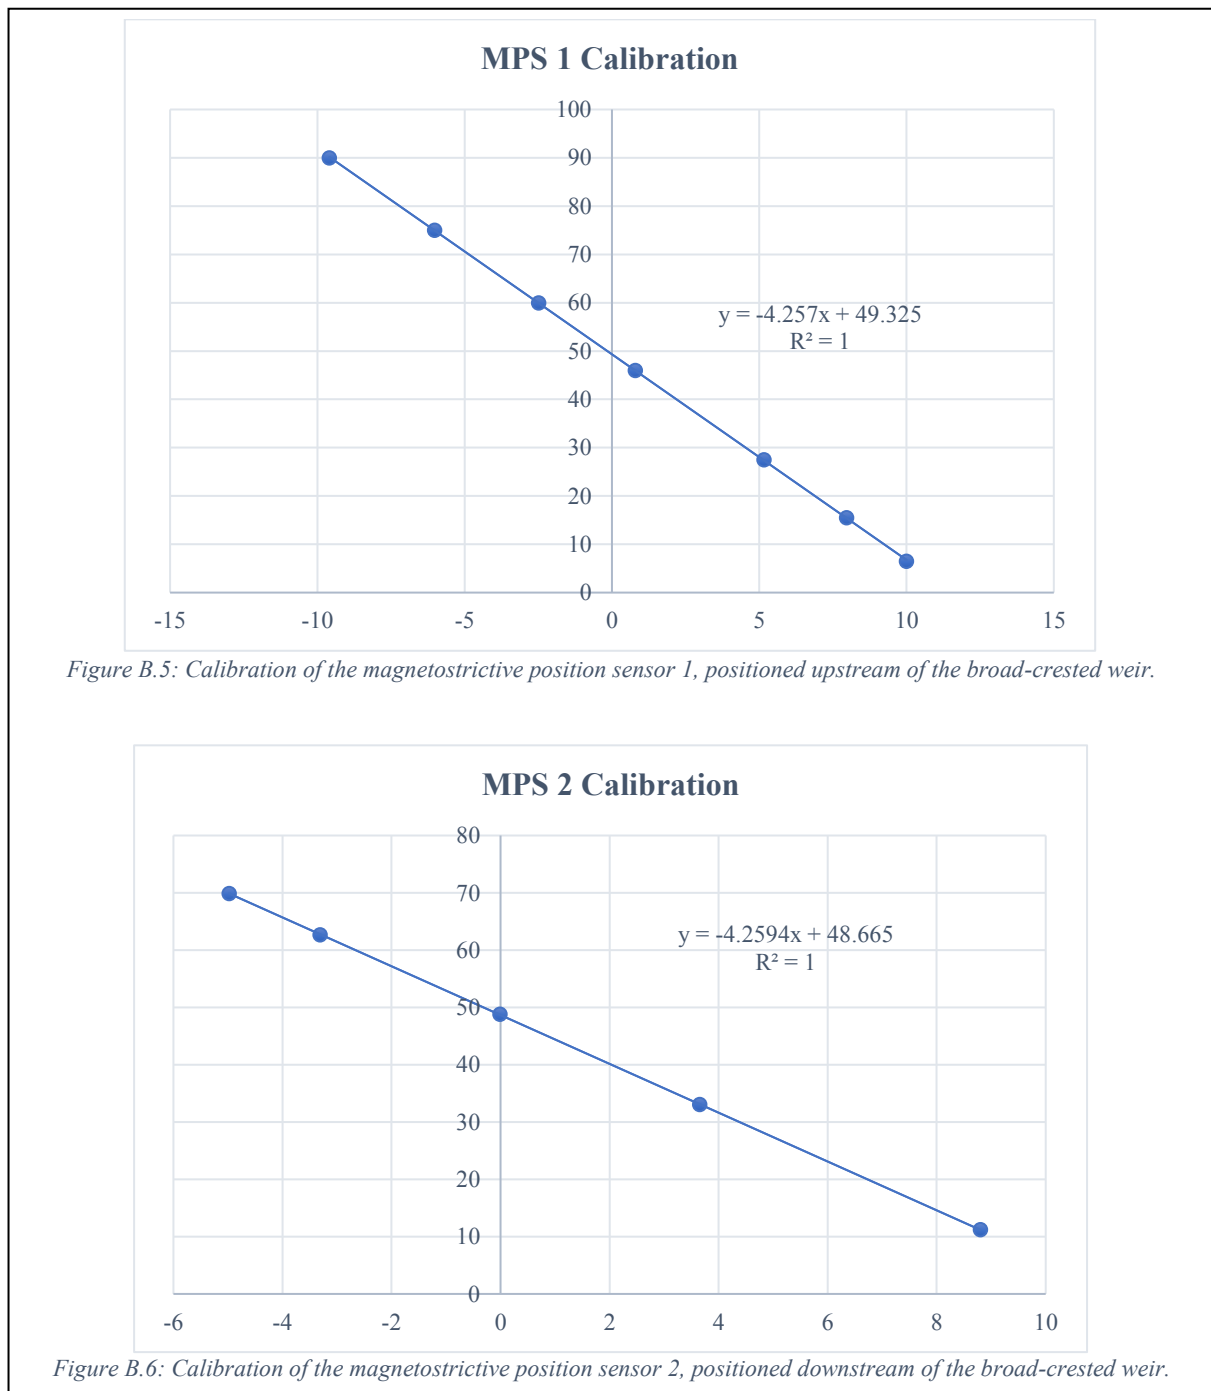
Figure B.5: Calibration of the magnetostrictive position sensor 1, positioned upstream of the broad-crested weir.
