## Soil Investigations As A Cornerstone For Geotechnical Design Of Liquefaction Mitigation Measures Below Levees

Proceedings of the 4th European Regional Conference of IAEG (EUROENGEO 2024)

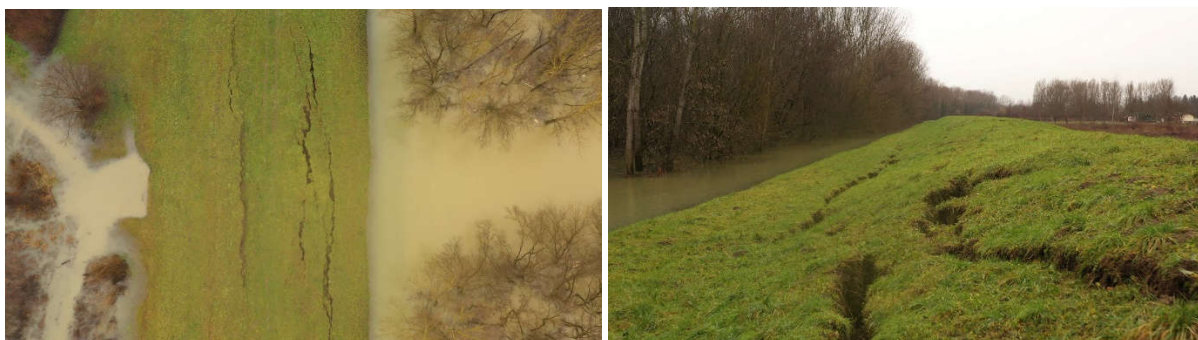
**Figure 1.** Deformed levees as a consequence of earthquake - induced liquefaction in Sisak – Moslavina County

As one of the consequences of the strong Petrinja earthquake in 2020, liquefaction occurred in large parts of Sisak–Moslavina County, whose geology is generally characterized by saturated, poorly graded sands and silty sands (Pollak et al., 2021). In the Rapid Damage Assessment Report (Republic of Croatia, 2021), it was estimated that liquefaction occurred on almost 1600 ha of the county area at varying depths from 3 to 15 m. All liquefaction zones are located in the alluvial deposits of the Kupa, Sava, Glina and Maja rivers at a maximum distance of about 1 km from the riverbanks. About 7% of the area affected by liquefaction is located under the levees. This was detected by numerous cracks in the ground surface and erupted sand, as well as numerous cracks and deformations of the levees (Figure 1).

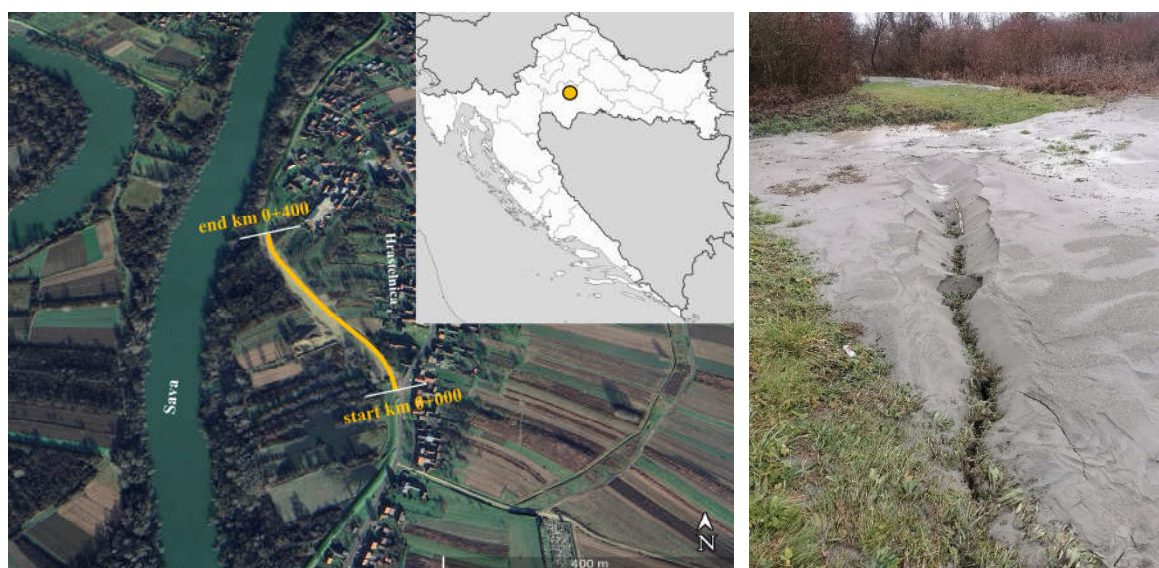
**Figure 6.** The layout of the damaged section of Hrastelnica levee with observed sand ejecta

As a result of the 2020 Petrinja earthquake, a levee on the left bank of the Sava River in Hrastelnica, Sisak-Moslavina County, showed significant deformations and cracks on the crest, slopes and surrounding soil. The length of the damaged section is 400 m, from km 106+200 to km 106+600 (Figure 6). The damage is largely due to liquefaction, with a large amount of sand ejecta observed.
