**A new accelerated salt weathering test by RILEM TC 271-ASC  
preliminary round robin validation**

Materials and Structures/Materiaux et Constructions

# A new accelerated salt weathering test by RILEM TC 271-ASC: preliminary round robin validation

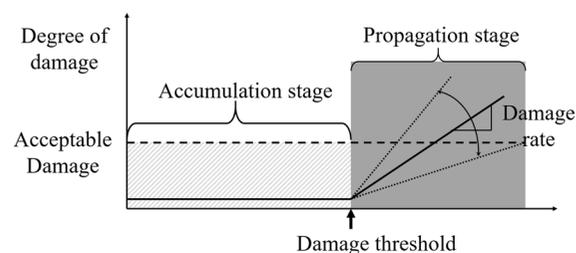
**Fig. 1** Schematic representation of durability of a stone, subject to salt damage, adapted from the concept proposed by Tuutti [13] to describe the durability of reinforced concrete (adapted from [12])

The RILEM TC 271-ASC was set up in 2016 with the goal of overcoming the above-mentioned limitations by the development of an improved test procedure. The salt crystallization test developed by the TC 271-ASC proposes a novel approach [12], different from existing salt crystallization tests, and derived from a common approach to the durability of reinforced concrete [13]. It starts from the consideration that a certain degree of salt accumulation (pore filling) is needed [14], to initiate damage. Salt damage can thus be seen as a process developing in two stages: accumulation and propagation (Fig. 1).

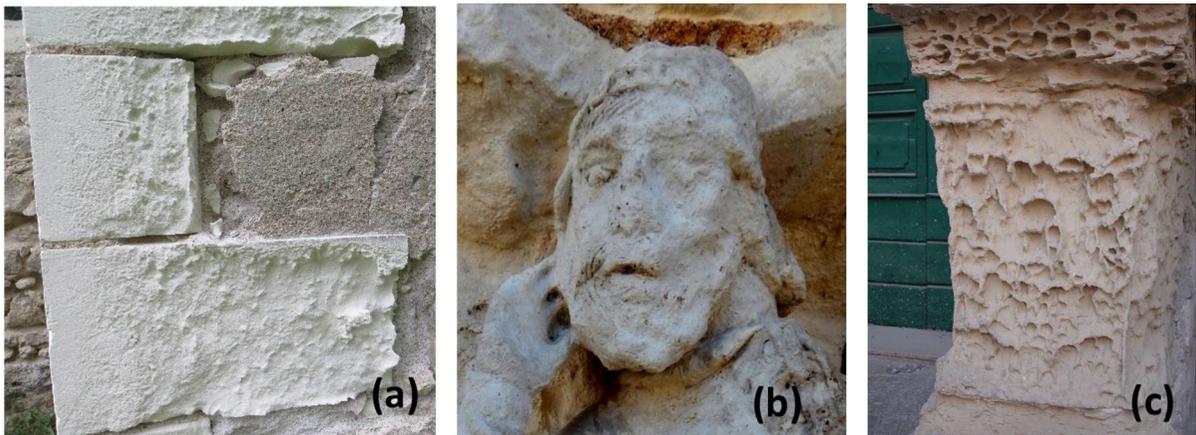
**Fig. 2** Decay patterns in the presence of salts in some of the selected substrates; **a** powdering in Tuffeau, chapel of Maurepas, Chambord (F) (photo, courtesy of Kevin Beck); **b** powdering and scaling in Migné stone, Notre-Dame-la-

Grande, Poitiers (F) (photo, courtesy of Veronique Verges-Belmin); **c** Alveolization and powdering in Lecce stone, Church of S. M. del Carmelo, Nardo' (I); (photo, courtesy of Rob van Hees)

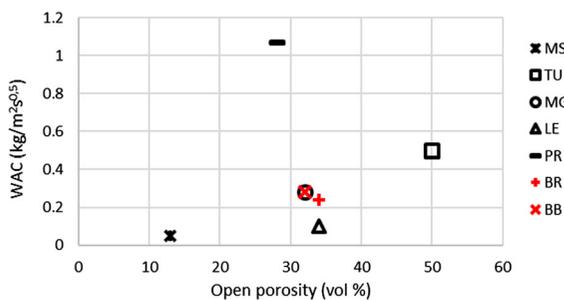
**Fig. 3** Open porosity and Water Absorption Coefficient (WAC) of the selected substrates

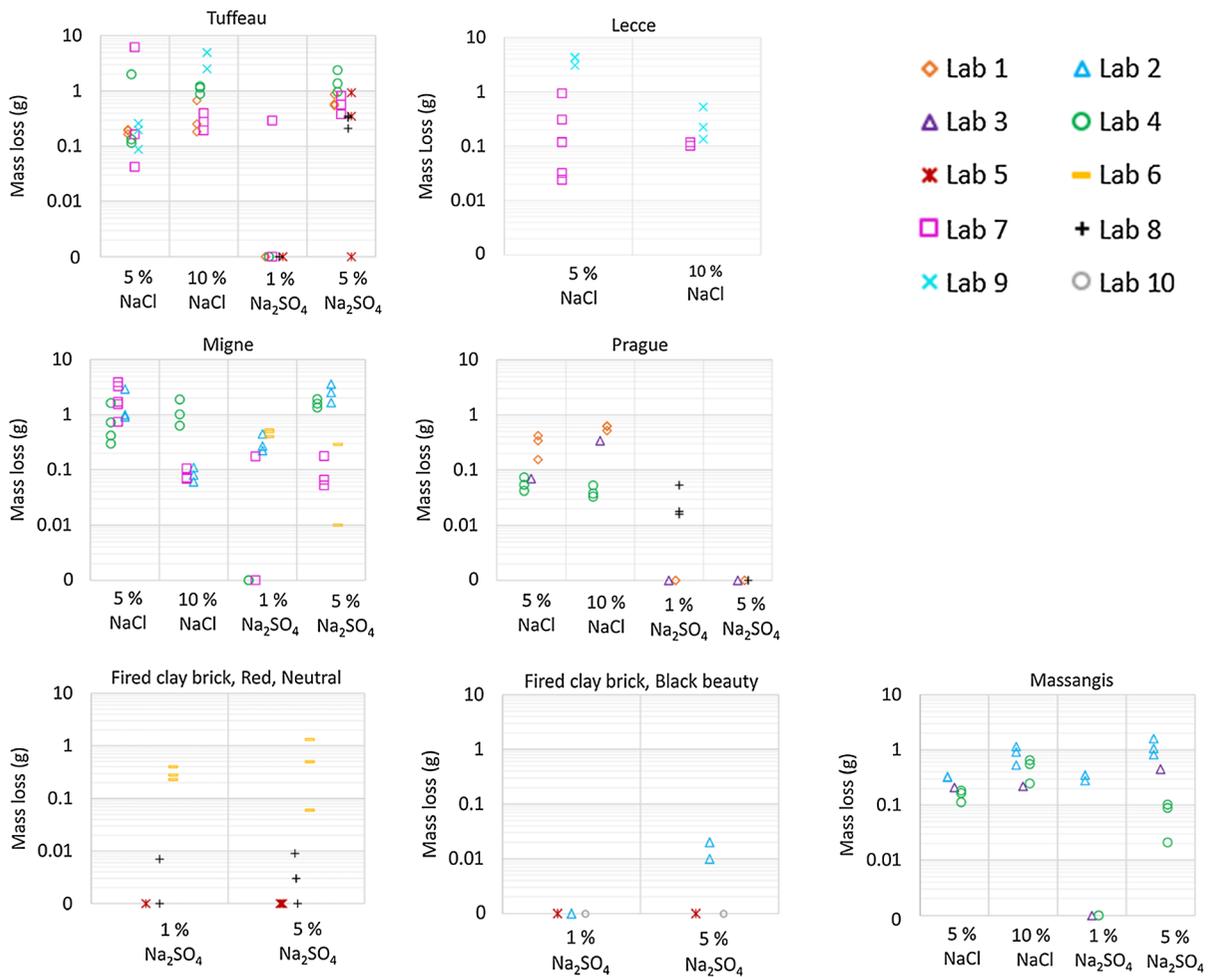
Fig. 4 Material loss in the different substrates at the end of the test

In the following subsection, the results for each of the substrates are discussed and some examples of the decay observed are given. Figure 4 provides an overview of the material loss measured at the end of the test; please refer to the supplementary material for the pictures of the evolution of the decay during the test for all substrates.

of the test, an average material loss of 0.51 g (standard deviation 0.26) was measured (Fig. 4). The damage type was similar between the labs and representative of the decay type observed in the field.

Massangis samples contaminated with  $\text{Na}_2\text{SO}_4$  showed powdering, concentrated at the borders of the evaporation surface, and a salt crust (Fig. 7a, b). The damage started to appear at the second re-wetting period in samples contaminated with 5 wt% solution and in the third cycle in those contaminated with the 1 wt% solution. The samples with the highest salt concentration had the highest material loss (Fig. 4).

Massangis samples contaminated with NaCl showed surface damage in the form of powdering and granular disintegration (Fig. 7c), mainly starting at the last re-wetting cycle. The weathering was more severe at the borders of the evaporation surface. The amount of material loss was low for the samples contaminated with the 5 wt% solution; a higher material loss was measured for the samples contaminated with the 10 wt% solution (Fig. 4).

material loss observed between specimens and between labs (Fig. 4).

Prague sandstone specimens contaminated with NaCl developed powdery efflorescences irregularly covering the evaporation surface at the end of the accumulation phase with both salt concentrations. No clear sign of deterioration was observed at this stage. After the first propagation cycle and during the following ones, the amount of surface crystallization decreased. Both salt concentrations induced surface changes due to persisting efflorescences, and granular disintegration was observed only at the end of the last cycle. The material loss associated with the 10 wt% concentration was generally higher than with the 5 wt% (Fig. 4). In some specimens, damage in the

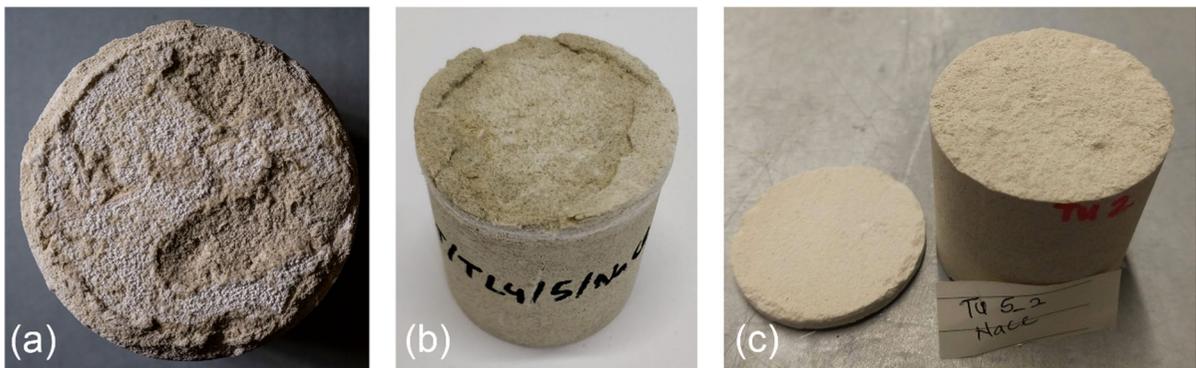
Fig. 5 **a** Decay in Tuffeau specimen contaminated with 5 wt% Na<sub>2</sub>SO<sub>4</sub> at the end of the test, after brushing off the evaporation surface; **b** decay in Tuffeau specimen contaminated with 10 wt% NaCl at the end of the test, after brushing off the

evaporation surface; **c** spalling of the outer layer of Tuffeau specimen contaminated with 5 wt% NaCl, after brushing off the evaporation surface

Specimens contaminated with 5 wt % solution showed efflorescence and loss of cohesion, including blistering, scaling, powdering and exfoliation (Fig. 5a). The damage started in the first propagation cycles and increased with subsequent cycle. At the end

Tuffeau specimens contaminated with NaCl showed similar decay type and severity at the different labs. Surface damage developed in the form of powdering (Fig. 5b); additionally, a crack, parallel to the evaporation surface, appeared during the test in most of the specimens; in some specimens this developed in detachment of the outer layer (Fig. 5c). The damage types were similar for both salt concentrations, but the severity of the damage was higher at higher salt concentration. While powdering is a common damage in NaCl contaminated Tuffeau in the field, cracks parallel to the evaporation surface and detachment of the outer layer are not generally observed. This suggests that the damage might be an artefact of the test procedure: the paraffin film nearby the evaporation surface might have detached/loosened during the test leading to evaporation and subsequent salt crystallization at the lateral sides.

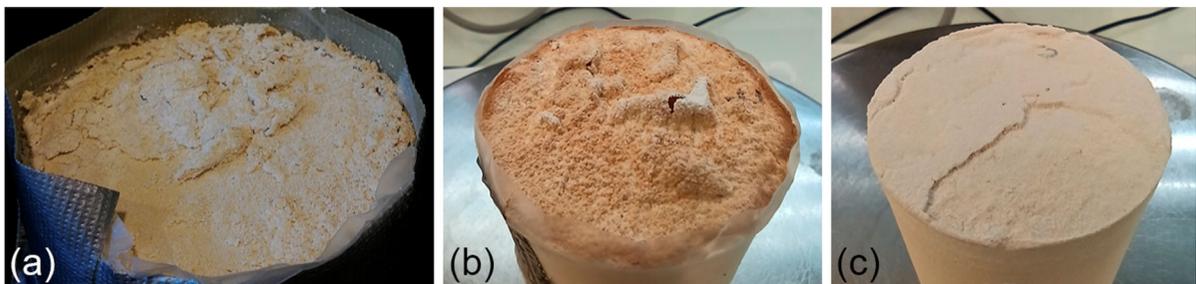
**Fig. 6** **a** Decay and efflorescences in Migné specimens contaminated with 1 wt%  $\text{Na}_2\text{SO}_4$  at the end of the test, before brushing off the evaporation surface; **b** decay in Migné specimen contaminated with 5 wt%  $\text{Na}_2\text{SO}_4$  at the end of the

test, before brushing off the evaporation surface; **c** decay in Migné specimen contaminated with 5 wt% NaCl at the end of the test, after brushing off the evaporation surface

Migné specimens contaminated with 1 wt%  $\text{Na}_2\text{SO}_4$  presented chromatic alteration, powdery and/or cauliflower-like efflorescence, and loss of cohesion in the form of scaling/flaking and granular disintegration (Fig. 6a). Damage initiated in the first propagation cycle and increased with subsequent cycles. With 5 wt%  $\text{Na}_2\text{SO}_4$ , chromatic alteration, efflorescence and progressive loss of cohesion were also observed (Fig. 6b). However, in at least one case, the mass loss recorded due to powdering/chalking/flaking at the end of the test was surprisingly less, compared to the test with 1 wt%  $\text{Na}_2\text{SO}_4$ ; this was attributed to the fact that salt crust remained attached to the surface of the specimens. Figure 4 depicts the amount of material loss with the use of 1 wt% and 5 wt%  $\text{Na}_2\text{SO}_4$  concentration in the various labs involved in the testing of this substrate. The results show considerable variation, both between labs and within each lab, mainly due to the presence of the salt crust on the surface of the test specimens, which inhibited (at least temporarily) material loss and encouraged cryptoflorescence and pore clogging.

Migné specimens contaminated with NaCl at 5 wt% and 10 wt% concentration showed a similar type of damage: loss of cohesion in the form of powdering, scaling and spalling of the surface layer (Fig. 6c). The amount of material loss varied (Fig. 4), depending on whether the surface layer detached or not. At two of the three laboratories involved,

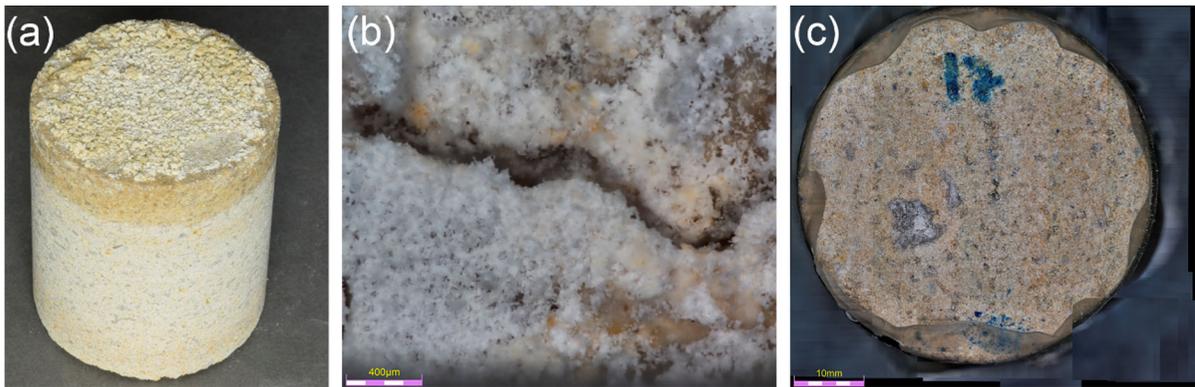
**Fig. 7** **a** Salt crust in Massangis specimens contaminated with 5 wt%  $\text{Na}_2\text{SO}_4$ ; **b** detail of salt crust on Massangis specimen contaminated with 1 wt%  $\text{Na}_2\text{SO}_4$  after brushing off the

evaporation surface; **c** decay in Massangis specimen contaminated with 10 wt% NaCl at the end of the test, after brushing off the evaporation surface

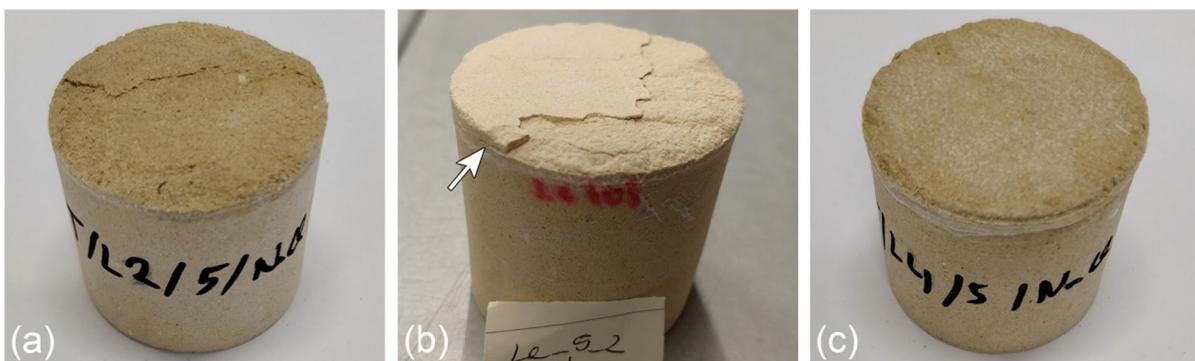
**Fig. 8** **a** Decay in Lecce stone specimens contaminated with 5 wt% NaCl at the end of the test, after brushing off the evaporation surface; **b** decay in Lecce stone specimen contaminated with 5 wt% NaCl at the end of the test, after brushing off

the evaporation surface (arrow indicates a crack); **c** decay in Lecce stone specimen contaminated with 10 wt% NaCl, at the end of the test, after brushing off the evaporation surface

In specimens contaminated with 5 wt% solution, damage occurred in the form of scaling and flaking (Fig. 8a). At the end of the propagation phase, the specimens made a hollow sound when gently knocking on their surface, suggesting a detachment of the top layer. In some cases, this top layer detached during the assessment of mass loss at the end of the test (Fig. 8b). This explains the large differences in

Specimens contaminated with 10 wt% NaCl showed mainly granular disintegration (Fig. 8c). The damage type and mass loss were comparable between labs. A thin layer of cryptoflorescence accumulated a few millimetres underneath the surface, which can be observed on the lateral side. When comparing specimens contaminated with 5 wt% and 10 wt% NaCl solution, the damage was more severe, in terms of mass loss, in the specimens with the lower salt content. This might be due to the not complete drying of the specimens during the adsorption/drying cycles.

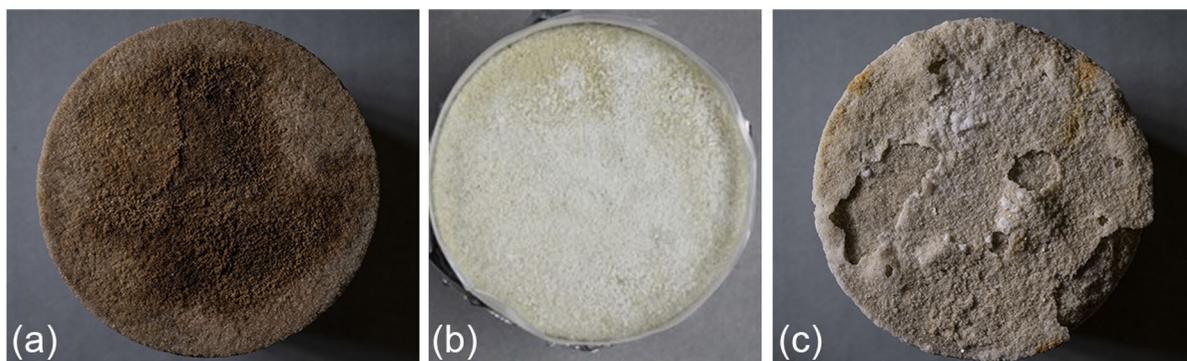
**Fig. 9** **a** Decay in Prague stone specimens contaminated with 5 wt%  $\text{Na}_2\text{SO}_4$  at the end of the test, after brushing off the evaporation surface; **b** salt crust in Prague stone specimen

contaminated with 1 wt%  $\text{Na}_2\text{SO}_4$ ; **c** decay in Prague stone specimen contaminated with 10 wt% NaCl, at the end of the test, after brushing off the evaporation surface

form of blistering was also observed after contamination with the highest salt solution concentration (Fig. 9c). The results obtained by the different laboratories are consistent as for the type of alteration and deterioration observed.

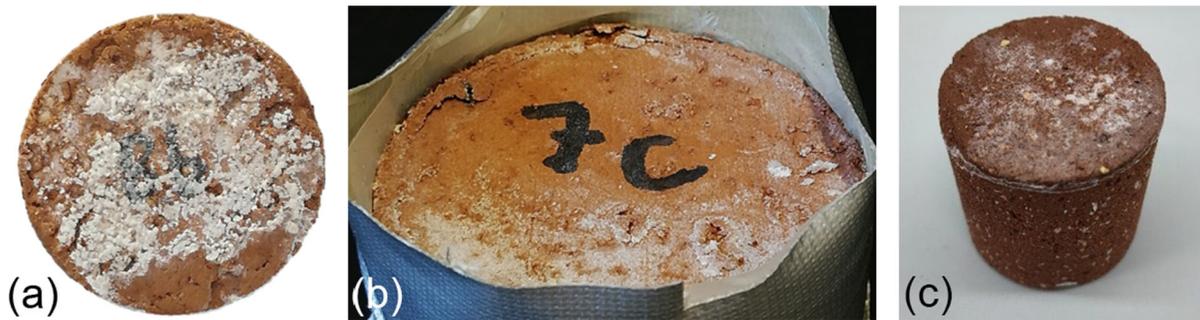
**Fig. 10** **a** Decay and salt crust on Red brick specimens contaminated with 5 wt%  $\text{Na}_2\text{SO}_4$  at the end of the test, after brushing off the evaporation surface; **b** surface of Red brick specimen contaminated with 1 wt%  $\text{Na}_2\text{SO}_4$ , at the end of the

test, before brushing off the evaporation surface **c** decay in Red brick specimen contaminated with 5 wt%  $\text{Na}_2\text{SO}_4$ , at the end of the test, before brushing off the evaporation surface

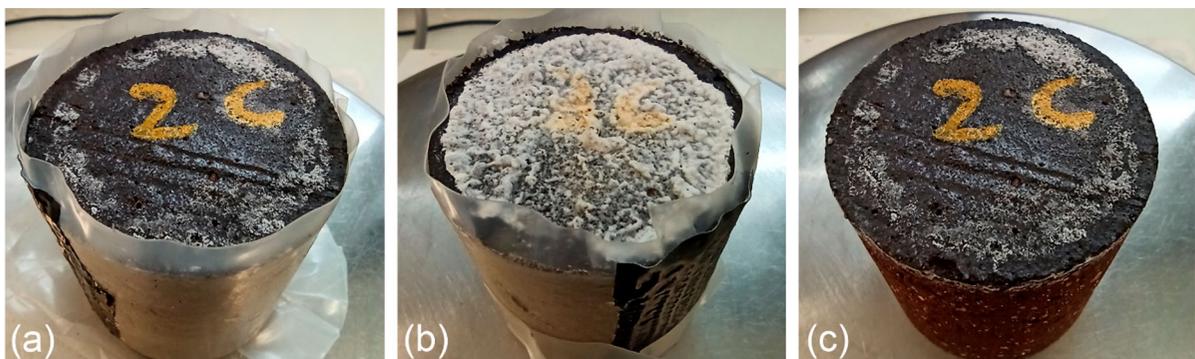
**Fig. 11** **a** Limited efflorescence on Black brick specimens contaminated with 1 wt%  $\text{Na}_2\text{SO}_4$  at the end of the test, before brushing off the evaporation surface; **b** more pronounced efflorescences on Black brick specimens contaminated with 5

wt%  $\text{Na}_2\text{SO}_4$ , at the end of the test, before brushing off the evaporation surface; **c** detail of Black brick specimen contaminated with 5 wt%  $\text{Na}_2\text{SO}_4$ , at the end of the test, after brushing off the evaporation surface

(Fig. 11c). Such minor material losses are challenging to document. In general, the results observed at the different labs, in regards to both material loss and efflorescence, were consistent.

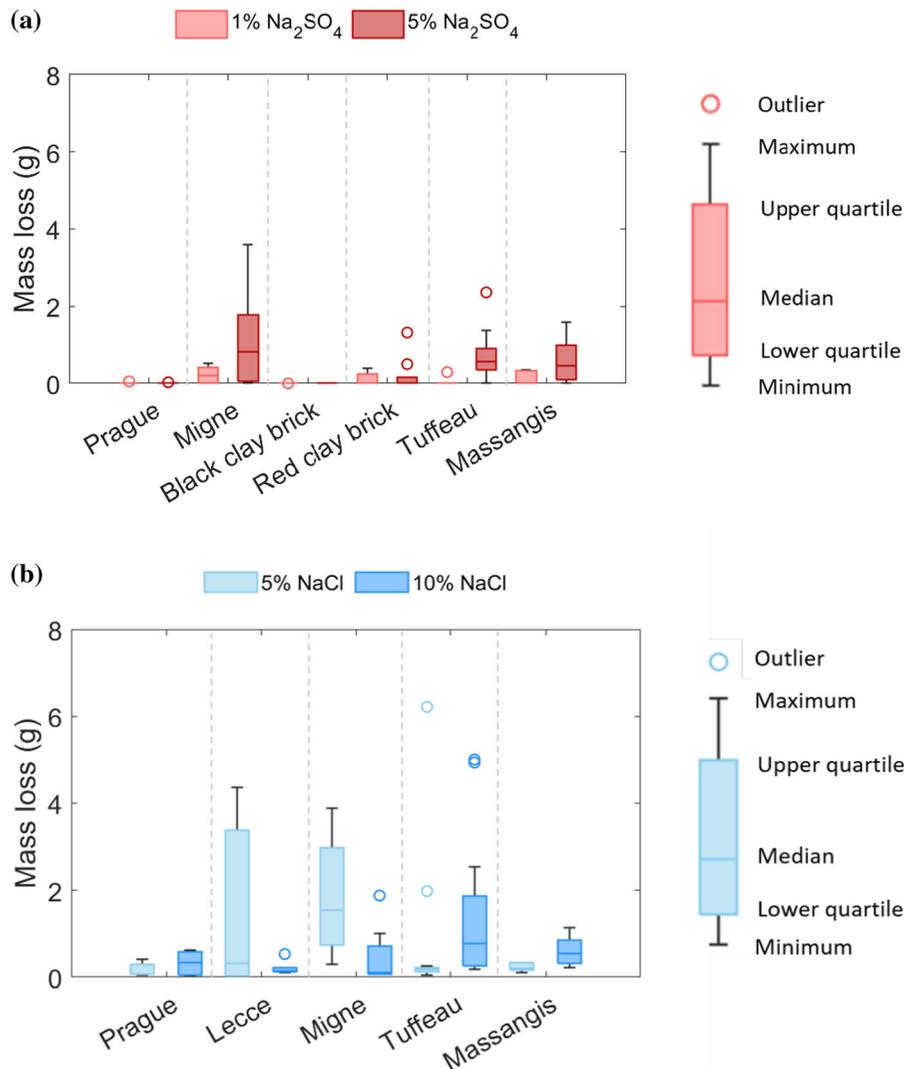
**Fig. 12** Material loss measured at the end of the test at the different labs on the tested substrates contaminated with Na<sub>2</sub>SO<sub>4</sub> (a) and NaCl (b)

Figure 12 reports the damage type and the material loss observed at the different labs. In general, the reproducibility of the results in the case of sodium sulphate contaminated specimens is quite good. In the case of sodium chloride contaminated specimens, a larger variation is observed: this is probably due both to the more complex procedure, which increases the chances of small differences in conditions between labs, and the occurrence of cracks parallel to the evaporation surface, leading to spalling at different moments of the test, depending on the intrinsic variability between specimens of the same type.
