MONITORING OF PROGRESSIVE DAMAGE IN BUILDINGS USING LASER SCAN DATA

Commission II, WG II/10

KEY WORDS: Change, monitoring, unreinforced masonry building, LiDAR, point cloud, post-disaster

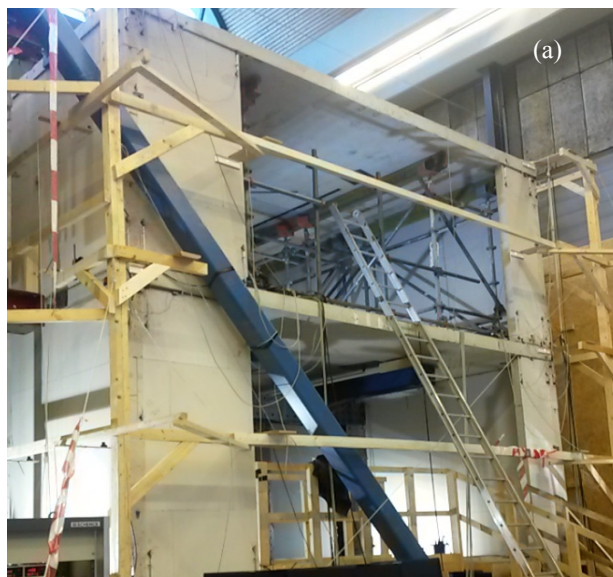
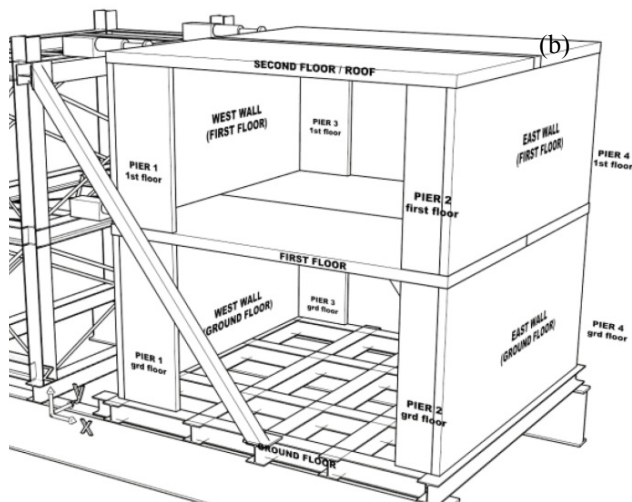
The building was a two-story high structure having walls made of calcium silicate (CS) element masonry and reinforced concrete slabs as floors. The structure had a floor plan of 5.4 x 5.2 m and a total height of 5.4 m (Figure 1). The south and

Figure 1. The structure: (a) Photo and (b) Schematic 3D view with building walls and piers.

north facades, which are identical, are represented only by the two piers connected to the transversal walls. Two sizes of the piers have been selected: on the western side the wide piers P1 and P3 have a width of 1.1 m, while on the eastern side the narrow piers P2 and P4 have a width of 0.6 m. Large masonry elements having dimensions 897x643x100-mm were used for the facade piers, while units having dimensions 897x643x120-mm were used for the transversal wall.

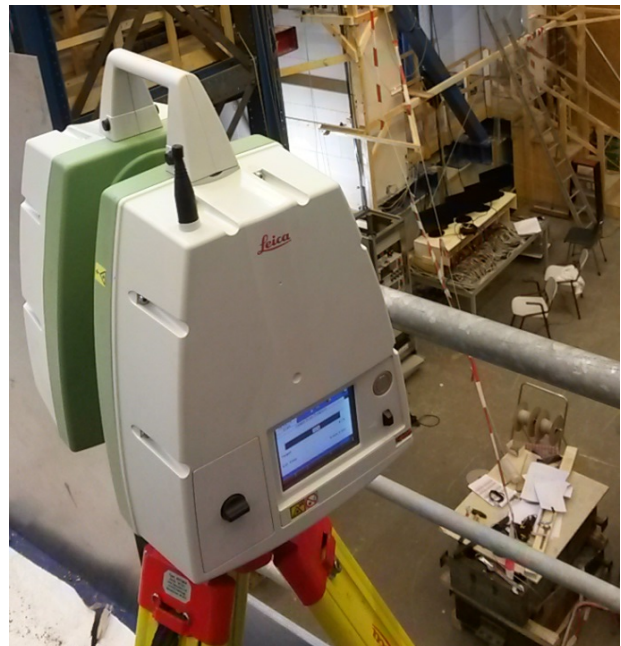
A *ScanStation C10* scanner was used during the experiment (Figure 2). This is a TOF scanner with an effective range of 300 m at 90% reflectivity. The accuracy of range measurements is 6 and 4 mm (1 sigma) (in position and depth, respectively) at ranges up to 50 m (Geosystems, 2012). The location of the laser stations was planned to minimize possible occlusions. A total of 40 scans was recorded during the four epochs.

Figure 2. Leica *ScanStation C10* used during field data collection.

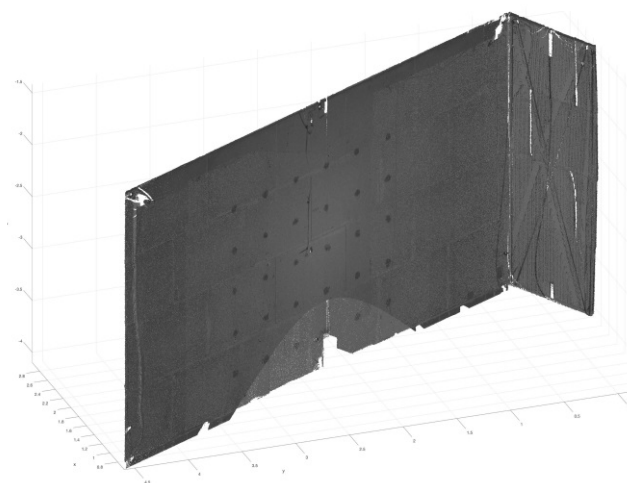
Before the method for this purpose is designed, two facts should be pointed out: (1) wide pier 3 collapsed before Post-Peak II and therefore, there is no TLS data available for that last epoch; (2) Initial TLS point clouds are located in a local coordinate system (Figure 4). To facilitate the interpretation of the deformation monitoring, we define the coordinate system as shown in Figure 1: The X axis is perpendicular to the west and east walls, Y axis is perpendicular to the piers while the Z axis is pointing upwards. The origin of coordinates is set at the ground floor corner of the west wall and the wide pier 3 (Figure 9).

Figure 4. Initial 3D point cloud of west wall and wide pier 3 (ground floor) after data registration of Post-peak I epoch. Data registration is only used for validation purposes.

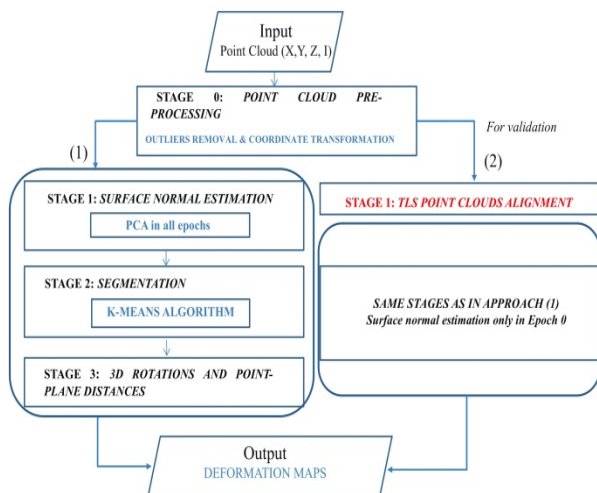
The algorithm overview summarizes the steps performed to detect deformations and rotations, as shown in Figure 5. The new approach (1) is then compared with the co-registered approach (2), used for validation purposes.

Figure 5. Algorithm overview

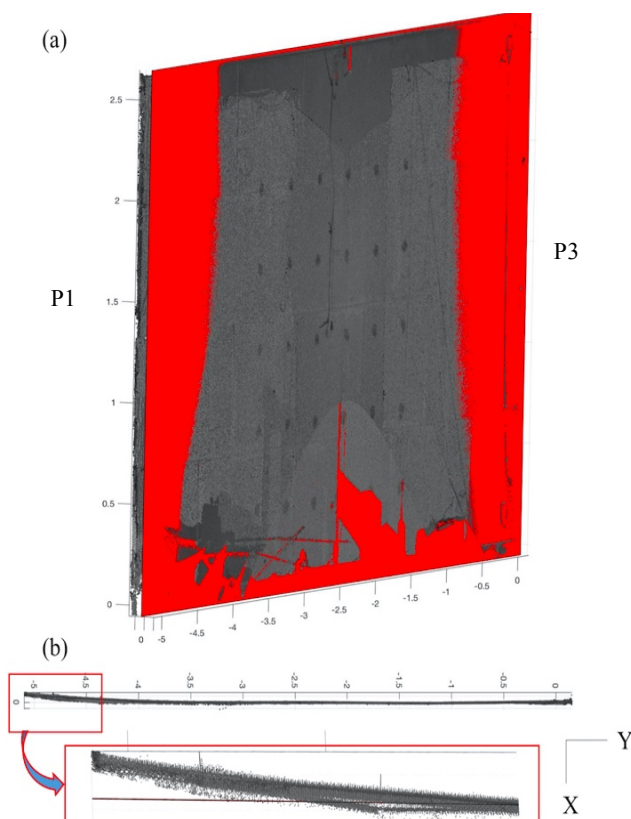
In fact, CS elements placed on the left side, namely 1, 2, 8, 14 and 21 show the largest mean distances: 46, 13, 33, 46 and 20 mm in the negative direction of the abovementioned axis, as displayed on Figure 8.

Figure 8. West wall point cloud: (a) Fitted plane to Post-Peak II data. (b) Top view showing the deformations along the X axis.

Moreover, rotations in these elements are more significant than for wide pier 3, varying in a range of 3.6° (element 1) to 6.1° (element 14). Elements on the right side (near pier 3) also have negative displacements, but to a lesser extent.

The extensive out-of-plane deformation of the west wall at the side of pier 1 was a direct consequence of the damage in the pier; fragments of CS elements fell between the pier and the wall creating a wedge effect that lead to local deformation of the wall. Lastly, those elements placed in the central part of the wall or adjacent to the outer elements show deformations, either in the positive direction of the X axis or very close to zero. This pattern is repeated in the previous epoch recorded (E_{II}), though the deformations are smaller. In the first two epochs, no significant displacements are detected.

The same patterns are again observed in both deformations maps with regards to the previous ones, which in turn demonstrates the feasibility of the proposed approach. However, deformation values are not exactly the same because Figures 6 and 8 show relative measurements while Figures 10 and 11 show the absolute ones with respect to the reference dataset (E_0). Moreover, Figures 10 and 11 might include the effect of the registration error, influencing the result of the mean distance value when is very close to its noise level (see for example, elements 1 and 8 in Table 3).

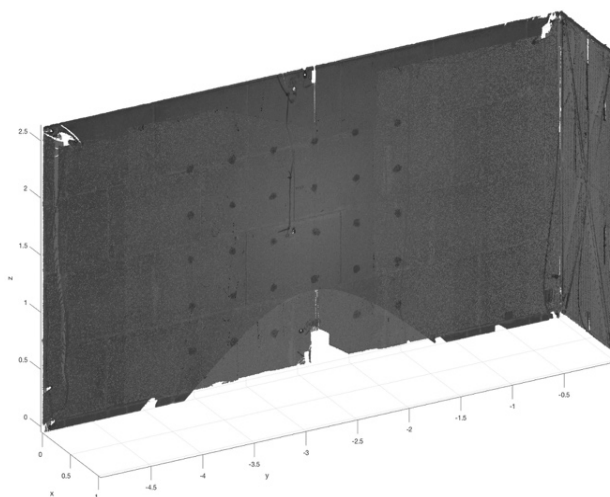
The point cloud alignment is performed by the Leica Cyclone software, using ground control points to improve the overall accuracy. The registration error shown as its mean absolute is 0.002 m, which is considered good. Subsequently, each point cloud was reoriented following the coordinate system defined in Section 2 (Figure 9).

Figure 9. Rotated 3D point cloud of west wall and wide pier 3 (ground floor) after data registration of Post-peak I epoch. Walls are now aligned with the three coordinate axes.

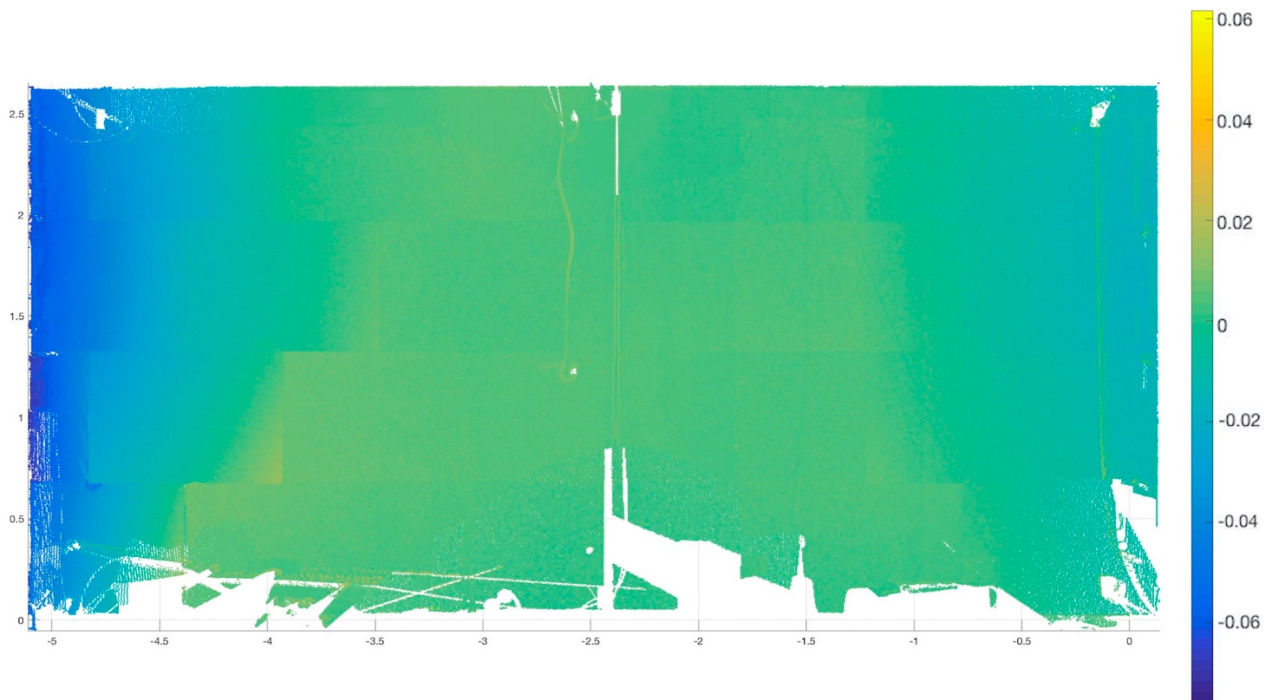
Particularly, the signed distances between each point forming the different point clouds and the best fitting planes of pier 3 and the west wall in Epoch E_0 (reference datasets) were computed. For comparison, the deformation map along the X axis of the west wall after E_{III} is represented in Figure 10. Similarly, the deformation map along the Y axis of wide pier 3 after E_{II} is plotted (Figure 11) together with the Table 3 containing the numeric results for the selected CS elements.

Figure 10. Front view of west wall after Post-Peak II. Blueish colors represent negative deformations along the X axis (from inside the building to outside) versus a reference plane computed using PCA on the first epoch. Units are in meters.

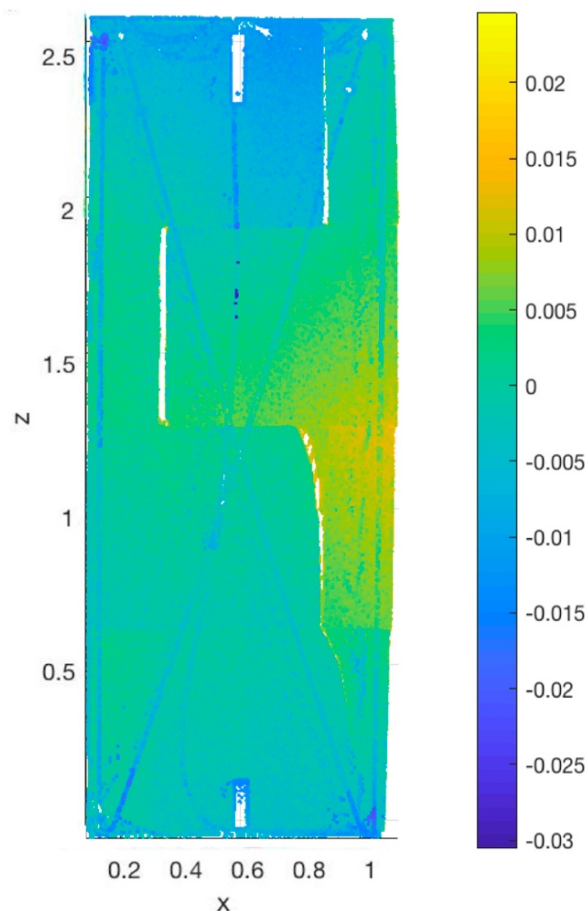
Figure 11. Deformation map along the Y axis (units in meters) for the entire wide pier 3 after Post-Peak I (E_{II}). Epoch 0 (E_0) was used as a reference to parameterize the plane model.
