Building water quality deterioration during water supply restoration after interruption Influences of premise plumbing configuration

Water Research

Building water quality deterioration during water supply restoration after interruption: Influences of premise plumbing configuration

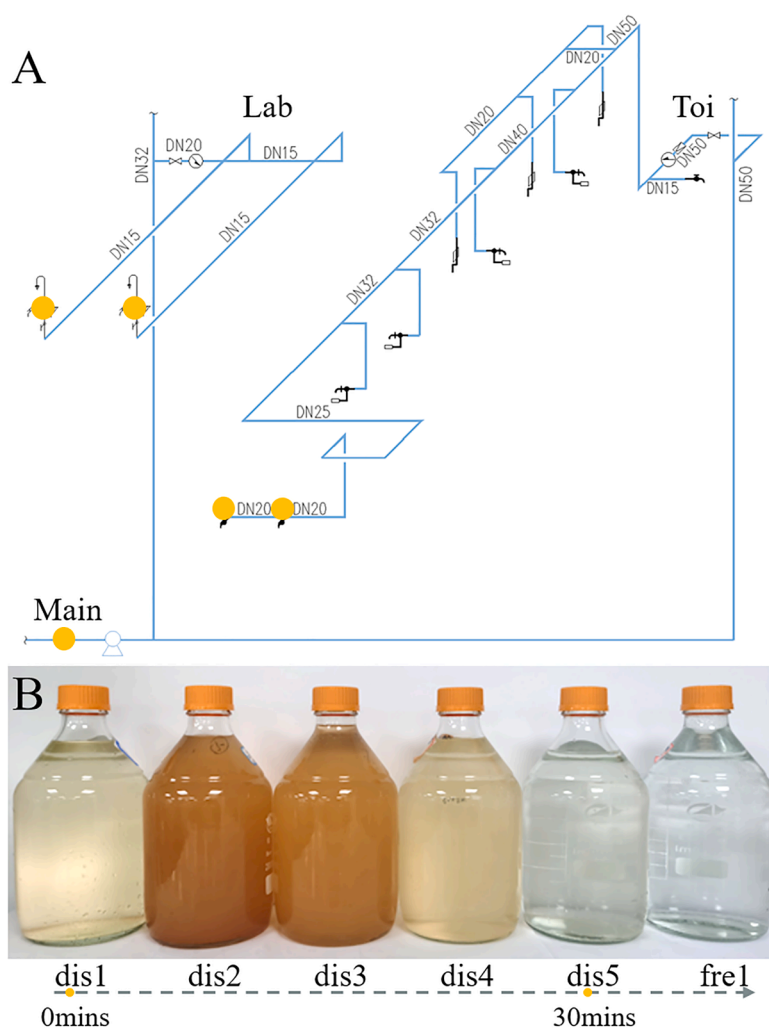
Fig. 1. A) Detailed configuration of the laboratory and toilet plumbing. Sampling points marked in Yellow. The pipe length, velocity, Reynolds number, and shear stress are given in Table 1; B) picture of disturbed samples from laboratory plumbing during restoration of the water supply condition (Lab-dis, heavy discoloration).

The study was conducted in an office building on the campus of the Research Center for Eco-Environmental Sciences, Chinese Academy of Sciences. It is an 8-floor building of 10,000 m² with office and laboratory rooms. The premise plumbing components that distribute water to laboratories and toilets are connected to the water main separately with parallel vertical pipes (Fig. 1A). The configurations of laboratory and toilet plumbing are different, both of which have a vertical plastic-lined galvanized steel pipe and horizontal branch polypropylene-random (PPR) pipes. There are two regular taps for the laboratory plumbing and seven flushing toilets and two taps for the toilet plumbing. The water usage in the laboratory and toilets are also different, which leads to significant differences in hydraulic conditions in the two piping systems (e.g., velocity, Reynolds number, and shear stress, Table 1).

Premise plumbing		Diameter (mm)	Length (m)	Velocity (m/s)	Reynolds number	Shear stress (Pa)	Water consumption (m ³ /d)
Laboratory (two taps)	Vertical	32	3.60	0.24	7546	0.09	0.25
	Horizontal	20	2.60	0.53	10,522	0.48	
		15	10.40	0.99	14,921	1.84	
Toilet (two taps)	Vertical	50	3.60	0.84	42,010	0.97	2.5
	Horizontal	50	2.20	0.72	35,955	0.71	
		50	2.70	0.70	34,820	0.67	
		40	0.75	1.04	41,400	1.56	
		40	1.45	1.00	40,196	1.47	
		32	1.80	1.59	50,931	3.89	
		32	1.00	1.54	49,357	3.66	
		25	5.60	0.30	7570	0.15	
		20	3.00	0.53	10,522	0.48

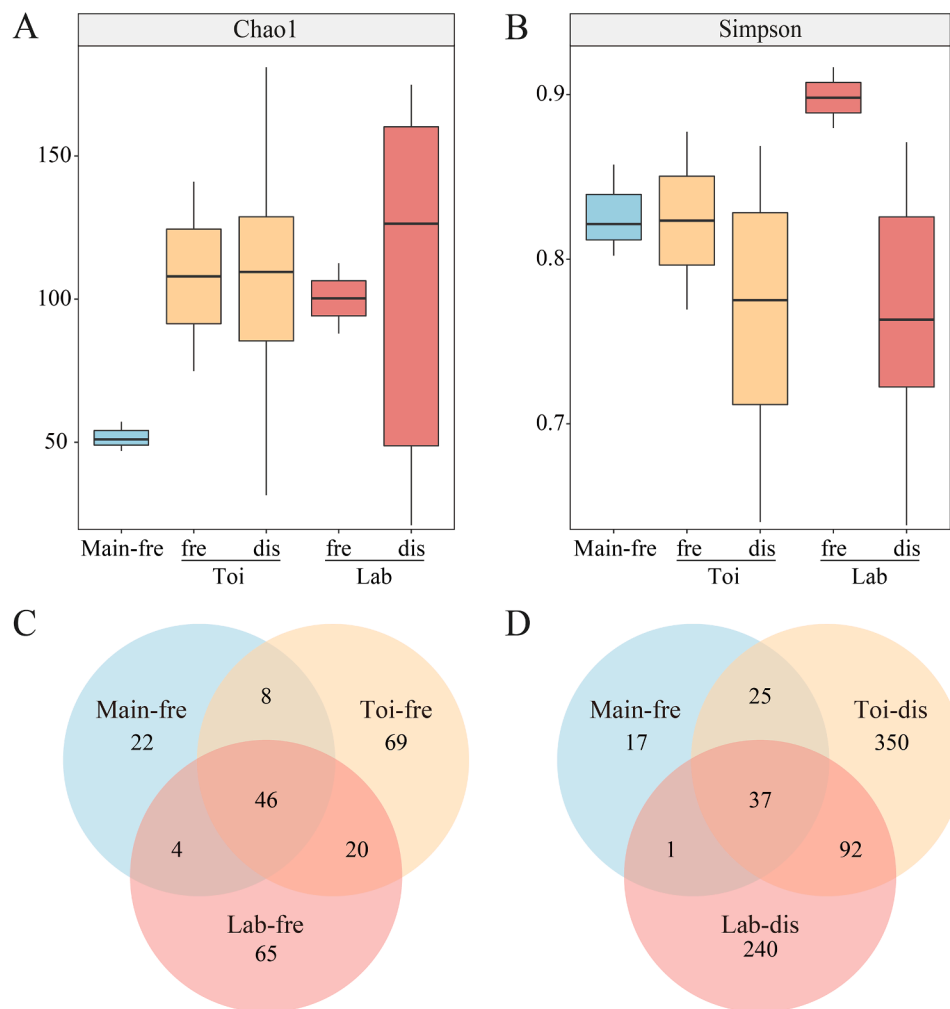
Fig. 3. A) Chao 1 indices of different sampling groups; B) Simpson diversity of different sampling groups; C) Venn diagram among fresh samples; D) Venn diagram among disturbed samples.

showed higher values and larger variations than the toilet samples. The higher species richness in disturbed samples during water supply restoration was better revealed by the Venn diagram in Fig. 3C and 3D.

Interestingly, although the species richness was higher in Lab-dis and Toi-dis, their Simpson diversities were much lower than those in Lab-fre and Toi-fre (Fig. 3B), indicating that the relative abundances of community members in fresh samples were more evenly distributed, while the community of planktonic bacteria during water supply restoration was possibly predominated by a few species. This is directly confirmed by the bacterial community composition results in the following section. Moreover, during regular water supply, toilet plumbing did not influence Simpson diversity, whereas laboratory plumbing clearly increased the Simpson diversity of the bacterial community (Fig. 3B).

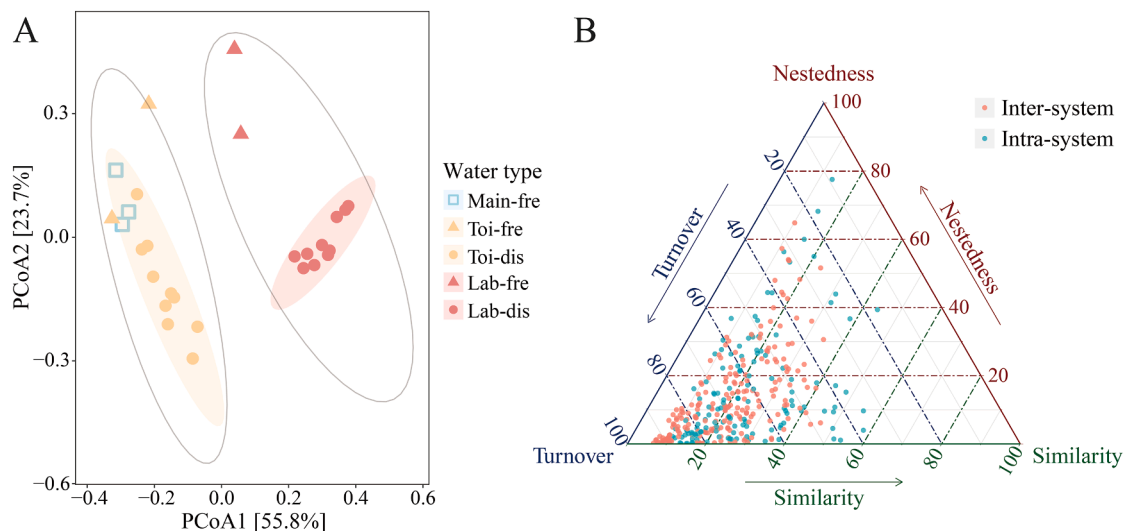
Fig. 4. A) PCoA plot based on Bray–Curtis dissimilarity; B) triangular plots of beta-diversity partitioning (using Jaccard dissimilarity index) comparisons for bacterial communities. Each point represents a pair of samples.

The PCoA plot showed clear clusters of sample groups, indicating the dissimilarity among their bacterial communities (Fig. 4A). According to statistical tests, both plumbing configurations and water supply interruption/restoration significantly influenced the planktonic bacterial community (PERMANOVA, $P < 0.05$, Table S1), while the variances were mostly explained by the former ($R^2 = 0.537$, Table S1). Comparing the fresh samples, the bacterial community of Main-fre is similar to that of Toi-fre (overlapping) but different from that of Lab-fre (different clusters), confirming the significant influences of the plumbing configuration. During the restoration of the water supply, Lab-dis clustered closely together and completely separated from Lab-fre, while Toi-dis is more dispersed and separated from Toi-fre samples. The differences between Lab-dis and Lab-fre are sharper than that of Toi system. This means sharper changes may occur in laboratory plumbing during water supply restoration, which complied with the visually observed discoloration in Lab-dis samples, as mentioned above.

To reveal the underlying mechanisms of variation in microbial assembly, the beta diversity was further partitioned into species turnover and nestedness (Fig. 4B). The average Jaccard pairwise dissimilarity

index was 0.794, which was predominantly governed by strong species turnover processes (82.5%) rather than nestedness-resultant dissimilarity (17.5%). Intersystem sample pairs (Lab vs. Toi) were less similar, and species turnover contributed more to their community dissimilarity than intrasystem (Lab vs. Lab; Toi vs. Toi) sample pairs, which confirmed that, as mentioned above, system configuration contributed more to the variations. Moreover, for intrasystem comparison, species turnover had a greater impact on the bacterial community in toilet plumbing than in laboratory plumbing (Fig. S3).

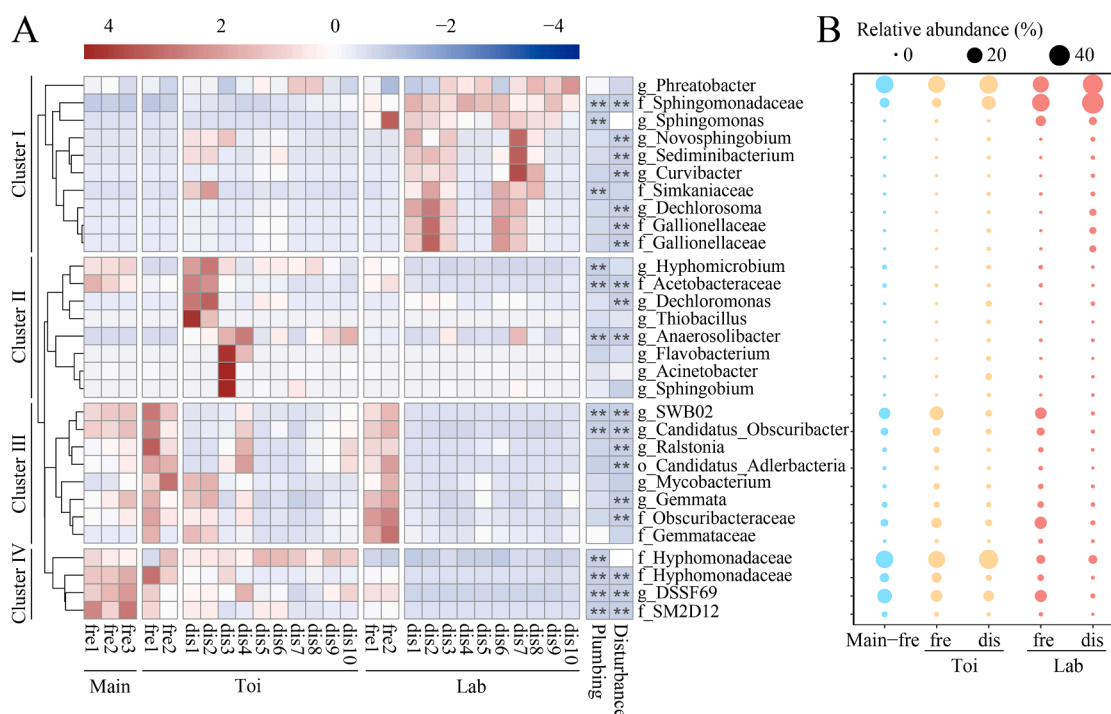
Fig. 5. Relative abundances of the top 30 genera: A) Distribution of the normalized relative abundance of the genera in different samples. Colors from blue to red denote an increase in normalized relative abundance. The significant difference between groups was calculated by Kruskal–Wallis tests (P values: $** < 0.05$); B) Relative abundances of the genera in different sampling groups. The genera were classified into two types and four clusters: affected by disturbance (Clusters I and III) or by both disturbance and plumbing system configuration (Clusters II and IV). The genera of Cluster IV were only less abundant in the Lab-dis group. The genera of Cluster II were mainly found in the Toi-dis group.

At the genus level, the top 30 abundant bacterial genera across all samples are shown as a heatmap in Fig. 5A (normalized relative abundance) and a bubble plot in Fig. 5B (relative abundance). During regular water supply, both laboratory and toilet plumbing promoted community members, such as *Mycobacterium* spp. (0.1% to 1.0%) and *Gemmata* spp. (0.9% to 1.3%), and prohibited community members, such as *DSSSF69* spp. (16.7% to 9.9%) and *Hyphomicrobium* spp. (0.4% to 0.1%). In contrast, laboratory plumbing promoted *Sphingomonas* spp. (0.1% to 6.8%), while prohibited *Phreatobacter* spp. (28.1% to 21.9%), but toilet plumbing did not. During the restoration of the water supply, it is remarkable to observe that a few genera were not present in fresh

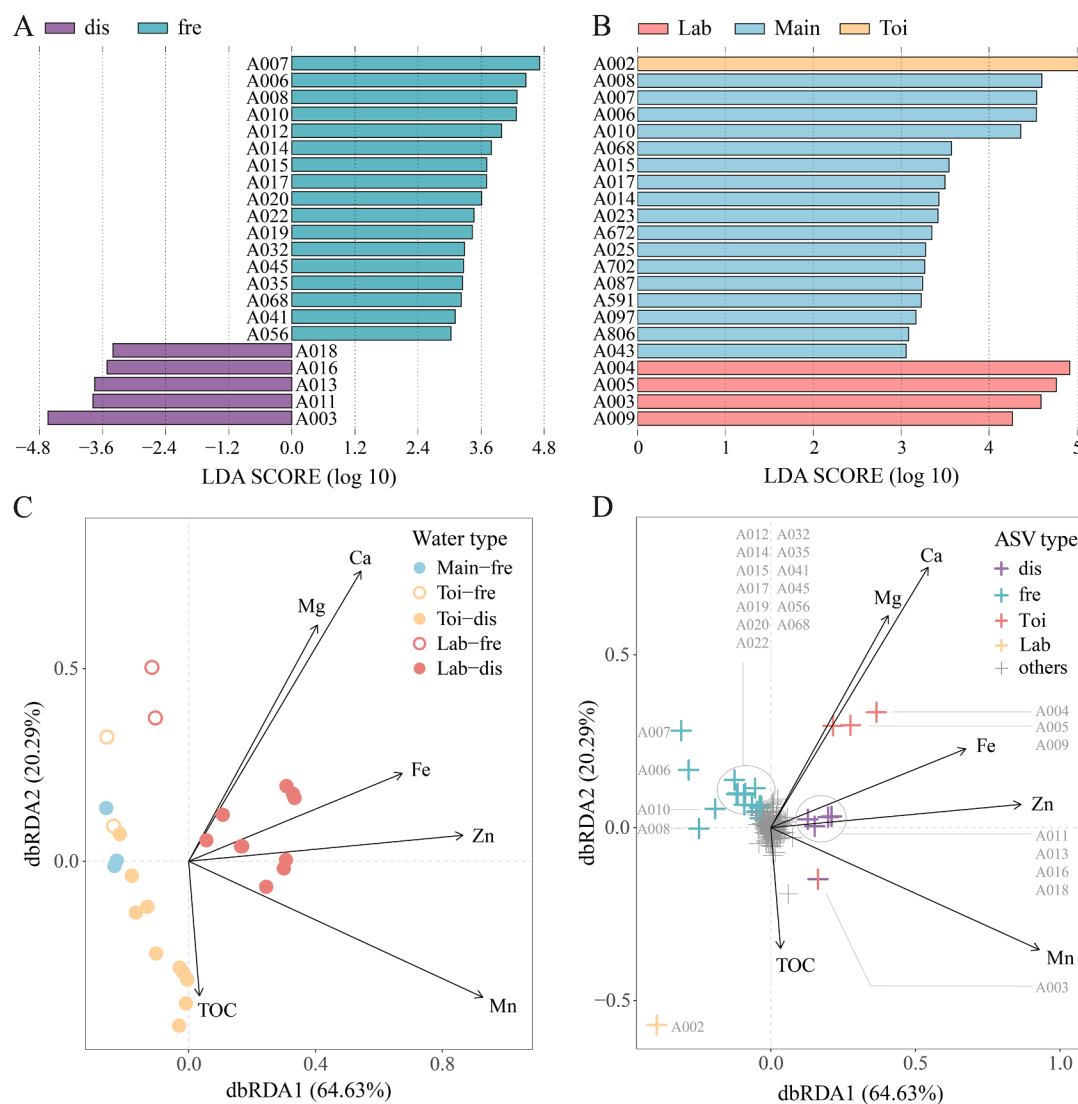
Fig. 6. A) LEfSe analysis selected significantly enriched ASVs during regular water supply (fre) and restoration of water supply (dis); B) LEfSe analysis selected significantly enriched ASVs in water main (Main), toilet (Toi) and laboratory plumbing (Lab); C) distance-based redundancy analysis (db-RDA) of the relationship between the bacterial community and environmental variables; D) db-RDA of the relationship between ASVs and environmental variables.

The LEfSe analysis identified ASVs significantly enriched by regular and interrupted water supply (Fig. 6A) and by premise plumbing with different configurations (Fig. 6B). The taxonomy information of these ASVs is given in Table S3. Remarkably, 3/5 of the ASVs enriched during water supply restoration were assigned as *f_Gallionellaceae*, the group of which is commonly called iron bacteria. This complies with, presented below, that iron drove bacterial community changes during the restoration of water supply (Fig. 6C, 6D). In addition, all ASVs enriched in laboratory plumbing belonged to *f_Sphingomonadaceae*, and the key sensitive ASVs in toilet and laboratory plumbing were strongly correlated with Ca and Mg.

The db-RDA plot showed that the first two axes cumulatively explained 84.6% of the total variance (Fig. 6C, 6D). The bacterial community of Lab-dis was mainly driven by metal elements (e.g., Mn), while the bacterial community of Toi-dis was mostly driven by TOC. This was directly confirmed by Mantel tests (Table S4). More specifically, the variations in species between the laboratory and toilet were more related to Ca, Mg, Fe and Zn, whereas the bacterial community changes induced by the disturbance during water supply restoration
