## Forensic Analysis of Levee Failures: The Breitenhagen Case

International Journal of Geoengineering Case Histories

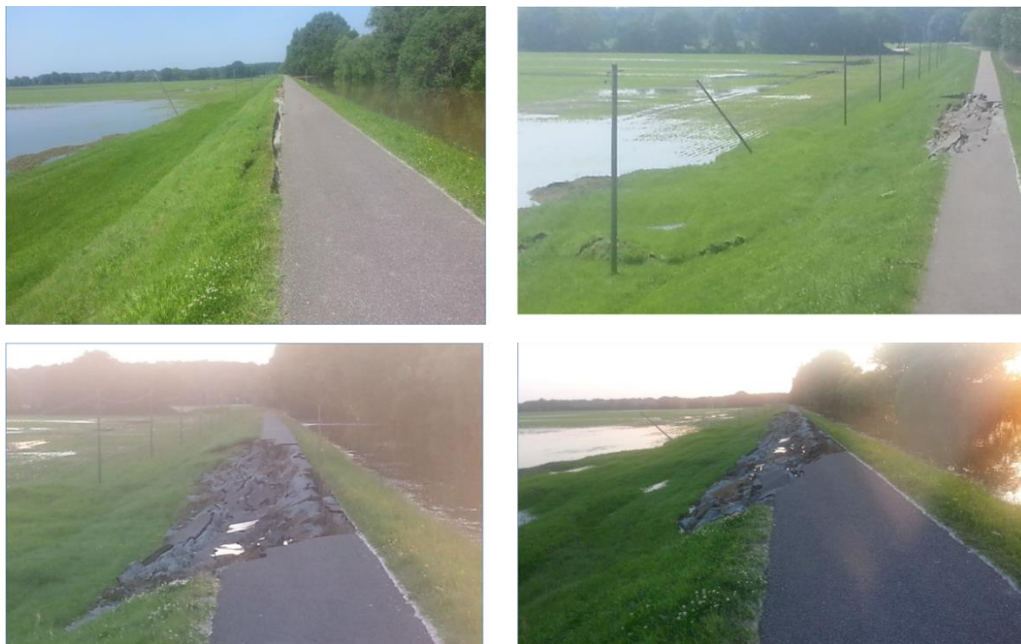
*Figure 6. Photo series over time (upper left: 08.06.2013-10:37, initial break at the edge of the slope, upper right: 08.06.2013-14:10, horizontal shifts, bulge of the toe, lower left: 08.06.2013-20:51 continuing failure, lower right, 08.06.2013-20:55, continuing failure with the visual predictors (Grubert, 2013). Riverside of the levee is on the right for all photos.*

On the left side of the picture an electricity pole is recognized which seems to tilt over time, until it is almost completely horizontal (Figure 6). Also the slip circle is expanding until the road is completely damaged indicating an increasing deformation over time. The initial failure is considered to have weakened the levee to such a level that the levee lost all its retaining capacity.

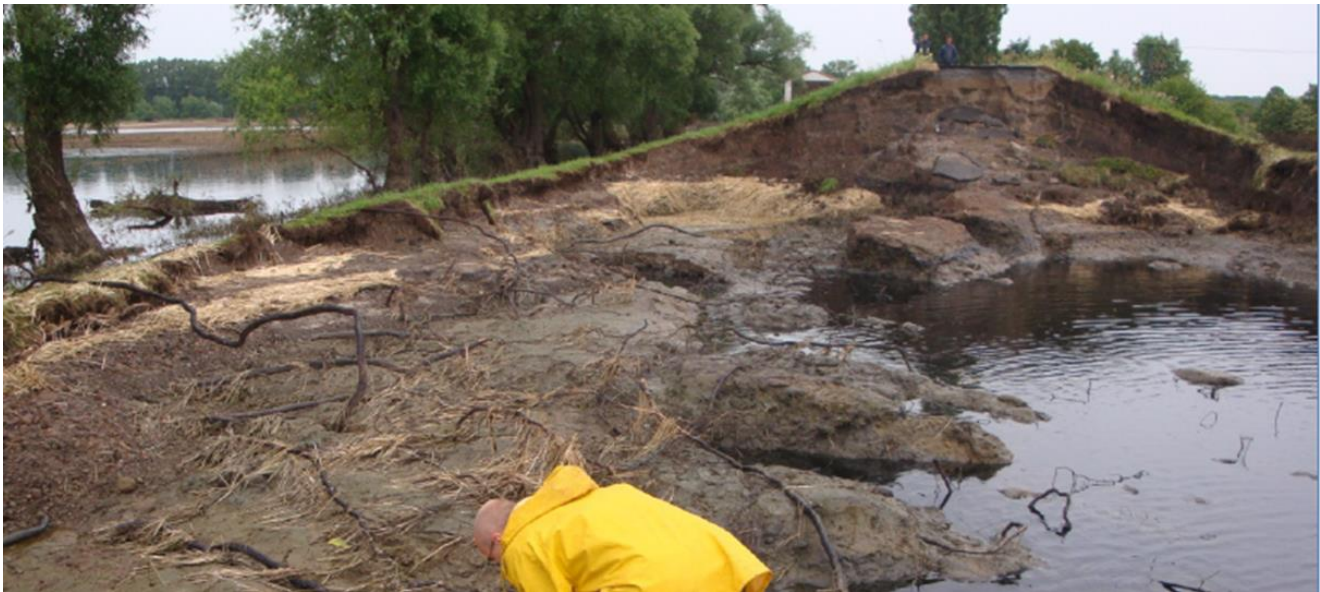
The photos taken after the breach show the presence of roots in the cross-section even after the breach as shown in Figure 7. The roots are numerous and the length of the roots indicate that they have grown deep into the levee. The presence of the tree roots might indicate a highly conductive layer which could have a direct effect on the local pore pressures inside the levee. The soil surface that is exposed by the breach, seems to consist of a cohesive material.

*Figure 7. Photo of the cross-section of the breached levee (Grubert, 2013).*
