Balancing the Limits of Acceptable Change in Design

Three future scenarios for São Luís Housing

Value Based Redesign Models

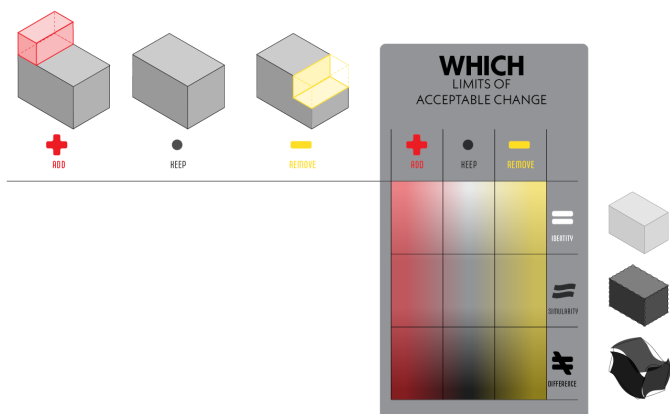
Figure 3. Diagram for the Limits of Acceptable Change, consisting out of add, keep, remove (x-axis) and identity, similarity, difference (y-axis)

Based on the research of Turner (1996, 1998) and Pereira Roders (2007) for the limits of Acceptable Change (LAC) context, a novel diagram was developed by Romeijnders (2023) to facilitate the analysis of heritage policies. Figure 3 depicts this diagram, which comprises six subcategories. The x-axis represents changes in heritage, categorized as add, keep, or remove. On the other hand, the y-axis represents the state of heritage, categorized as identity, similarity, or difference.

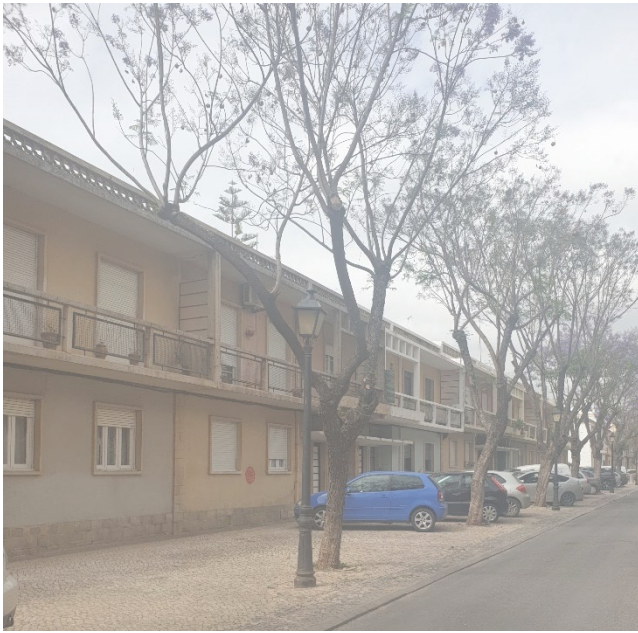
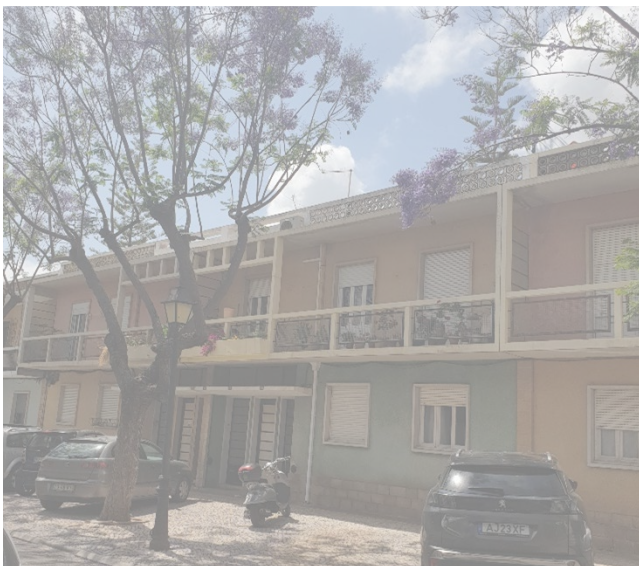
Figure 6 Pictures of the Rúa de Emiliano da Costa in May 2022,

Notes. Overview of the uniform street (Top) and a picture of the façade of Rúa Emiliano da Costa 33&35 (Bottom), showing the stones, tiled eave parapet and the first floor extending over the front façade.

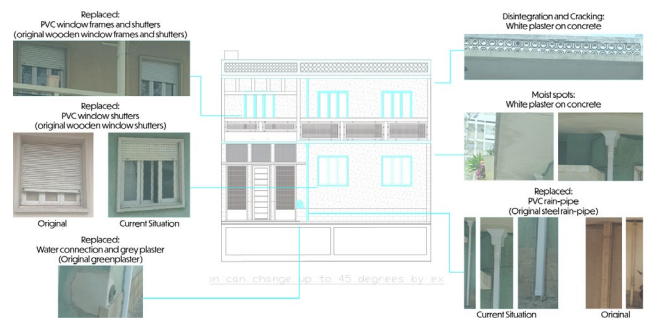
Figure 7: Front Façade with assessed damage

The front façade of the building exhibited both replacements and signs of damage. Replacements involved

the complete substitution of the original wooden window frames and shutters with PVC alternatives, accompanied by the replacement of single-sided glass windows with double-sided glass. Additionally, the original green plaster was replaced with grey plaster following the replacement of a water connection element, and the original steel rainpipe was replaced with a PVC rainpipe.

The front façade also exhibited areas of damage. Notably, disintegration and cracking were observed in the white plaster on the concrete of the top parapet balustrade. Furthermore, the presence of moist spots was noted around the upper floor extension, resulting in visible effects on the plaster of the concrete.

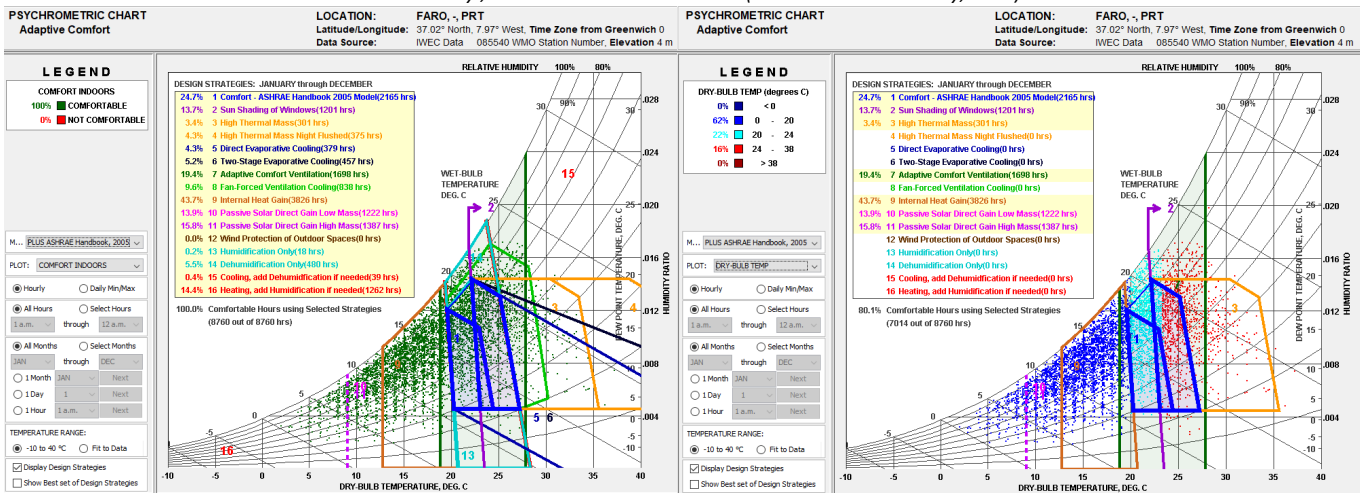
Psychrometric chart in general for the climate in faro (left) and the current situation (right)

The Climate Consultant has the option to produce a psychrometric chart. The graph displays the dry bulb temperature on the horizontal axis and the moisture content of the air on the vertical axis [1]. The program assesses the effectiveness of various design strategies for indoor comfort, as depicted in The most effective measures include 7 - adaptive comfort ventilation (19.4%), internal heat gain (9) with 43.7%, passive solar direct gain on high (15.9%) and low (13.9%) mass (10,11), and 16 – heating (14.4%). There is a lot of overlap with the current situation, almost all the most effective design measures are already happening, namely: 2,3, 7, 9, 10, 11. Using these six measures the building reaches a comfort level of 71.3%. The following could be applied in the future: heating (16), night flushing (4), and fan-forced ventilation which could increase the comfort level to 98.6%.
