## A comparative study between low- and high-tech methods for the detection and mitigation of illicit connections in stormwater systems

Water Science and Technology

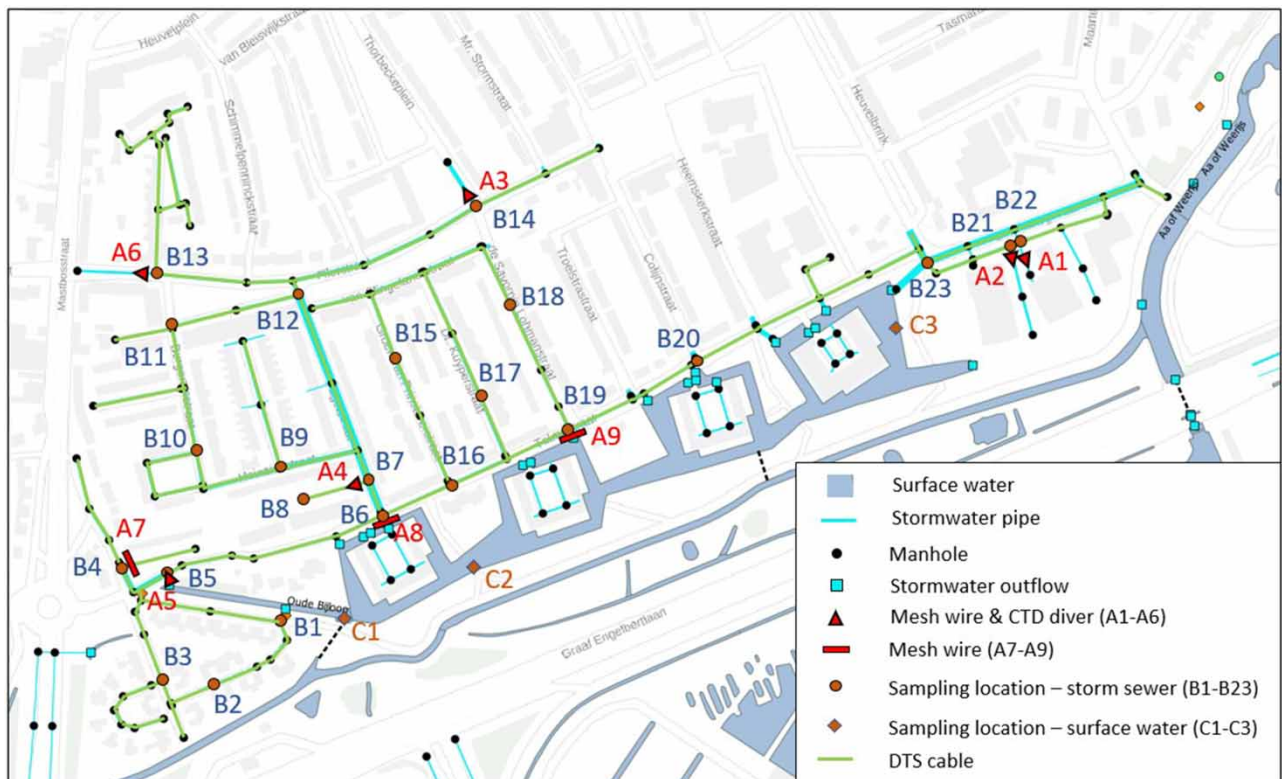
**Figure 1** | Catchment area De Heuvel with type and locations of the applied methods/techniques.

Six conductivity sensors (CTD divers<sup>®</sup>, van Essen Instruments) were utilized, measuring high-frequency conductivity and temperature at various locations in the stormwater system (Figure 1). The idea behind the use of CTD divers in the search for illicit connections is that, due to a different composition, wastewater discharges may be observed as a temporary increase in conductivity and/or temperature. The CTD divers were attached to (a selection of) the same setups as used for the wire screens, hence measuring at the same locations (A1–A6).

from the pond (C1–C3) are shown in Figure 1. The DTS monitoring was performed between October and December 2019 yielding a total of 26 days of data fit for data analysis (DTS data collected during storm events are not suitable for analysis). The wire screens and CTD divers were installed on 28 October 2019. The screens were inspected on 7 November and prior to their removal on 20 November 2019.

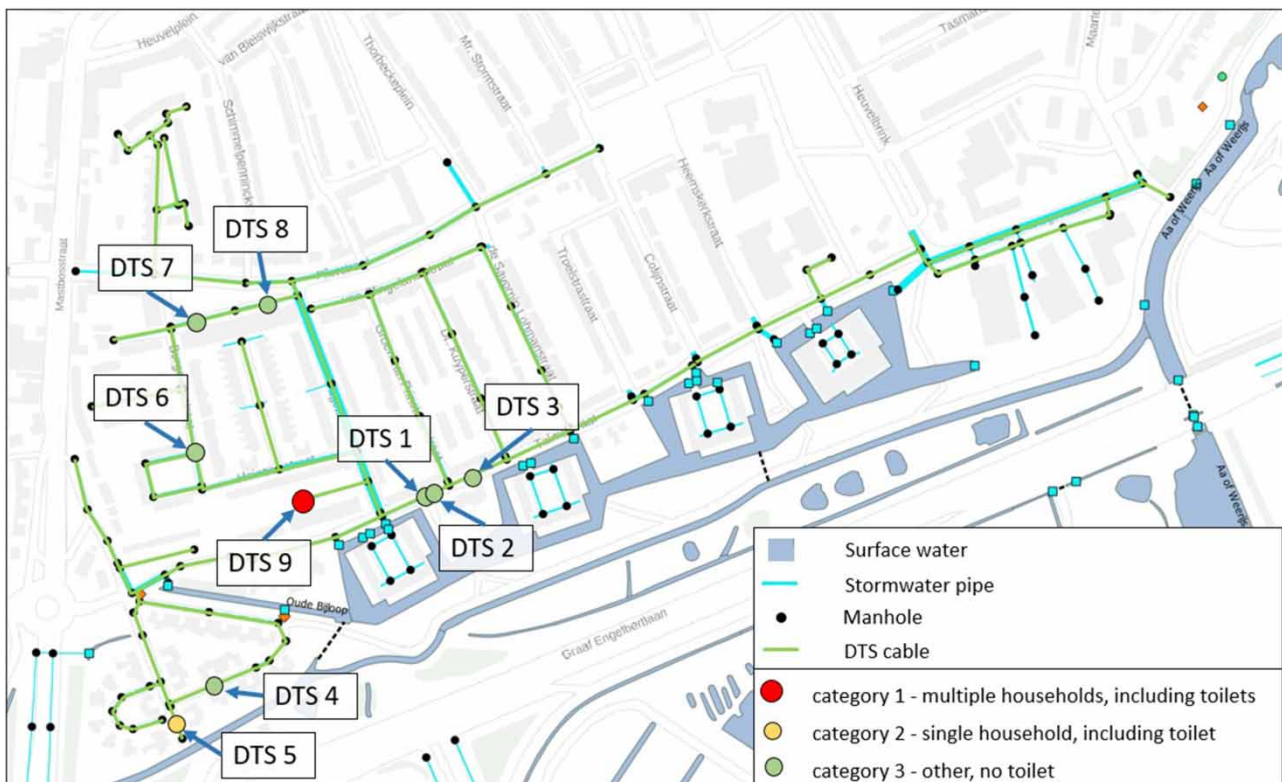
Figure 2 | Results of DTS monitoring with categorization of illicit connections.

Frequent and/or large temperature deviations in the DTS measurements were found at nine locations in the sewer system (Figure 2). These locations were further examined by conducting systematic appliance discharges (e.g. in toilets, bathrooms, washing machines) in the houses around the detected discharge points.

Location DTS 9 proved a large illicit connection with all wastewater from a three-storey building (three households) misconnected to the storm sewer. This illicit connection was repaired in March 2020. At location DTS 5, a visual inspection of the manhole revealed that wastewater (including fecal material) was present in the stormwater system, but the exact source could not be determined during the site visit. As a result, this illicit connection was not (yet) repaired by September 2022.

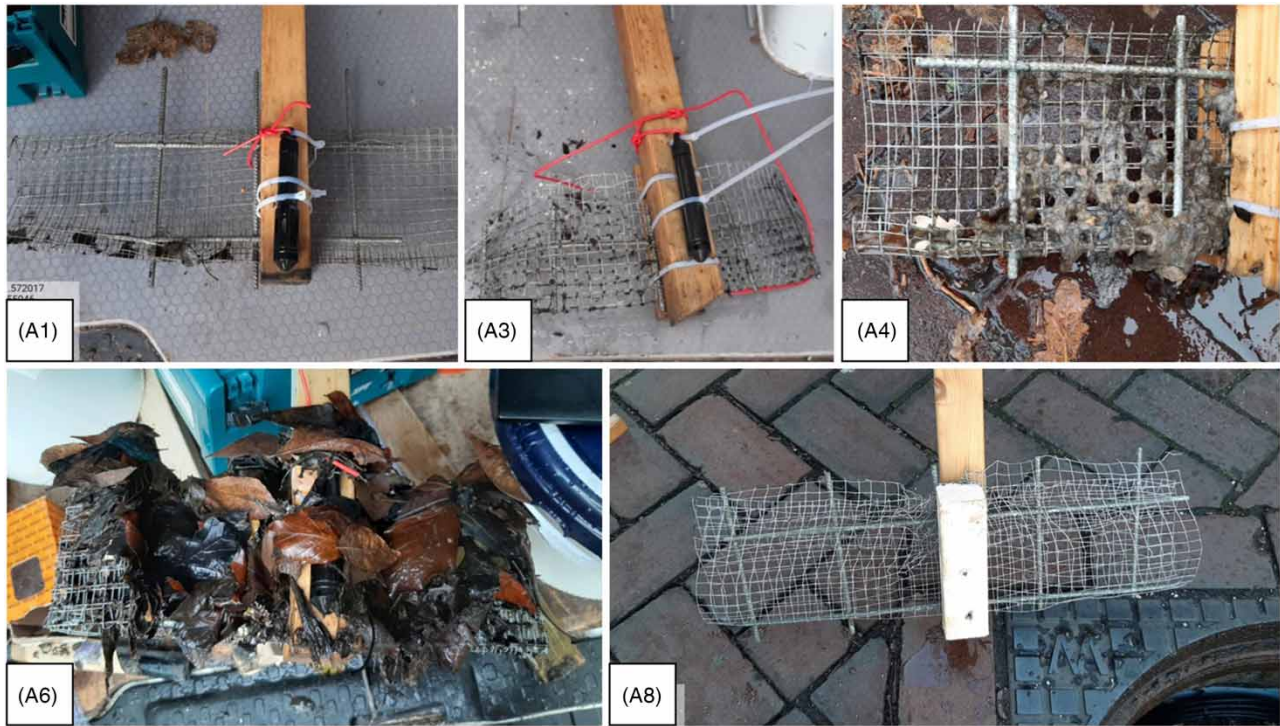
**Figure 3** | Mesh wire screens during inspection in November 2019.

Figure 3 shows a selection of results of the wire screens. No signs of fecal contamination (i.e. no toilet paper or fecal matter) were found on the majority of the inspected screens, although (remnants of) leaves were found at some locations. Only the screen at location A4 (downstream of DTS 9 where sewage was detected) showed clear traces of greasy contamination and a distinct sewage smell during the inspections.

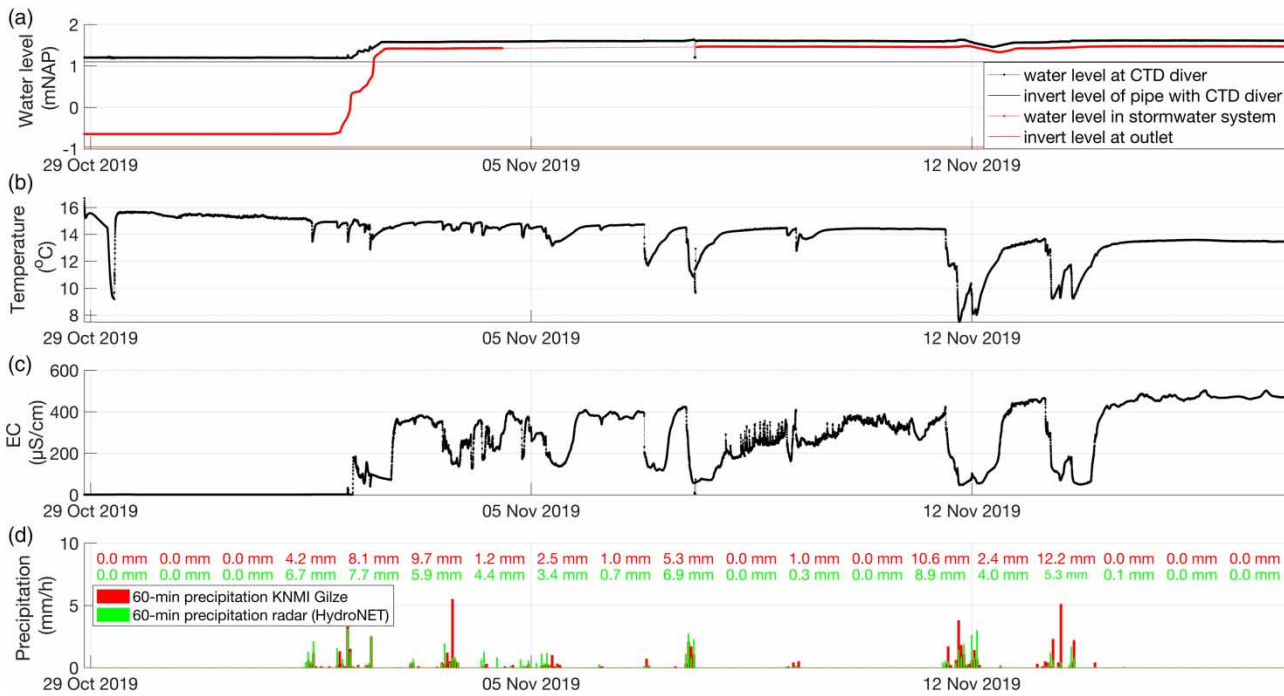
**Figure 4** | CTD diver® data at location A4: (a) water levels, (b) temperature, (c) electrical conductivity, and (d) precipitation.

The same pattern was observed at almost all locations, with constant temperature and conductivity values during dry weather and more variability in both parameters during storm events (results are presented in Figures S1–S5 in Supplementary Material). The inflow of stormwater runoff is often colder and has a more variable composition than the water already in the storm sewer. The only exception to this finding was again at location A4 where variations in electrical conductivity were observed during dry weather periods ([Figure 4](#)). These variations occurred at high frequency with several peaks per day and higher absolute values of 400–500  $\mu\text{S}/\text{cm}$ , whereas at other locations, the maximum values were around 200  $\mu\text{S}/\text{cm}$ .

For the conductivity and temperature measurements, the results were comparable to those for the mesh wire screens. The category 1 illicit connection at location DTS 9 was visible at location A4 via the EC signal (high-frequency variations and high absolute values during dry weather situations that fit the discharge of wastewater), but was not visible in the EC measurements at the downstream outlet A8. Again, the difference in hydraulic conditions is probably the explanation for this difference: the large upstream in-sewer water volume may attenuate the variations in EC signal to the point that these can no longer be distinguished in the data. EC monitoring at outlets proved insufficient in this sewer system to detect illicit connections. Similar to the wire screens, the absence of dry weather variations in the EC signals at locations without large upstream in-sewer volumes (A1, A2, and A6) confirms the earlier conclusion that no illicit connections are present in these pipes.

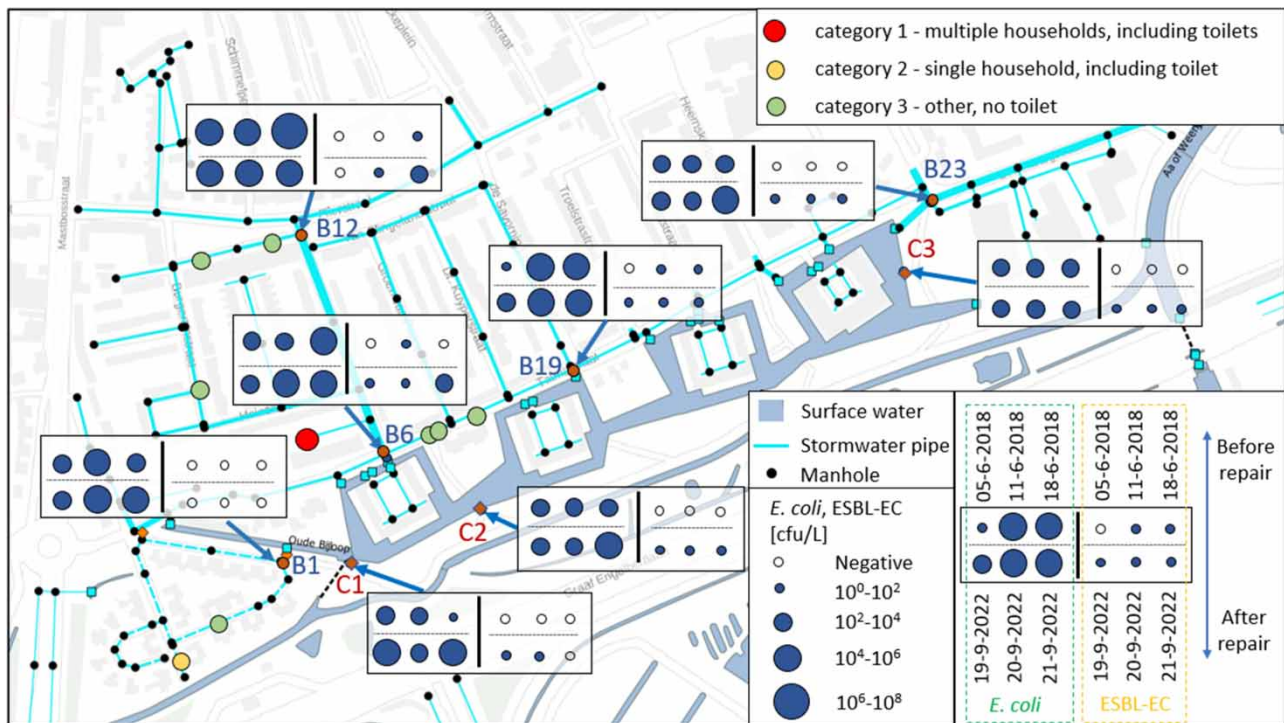
**Figure 5** | *E. coli* (per location left-hand side) and ESBL-EC (right-hand side) concentrations in June 2019 (before repair of illicit connections, per location upper row) and in September 2022 (after repair, bottom row). Results are categorized according to their (log)value. Analysis results are given in Table S1 in Supplementary Material. The locations of the illicit connections found with DTS are also indicated in the figure.

[Figure 5](#) shows an overview of the analysis results for *E. coli* and ESBL-EC for samples collected before and after the repair of illicit connections. *E. coli* was detected in all samples from the stormwater system as well as from the pond. Removal of illicit

connections did not result in the expected reduction of *E. coli* concentrations. In contrast, the average storm sewer concentrations were about three times higher in 2022 compared to that in 2019 (geometric mean  $5.7 \times 10^5$  vs.  $1.9 \times 10^4$  cfu/L, respectively). Especially the consistently high concentrations at location B6 (two manholes downstream of the removed category 1 illicit connection) were unexpected.

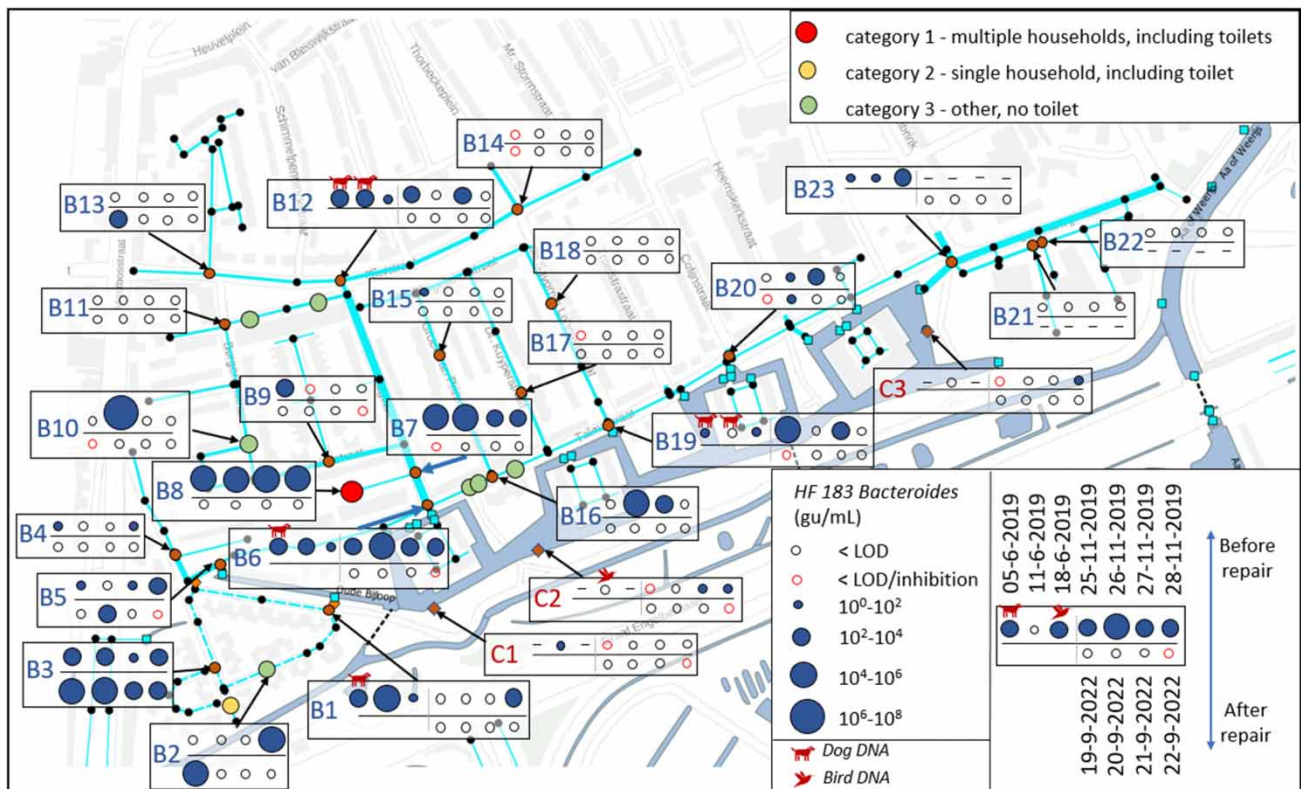
**Figure 6** | Human-specific DNA results before (June and November 2019, per location upper row) and after (September 2022, bottom row) repair of illicit connections. Dog and/or bird-specific DNA marker was analyzed only for samples collected in June 2019; a positive sample for these targets is indicated with a red symbol. Detailed analysis results are given in Tables S2–S4 in Supplementary Material. While the absolute concentrations might not be directly comparable due to the different methods used, the orders of magnitude of the results as shown in this figure are considered valid and as such allow comparison.

Figure 6 shows the results of DNA analysis for human markers. The human-specific DNA marker was found in 60 of a total of 214 samples (28%). There is a large difference between the samples before repair of illicit connections (44% positive) and after repair (8% positive). Moreover, five of the eight positive samples from September 2022 were collected at locations B2 and B3 near the unresolved illicit connection at location DTS 5 (yellow dot). The results at locations B8, B7, and B6 show a strong effect associated with the repair of the illicit connection at location DTS 9 (large red dot): consistently positive results before repair and consistently negative results after repair.
