# Comparing overflow and wave-overtopping induced breach initiation mechanisms in an embankment breach experiment

**Abstract.** As part of the SAFElevee project Delft University of Technology collaborated with Flanders Hydraulics Research, and Infram B.V. in the preparation and execution of a full scale embankment breach experiment in November 2015. This breach experiment was performed on an 3.5m high embankment with a sand core and clay outer layer situated along the tidal river Scheldt in Belgium near Schellebelle. During the experiment a wave overtopping simulator and overflow simulator were used to initiate a breach. Both simulators were placed near the top of the waterside slope. The use of the simulators facilitated comparison between the effects of continuous overflow and the effects of intermittent wave overtopping. This paper presents the data collected during the experiment, describe the development of hypotheses on the failure processes using the latest insights, and comment on the failure initiation process of a grass covered flood embankment with a clay outer layer and a sandy core.

## 2 Test methodology

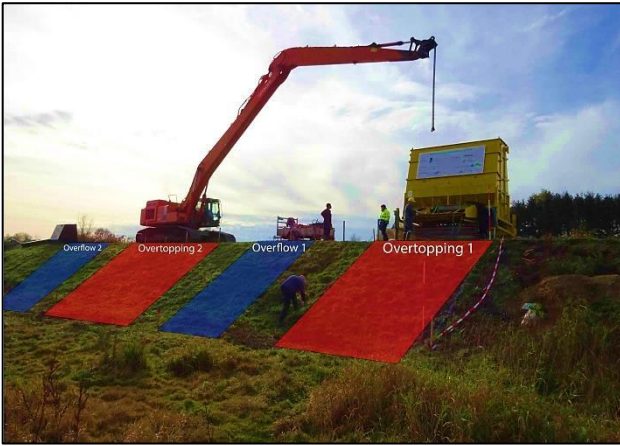
**Figure 1.** Overview test locations on embankment.

Over an approximate 50m long stretch of embankment, two tests were performed on breach initiation due to wave overtopping using the 4m wide wave overtopping simulator developed by Van der Meer [5], [6][7]. Also two breach initiation experiments had been performed using a 2m wide overflow simulator developed specifically for this experiment by Delft University of Technology. An overview of the test sections has been depicted in Figure 1.

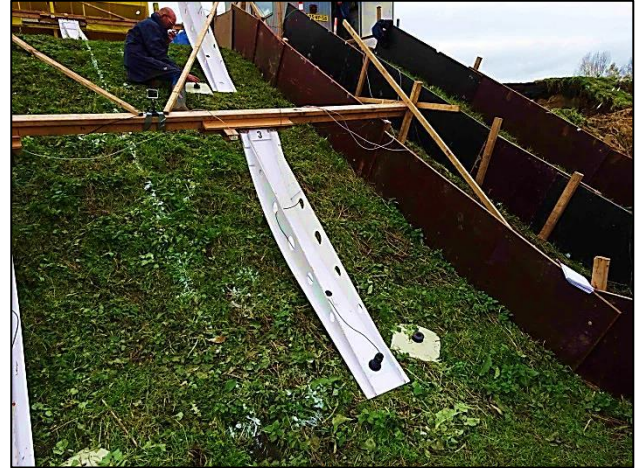
To assess the roughness parameters on the embankment, hydraulic measurements were performed with waves of respectively 500, 1000, 1500, 2000, 2500, 3000, and 3500 l/m. During the hydraulic measurements the flow velocities were continuously measured at the bed and surface of the waves using paddle-wheels. To measure the change in depth profile of a wave over time, a surf-board like construction was used (see Figure 2). The

water depth was derived from measuring the change in angle of the surfboards when a wave passed under it. The paddle-wheels were placed near the downstream tip of the surfboard, both in the embankment surface and on the tip of the surfboard. This way both the flow velocity at the bed and at the surface could be measured. The front velocity of the wave was derived by measuring the time lapse in signal from the surfboards and the known distance between two surfboards.

**Figure 2.** Setup for performing hydraulic measurements during wave overtopping tests.

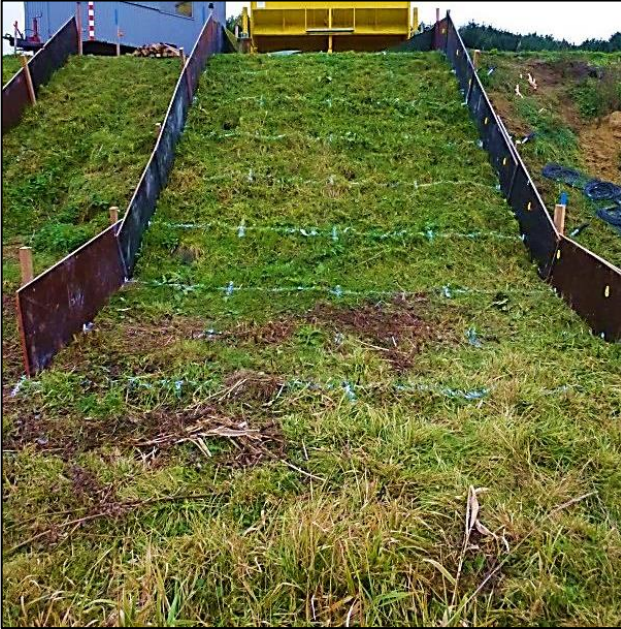
**Figure 3.** Overview picture taken prior to the first wave overtopping experiment

Prior to the tests the embankment was divided into 1x1m quadrants (see Figure 3). The first quadrant (1A) started on the far left hand side of the outflow point of overtopping simulator. The flow channel was 4m wide. Across, it was divided into Sections A through D with A being on the left hand side looking upstream. In total 11 cross sections were created. During the first test cross sections 1, 2, and the first half of cross section 3 were fully covered with a plastic sheet to prevent erosion of the gravel road. Between the end of the plastic sheet and the top of the landside slope some flattened grass cover was present. On the landside slope several stones were present. In Section 4A a small hole was visible. In cross sections 6A and 8C stones were visible from the surface. In section 7 the nettles and moss were visible. In general the grass cover was not nice and smooth but represented a rough surface. Characteristic of the behaviour of grass under the wave loading was that every time the wave had passed the grass bounced back into an upright position. This could therefore have contributed to a higher roughness experienced by the waves and hence higher shear stresses.
