In-plane pushover analysis of a quay wall with an uneven pile foundation

The case study of the Grimburgwal

Master of Science
in Civil Engineering

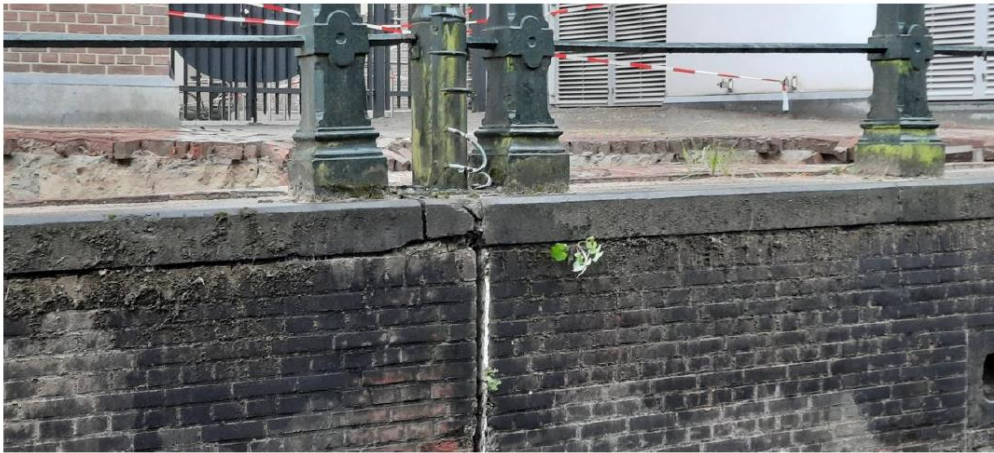
Figure 2.4: a dilatation joint in the Grimburgwal from the research of Korff et al. (2021).

The quay walls are divided from other quay walls and other types of hydraulic structures in the longitudinal direction with dilatation joints. In figure 2.4, a dilatation joint present in the case of the Grimburgwal, that represents a small space between two masonry parts. According to information gained from the municipality of Amsterdam, for new hydraulic structures, a gap of 20 mm is kept between two structures. It is possible for these gaps to be filled with a linear elastic (glue like) material with a low stiffness. However, for old structures like the Grimburgwal, it is not known how large this gap exactly is or if there even is a gap. Since there is not a lot of data available on dilatation joints, assumptions will be made to model them.

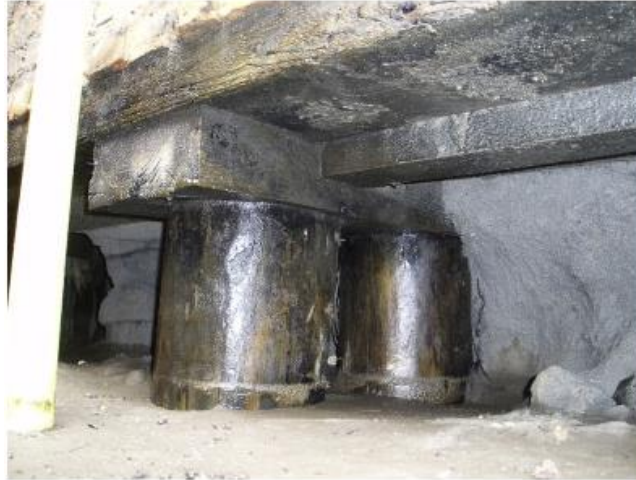
Figure 2.13: an ordinary wooden foundation from the Netherlands (Klaassen & Creemers, 2012).

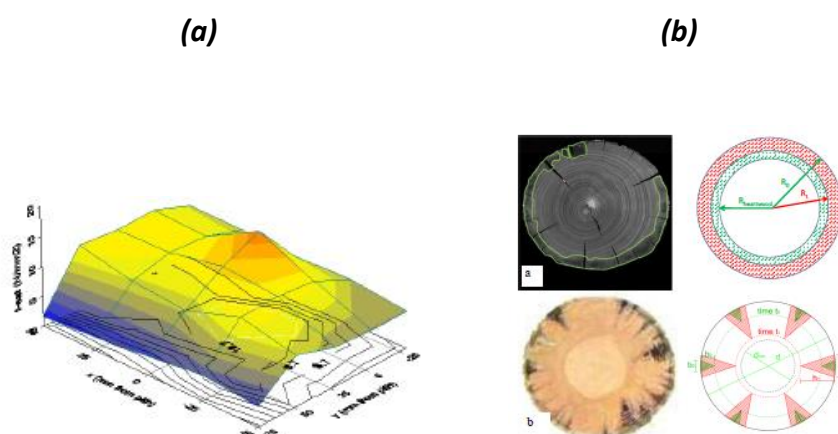
Figure 2.15: (a) the compression strength that is left of a pile that is 167-year-old.
 (b) the cross-section of profiles that experience bacterial (top) and fungal (bottom) decay.

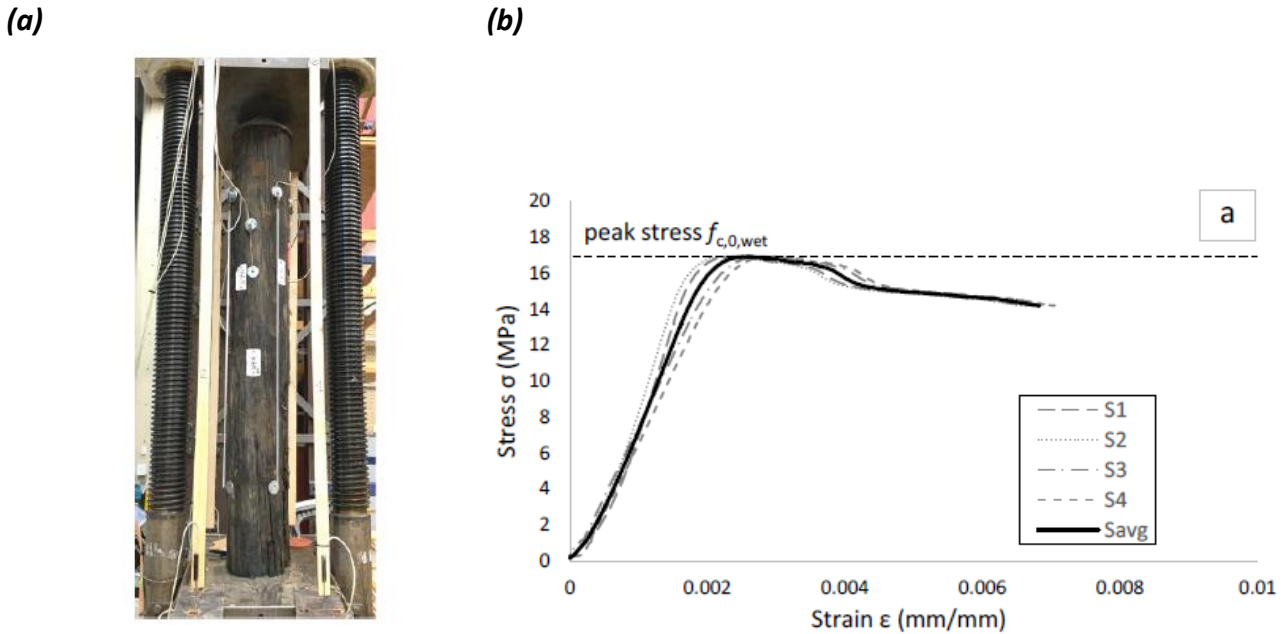
Figure 2.17: (a) arrangement for loading pile parts and (b) behaviour of a pile in compression (Pagella et al., 2022).

A representation of a wet pile when undergoing a compression test can be seen in figure 2.17 (a) and the behaviour can be seen in 2.17 (b). It was noticed that the strength and stiffness were in a close range similar to each other. Pagella et al. (2022) stated that also decomposed piles have load-bearing resistance left, which means that the load distribution of decomposed piles from foundations that were retrieved from a bridge cannot be neglected. The results of the tests are presented in figure 2.18 (Pagella et al., 2022).

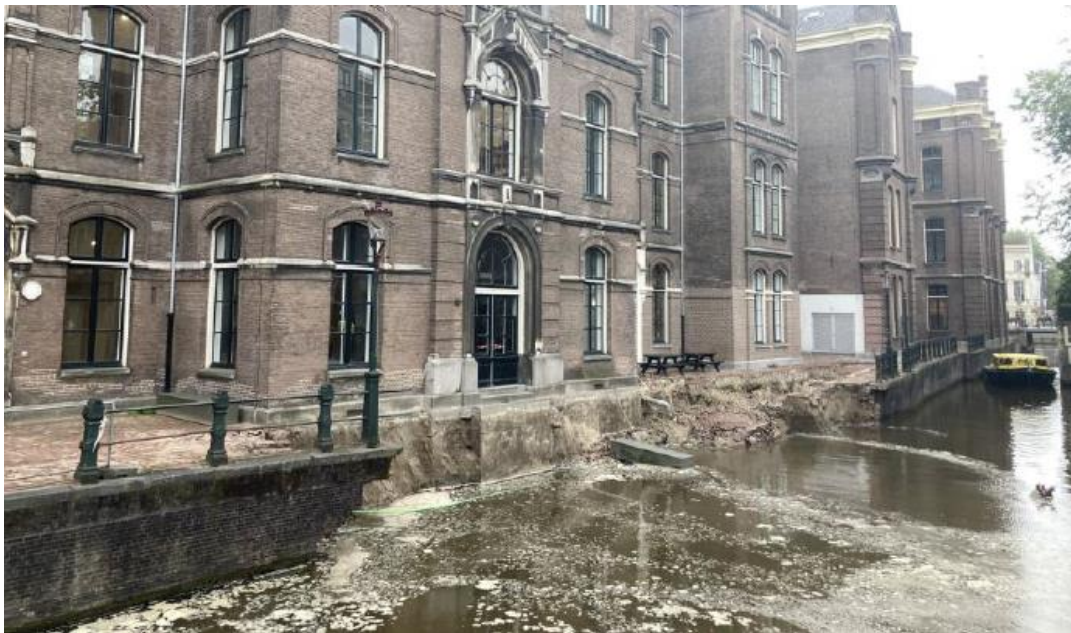
Figure 3.1: the Grimburgwal after collapse from the research of Korff et al. (2021).

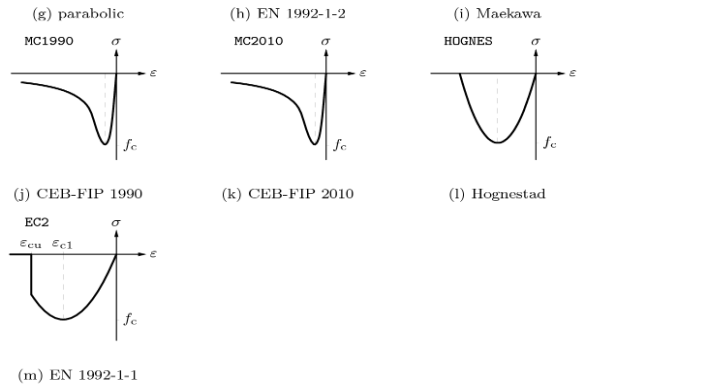
Figure 4.4: compressive behavior for TSCM, according to (DIANA, 2021).

The Thorenfeldt curve will be used as an input for the masonry, because it is most similar with the compressive behaviour of quasi-brittle materials (van Hulthen, 2021). If the compression and tension curves are combined, it would result in a stress and strain relation that is presented in figure 4.6, which shows the behaviour for loading and unloading in concrete (Schreppers et al., 2016). In the research of van Hulthen (2021), it is mentioned that the compressive strength of quasi-brittle materials is 85 times as much as the tensile strength. The fracture energy of these materials in compression is more than 200 times greater than the fracture energy of tension. It is possible to presume that the behaviour of masonry is linear elastic, since there is a good chance that macro-cracks have appeared in masonry when the tensile strength is not yet reached due to the inconsistency between the compressive and tensile strength. Including linear elastic behaviour for masonry, makes it easier for modelling because the time for computing is reduced (van Hulthen, 2021).

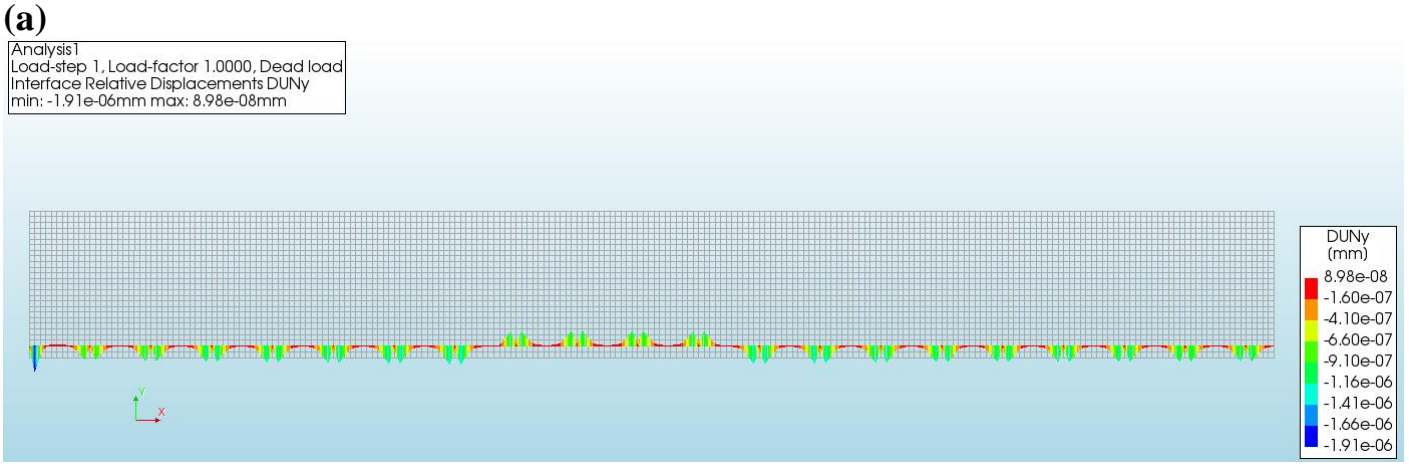
Figure 5.3: openings in the interface in the (a) y-direction and the (b) x-direction at the last load step.

From figures 5.1 (a) and (b), it is seen that the settlement for the whole length of the wall is in the negative y-direction, so to the bottom. This means that all piles will be in compression, instead of partly compression and tension. The deformation is small in the x-direction. Only at the location of the dilatation joint, some deformation in the x-direction is experienced, which is because this part is not constrained and can deform due to the Q-load. The force-displacement diagram is presented in figure 5.2 for point A and B that were indicated in figure 5.1 (b). Point A will be checked because the largest settlements and cracks are expected near this point. Point B will be checked to observe the force and settlement relation near the dilatation joint. The next part that will be discussed are the openings in the interface between the timber floor and masonry. Figures 5.3 (a) and (b) show that the openings at the interface are quite small in both the x and y-directions. The connection between the masonry and timber elements is not the reason why the model runs into divergence. In figure 5.4, the stress distribution of the model can be seen with the principal stresses.

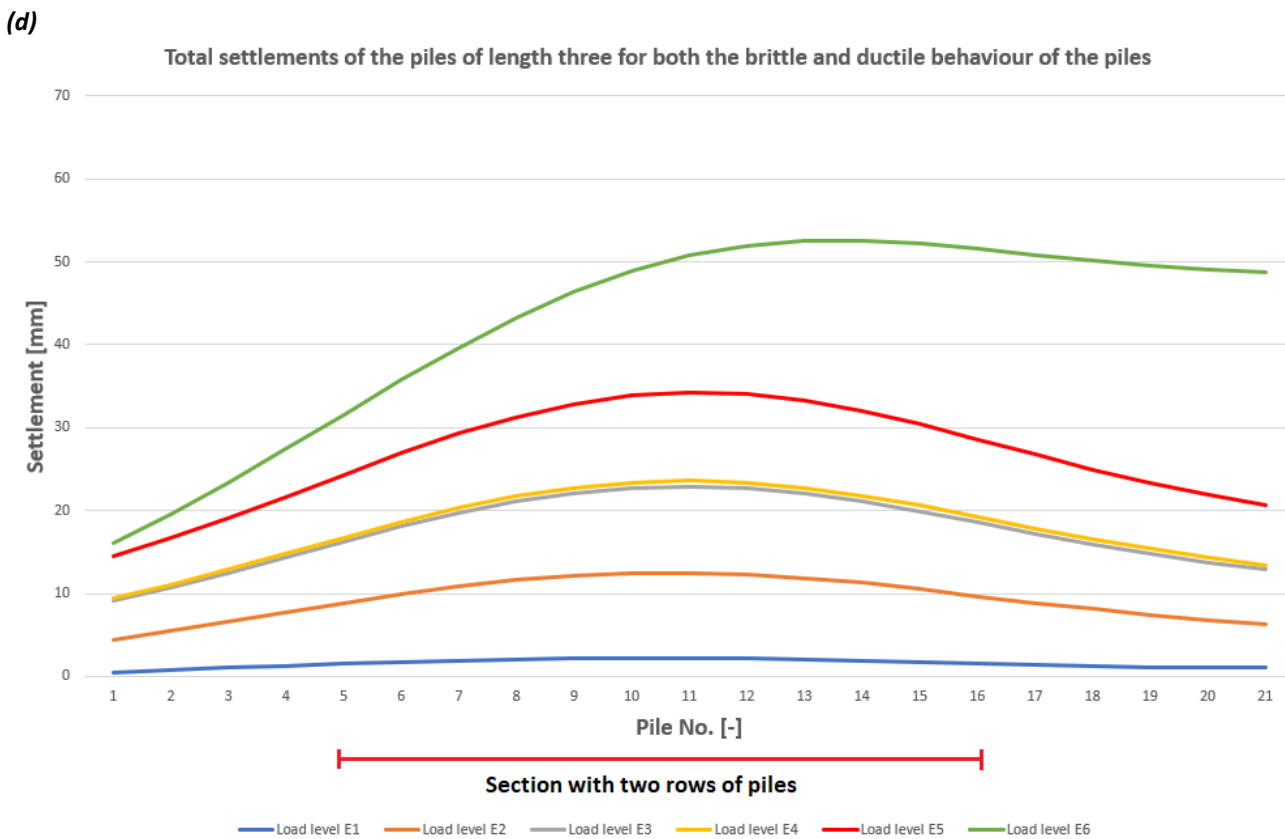
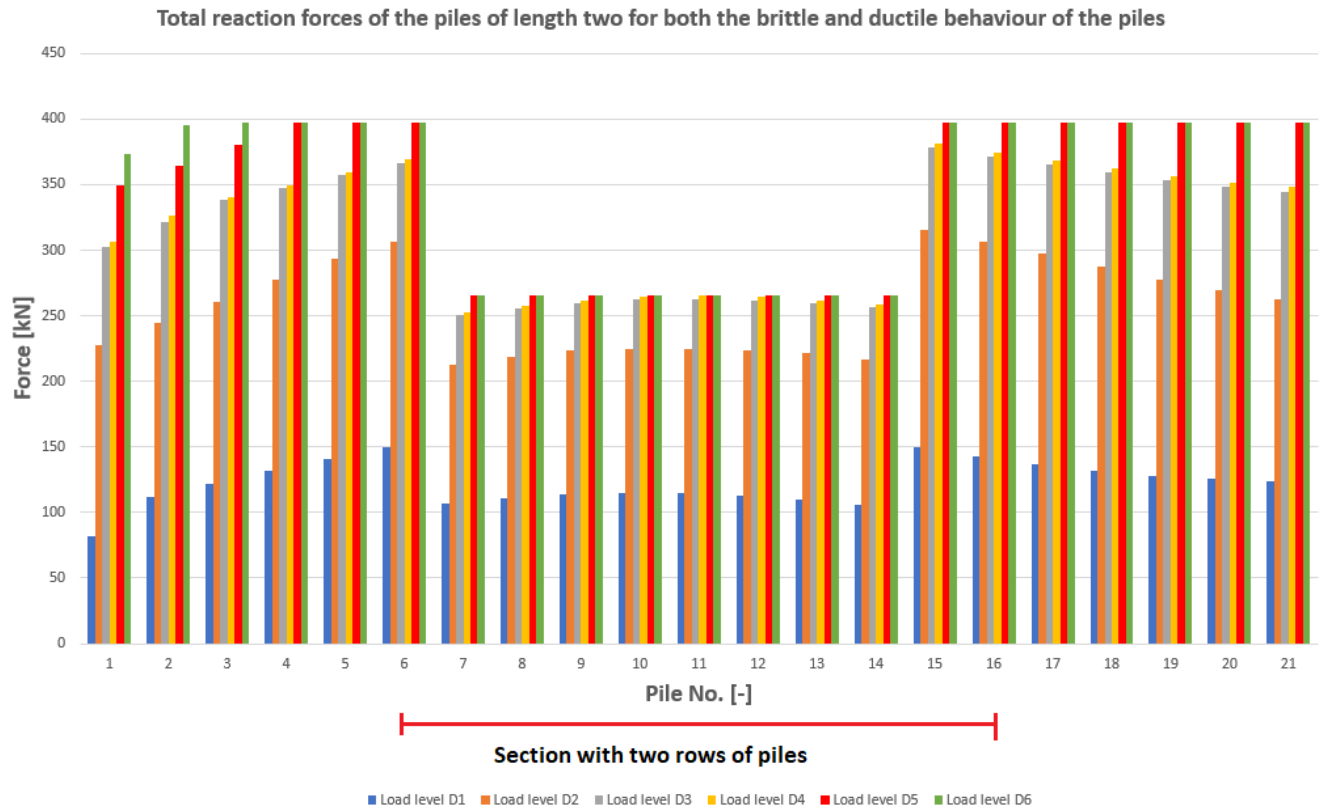
Figure 6.22: total settlement of the piles for (a) length zero, (b) length one, (c) length two and (d) length three for both the brittle and ductile behaviour of the piles.

In the figures 6.22 to 6.24, the settlements, the distribution of forces and stresses (in cross-section A) of the piles in all cases and for all load levels can be observed. For the load levels when brittle behaviour was assumed for the piles, the piles from the section with two rows of piles are most critical because of the large settlement in that section (except for length zero). The piles near the constrained edge seem to be settling more than the piles near the dilatation, because of the limited rotation that is possible near the dilatation. After the first number of piles have ductile behaviour, the settlement of the piles and the load distribution seem to be similar to the phase where these piles were close to having ductile behaviour.
