Journal of Coastal and Riverine Flood Risk

# Assessing the extent and connectivity of animal burrows using smoke: a practical tool for levee inspections

This short communication presents a practical tool for assessing the subsurface connectivity of animal burrows. It focuses on its potential for early detection and evaluation of animal-induced damages in levees that can compromise their structure during high water episodes.

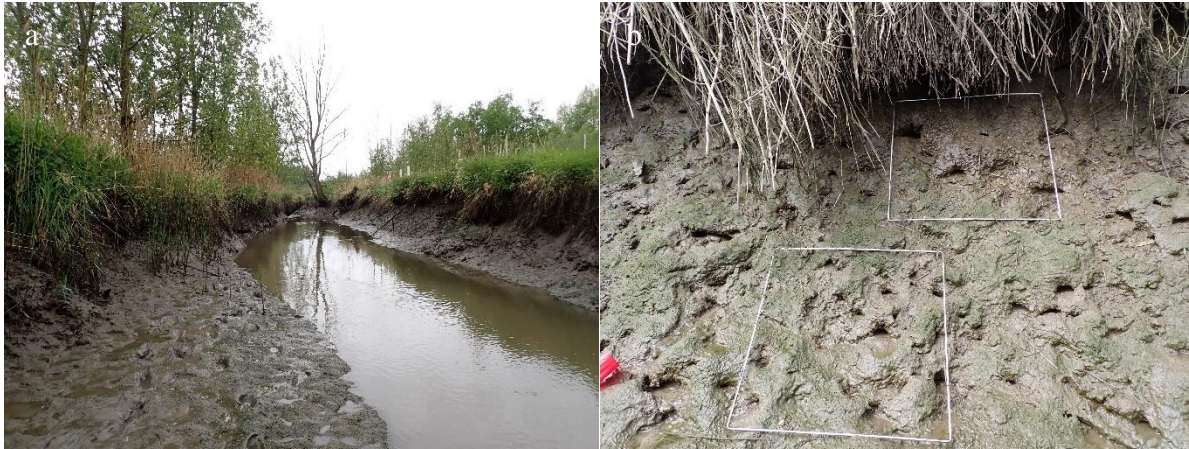
Figure 4: (a) The main creek of Lippenbroek at low tide, (b) Quadrants are placed randomly on the bank to determine local burrow density.

Prior to the smoke test, a visual inspection of the burrow openings in the bank was performed. A quadrant ( $0.5 \times 0.5$  m) was placed randomly three times onto the surface of the creek bank (Fig. 4b) within the study area ( $\pm 3 \text{ m}^2$ ). All burrows within the quadrant were counted and the local surface burrow density was determined. Next, the smoke test was performed according to configuration 1 (Fig. 2a).

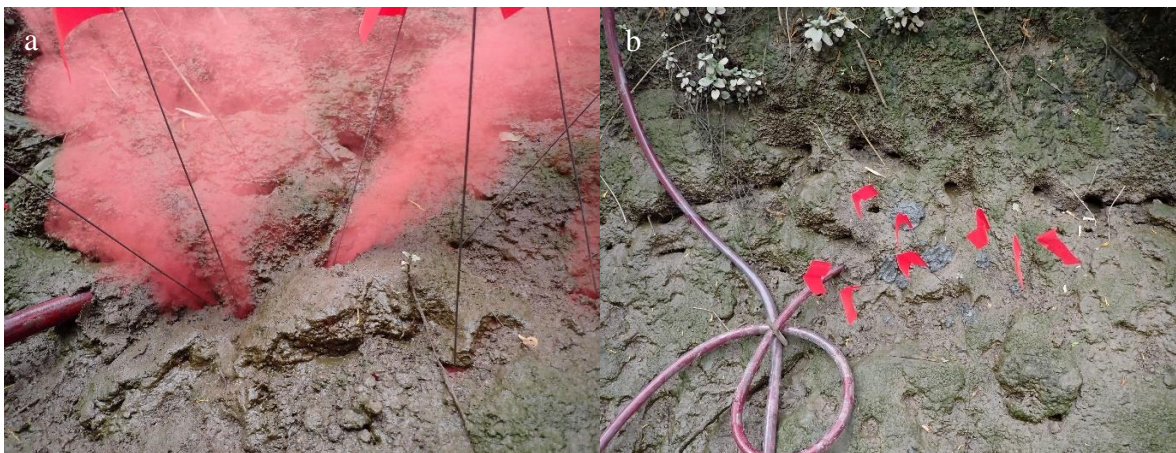
Figure 5: (a) Smoke is inserted into the burrow network through a hose in a burrow opening (left) and the smoke emerges from interconnected burrows, which are marked with red flags. (b) After measuring, the burrow openings are closed off with local sediment before the second round of the smoke test.

**Configuration 1** (Fig. 2): The tests were performed on a dry day with a calm to light air wind level. A plastic container (25 L, height 40 cm, diameter 28 cm) was connected via its venting hole at the bottom to the selected burrow opening (smoke inlet) with a plastic hose (diameter 28 mm, length 4.5 m). To minimise the loss of smoke, the gaps around the hose were sealed with sediment. A coloured smoke bomb (length 60 mm  $\times$  diameter 80 mm, ignition by drawstring, burning time 60 s, colour red, orange or pink) was ignited and placed inside the container. A leaf blower (Stiga, type SBL 327 V, gasoline engine power 800 W and  $27.6 \text{ m}^3$ , maximum air flow rate  $10.2 \text{ m}^3/\text{min}$ , maximum air speed 72 m/s) was placed with its outlet on top of the opening of the container. Through the pressure of the leaf blower, the smoke was blown from the container, through the hose, inside the burrow network. While blowing, the bank was inspected visually by multiple surveyors for the emergence of smoke. Every hole that was venting smoke was marked with a flag (Fig. 5a). After the first test, the width and height of all burrow openings were measured (up to 0.5 cm precision) with a feeler gauge or measuring tape for large burrows. Using measuring tape, the distance between the flagged burrow opening and the smoke inlet was measured. Next, all the burrows were sealed (Fig. 5b), using the local silty sediment, and the whole smoke test was performed again using the same burrow as inlet to identify extra connected borrows that had been missed in the first test. Practice showed that, at this site and for this type of burrow

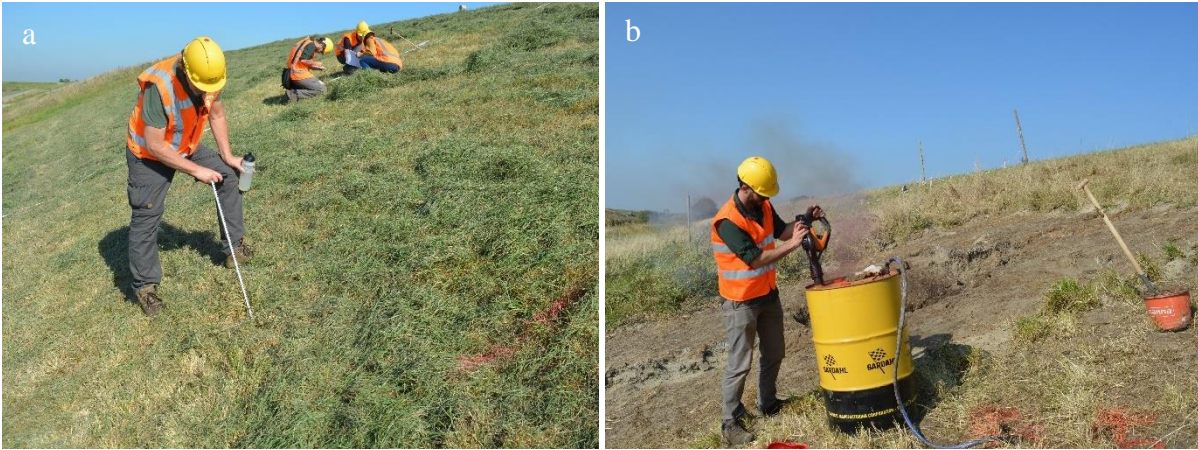
Figure 7: (a) A probe was used to measure the depth of the burrows during the visual inspection of the levee. The burrow openings were not clearly visible because of the vegetation. (b) The smoke test was performed using configuration 1: with a leaf blower the smoke is blown from a container through a hose into the burrow network.

Prior to the smoke tests, visual inspections were carried out. At both locations, a levee stretch of 100 m was inspected from crest to toe (approximately 250 m<sup>2</sup>) by four surveyors that walked the levee in horizontal and vertical transects to search for burrows. All detected burrows were mapped and their locations noted using measuring tapes and grid paper, including their measurable depth (precision up to 1 cm) and diameter (precision up to 1 cm) (Tsimopoulou & Koelewijn, 2022). Depth was measured using inspection probes (Fig. 7a). The map helped the team identify clusters of burrows of small rodents and moles that could be leading to subsurface dens. At location 1, a section with mole burrows was selected. The smoke test was successfully performed at this location twice with two different configurations (Fig. 2a, b). At location 2 a 4 m-wide section was selected for the smoke test, where a relatively higher density of burrows was mapped. Within this section sand was found at the periphery of a burrow, indicating that the subsoil cavities reached the sand core of the levee. The smoke test was successfully performed once at this location with configuration 1 (Fig. 2a). At both locations, no animal activity was observed prior to the smoke test.

*Configuration 1* (Fig. 2): This configuration is the same as the one used in the first case study, but with variations in the dimensions and materials of its basic components (i.e., leaf blower, container, hose). The variations were only made because the team did not have access to the exact same components that were used in the first case study. A container (200 L, height 876 mm, diameter 584 mm) was connected via its venting hole at the top to the burrow opening using a standard garden hose (diameter 12 mm, length 1.5 m). A coloured smoke bomb (orange, red) was ignited and placed inside the container. Using a leaf blower (WORX, type WG549E.5, 18V battery powered, maximum air speed 56 m/s) the smoke was blown through the hose into the burrow network (Fig. 7b).

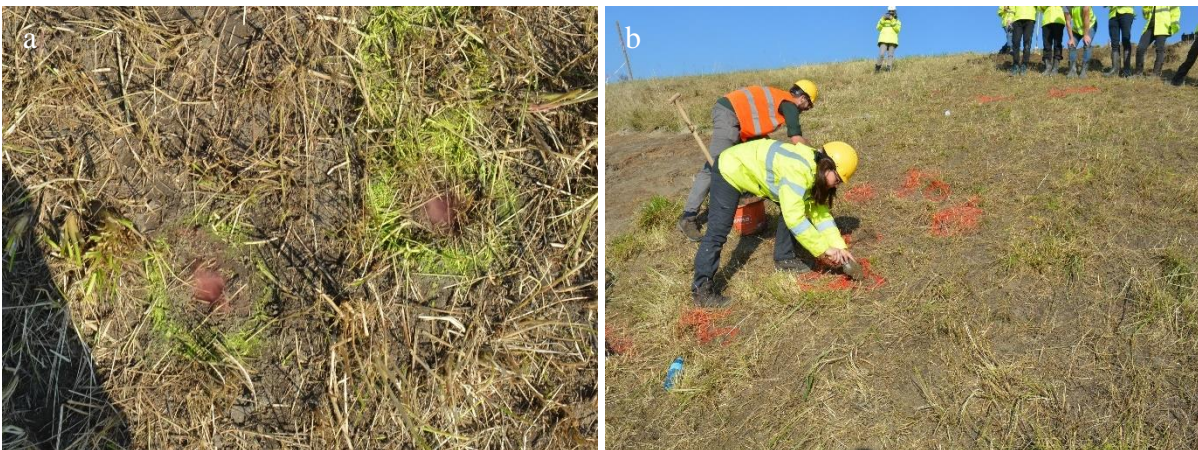
Figure 8: (a) Smoke emerges from two burrow openings. (b) The burrows that were emitting smoke were closed off with wet clay.

In both variations of the experiment, the levee was inspected for smoke emerging from holes (Fig. 8a) by multiple surveyors and the discovered burrow openings were promptly sealed using sediment (wet clay, Fig. 8b) or plexiglass plates. The smoke test was repeated twice to ensure that all burrows in the same cluster were discovered. During these tests, the wind conditions were limited to little more than a small breeze (cf. Fig. 7b). On later occasions, sometimes a stronger wind was present, which made it more difficult to detect smoke coming out of the burrows.

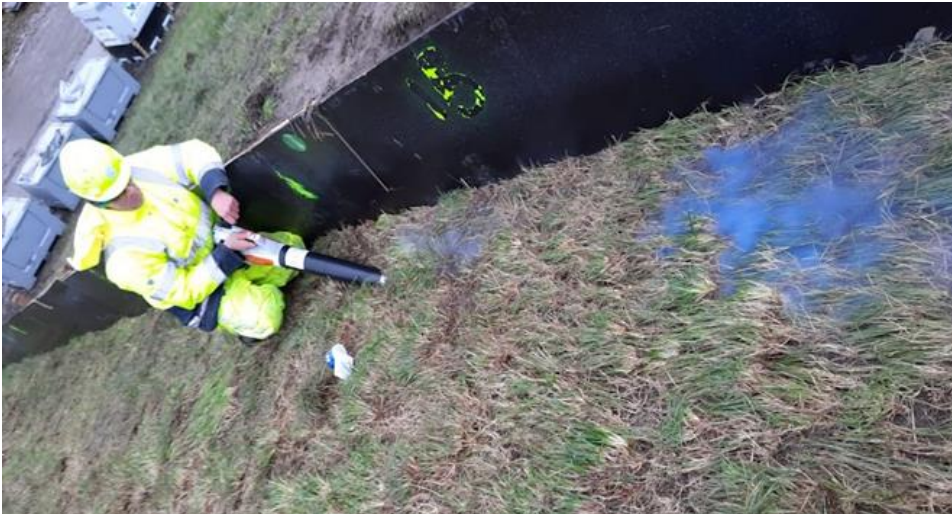
Figure 9: The smoke test was performed using configuration 2: with a leaf blower the smoke is blown directly into the burrow network. Diffuse smoke can be seen exiting from the burrows (source: Interreg 2 Seas project Polder2C's, Courtesy of Wouter Zomer, BZ Ingenieurs & Managers).

*Configuration 2* (Fig. 2): A coloured smoke bomb (red, blue, purple) was ignited and placed directly inside the burrow. The outlet of a leaf blower (BGA 45, 18V battery powered, maximum air speed 38 m/s) was placed on the opening of the burrow (Fig. 9), blowing the smoke inside the burrow network.
