Coupled effects of corrosion damage and sustained loading on the flexural behavior of RC beams strengthened with CFRP anchorage system

2022

Composite Structures

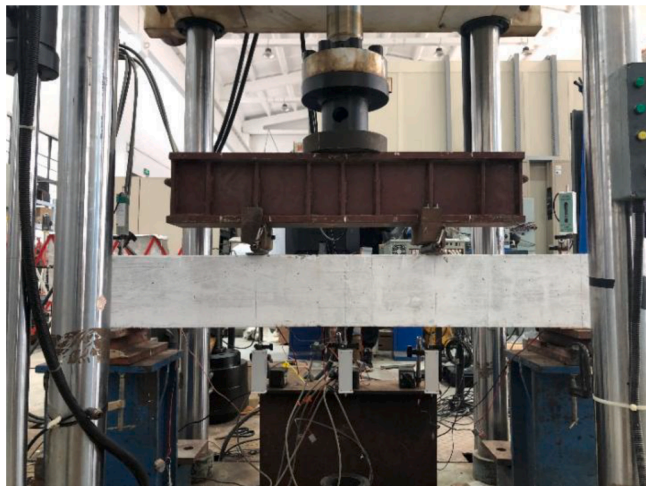
Fig. 5. Monotonic four-point loading of CFRP-strengthened RC beams.

To obtain the residual strength of laboratory beams, monotonic four-point loading tests were performed on all beams, as shown in Fig. 5. All tests were conducted with the MTS drive at a speed of 1 mm/min for displacement control. The deflections at the mid-span and two loading points of the beams were monitored by linear variable displacement transducers (LVDTs). One strain gauge was placed at the top of the test beam in the mid-span pressure zone. Five strain gauges were distributed evenly throughout the fiber of the CFRP-reinforced beam, as shown in Fig. 6.

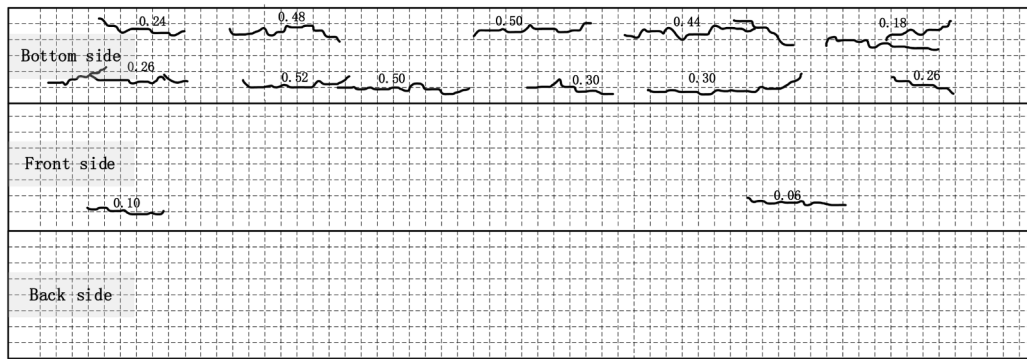
Fig. 7. Corrosion cracks patterns.

The concrete cover started to crack with the accumulation of damage induced by corrosion. After each beam reached its corrosion time, the RC beams were removed from the reaction tank and the reddish-brown corrosion products at the cracks on the concrete surface were washed out. In order to evaporate the moisture on the concrete surface, the tested beams needed to be placed in a natural environment for 12 h. All cracks on the bottom and sides of each beam were depicted on square grid paper following the crack direction, and the maximum width of each crack was measured using a crack gauge, with each grid corresponding to a 50 mm × 50 mm area of the realistic beam. It was observed that the overall trend of longitudinal cracks was along the direction of the longitudinal tensioned reinforcement at the bottom of the beam. The length of the cracks in the pure bending zone at the bottom of the beam was the longest, and the width of the cracks was greater, and the widest part of the cracks was generally near the span position of the beam. The corrosion cracks patterns are shown in Fig. 7.

Table 3 lists the maximum corrosion crack width, w_{max} , for each beam. The values of the maximum crack width were 0.64, 1.08, and 1.42 mm for groups A, B, and C, respectively; hence, the crack width increased proportionally as the corrosion duration increased. Besides, it can be obviously observed that the crack width of beams exposed to the sustained loading was larger than that of beams without the sustained loading with the same corrosion duration. For instance, at low levels of corrosion, the corrosion crack width was 0.64 mm for beam CS-5-HL, an increase of 22.2% compared to beam CS-5-NL (Fig. 7a, b). At a severe level of corrosion, however, the corrosion crack width was 1.46 mm for beam CS-20-HL, almost the same as beam CS-20-NL (Fig. 7e, f). This implied that in the early phases of corrosion, the sustained loading causes the cracks to grow faster, thereby speeding the corrosion further, expanding the fractures; however, when it reaches a high degree of corrosion, sustained loading has only a partial effect on corrosion crack width.

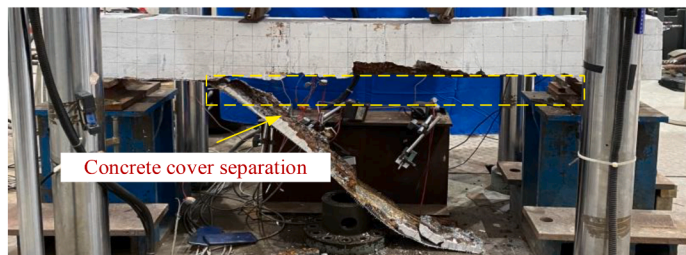
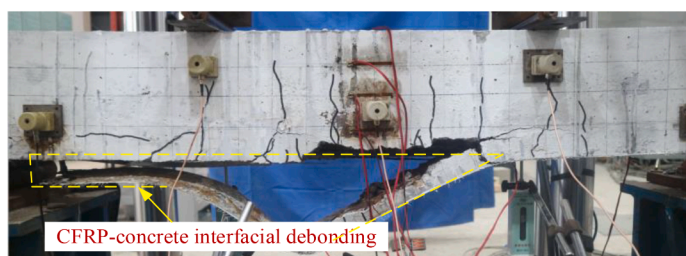
The failure modes of all nine test beams are summarized in Table 2. Photographs of typical failure mechanisms are shown in Fig. 9. The beam UU (control) and the CU (corroded unstrengthened) have similarities in crack patterns and failure modes. They failed by yielding tensile bars followed by the crushing of top concrete (referred to as "CC" for simplicity in Table 3). Large transversal cracks occurred at the constant moment zone as the load exceeded the cracking load. (see Fig. 9a). On the other hand, the failure modes of corroded beams strengthened with the CFRP anchorage system were diverse. The failure modes were affected by several factors, including the parameters of the CFRP anchor system and the corrosion-damaged degree of steel bars. To achieve a better understanding of the failure mechanism of CFRP-strengthened beams and the combined effects of accelerated corrosion and sustained loading, all distinct failure modes are explained in detail as follows.

This type of failure was reported for beam CS-5-NL, as shown in Fig. 9b. In this mode, it can observe that the concrete cover at the bottom was coming off extensively (referred to as CCS). It is worth noting that there was no debonding at the interface between the CFRP sheet and the concrete. This failure mode was more brittle than that of other strengthened beams, probably due to the fact that the corrosion cracks and flexural cracks being interlinked, causing the concrete to fall off at the bottom.

Fig. 9. Modes of failure.

As shown in Fig. 9e, this type of failure occurred in the beam with a high degree of corrosion, i.e. CS-20-HL. With increasing load, the concrete matrix at the span of the sheet/concrete interface started to crack progressively, followed by fracture of the CFRP sheet. Neither interfacial debonding nor anchors pull-out was observed during the loading process. Instead, the CFRP sheet ruptured near the loading point. This failure of mode was mainly attributed to the stress concentrations in the span of the CFRP sheet caused by the cracked concrete.

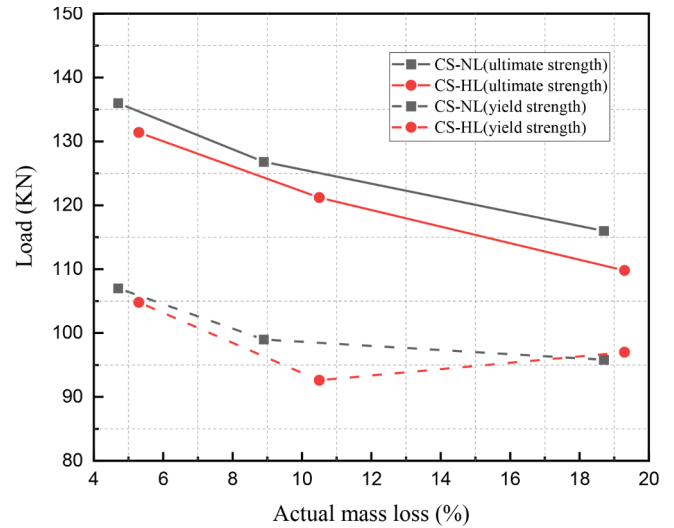
Fig. 14. Effect of sustained loading on the load capacity of strengthened beams.

Fig. 14 illustrates the influence of the sustained loading on the flexural strengths of the CFRP-strengthened RC beams. As shown in Fig. 14, the effect of corrosion on load capacity is correlated with the level of sustained loading. For group A (theoretical mass loss of 5%), beam CS-5-HL showed a decrease of 2.0% and 2.6% of the yield and ultimate strengths, respectively, in comparison to beam CS-5-NL. For Group B (theoretical mass loss of 10%), the yield and ultimate strength of CS-10-NL beams were 6.5% and 4.4% lower than those of CS-10-NL beams. For group C (theoretical mass loss of 20%), the ultimate strength of beam CS-20-HL decreased by 4.5%, while the yield strength increased by 1.3%. On the basis of these results, it can be concluded that the yield and ultimate load of the CFRP-strengthened beams with sustained loading are inferior to that of the beams without sustained loading, except for the yield capacity of beam CS-20-HL. This indicated that the accelerated corrosion process combined with sustained loading caused an adverse effect on the yielding and ultimate load of the CFRP-strengthened beams, especially in the cases of more significant corrosion damage.

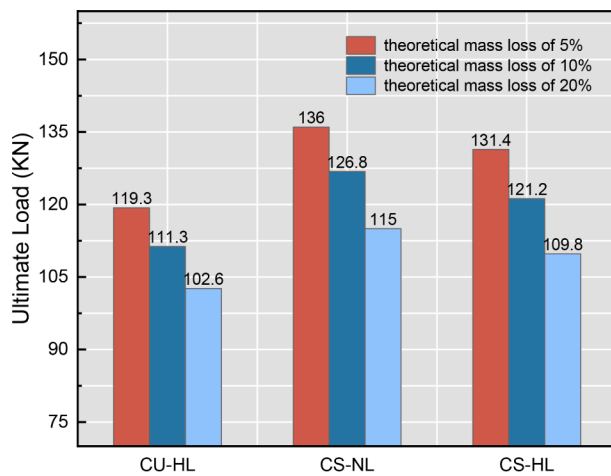
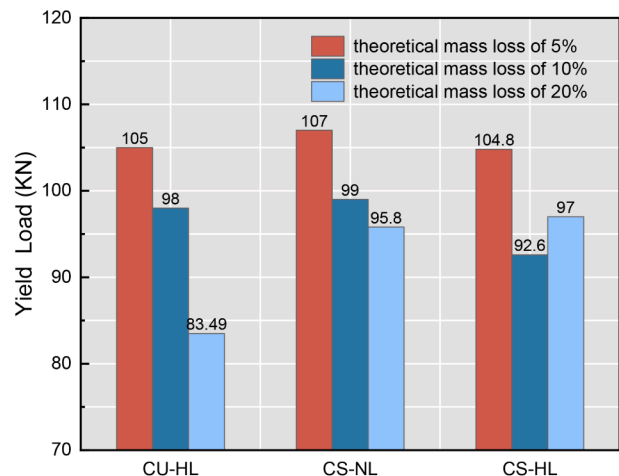
Fig. 13. Effect of corrosion damage on the load capacity of strengthened beams.

Table 3 summarizes the yield load, P_y , the ultimate load, P_u , of all beams. As shown in Fig. 13, the load capacity of corroded beams gradually decreased with an increasing corrosion ratio. The yield and ultimate loads of the unstrengthened beams (CU-5-HL, CU-10-HL, and CU-20-HL) were decreased by 3% and 4%, 7% and 8%, and 14% and 16%,

Fig. 13 shows the effect of corrosion degree on the load capacity of the reinforced beams. The use of CFRP anchor systems in beams CS-5-HL restored 92.7% and 104.8% of the yield and ultimate loads of the virgin beam, respectively. Increasing the corrosion level further decreased the yield and ultimate loads (beam CS-10-HL restored 81.9% and 96.7%, and beam CS-20-HL restored 85.8% and 87.6% of the yield and ultimate loads, respectively). Nevertheless, the change in strength was not linearly proportional to the degree of corrosion. Also, all the CFRP-strengthened beams exhibited a yield strength of 95.8 kN to 107 kN were well below the control, and the change was not significant. It was also attributed that the CFRP anchorage system significantly increased the stiffness of the corroded beam, which is mainly determined by the CFRP anchorage system.

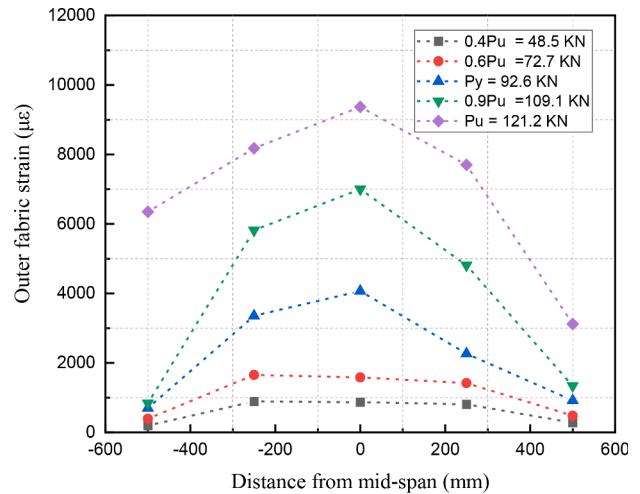
Fig. 17. The outer fabric tensile strain distributions on the CFRP sheet.

Fig. 17 shows the outer fabric tensile strains distributions on CFRP sheet along the bond length at different loads for beams CS-5-HL, CS-10-HL, CS-20-HL. The horizontal coordinate represents the distance between the strain gauge and the mid-span, while the vertical coordinate represents the strain value. In the initial stage, the strains of beams strengthened with the CFRP anchorage system was essentially the same as those in the unreinforced beams before concrete cracking. Only the first and second strain gauges near the mid-span generated strain values. Also, the first strain gauge, which was closest to the mid-span, had a substantially higher value than the second strain gauge. Then the concrete began to crack when the tensile strain of concrete in the tensile zone exceeded the ultimate tensile strain. The tension at the crack was shared between the tensioned reinforcement and the CFRP fabric, leading to an increase in the strain growth rate. After yielding of the reinforcement, its stress stayed increased at a low rate and the strain of the CFRP sheet continued to increase at a high rate due to the fact that the additional tension applied to it during fracture was mainly carried by the CFRP anchorage system. With the external load further increasing, interfacial debonding occurred near the mid-span as the tensile stress in the interface approached the interfacial strength. Interfacial stresses were redistributed, and the distal strain reached a maximum, followed by the CFRP anchorage system breaking down.
