## The Paintwork and the Colours of the Exterior

van Thoor, M.-T. (2019). The Paintwork and the Colours of the Exterior. In M.-T. van Thoor (Ed.), *Colour, Form and Space: Rietveld Schröder House Challenging the Future* (pp. 22-33). Delft University of Technology.

# 2 / THE PAINTWORK AND THE COLOURS OF THE EXTERIOR

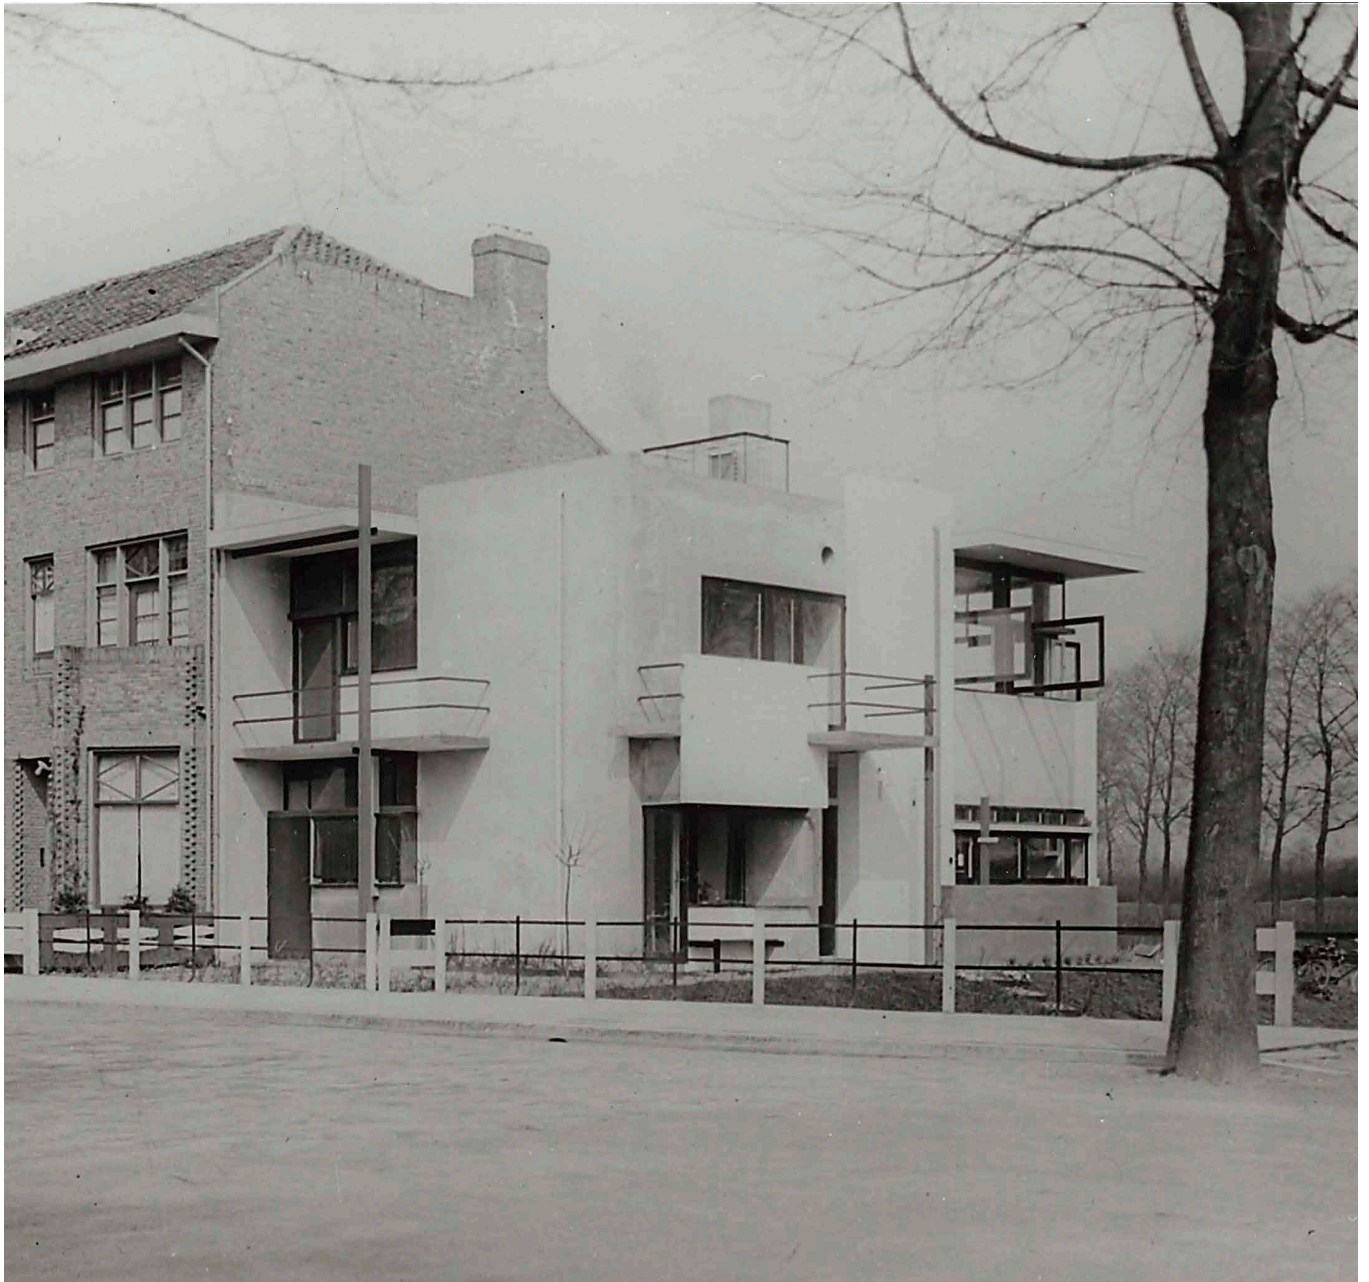
FIG. 2.1 One of the earliest photographs of the Schröder House, c. 1925

In the very first photographs taken directly or not long after construction, it is possible to see that various wall surfaces, as Truus Schröder had recalled, look very spotty [FIG. 2.1]. Apart from the spots, the photographs reveal that the walls were painted in white and shades of grey. But these images do not allow the number of greys to be ascertained – maybe four, maybe five. Looking at the photos from the next decade, there appear to be differences in the composition of the white and grey values of the various surfaces, but it may simply be a case of differences in nuance.

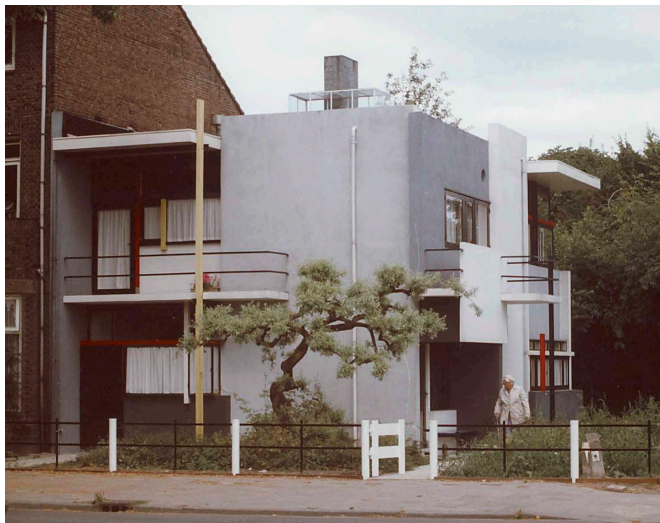
FIG. 2.6 The house in spring 1975, about a year after the first treatment of the exterior

According to Veroude's 1970 technical report, mentioned in the previous chapter, all existing coats of paint on walls, woodwork and steel were to be removed before the restoration. Before repainting, samples were to be taken, which would then be used as a guide to the new colours.<sup>15</sup> Mulder asked the TNO's Paint Research Institute whether it would be possible to separate successive coats of paint so as to reveal the colour of each coat. That would be no problem at all, TNO replied.<sup>16</sup> When the restoration was in full swing Mulder promised the foundation's board 'photos, specimens, colour samples and other relevant information' [FIG. 2.6].<sup>17</sup>

blue. Mrs Schröder recalled that when she first met Rietveld, many people considered black obtrusive, but according to Rietveld black actually receded into the background. He used it for elements – like door and window frames – that were not intended to obtrude, with the result that everything appears to be in the same plane and the composition is emphasized [FIG. 2.6/2.10].<sup>25</sup>

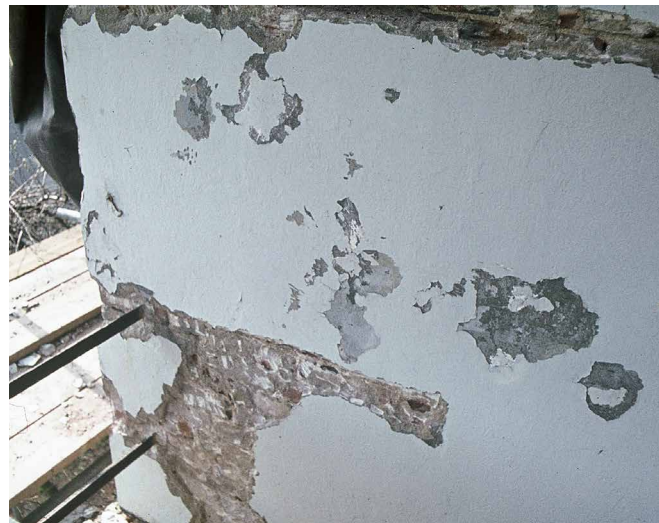
FIG. 2.7 In various places, such as the chimney, B. Mulder found still more finish coats and colours that he could include in his colour research

Despite the fact that the Schröder House had been regularly repainted (possibly as many as ten times), and colour coats had been removed on previous occasions, old paint was evidently still to be found in certain places, such as behind the prickly ivy or on the chimney [FIG. 2.7].<sup>18</sup> Mulder included these remnants in his colour research, and investigated their composition [FIG. 2.8].<sup>19</sup> Once the restoration was finished he threw the samples away.

Upon inquiry Mulder turned out to have yet more information in the form of a series of slides and a set of colour samples.<sup>20</sup> Detail photos of the chimney show various finish coats and it appears possible to distinguish several colours. Even more interesting is a photo of the wall below the kitchen window in the east elevation [FIG. 2.9]. We can see various shades of grey, from light to dark, and between them the white of a base coat. Mulder's caption reads: 'I opted for a dark grey from top right corner.'<sup>21</sup> This is one of the wall surfaces that were not repaired and on which the original plaster is still present, according to Mulder. Nevertheless, we are left guessing about the dates of these grey coats because there is simply no further documentation and also because references to other wall surfaces are lacking. The layers of paint on the walls, which were entirely stripped in 1979, were removed together with the old layers of render.

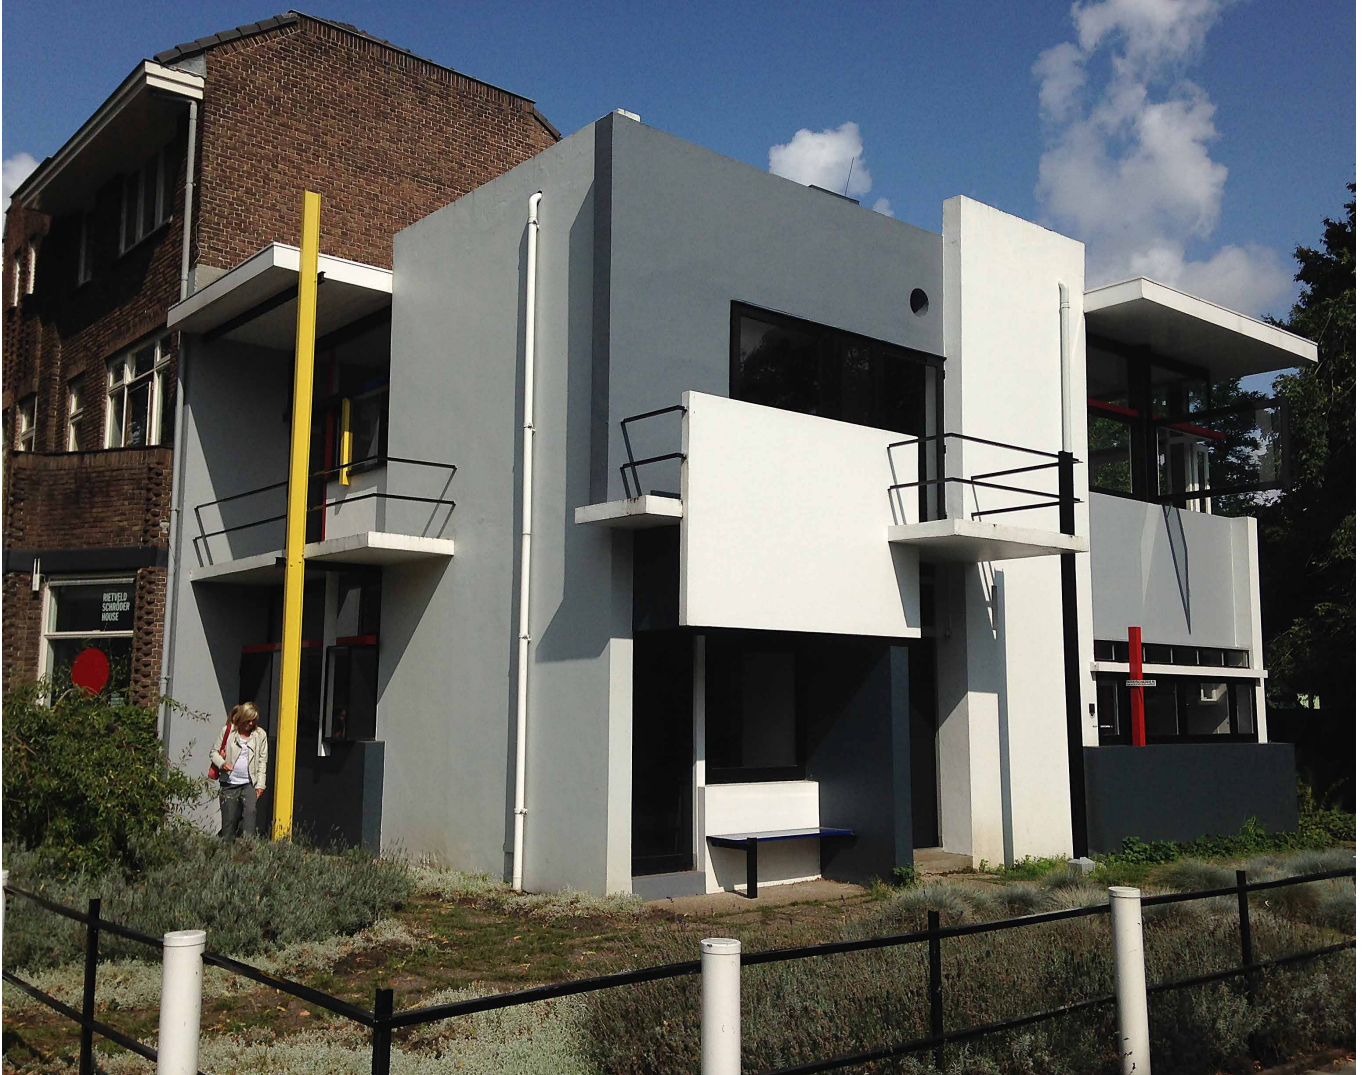
FIG. 2.10 The Rietveld Schröder House in 2017

Currently, the walls display not three, four or six, but five shades of grey, because that is what Mulder says he found during his on-site inspection [FIG. 2.10]. In consultation with the foundation he opted to return to the colour composition of the initial period. With that frame of reference, which involved mixing the greys on site with the painter, he made a composition with five greys (photo on page 22). For the record, Mulder said that making the different shades of grey was the most difficult part of the entire restoration and occasionally even drove him ‘to despair’.<sup>26</sup>
