An Overview

Overflow Tests on Grass-Covered Embankments at the Living Lab Hedwige-Prosperpolder: An Overview

Abstract: In regions with a temperate climate, a well-maintained grass sod on a clay layer is considered a reliable protection for dams and dikes. In the Living Lab Hedwige-Prosperpolder, on the left bank of the Scheldt river straddling the border between Belgium and the Netherlands, a series of 27 overflow tests with a purpose-built overflow generator has been executed to determine the strength of the protective layer against erosion at various conditions. The goal of this paper is to inform on the executed test program and the initial results. From the results, it was concluded that in general, a high-quality grass cover on the landside dike slope can withstand high overflow discharges well for 12 to 30 h, without severe erosion damage. Anomalies, such as the presence of animal burrows, reed vegetation, and already present deformations can strongly reduce the resistance of the cover layer and may lead to failure within a couple of hours.

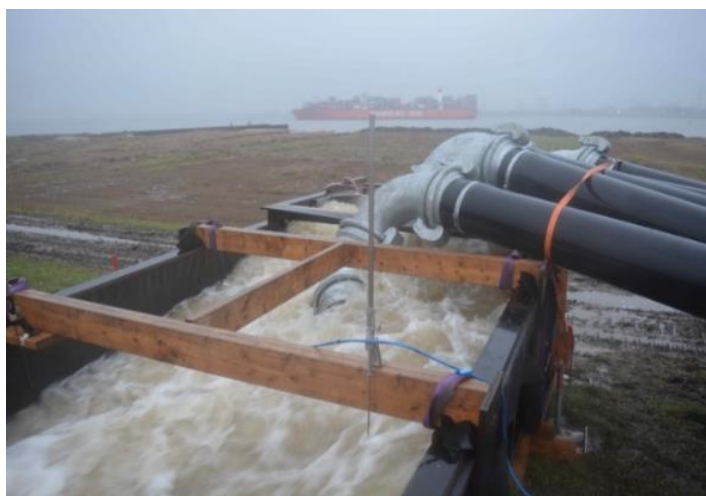
Figure 3. (a) Overflow in progress; (b) Overflow generator at maximum discharge of 1100 L/s.

The flow canal used for directing the water flow over the grass cover of the dike was 2 m wide. At the crest of the dike it was connected to the overflow generator. Both sides of the flow canal were made of coated hardboard plates of $2 \times 0.7 \times 0.01$ m. The plates were hammered and sliced into the ground to a depth varying between 7 and 15 cm deep. The plates were screwed to wooden poles of a size of approximately 0.1–0.1–1.0 m with one pointed end. The poles were hammered into the ground to a depth of approximately 0.2–0.3 m. Figure 3a shows a typical flow canal that was realized on virtually every test section during the overflow experiment. Figure 3b shows the uppermost part at the maximum discharge.

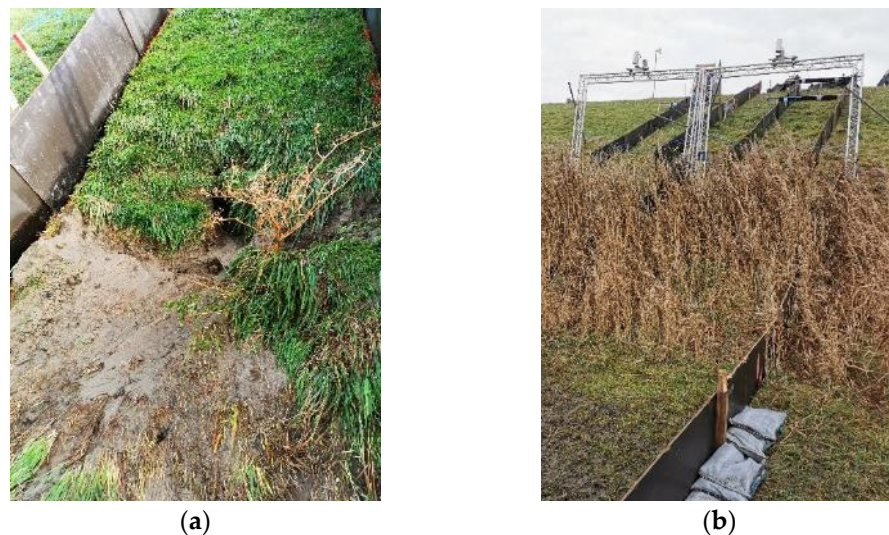
Figure 8. (a) Burrow entrance halfway the landside slope on a Dutch dike; (b) Sections with softened, saturated soil and reed overgrowth on a Dutch dike.

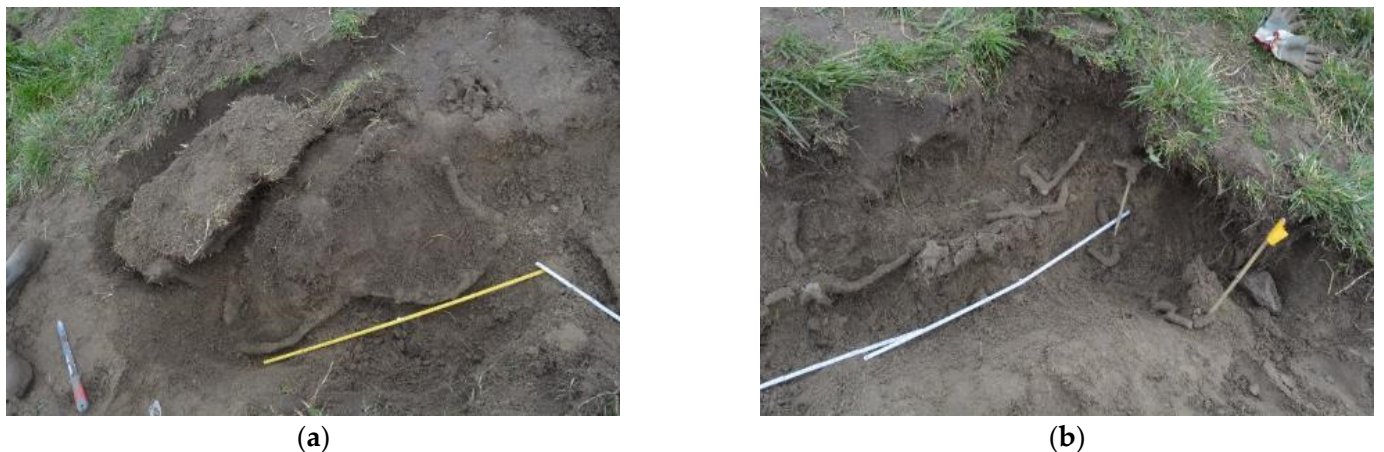
Figure 10. (a,b) Examples of excavated grouted animal burrows.

To learn more about the structure, dimensions and depth of animal burrows, some burrow systems were filled with grout and exposed (Figure 10). These activities led to an increased understanding of the processes at hand [16,18]. The critical factor in the damage to develop appears to be whether the burrows are in contact with the sand core and whether sand can be mobilized from within the core and exported to the outside of the dike. The requirements for this seems to be (1) a burrow system that is connected over meters to decameters distances; (2) a burrow system that reaches deep enough so that the dike clay cover is pierced and contact with the sand is made; (3) a flow of water through the burrow system is generated by the overflow process so that core sands are mobilized. Surprisingly, the artificially made holes, supposed to resemble animal burrows, were generally better resistant to flow, even if they were clearly connected to the sand core, with both an entry pipe and an exit pipe. In test B-11 for instance, the artificial hole was the very last part to collapse.
