Effect of Unit-Cell Size on the Barely Visible Impact Damage in Woven Composites

Applied Sciences

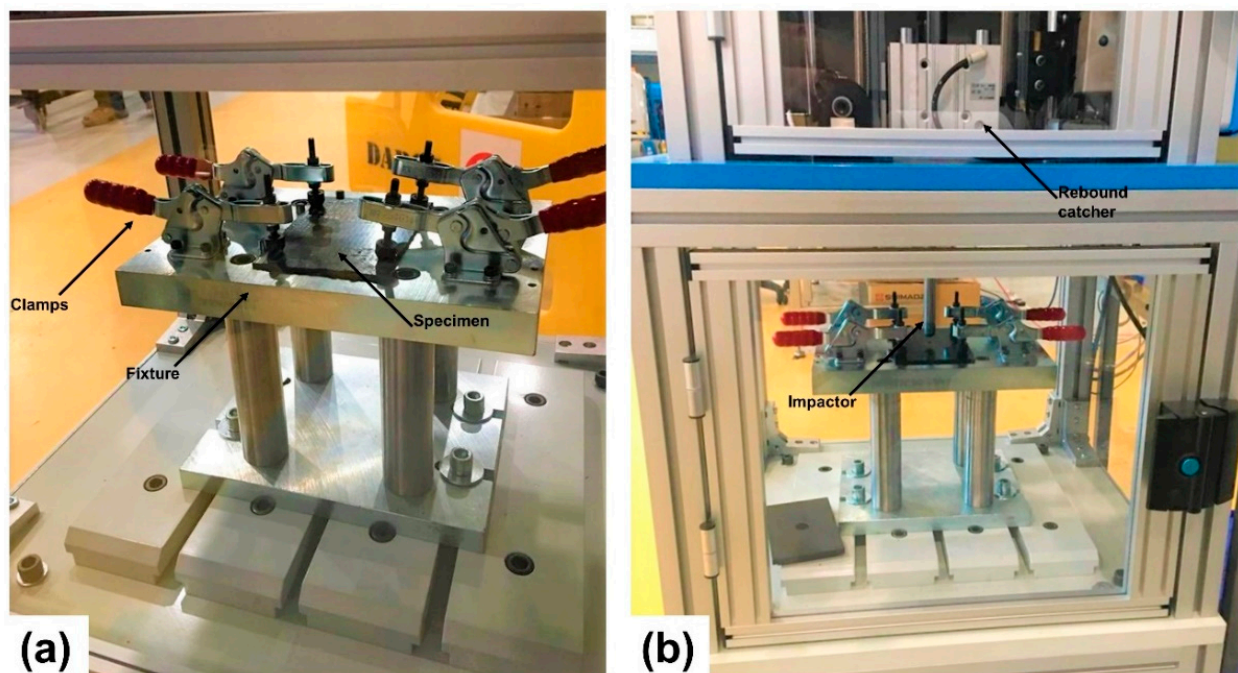
Figure 2. Testing setup (a) before and (b) after impact.

Using a drop-weight impact tester (IMIC-15) from Imatek Ltd. UK, impact testing for all specimens, 3 repeats per architecture, was carried out as per the ASTM D7136 [27] standard. The SI Units version of the standard was used. The clamping fixture of the specimens, according to the ASTM standard, should have a cut-out with an area of 125×75 mm². All specimens were secured with four clamps to ensure they were fully restrained during the impact test (see Figure 2). A 16 mm diameter hemispherical impactor with a mass of approximately 6.7 kg was used to impact all the specimens in the centre. To avoid puncture of the specimens due to impact, initial trials were conducted with 15 , 18 , 20 and 25 J. The 15 J energy level was then chosen as the weakest architecture. “NCF” could not survive the higher energy levels. The force, velocity and displacement as a function of time were recorded during the testing. In addition, the drop-weight tower was equipped with a rebound catcher to ensure that the striker would only hit the specimen once and no damage accumulation due to multiple repeated impacts would occur.

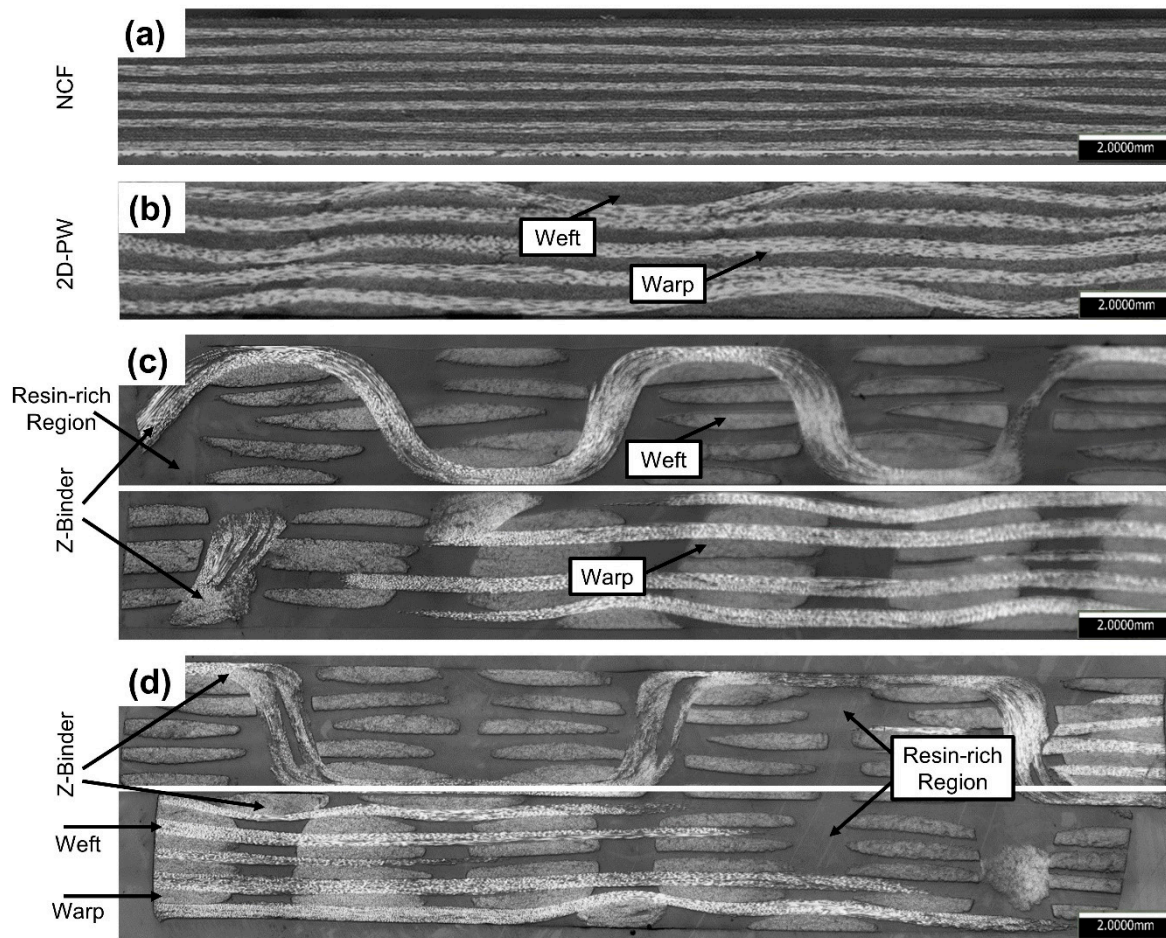
Figure 3. Optical micrographs of composites cross-sections: (a) NCF, (b) 2D-PW, (c) ORT-PW and (d) ORT-TW. For ORT-PW and ORT-TW architectures, two micrographs were captured: along the warp (top image) and along the weft (bottom image).

Images of the optical cross-sections were obtained for all architectures, namely: NCF, 2D-PW, ORT-PW and ORT-TW (see Figure 3). In the case of NCF (Figure 3a) and 2D-PW (Figure 3b), one cross-sectional image is shown for each along the warp direction. However, for the ORT-PW and ORT-TW, in order to fully inspect the microstructure of these complex architectures, micrographs are taken along both the warp and weft directions. All the optical cross-sectional images show no trace of voids in the microstructure, confirming the quality of the infusion process. The NCF specimen is characterised by straight yarns with minimal crimp as opposed to the 2D-PW and the 3D woven architectures. Moreover, as expected, due to the infusion process and compaction of the 3D preforms, some geometrical distortions of the cured laminates can be observed. This is even more significant in ORT-PW when it comes to the weft yarns being staggered (see Figure 3a). It is also observed in the nonuniform thickness of the z-binding yarns in the ORT-TW case (see Figure 3b), especially at the interlacement locations with the weft yarns. Clearly, the optical images confirm that all the manufactured specimens are void-free. However, the existence of the z-binding yarns resulted in relatively large resin-rich regions in the cured laminates, which is one of the well-known drawbacks of 3D woven composites. In addition, it is clear that in the case of ORT-PW architecture, the frequency and undulation of z-binding is higher than that of ORT-TW confirming that the ORT-TW is less crimped.

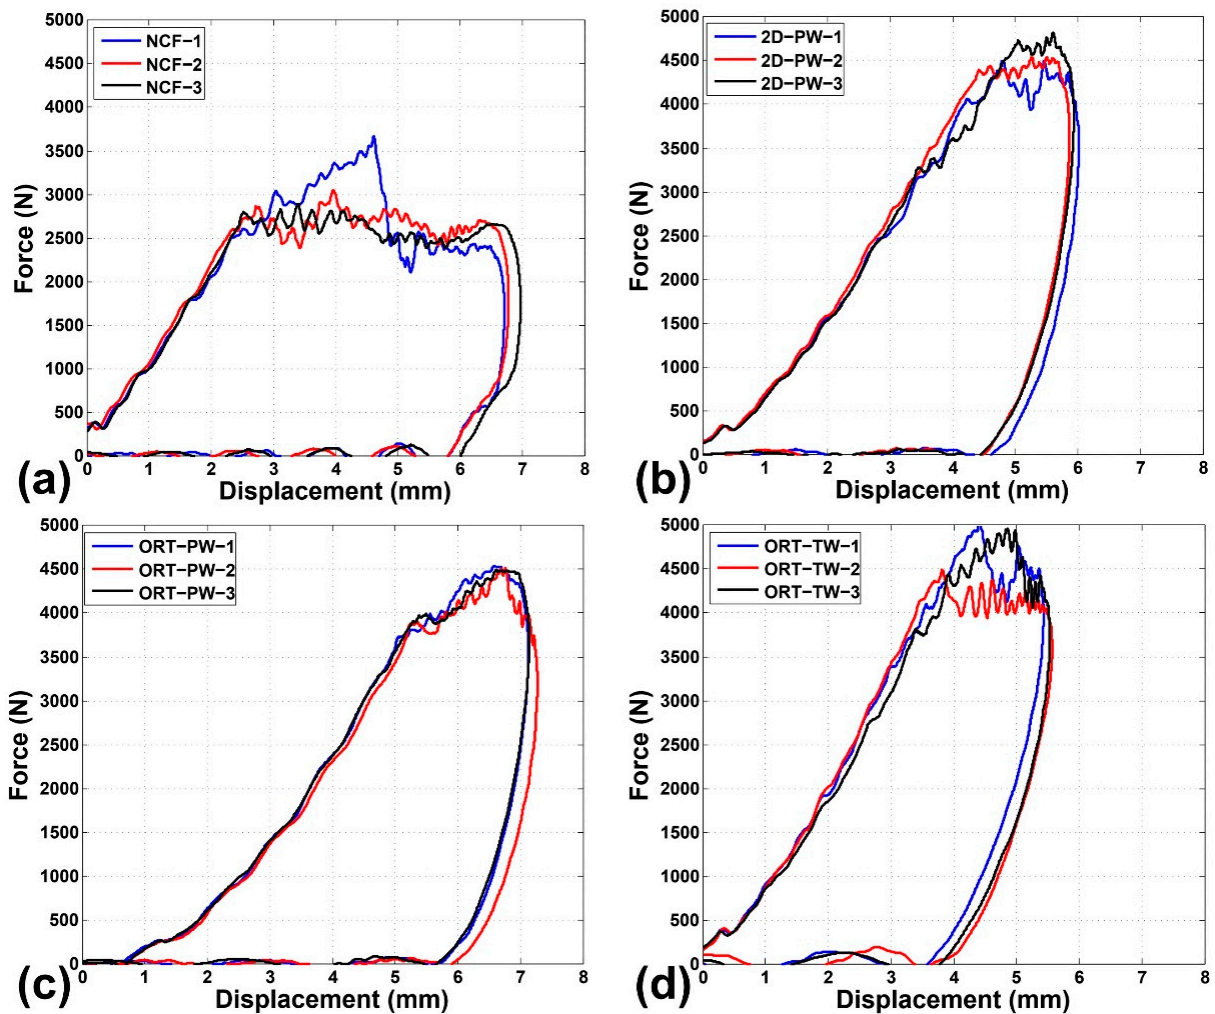
Figure 4. Impact force–displacement curves for the impacted specimens: (a) NCF, (b) 2D-PW, (c) ORT-PW and (d) ORT-TW.

The impact force–displacement curves of the four impacted architectures are depicted in Figure 4. The displacement was calculated by numerically integrating the acceleration (the impact force divided by the mass of the impactor) as a function of time. The reproducibility of the test results and the repeatability of the impact response are confirmed by the small experimental scatter in all cases. In an impact test, the force increases linearly as a function of the displacement/time up to a maximum value when the impactor velocity changes direction. This can be accompanied by damage occurrence in the specimen, in the form of a sudden drop in the force. Afterwards, the force gradually decreases to zero and the impactor returns back to zero displacement. The stiffness of the specimen can be calculated as the slope of the initial linear segment of the force–displacement curve. A clear difference is noticed among the architectures in the sense that the NCF specimens experience the least maximum force of approximately 2500 N while all the other remaining architectures (2D-PW, ORT-PW and ORT-TW) have almost the same range of maximum force ~4500 N. However, the calculated stiffness of all the architectures is comparable (NCF: 954 ± 50 , 2D-PW: 966 ± 29 , ORT-PW: 963 ± 14 and ORT-TW: 1075 ± 70 N/mm). This suggests that the crimp and undulation in the 2D and 3D woven architectures have a negligible effect on the stiffness of the impacted specimens.

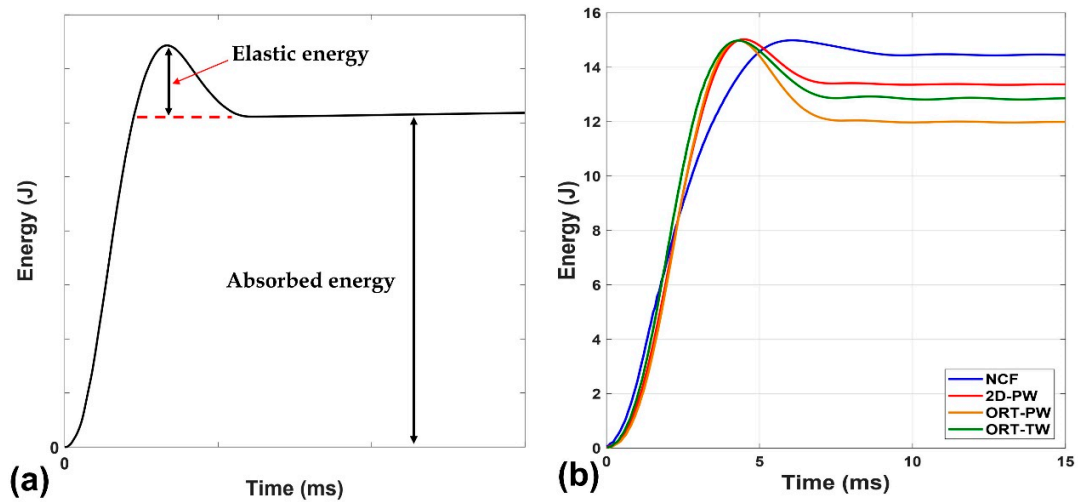
Figure 5. Energy versus time: (a) schematic explaining the elastic and absorbed component and (b) representative sample for each architecture.

In an impact test, the majority of the energy is absorbed by the impacted specimen in the form of permanent induced damage while the remaining part of the energy is stored in the form of elastic energy due to the specimen deformation. As a function of time, the energy can be calculated by numerically integrating the area below the impact force–displacement curve. Figure 5a depicts a representative energy vs. time impact curve [29]. This curve clearly differentiates the elastic component of the energy from the absorbed energy component by the asymptotic dashed line shown (see Figure 5a). The higher the absorbed energy, the larger the damage induced in the specimen due to impact. When applying this principle on the comparison among the four tested architectures in this study (see Figure 5b), it is found that the NCF architecture absorbs the highest energy followed by the 2D-PW, then ORT-TW and finally the ORT-PW. This suggests that the induced damage size should be expected to follow the same pattern. This can be supported by the ultrasonic C-scanning results as well as the damage quantification using the X-ray CT data.

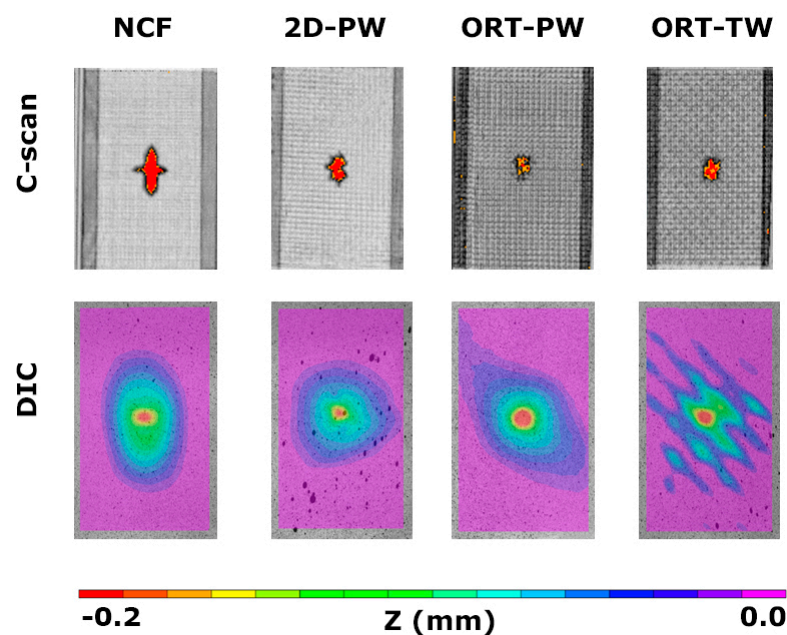
Figure 6. C-scanning and digital image correlation (DIC) results for the impacted specimens.

After all the specimens were impacted, the ultrasonic C-scanning was used to have a better idea of the level of the internal induced damage. A representative C-scan of each architecture is shown in Figure 6. Just by visual inspection, it was difficult to spot the difference among all the different architectures as the impact was a BVID; however, thanks to the C-scans, a clear distinction can be made. Before even calculating the size of the damaged area, it is obvious that the shape of the induced damage is dependent on the architecture. For the NCF case, which has the minimum waviness among all the tested architectures, the shape of the damage induced is characterised by a cross ($0^\circ/90^\circ$) shape. This can be attributed to the fact that, due to impact loading, splitting occurs in the 0° plies, which have longer floats as opposed to the 90° counterparts [29]. Moving on to the 2D-PW case, this cross shape almost disappears with a relatively smaller damage region, but still, it is larger compared to the 3D woven architectures. For both ORT-TW and ORT-PW, the damage size is smaller but still, the ORT-PW demonstrates the smallest induced damage region.

Impact damage resistance is generally evaluated in light of the size of induced damage and the energy absorption. The comparison among all the architectures using these two parameters should help in understanding the effect of the fabric/composite architecture. Therefore, the size of the induced damage was calculated using MATLAB image segmenting tool for all the architectures using the C-scan images. Table 1 summarises the percentage of the damaged area normalised by the total area of the specimen. It is clear that the NCF architecture experienced the largest damage due to impact followed by the 2D-PW. When it comes to the 3D woven architectures, although both architectures experienced less damage as opposed to the NCF, a significant difference is observed between the ORT-PW and the ORT-TW specimens. The induced damage in the case of ORT-TW is almost 1.5 times the damage in the case of the ORT-PW, which clearly highlights the effect of the z-binding yarns frequency or in other words, the unit-cell size of the weave on the impact resistance of the woven composites. This is very much in line with observations, previously reported in [30–35], explaining the role of the z-binding yarns in resisting delamination propagation in 3D woven composites for different loading conditions. The z-binding yarns' path effect is further discussed in this study using the X-ray CT ortho-slices. When it comes to energy absorption, the results confirm the findings obtained from the C-scan images. The NCF architecture which experienced the largest damage absorbed approximately 1 and 2 more Joules compared to the 2D-PW counterpart and the two 3D woven architectures, respectively. In the case of the 3D woven architectures, despite the comparable energy absorption of both the ORT-PW and ORT-TW, the damage is less severe in the former.

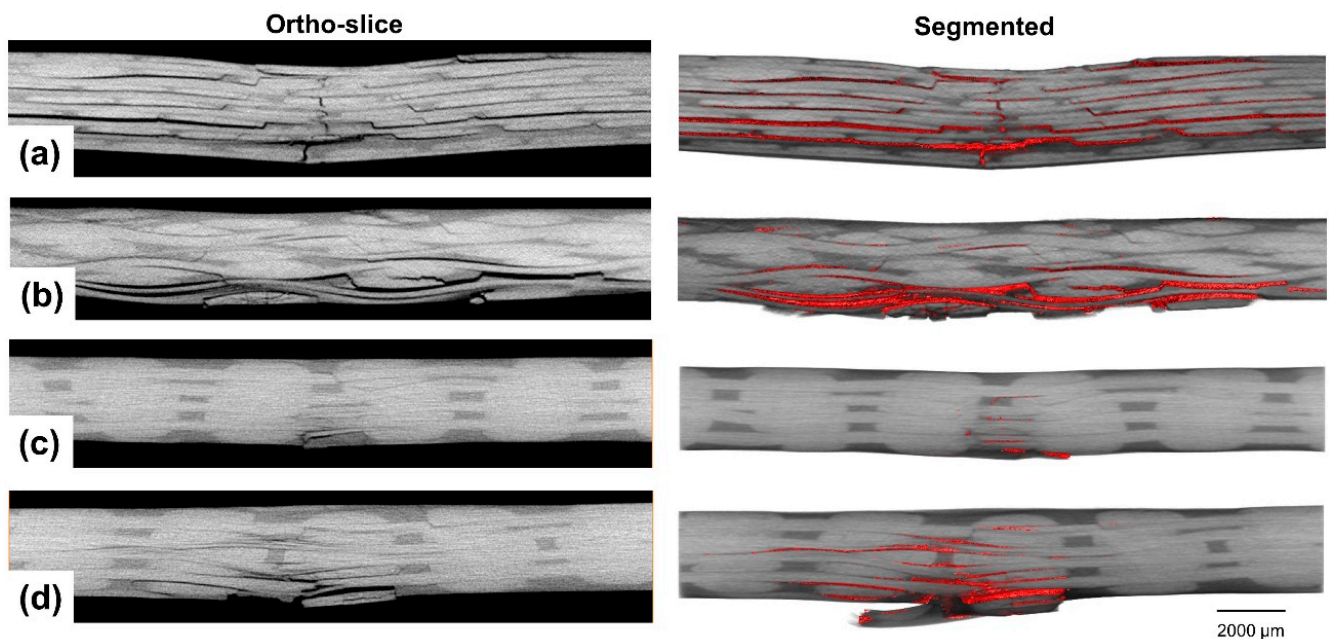
Figure 8. Ortho-slices and segmented damage highlighted in red in locations where there are no binding yarns (the top is the front side of the impact and the bottom is the backside) for: (a) NCF, (b) 2D-PW, (c) ORT-PW and (d) ORT-TW.

In locations where no z-binding yarns exist (see Figure 8), The dominant damage mechanisms represent the typical damage mechanisms due to low-velocity impact [37]: matrix cracking (due to shear and bending stresses), delamination (because of the large out-of-plane deformation and interlaminar shear) and localised fibres/yarns breakage (directly beneath the impactor at the front side and tensile failure at the backside due to bending). The severity of each damage mechanism differs from one architecture to the other. In the case of the NCF specimen (see Figure 8a), interlaminar delamination between all the adjacent plies, extending from the impact location, is very obvious as well as surface plies splitting. This is also accompanied by extensive matrix cracking and fibre/yarn breakage especially at the backside of the specimen, away from the impact location in the thickness direction. The interlaminar delamination, however, in the case of the woven architectures (2D-PW, ORT-PW and ORT-TW), is guided by the waviness of each architecture. The severity of the damage beneath the impact location at the front side is very minimal compared to the damage experienced at the backside. Tensile matrix cracking and fibre/yarn breakage are dominant especially in the 2D-PW (Figure 8b) and ORT-TW (Figure 8d) specimens. Moreover, this type of damage is much localised in the ORT-TW case, which could explain the reason why the dent depth previously measured in Section 4.2.2 using the DIC was found to be the largest. By visual inspection of the damage size among all the architectures in these locations, it is clear that the ORT-PW (Figure 8c) experiences the least damage, but this should be also confirmed in other planes as well as the 3D reconstructed volume as discussed later.

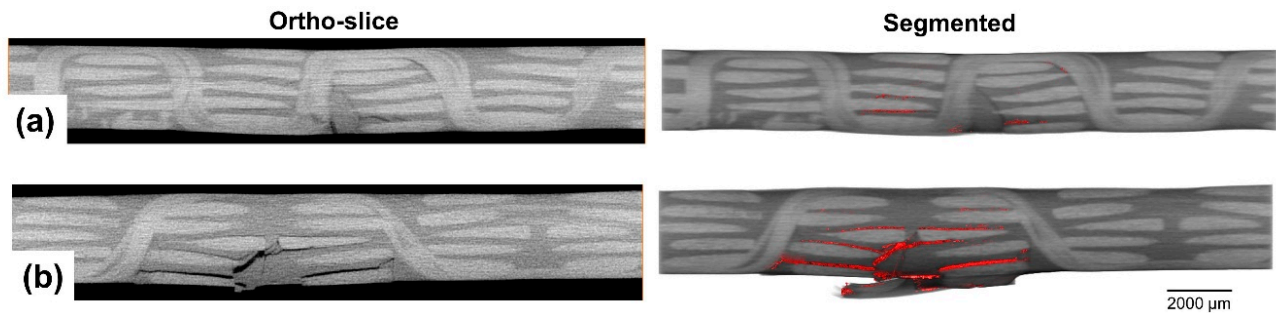
Figure 9. Ortho-slices and segmented damage highlighted in red in locations where there exist binding yarns in the 3D woven composites (the top is the front side of the impact and the bottom is the backside) for: (a) ORT-PW and (b) ORT-TW.

Moving on to locations where z-binding yarns exist (see Figure 9), a comparison can be made between the two 3D woven architectures, the ORT-PW and ORT-TW. Although the aforementioned dominant damage mechanisms (matrix cracking, delamination and fibre/yarn failure) are still the same, it is very obvious that the size of them is much smaller in the planes where the z-binding yarns exist. Again, most of the damage occurs at the backside, which is typical for low-velocity impact damage. Nevertheless, the unit-cell size effect is very significant. In the case of the ORT-PW (Figure 9a), the frequency of the z-binding yarns is double the frequency of the ORT-TW (Figure 9b) counterpart. In other

words, the unit-cell size of the ORT-PW is half of the ORT-TW. This enables the ORT-PW architecture to resist the induced impact damage more than the ORT-TW. In both cases, the z-binding yarns act as crack/delamination stoppers, hence delamination or matrix cracking grows as long as it is not arrested by any z-binding yarn. This results in longer delamination and larger damage size in the case of the ORT-TW as opposed to the ORT-PW architecture.

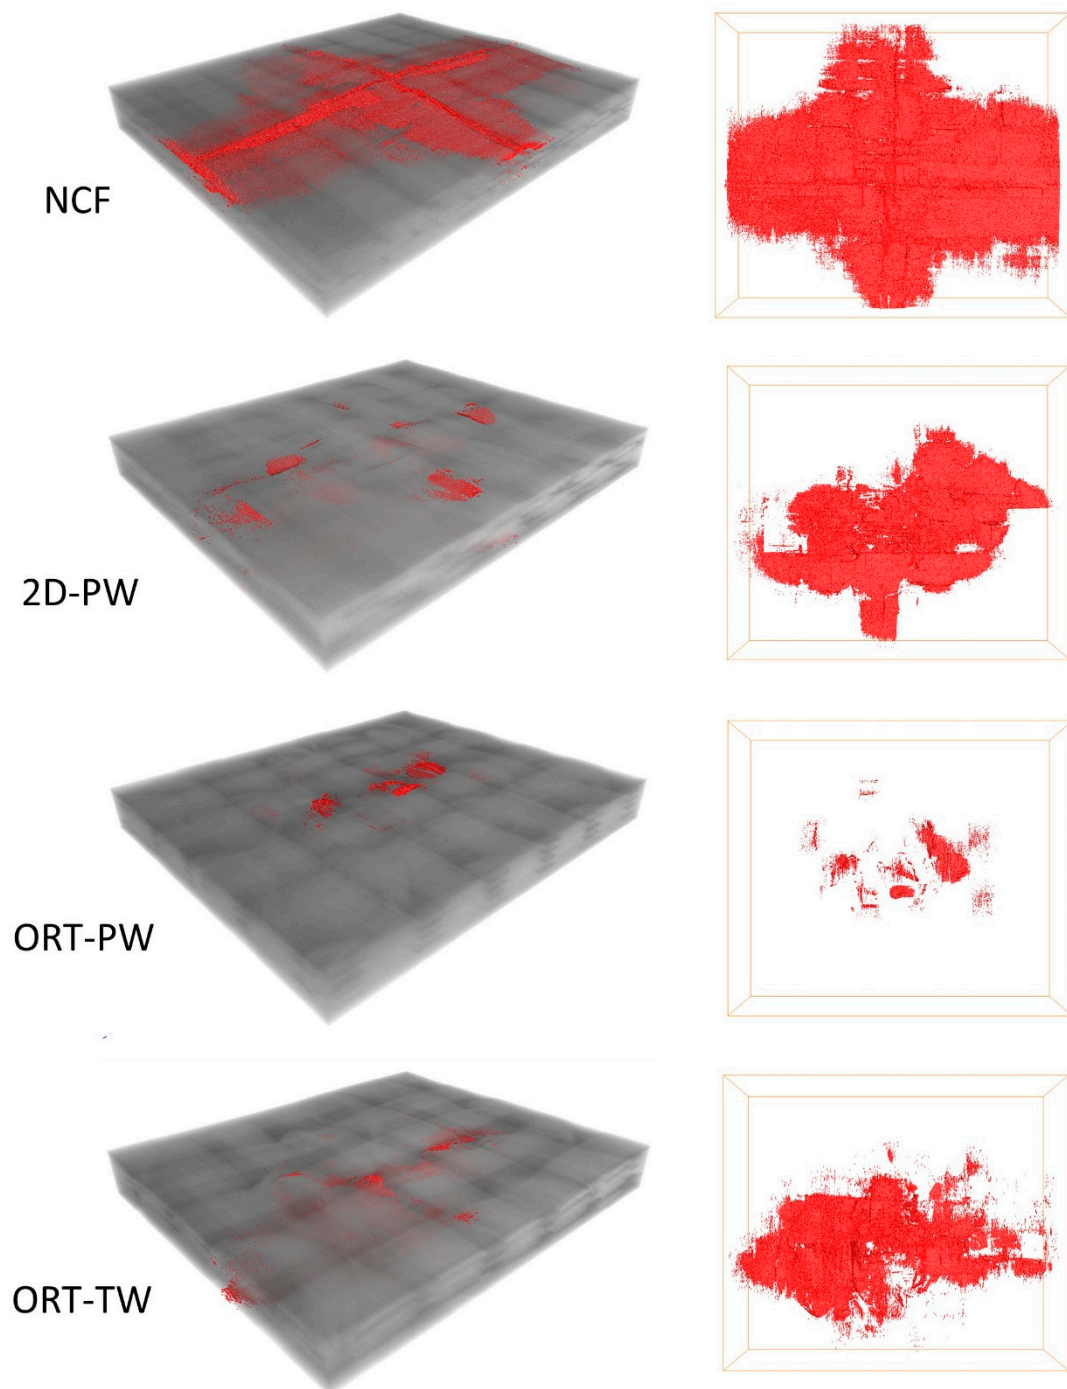
Figure 10. 3D X-ray CT reconstructed volume with the segmentation of damage due to impact highlighted in red (left) and 2D top view (right).

So far the discussion and comparison have been made only based on 2D planar data. To confirm the findings in 3D space, volume reconstruction and segmentation are inevitable. Here, the 3D morphology and distribution of interyarn impact damage are of interest and simple automatic thresholding could not fit this purpose. Thus, a routine was developed to segment interyarn damage (mostly in-plane but may deviate when z-binding yarns exist) in a reliable and repeatable way across different structures. The full composite volume was firstly segmented out to define the region-of-interest for further image processing. This was followed by applying the top-hat segmentation tool to the composite volume. Line kernels sized 40 lying in-plane were used as seeds to extract black features (in this case, the impact image) and the masking range of 48–255 was selected. The selected damage volume was then denoised by removing all isolated islands smaller than 5 voxels in 3D to provide the final segmented interyarn damage volume for all types of architectures as shown in Figure 10.

The damage volume fraction (see Table 2) was calculated by dividing the volume of the segmented impact damage by the analysed image volume (width ~ 19 mm \times height ~ 22 mm \times thickness) of the composite panel before impact. It is clear from the comparison that the same trend observed from the C-scan results is prevailing. The NCF architecture experiences the maximum damage due to the single impact followed by the 2D-PW. Both 3D woven architectures experience less damage with the ORT-PW having the least damage volume fraction. This demonstrates first the effect of the z-binding yarns in resisting the induced damage due to out-of-plane loading compared to laminated and 2D woven composites. Second, the frequency of the z-binding yarns through the thickness also has a noticeable effect on the damage resistance. The higher the z-binding yarns' density, as in the ORT-PW case, directly translates into less damage volume fraction compared to the ORT-TW.
