# THE RISE AND FALL OF WINKELCENTRUM SCHALKWIJK

Delft University of Technology

Thesis  
AR1A066

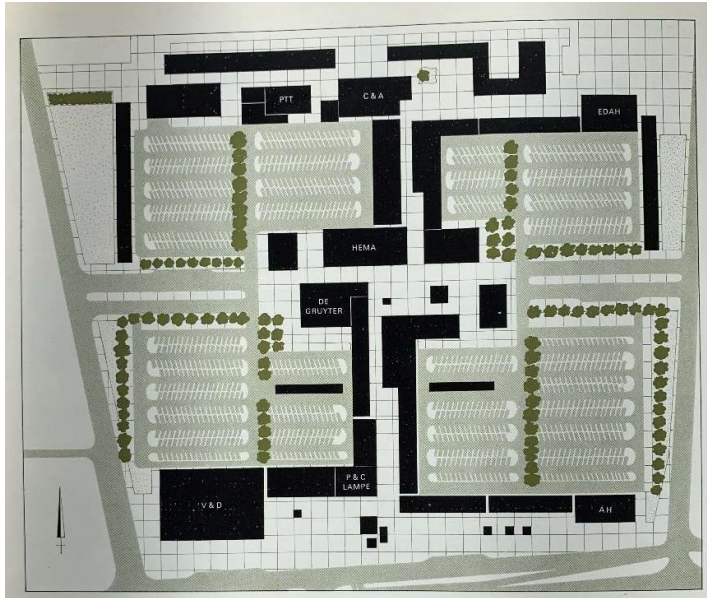
Fig. 1.4 Diagram illustrates the positioning of popular stores in the shopping mall (Amsterdam: Raad voor het Grootwinkelbedrijf, 1970)

According to the Raad voor het Grootwinkelbedrijf (1970), large and popular stores, such as department stores and large clothing brands, should be evenly distributed throughout the mall to create a field of tension. In cases where such big names are lacking, supermarkets should be positioned near the borders of the mall. Smaller establishments can then fill in the gaps between these larger stores.

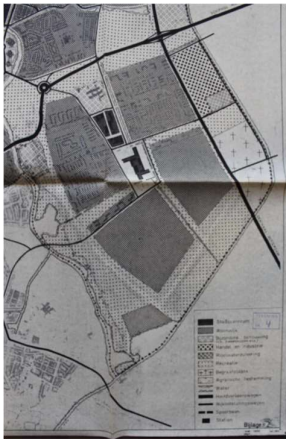
Fig. 2.1 Structuurplan Haarlem 1962

Following the Second World War, the city of Haarlem faced severe challenges in accommodating its growing residential population. In response, the municipal administration formulated the "structure plan Haarlem 1962," which identified Schalkwijk as the sole viable option for expansion, given that the surrounding natural areas, such as the dunes, are protected.

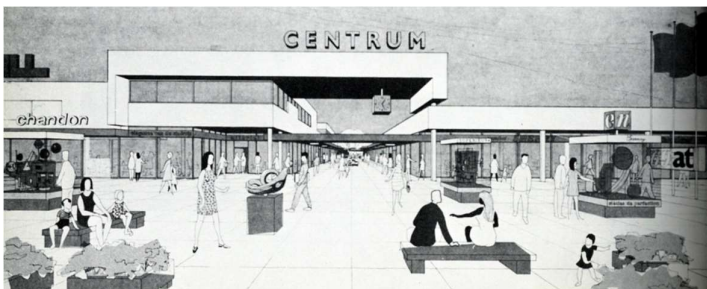
Fig. 2.2 Impression, one of the entrances of the mall (circa 1970. Illustratie uit Blijsta, p.248)

Winkelcentrum Schalkwijk, designed by the architecture firm Spruit, was intended to be subservient to the city center of Haarlem, in keeping with the prevailing philosophy of the "detailhandelsapparaat." This approach aimed to ensure that the shopping mall would not compete with the established commercial centre of Haarlem. To facilitate future growth or contraction of the shops, the shopping mall was designed with a flexible layout. Notably, the mall's architecture is characterized by a restrained modernism that emphasizes a minimalist aesthetic.

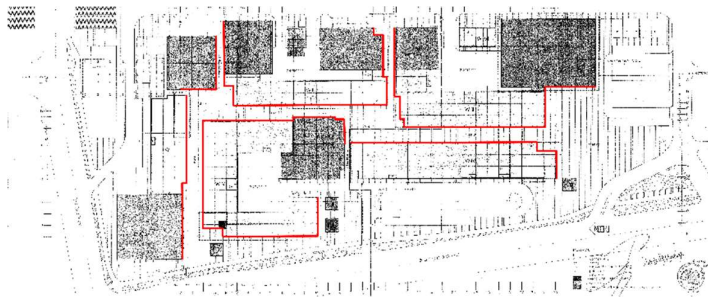
Fig. 2.9 Winkelcentrum Schalkwijk storefronts indicated in red (own illustration)

In accordance with the checklist, the presence of two-sided shopping is a crucial point. The layout of Winkelcentrum Schalkwijk, as depicted in the illustration below, demonstrates that there is a two-sided passage present throughout the entire mall. Notably, the mall's design has no blind walls, thanks to the implementation of a grid structure(kolomstructuur) that allows for all facades to be transparent and open. Additionally, the supply areas are hidden from visitors in designated service areas known as "diensthoven". The numeric requirements of this criterion are adequately met by Winkelcentrum Schalkwijk, with a maximum walking distance of 300 metres being specified. Upon measuring the mall's archival drawing from its outermost point to the other end, a total of 350 metres is obtained. The checklist also mandates a passage width of 8 to 12 metres, and the majority of the passages in Winkelcentrum Schalkwijk are 10 metres wide.

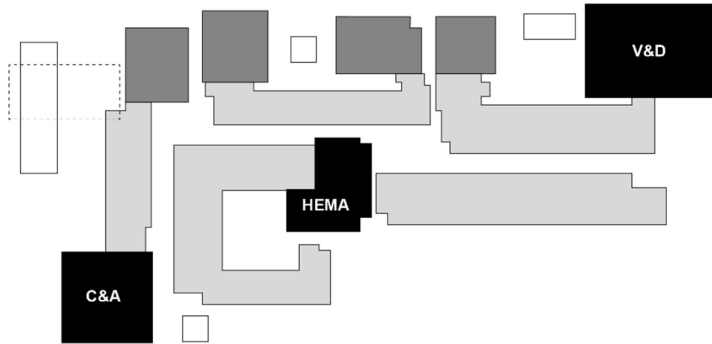
Fig. 2.10 Winkelcentrum Schalkwijk anchor stores in black, Optanol anchor stores in dark grey, regular stores light grey (own illustration)

Concerning store placement, Winkelcentrum Schalkwijk has demonstrated a commendable adherence to the checklist guidelines. The mall features three prominent stores; C&A, Hema, and V&D, which have been strategically positioned on the two outer ends and one in the middle, as illustrated below. Additionally, sizable stores are located in close proximity to the entrances on the upper sides, while smaller establishments are situated in between the popular stores and entrances. This layout aligns favorably with the recommendations set forth by the 'Raad voor Grootwinkelbedrijf'.

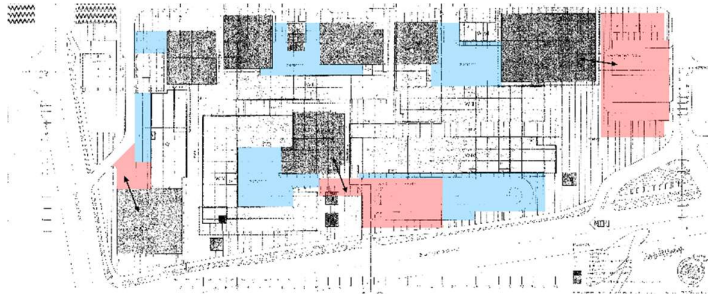
Fig. 2.11 Winkelcentrum Schalkwijk, blue=unloading area regular stores, red=unloading area anchor store (own illustration)

In order to ensure unobstructed pedestrian flow and a clutter-free environment, Winkelcentrum Schalkwijk has positioned unloading points out of sight. As indicated in the accompanying illustration, marked in blue, are the regular unloading points, located behind the mall. Additionally, the mall's three larger popular stores have been granted their own unloading area, which is marked in red. V&D, in particular, boasts the most extensive work terrain, complete with its own parking lot. In this regard, it is evident that Winkelcentrum Schalkwijk meets the criteria established by the checklist.

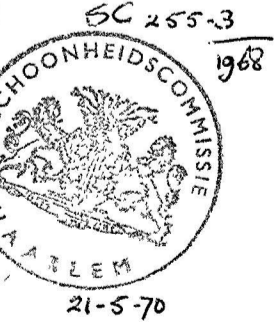
GEMEENTE HAARLEM sectie Y nr. 720 gedeelte

- RENOOI:
- b beheer/af
  - c containers
  - tr trafo
  - cv centrale verwarming
  - p parkeren
  - r rijwielen
  - vertical transport
  - winkels
  - grootwinkelbedrijven en warenhuizen
