# Comparing overflow and wave-overtopping induced breach initiation mechanisms in an embankment breach experiment

**Abstract.** As part of the SAFElevee project Delft University of Technology collaborated with Flanders Hydraulics Research, and Infram B.V. in the preparation and execution of a full scale embankment breach experiment in November 2015. This breach experiment was performed on an 3.5m high embankment with a sand core and clay outer layer situated along the tidal river Scheldt in Belgium near Schellebelle. During the experiment a wave overtopping simulator and overflow simulator were used to initiate a breach. Both simulators were placed near the top of the waterside slope. The use of the simulators facilitated comparison between the effects of continuous overflow and the effects of intermittent wave overtopping. This paper presents the data collected during the experiment, describe the development of hypotheses on the failure processes using the latest insights, and comment on the failure initiation process of a grass covered flood embankment with a clay outer layer and a sandy core.

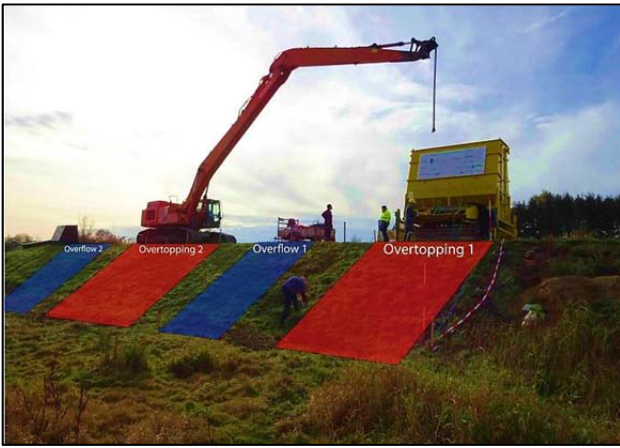
Figure 1. Overview test locations on embankment.

Over an approximate 50m long stretch of embankment, two tests were performed on breach initiation due to wave overtopping using the 4m wide wave overtopping simulator developed by Van der Meer [5], [6][7]. Also two breach initiation experiments had been performed using a 2m wide overflow simulator developed specifically for this experiment by Delft University of Technology. An overview of the test sections has been depicted in Figure 1.

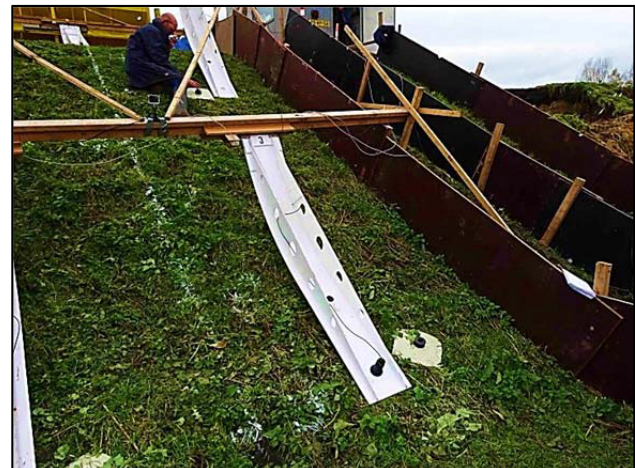
To assess the roughness parameters on the embankment, hydraulic measurements were performed with waves of respectively 500, 1000, 1500, 2000, 2500, 3000, and 3500 l/m. During the hydraulic measurements the flow velocities were continuously measured at the bed and surface of the waves using paddle-wheels. To measure the change in depth profile of a wave over time, a surf-board like construction was used (see Figure 2). The

water depth was derived from measuring the change in angle of the surfboards when a wave passed under it. The paddle-wheels were placed near the downstream tip of the surfboard, both in the embankment surface and on the tip of the surfboard. This way both the flow velocity at the bed and at the surface could be measured. The front velocity of the wave was derived by measuring the time lapse in signal from the surfboards and the known distance between two surfboards.

**Figure 2.** Setup for performing hydraulic measurements during wave overtopping tests.

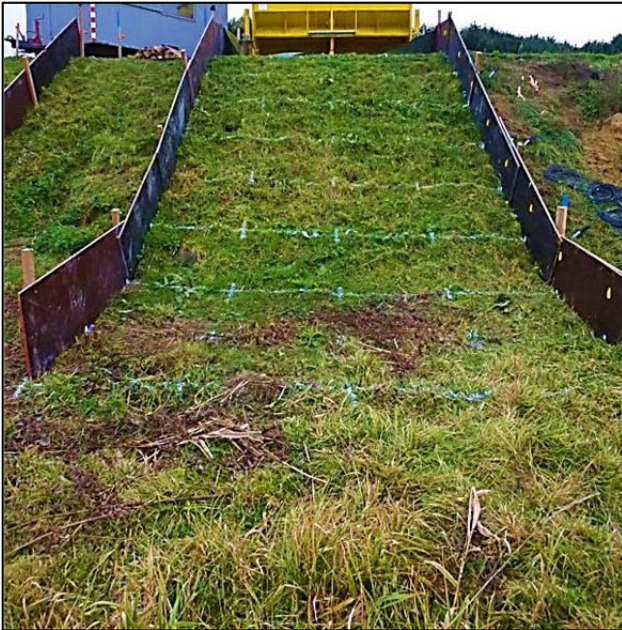
**Figure 3.** Overview picture taken prior to the first wave overtopping experiment

Prior to the tests the embankment was divided into 1x1m quadrants (see Figure 3). The first quadrant (1A) started on the far left hand side of the outflow point of overtopping simulator. The flow channel was 4m wide. Across, it was divided into Sections A through D with A being on the left hand side looking upstream. In total 11 cross sections were created. During the first test cross sections 1, 2, and the first half of cross section 3 were fully covered with a plastic sheet to prevent erosion of the gravel road. Between the end of the plastic sheet and the top of the landside slope some flattened grass cover was present. On the landside slope several stones were present. In Section 4A a small hole was visible. In cross sections 6A and 8C stones were visible from the surface. In section 7 the nettles and moss were visible. In general the grass cover was not nice and smooth but represented a rough surface. Characteristic of the behaviour of grass under the wave loading was that every time the wave had passed the grass bounced back into an upright position. This could therefore have contributed to a higher roughness experienced by the waves and hence higher shear stresses.

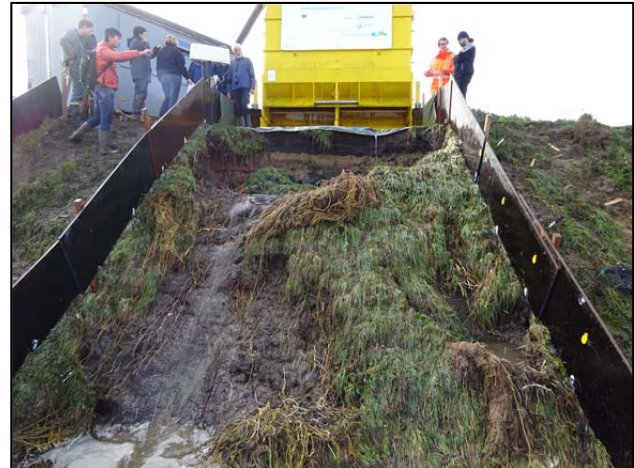
**Figure 4.** Overview picture taken at the end of the 25 l/m/s tests at the first test section

site. At the end of the 10 l/m/s test, the hole had grown to approximately 0.5m deep. During the 25 l/m/s the hole in on the slope increased in size. After 3 minutes, part of the grass cover came loose near the hole. After 12 min the sand layer was reached in the hole. Once the sand layer was reached a trench developed due to erosion downstream of the hole (see Figure 4)

Simultaneously headcut erosion caused for the upstream progression of the hole. The sand under the clay layer acted reasonably cohesive maintaining near vertical slopes. The processes observed during the retreat of the landside slope were similar to the underwater breaching process as observed during dredging at sand pits. Here the dilation of sandy soil due to water infiltration in combination with the reduction of negative pore pressures determine the rate of erosion and prevent large scale slope failures from occurring.

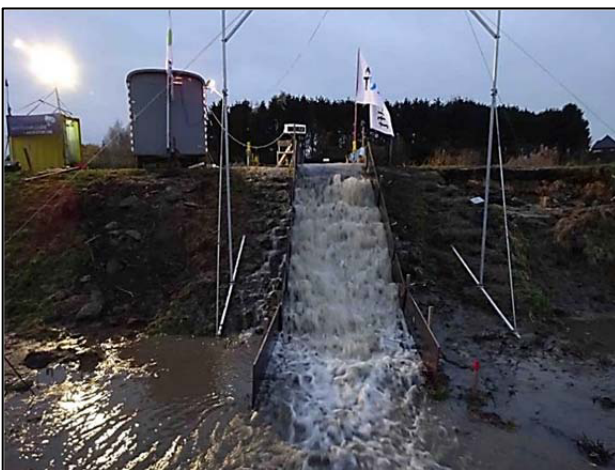
Figure 6. Observed aerated flow during the overflow experiment

Due to limitations in the minimum allowable frequency at which the pump could be operated, tests with the overflow simulator started at 10 l/m/s, followed up by 25, 50 l/m/s and 85 l/m/s. Contrary to expectations, the damage that occurred to the grass cover at overflow discharges of 50 l/m/s and 85 l/m/s was negligible. Instead of the theoretical nice smooth flow of constant density, during all overflow tests the flow became highly aerated down the landside slope (see Figure 6). This could be of influence to the spatial velocity distribution down the slope. Between changes in the discharge the flow was stopped during which became apparent that contrary to the behaviour of grass during wave overtopping the grass cover remained in a flattened position and did not bounce back upwards. Another noticeable, and potentially important observable difference with the wave overtopping tests, was that during overflow the reattachment point of the flow was closer to the crest than during wave overtopping. The normal impact at the reattachment point is therefore also expected to be smaller during overflow than during wave overtopping. These differences with wave overtopping could potentially help in better explaining the difference in timing in failure initiation of the grass cover.

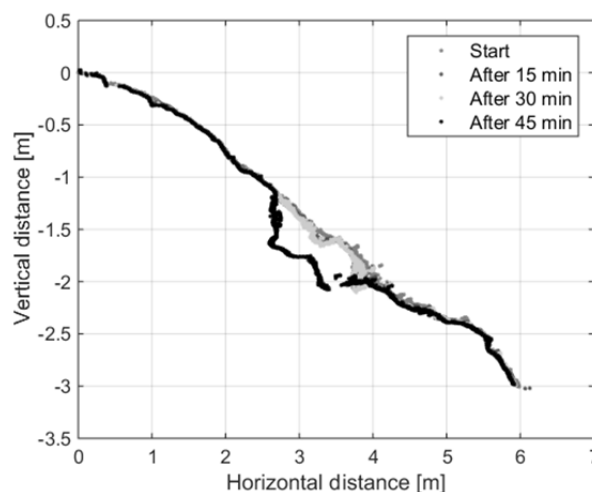
Figure 8. progression in breach initiation to the point the sand layer was reached. Point (0,0) is the intersection of the crest and the landside slope
