# Calibrated Numerical models for masonry buildings subjected to subsidence-related ground settlements

**a Master Thesis**

A study into the capabilities and development of assessment methods for predicting damage to masonry structures undergoing subsidence-related settlements.

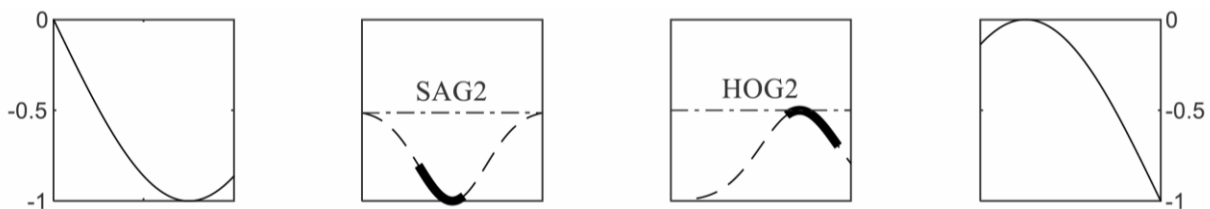
Figure 6: Most encountered displacement profile shapes in a Dutch buildings measurement survey (Prosperi, et al., 2023).

Similar shapes have also been identified in urban subsidence settings. In Prosperi, et al., 2023 a Dutch subsidence survey performed on 615 building walls, reconstructed the displacement profiles for 499 of these walls. Although the displacement on the wall does not equate to the subsidence experienced by these walls they are nonetheless strongly correlated. These measured displacement fields were then split into regions with discrete shapes, which were later compared against each other. Then a database was built based on categorised displacement shapes of different buildings. The results showed a relatively even split between hogging and sagging subsidence profiles. In particular, two displacement profile shapes (Hog 2 and Sag 2) saw a greater likelihood than other shapes, these shapes corresponded to strong one-ended settlements at the point of maximum curvature. All other settlement types were in some way resembling different Gaussian shape combinations of different length scales and curvatures.

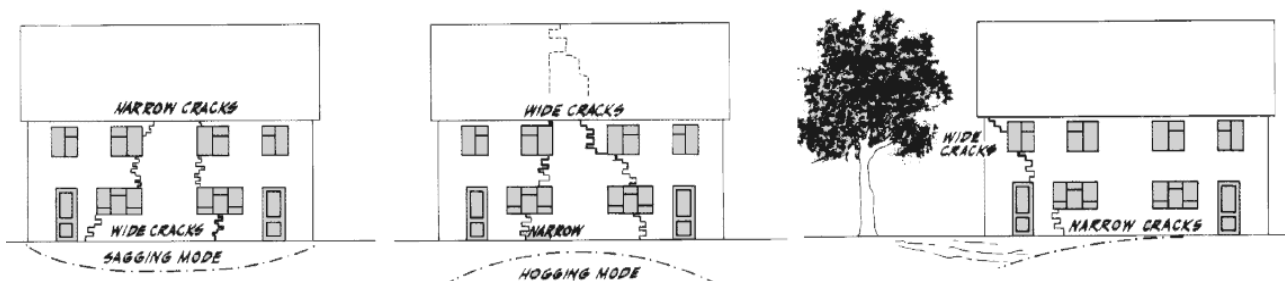
Figure 11: Distortion and cracking caused by a hogging subsidence profile (Chancery group, s.f.).

Researchers have mostly focussed on correlating the above symptoms to the most relevant deformation measures. In instances where the superstructure (i.e. the section of the structure above the ground) deforms through a hogging curvature, cracks are expected to initiate at the top of the wall and propagate along the height of the wall, up to the point where a full mechanism is formed and the building begins to behave as two different units of reduced stiffness. This is similar to one ended settlement where this process takes place at the location of greatest curvature change. In sagging deformations, the process is inverse to hogging deformations yet the curvature results in the area experiencing tension to be that which tends to be stiffer, the foundation and ground floor.

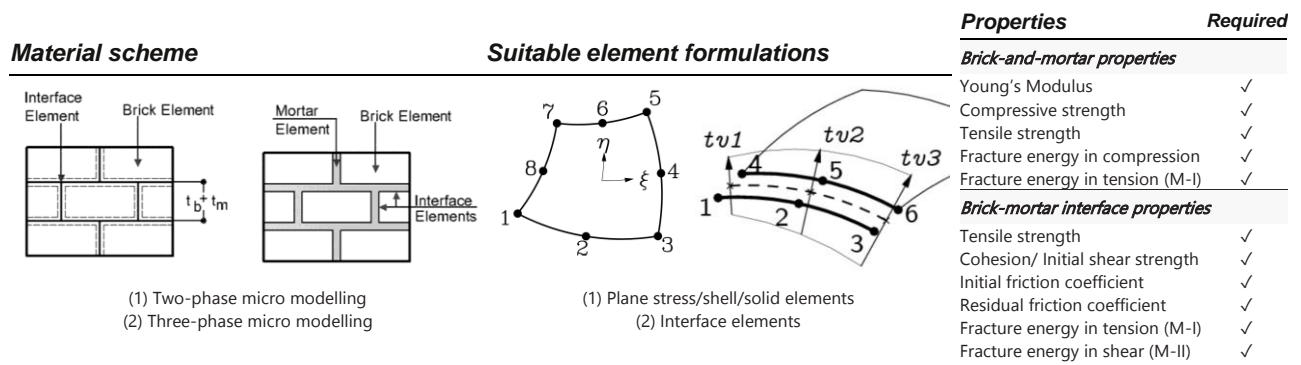
Figure 16: Block-based modelling strategies (Asteris, et al., 2015; DIANA FEA BV, 2024)

Block-based models which employ the FEM mostly employ micro-modelling, this approach to different levels of detail models the units, mortar behaviour and interface behaviour between both elements. The two main variants are two-phase micro-modelling or simplified micro-modelling, a model where the mortar is modelled through a single interface of no thickness that can account for the crushing, debonding and slipping of the mortar, as well as the general brick behaviour and, three-phase micro-modelling, where the mortar is explicitly modelled and connected to the brick elements through discrete interfaces. This last approach represents the most realistic representation of the masonry yet is prohibitively computationally expensive which is why it’s mostly reserved for small-scale investigations against laboratory specimens.

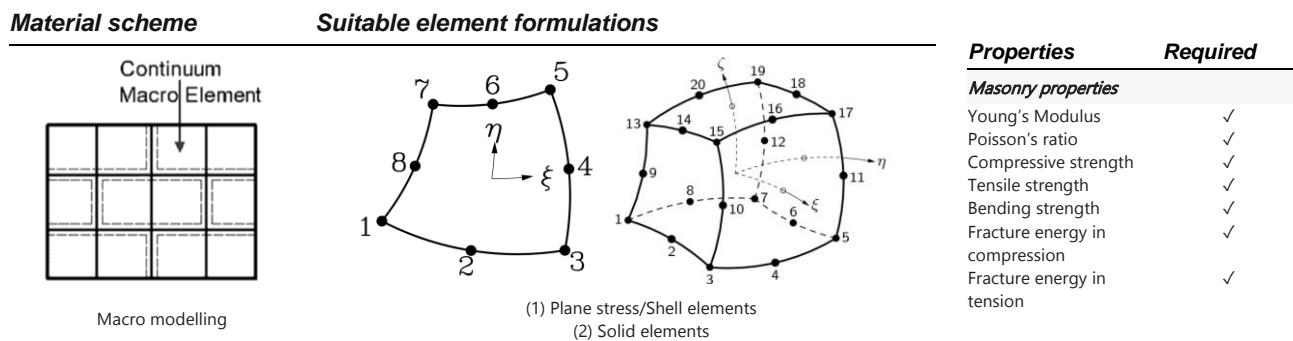
Figure 17: Continuum homogeneous modelling strategies (Asteris, et al., 2015; DIANA FEA BV, 2024)

The second simplest form of continuum models base their behaviour on non-linear constitutive laws based on fracture mechanics, damage mechanics or plasticity theory, these models are called smeared crack models and are the most popular direct approach form which allows relatively easy simulation of the main mechanisms which occur in masonry. They nevertheless still have some limitations based on their mesh-sensitivity in crack energy dissipation, caused due to the regularization of the fracture energy in the continuum and the influence meshing has on the length and pattern of the crack. The most popular laws in the FEA of masonry available in the software package Diana are the Total Strain Based Crack Model (TSCM) and the Engineering Masonry Model (EMM).

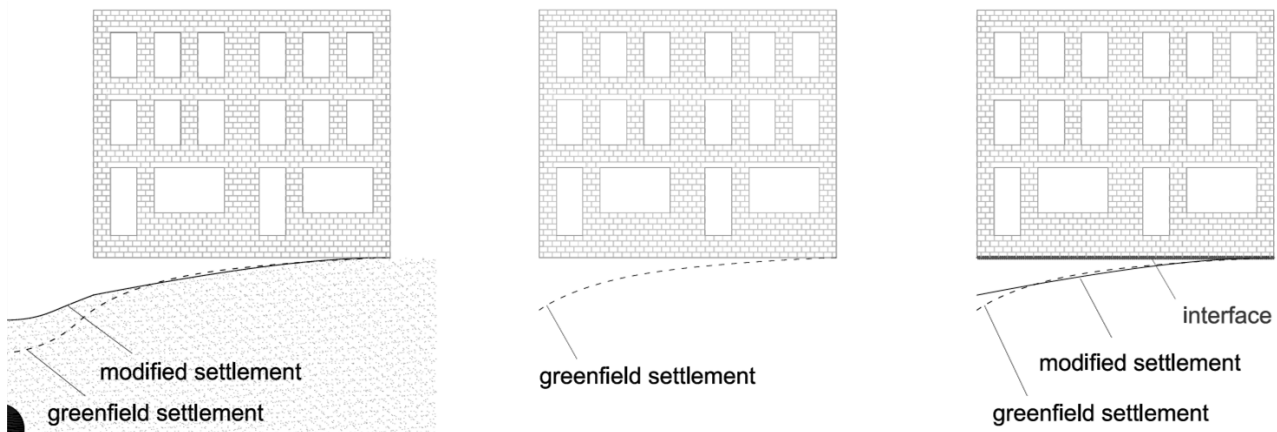
Figure 20: Subsoil modelling approaches for settlement-induced building damage. Coupled (Left), uncoupled (centre) and semi-coupled (right) (Giardina, 2013).

The application of masonry models for subsidence processes has not been as widespread examples include Sangirardi et al. (2020) which performed a set of NLFEA to two different case studies, Erturk Atmaca et al. (2023) who assessed the collapse risk of masonry structures subjected to subsidence due to adjacent excavations through semi-coupled and coupled strategies. Further models were also implemented in Giardina, 2013 which implemented a range of coupled semi-coupled and uncoupled models to predict masonry damage due to tunnelling settlements.

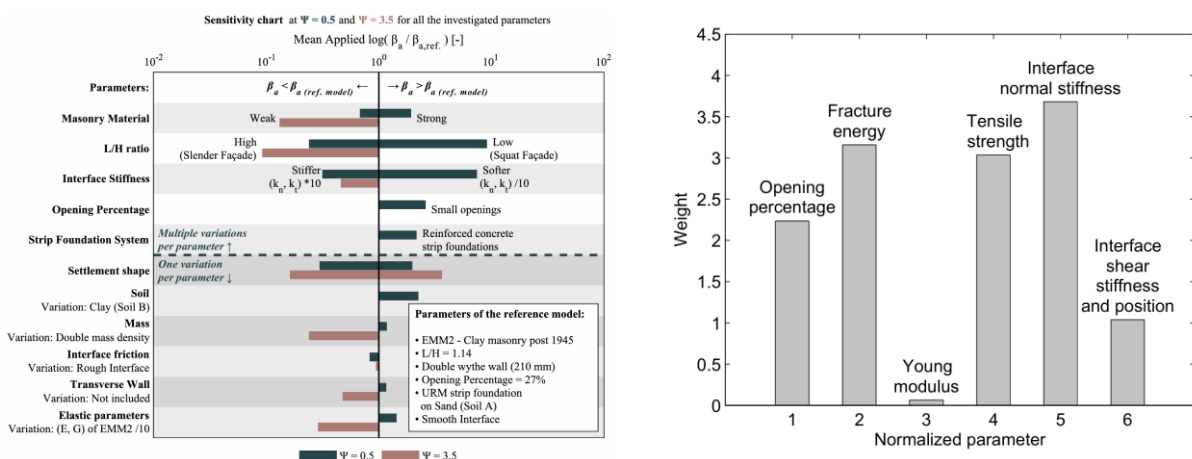
Figure 21: Sensitivity analysis on settlement experiencing FE Models (Prospero, et al., 2023; Giardina, 2013).

Lastly, Giardina, 2013 found for a set of analyses on masonry buildings settled due to tunnelling settlements that the parameters that had the biggest influence on the analysis damage level were the soil structure interface stiffness followed by the masonry fracture energy and the Tensile Strength.

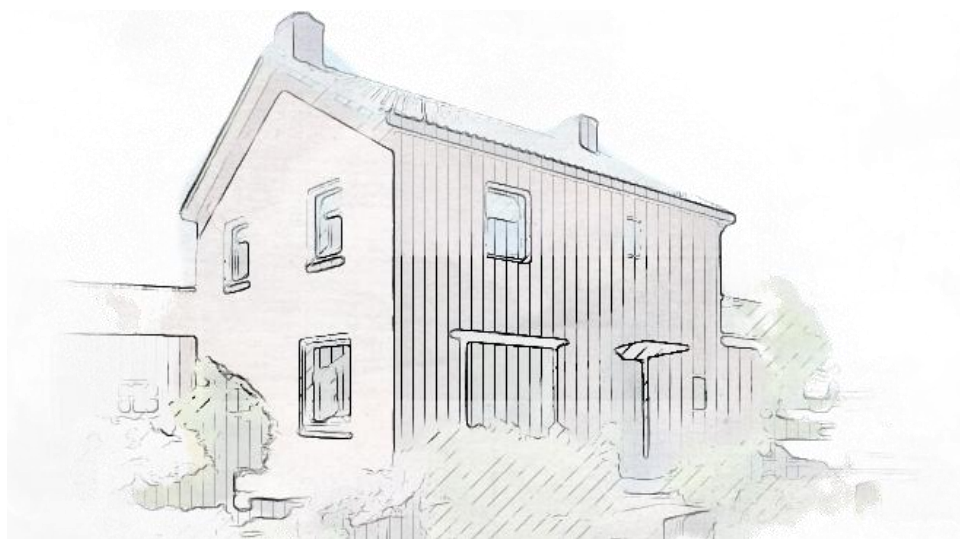
*Figure 26: Adaptation sketch of the case study building*

In this instance, the main conclusion drawn by the inspectors was that the building's foundation capacity was insufficient given the beneath soil conditions and measured deformations. The conclusions advocated that countermeasures should be retrofitted in a 1-5 years period to the building following the assessment date. Consequently, the building was demolished circa 2019 due to the assessed insufficiency from the foundation to prevent future settlements.

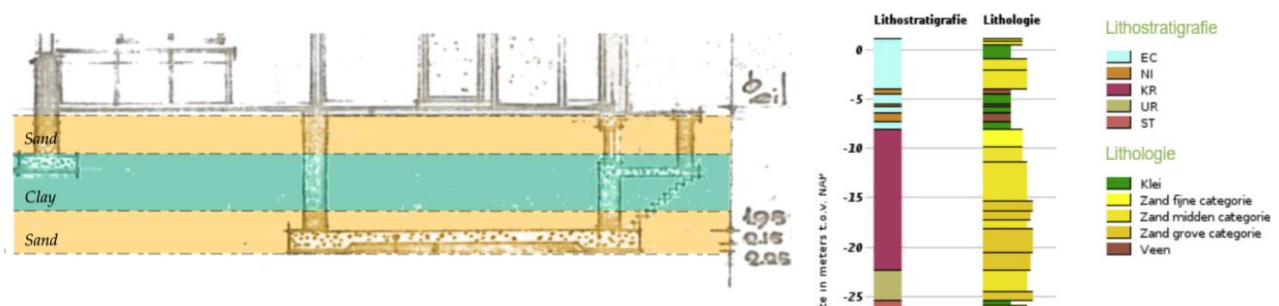
Figure 28: Approximated lithology at building foundation level and Borehole sample lithological graph.

Further information on the nearby soil is available due to two perforation samples have been made nearby to the building, one date to the construction of the building itself from 1961 and another is available from publicly available perforation data, this sample was taken at a location 1km east of the building, but no information is provided about the exploration date. Both constructed lithology graphs show similar soil layer compositions. There are variations as to the thickness and thus the relative location of soil layers but in all, the open data samples help validate the original exploration made at the building's location. The building's soil profile has only been shown for the first 25m as these are the most influential soil layers. The soil layers show a primary soil composition of sands especially at lower depths. Nonetheless, the soil composition, near-surface is significantly different with mostly clay layers being located close to the foundation level and another 4 metres below that, some small peat layers are also located at around 7m below surface level. No water table measurements were made available, but the water table is possibly quite high due to the nearby presence of a large canal.

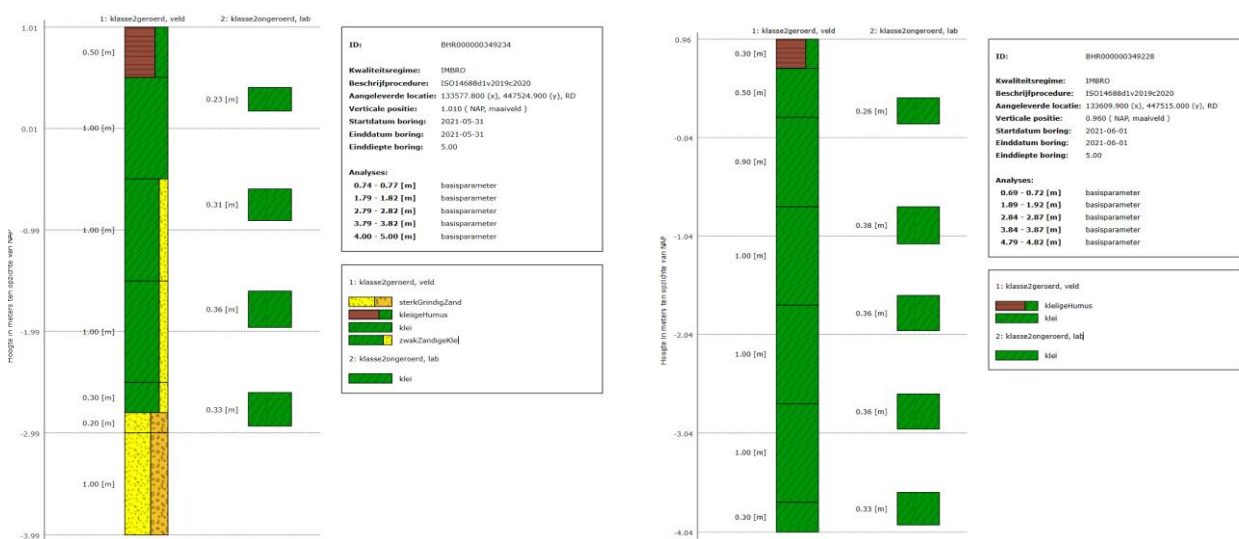
Figure 29: Open data CPT exploration around 1km east of the building.

The identified discrepancies all most likely hint at the imbalanced resistance from both foundation systems although, the above reasoning is highly assumptious. The main driver behind the soil's resistance remains to be unknown in the water table location. Therefore, for this example, the soil simulation and analyses may pose an uncertain undertaking because of changing water tables as well as other temporal effects in weathering, non-linearity in soil properties and irregular spatial distribution of soil layers.

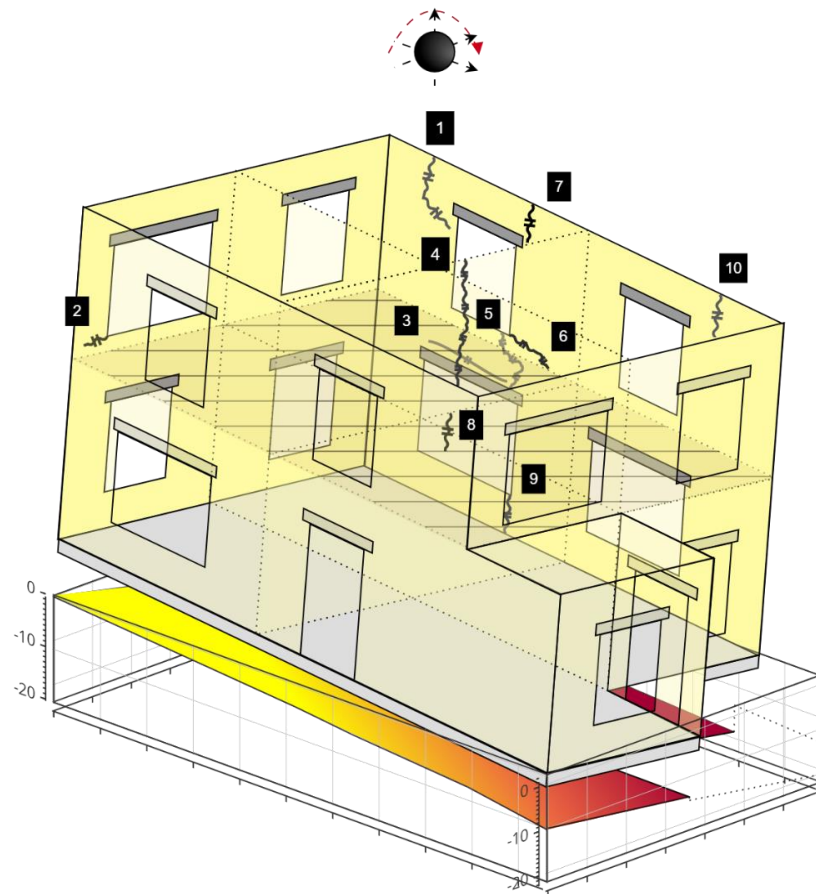
**Building state diagram**

Crack ID	Wall ID	Image	Class	Description	Crack Width	Crack Length
1	2	 	DL3	Tension due to settlement of the left-ward section of the wall.	4mm	885mm
2	1	 	DL2	Cracking on left building wall	≈2mm	1670mm
3 & 5	2	 	DL3	[3] Dilation crack [5] Operation lintel	[3] ≈3mm [5] ≈3mm	[3] 868mm [5] 670mm
4	7	 	DL3	Hairline Crack	≈0.1mm	2000mm
6	2	 	DL3	Differential settlement of the lintel towards the easter profile of the Building.  Previously repaired crack.	>3mm	1200mm

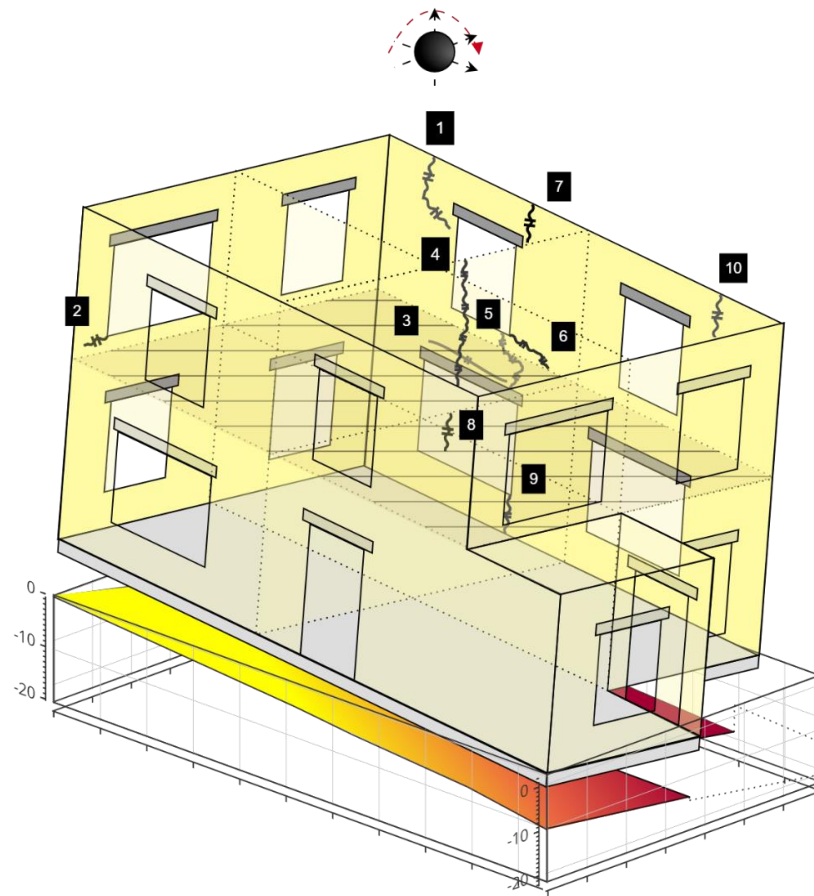
#### Building state diagram

Crack ID	Wall ID	Image	Class	Description	Crack Width	Crack Length
7	2	 	DL1	Interaction of settlement and lintel	≈2mm	600mm
8	7	 	DL1	A crack formed most likely due to bearing stress	≈0.1mm	500mm
9	2	 	DL0	Formed dilation	≈1mm	994mm
10	2	 	<DL2	Possible operation rafter wood	≈2mm	980mm

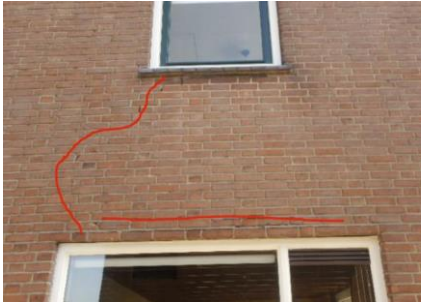
DS1 - DL3 ≈2mm 8mm	Crack	In composite masonry	In column or wall	Horizontal	Halfway the length	Near the roof or floor level	[Pattern 20] Horizontal crack near roof or floor	Overloading due to change in load path

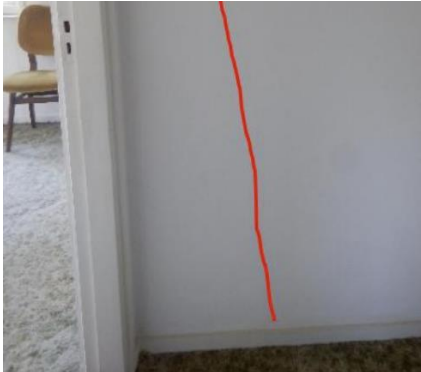
DS1 - DL3 ≈0.1mm 2000mm	Crack	In composite masonry	In column or wall	Vertical	Tapered towards one end	Widest at top + At top of the building	[Pattern 23] Vertical tapered crack at the top of a building	Vertical settlement : one-end-settlement

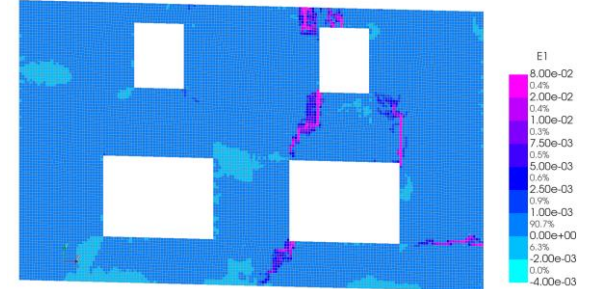
NLA  
Load-step 750, Load-factor 0.99936, Sub Deformation  
Total Strains E1  
min: -3.23e-04 max: 1.53e-01
