around the window,

msc architecture graduation project, explore lab studio
january 2024

by amber sikkema
tutors: mieke vink, stavros kousoulas and jan van de voort

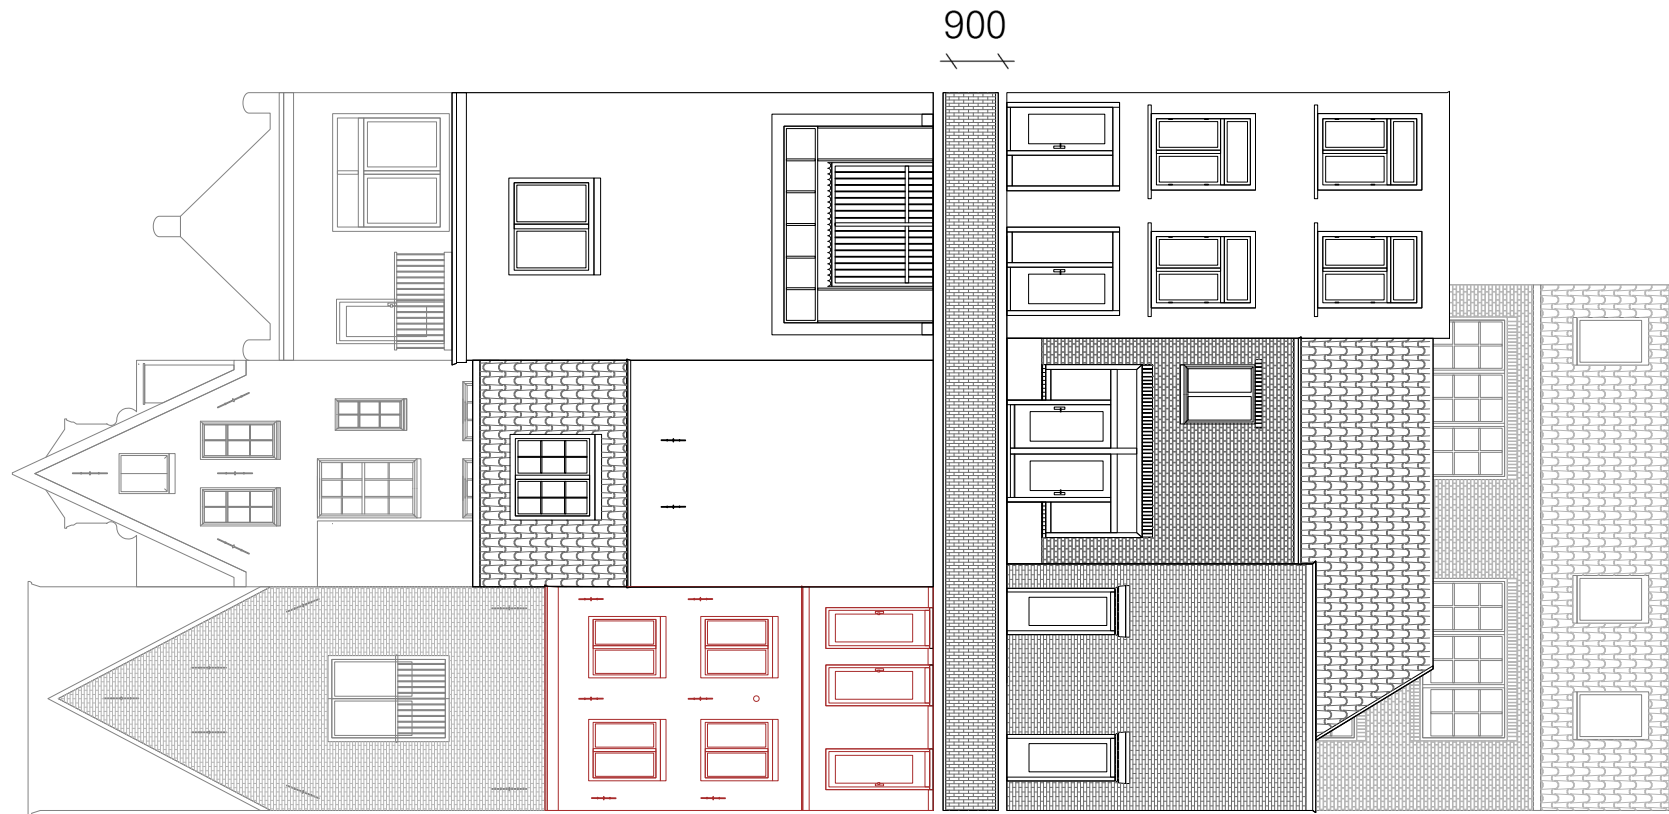
facades trompettersteeg

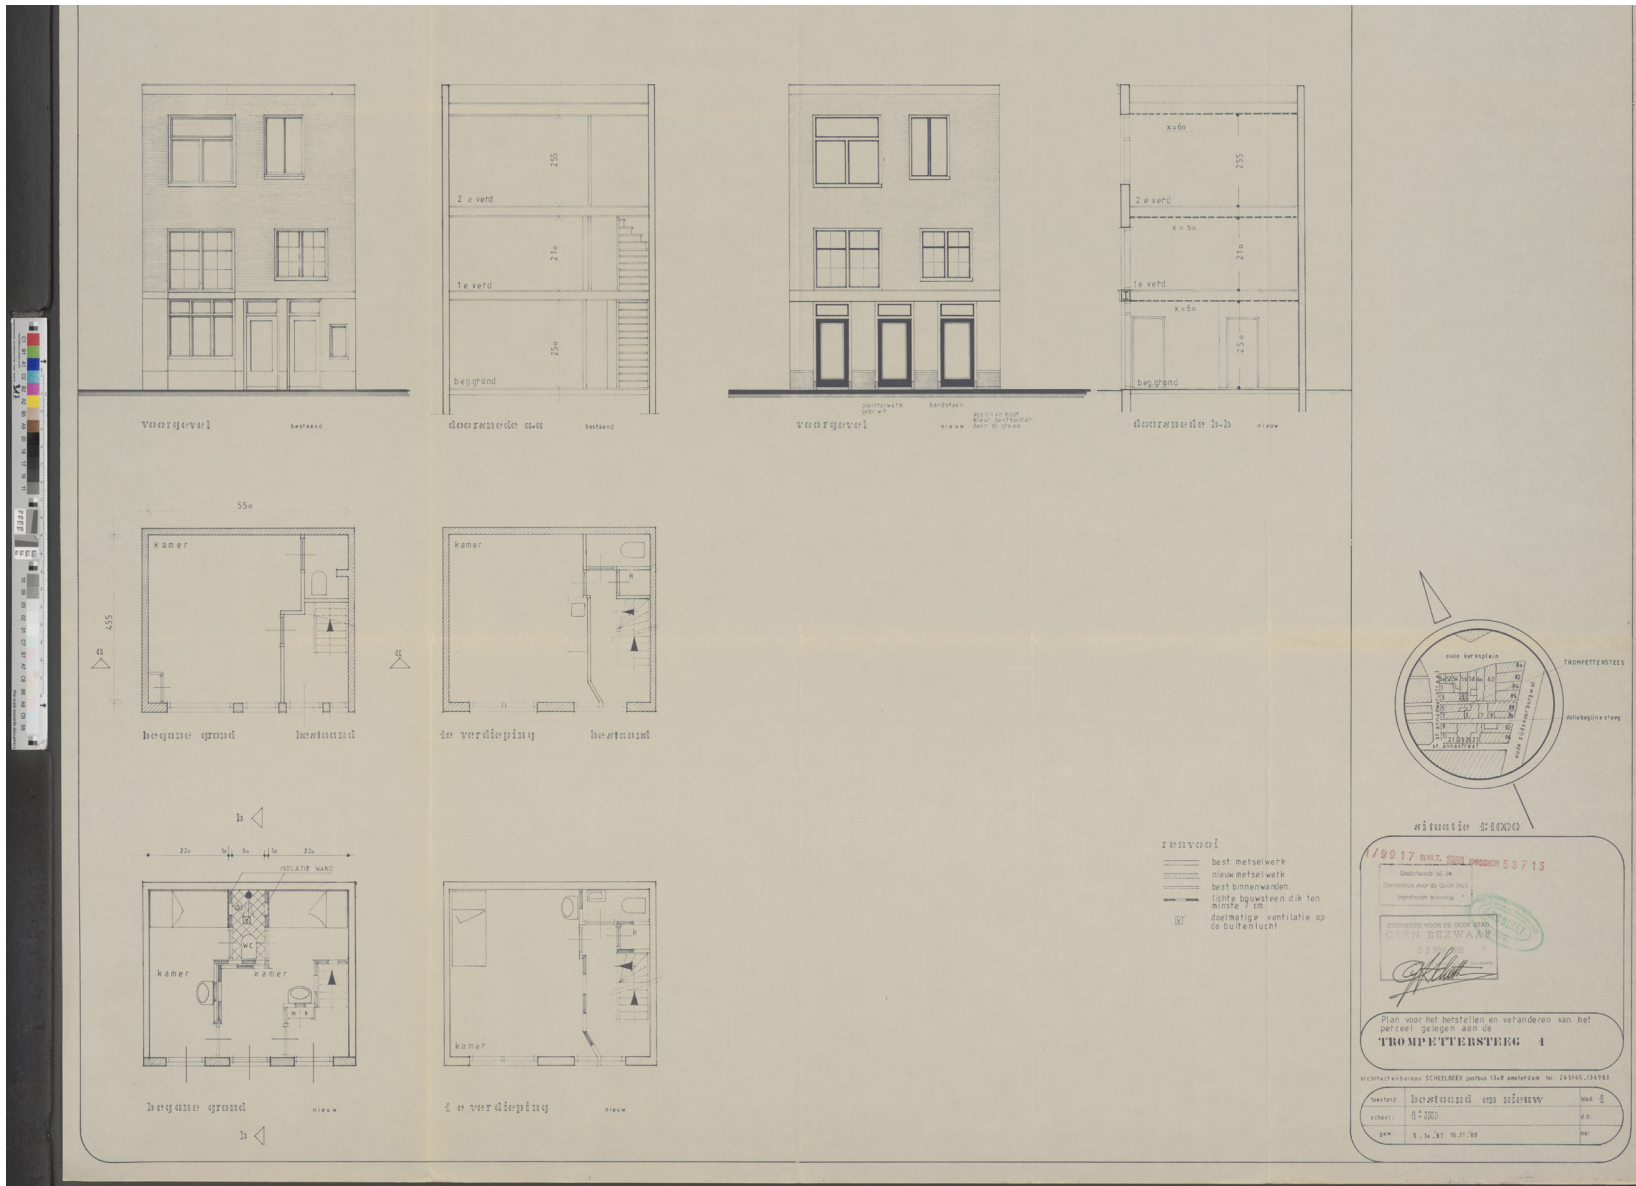
trompettersteeg 1 historical building plan 1988

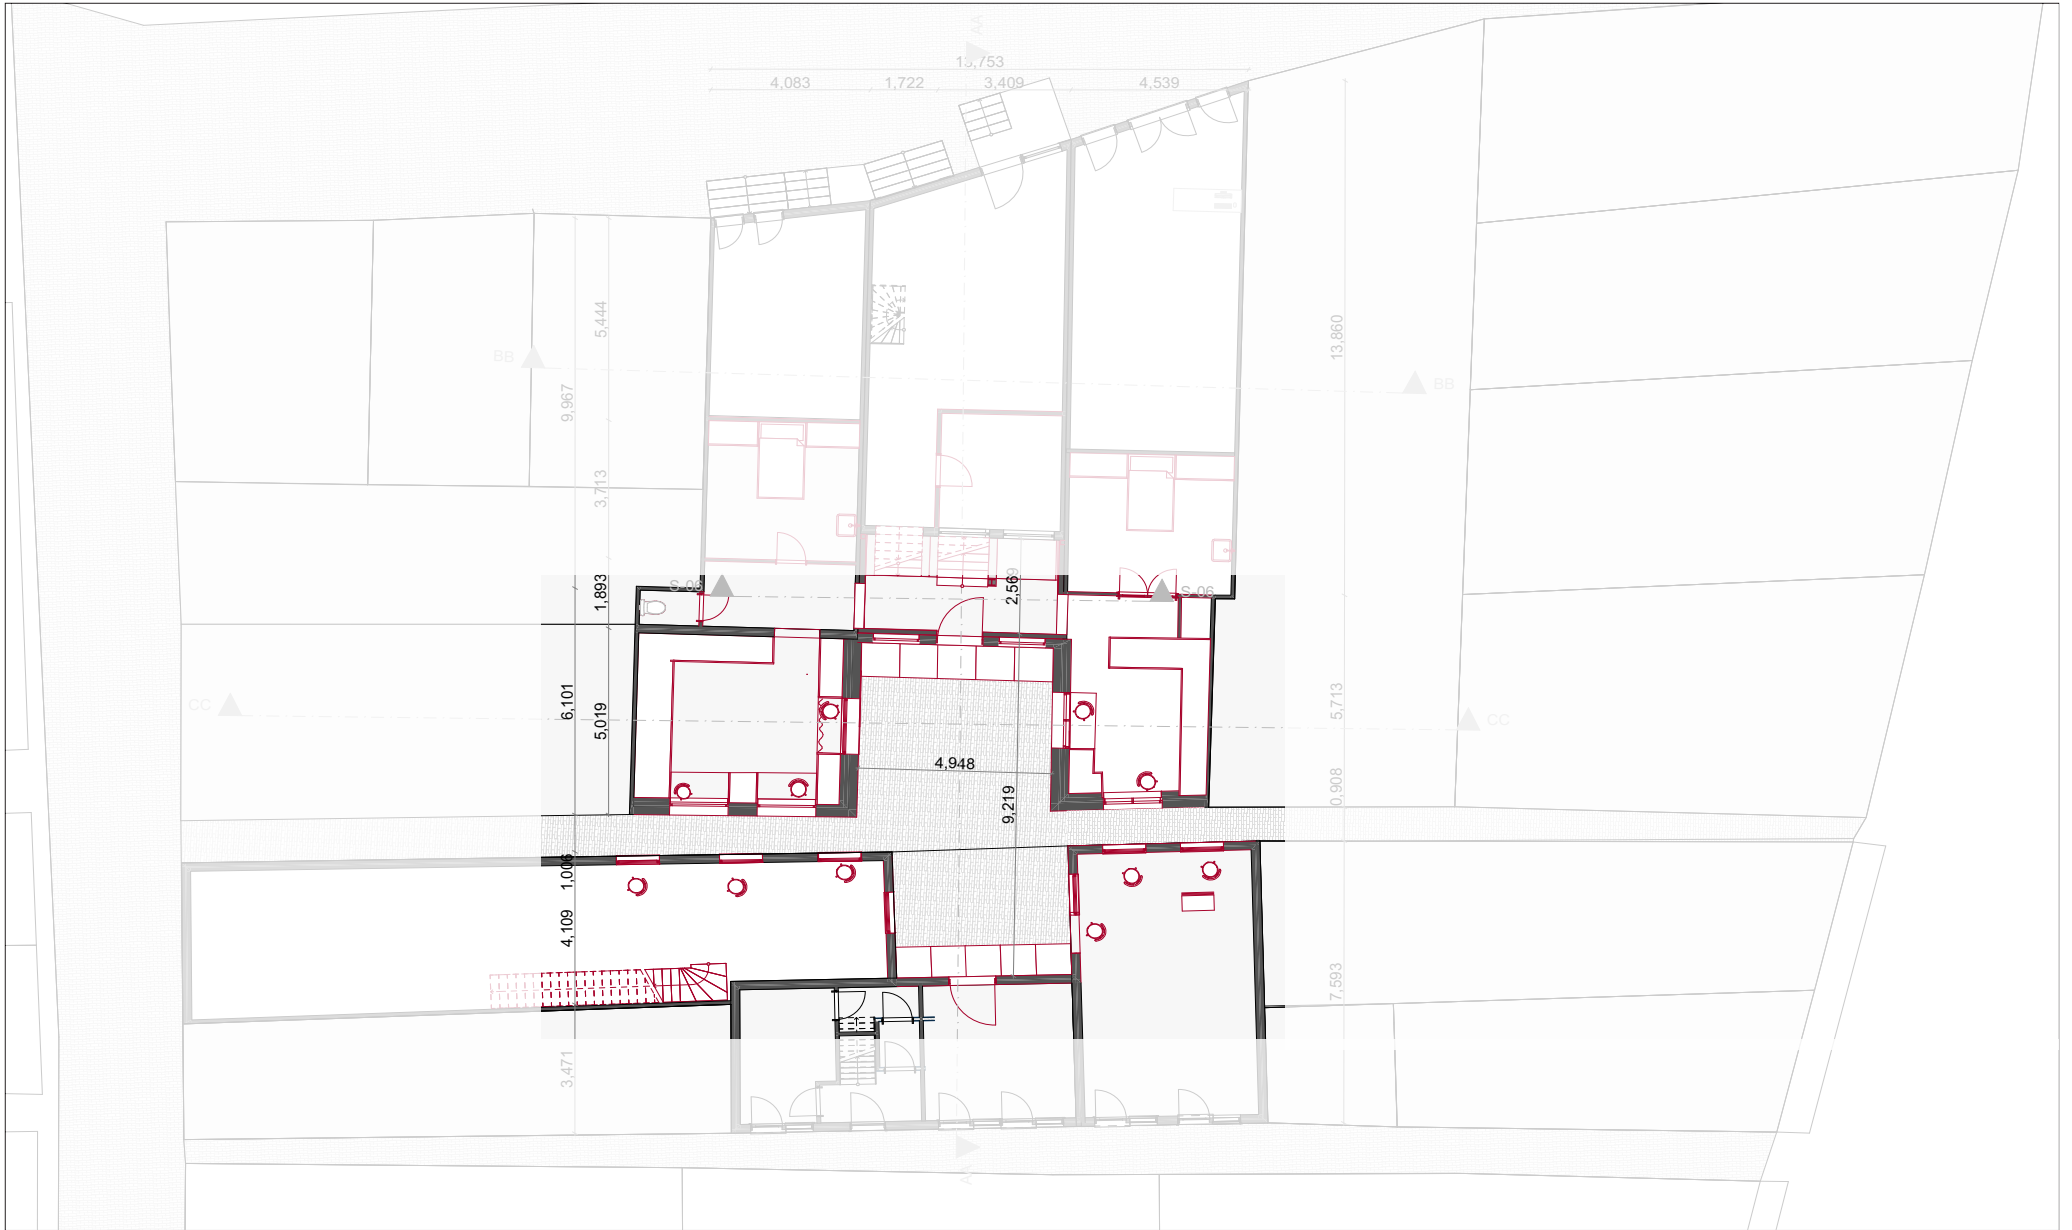
Floorplan

Ground Floor
Window Spaces and Tattoo Shop

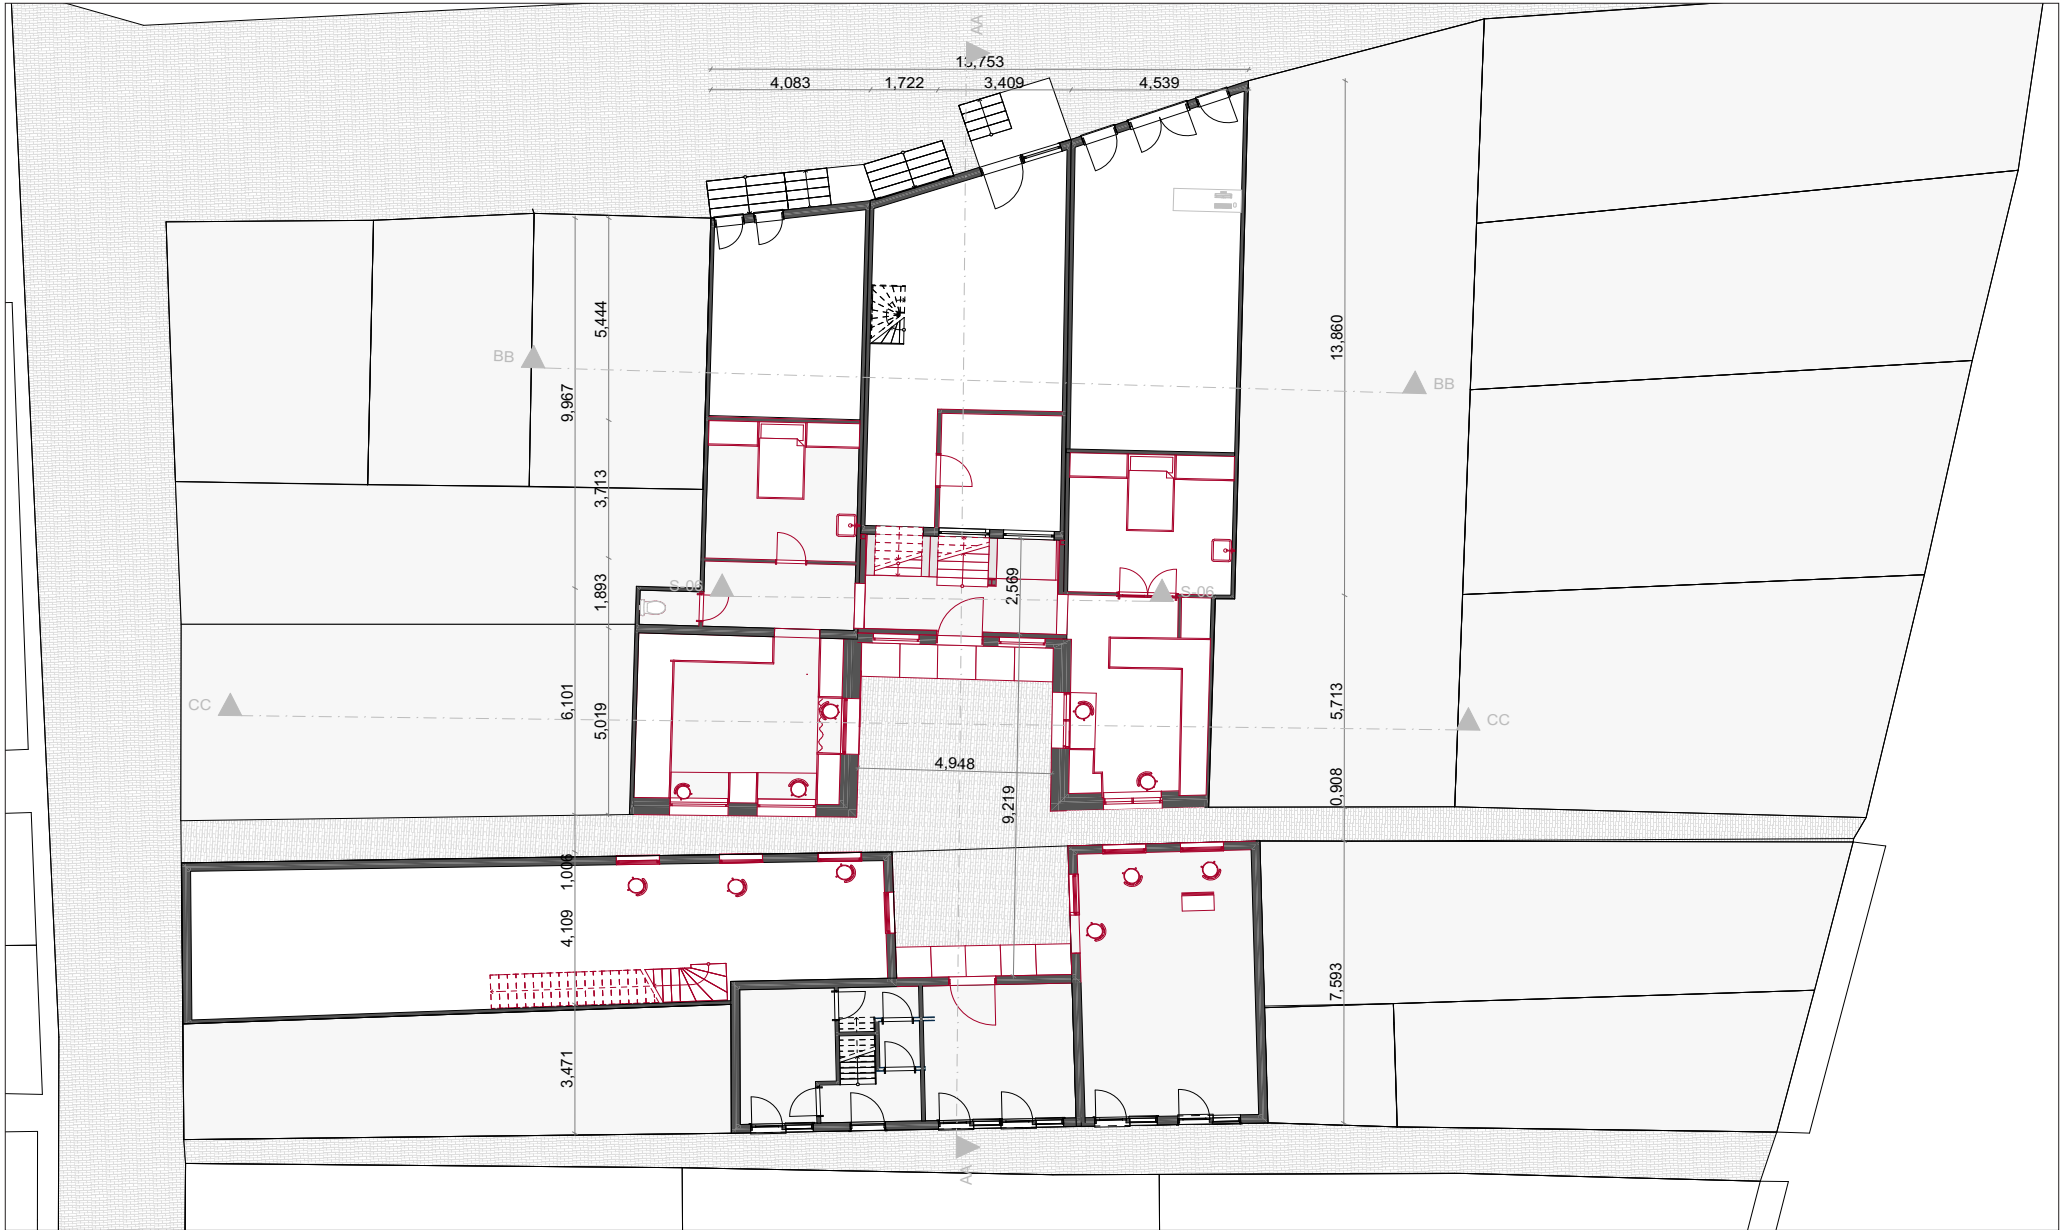
Floorplan

Ground Floor
Window Spaces and Tattoo Shop

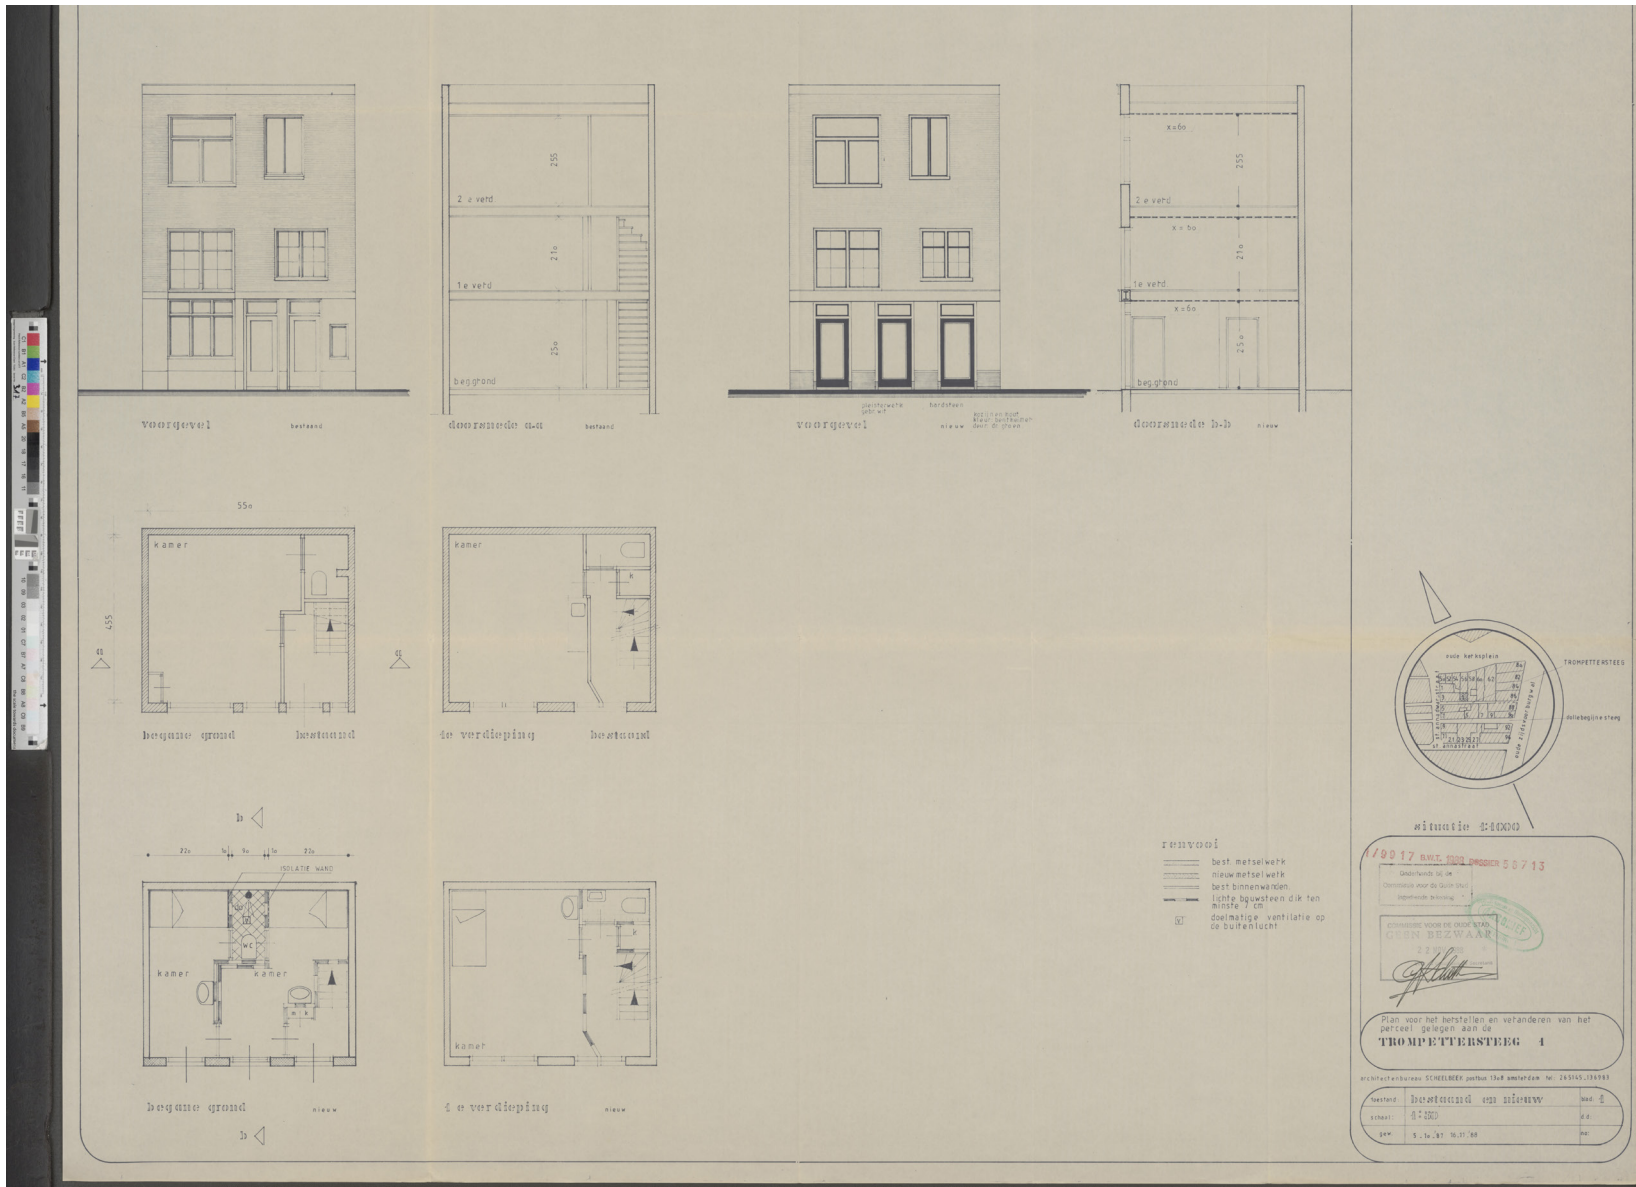
trompettersteeg 1 historical building plan 1988

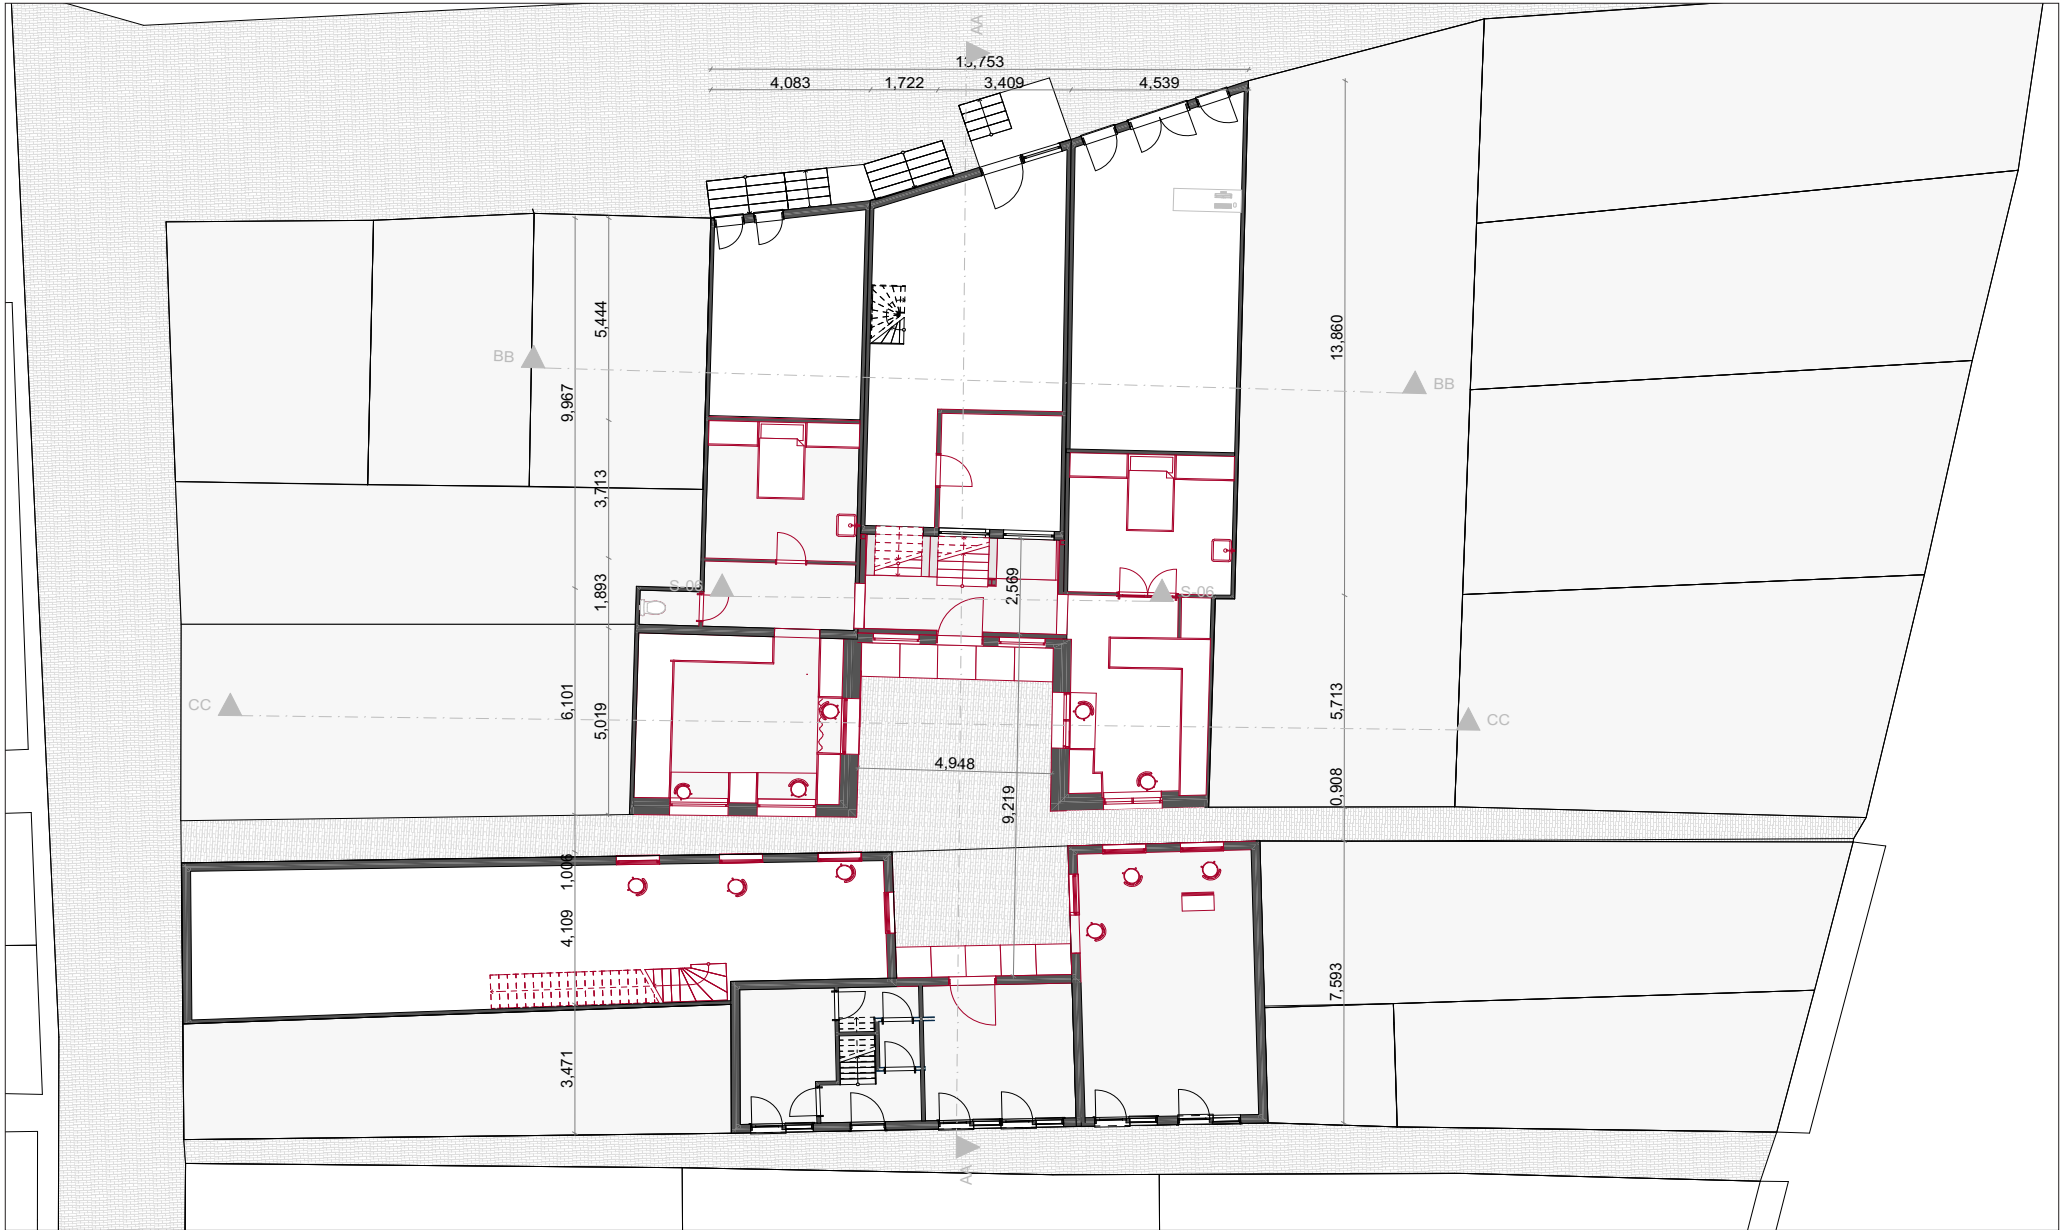
Floorplan

Ground Floor
Window Spaces and Tattoo Shop

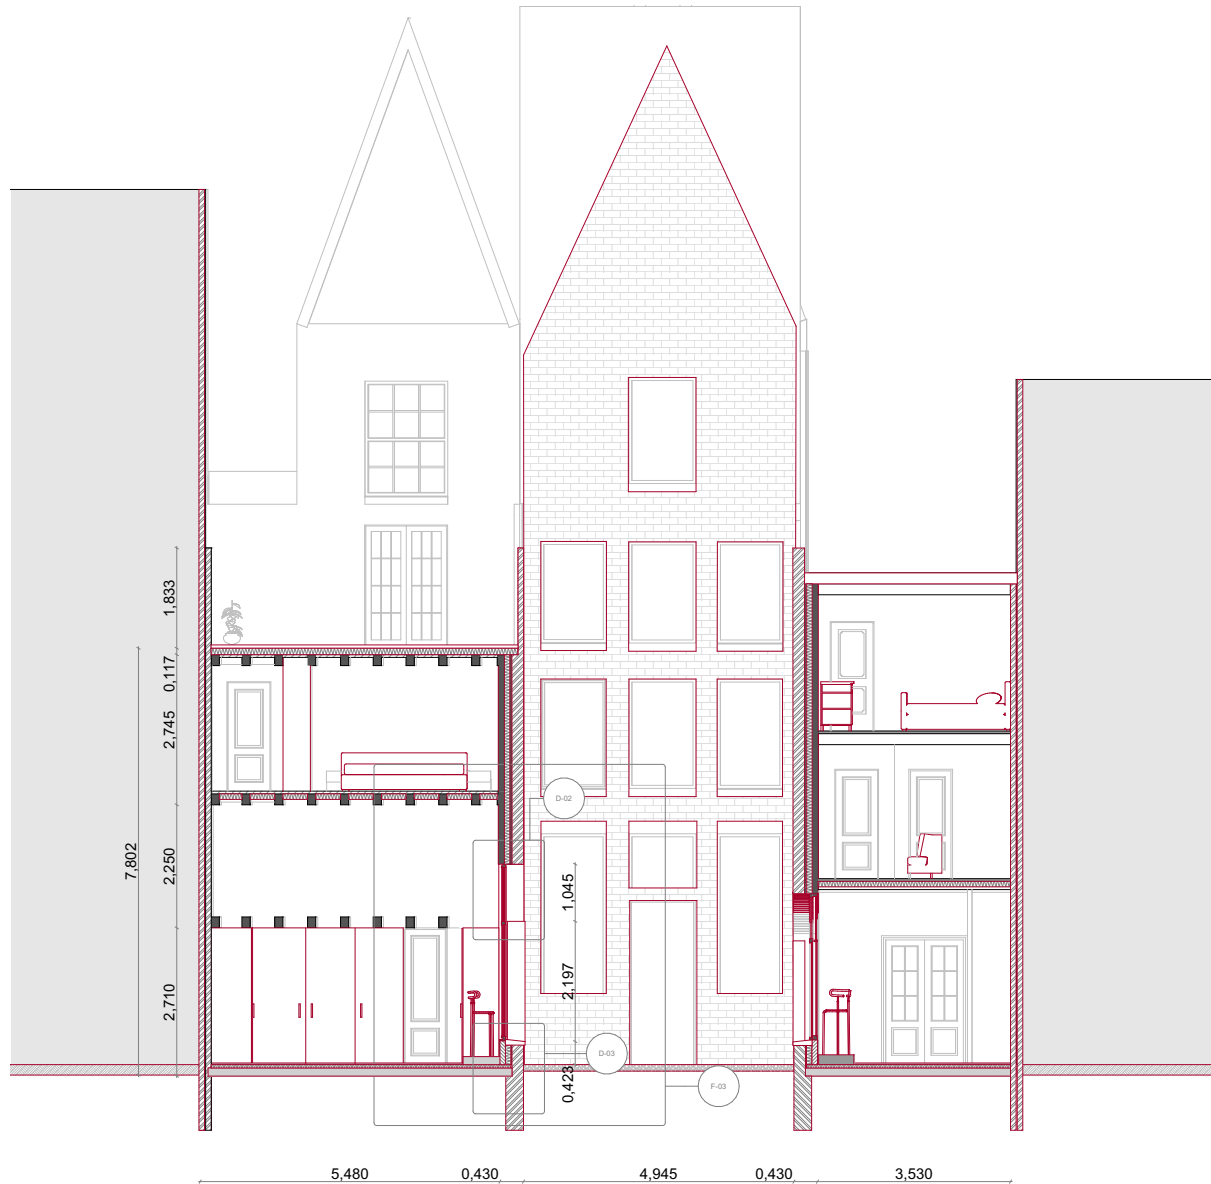
Section CC

Cross Section
Window Spaces

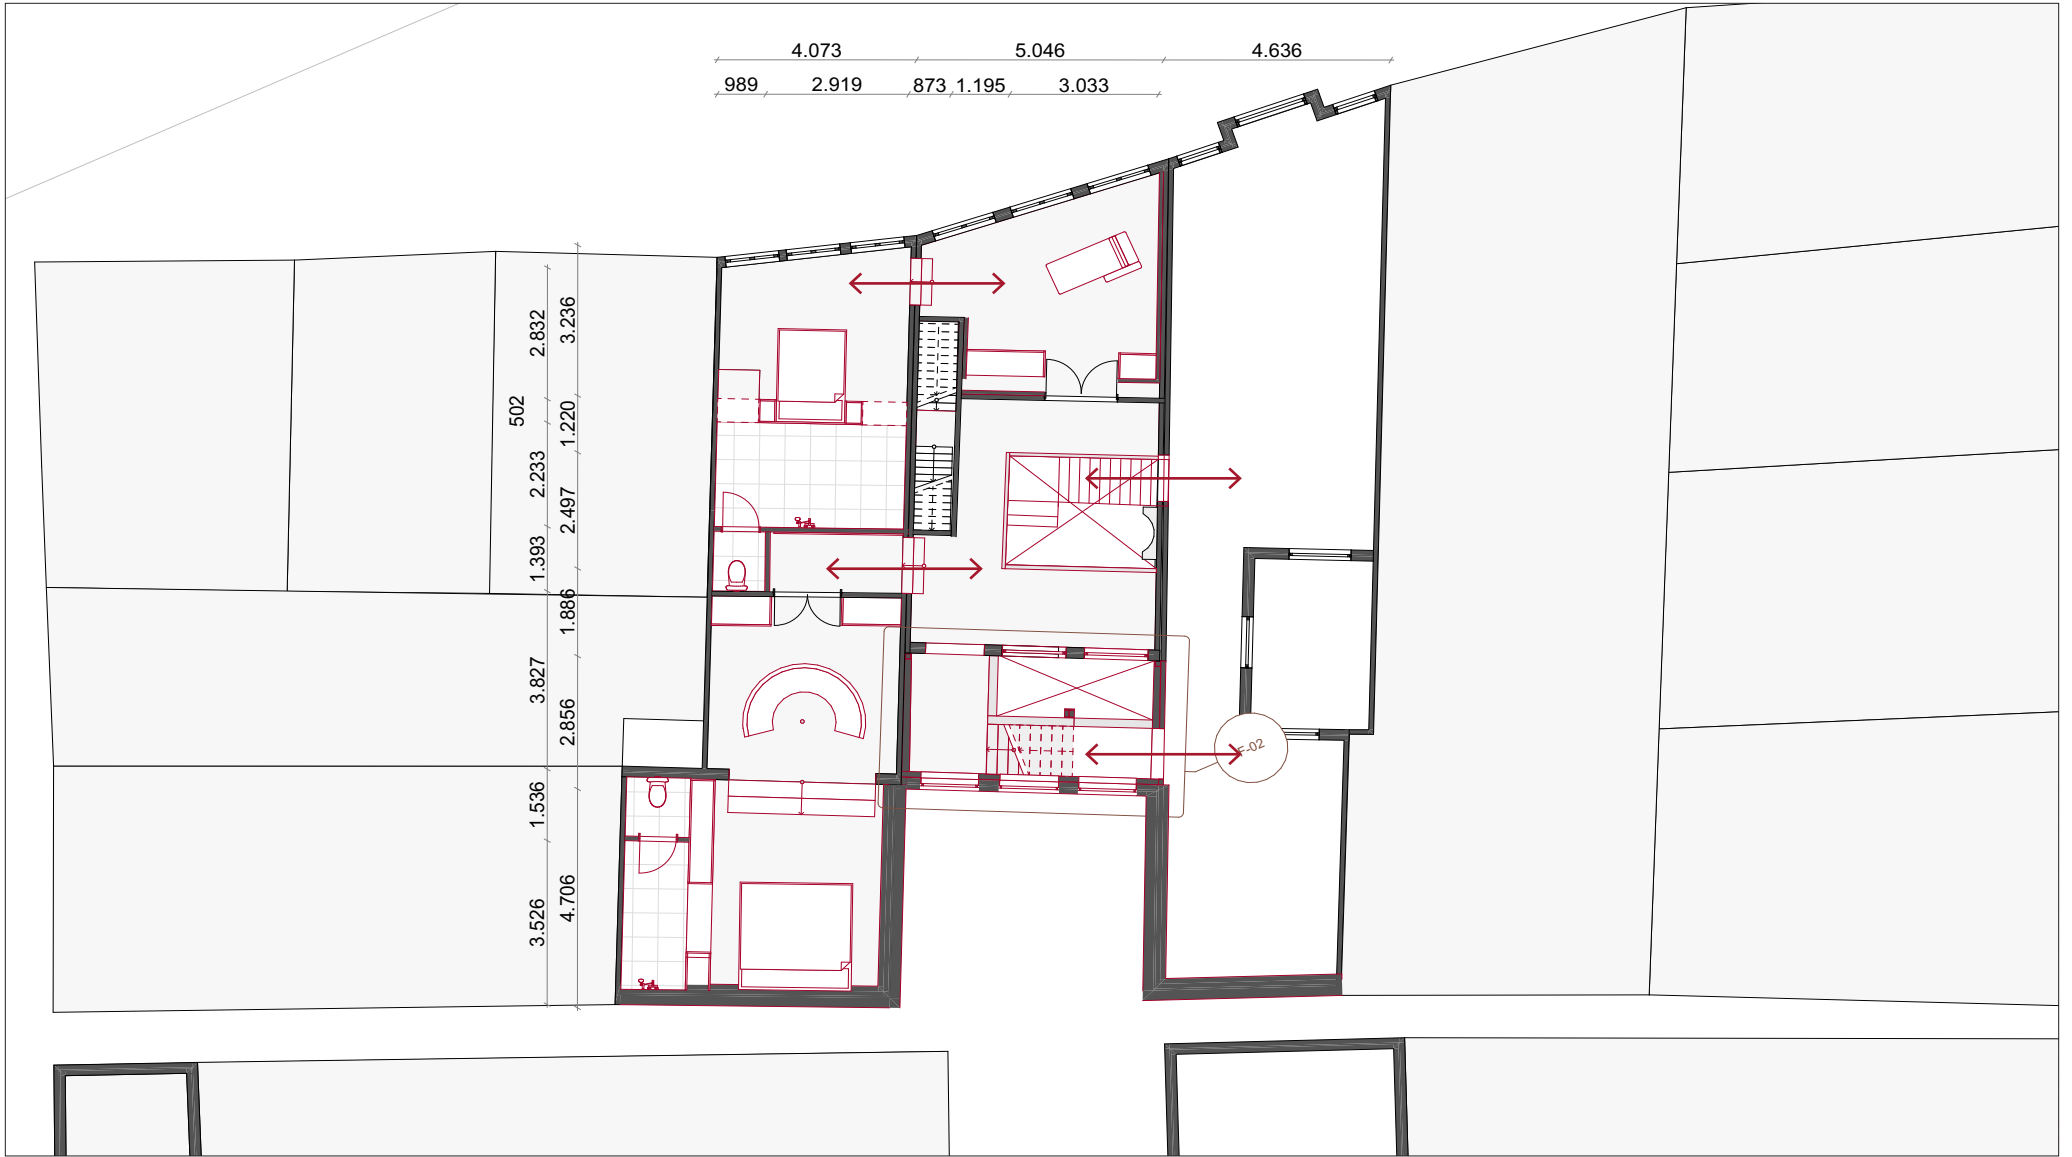
Floorplan

Fourth Floor
Sex Work Spaces

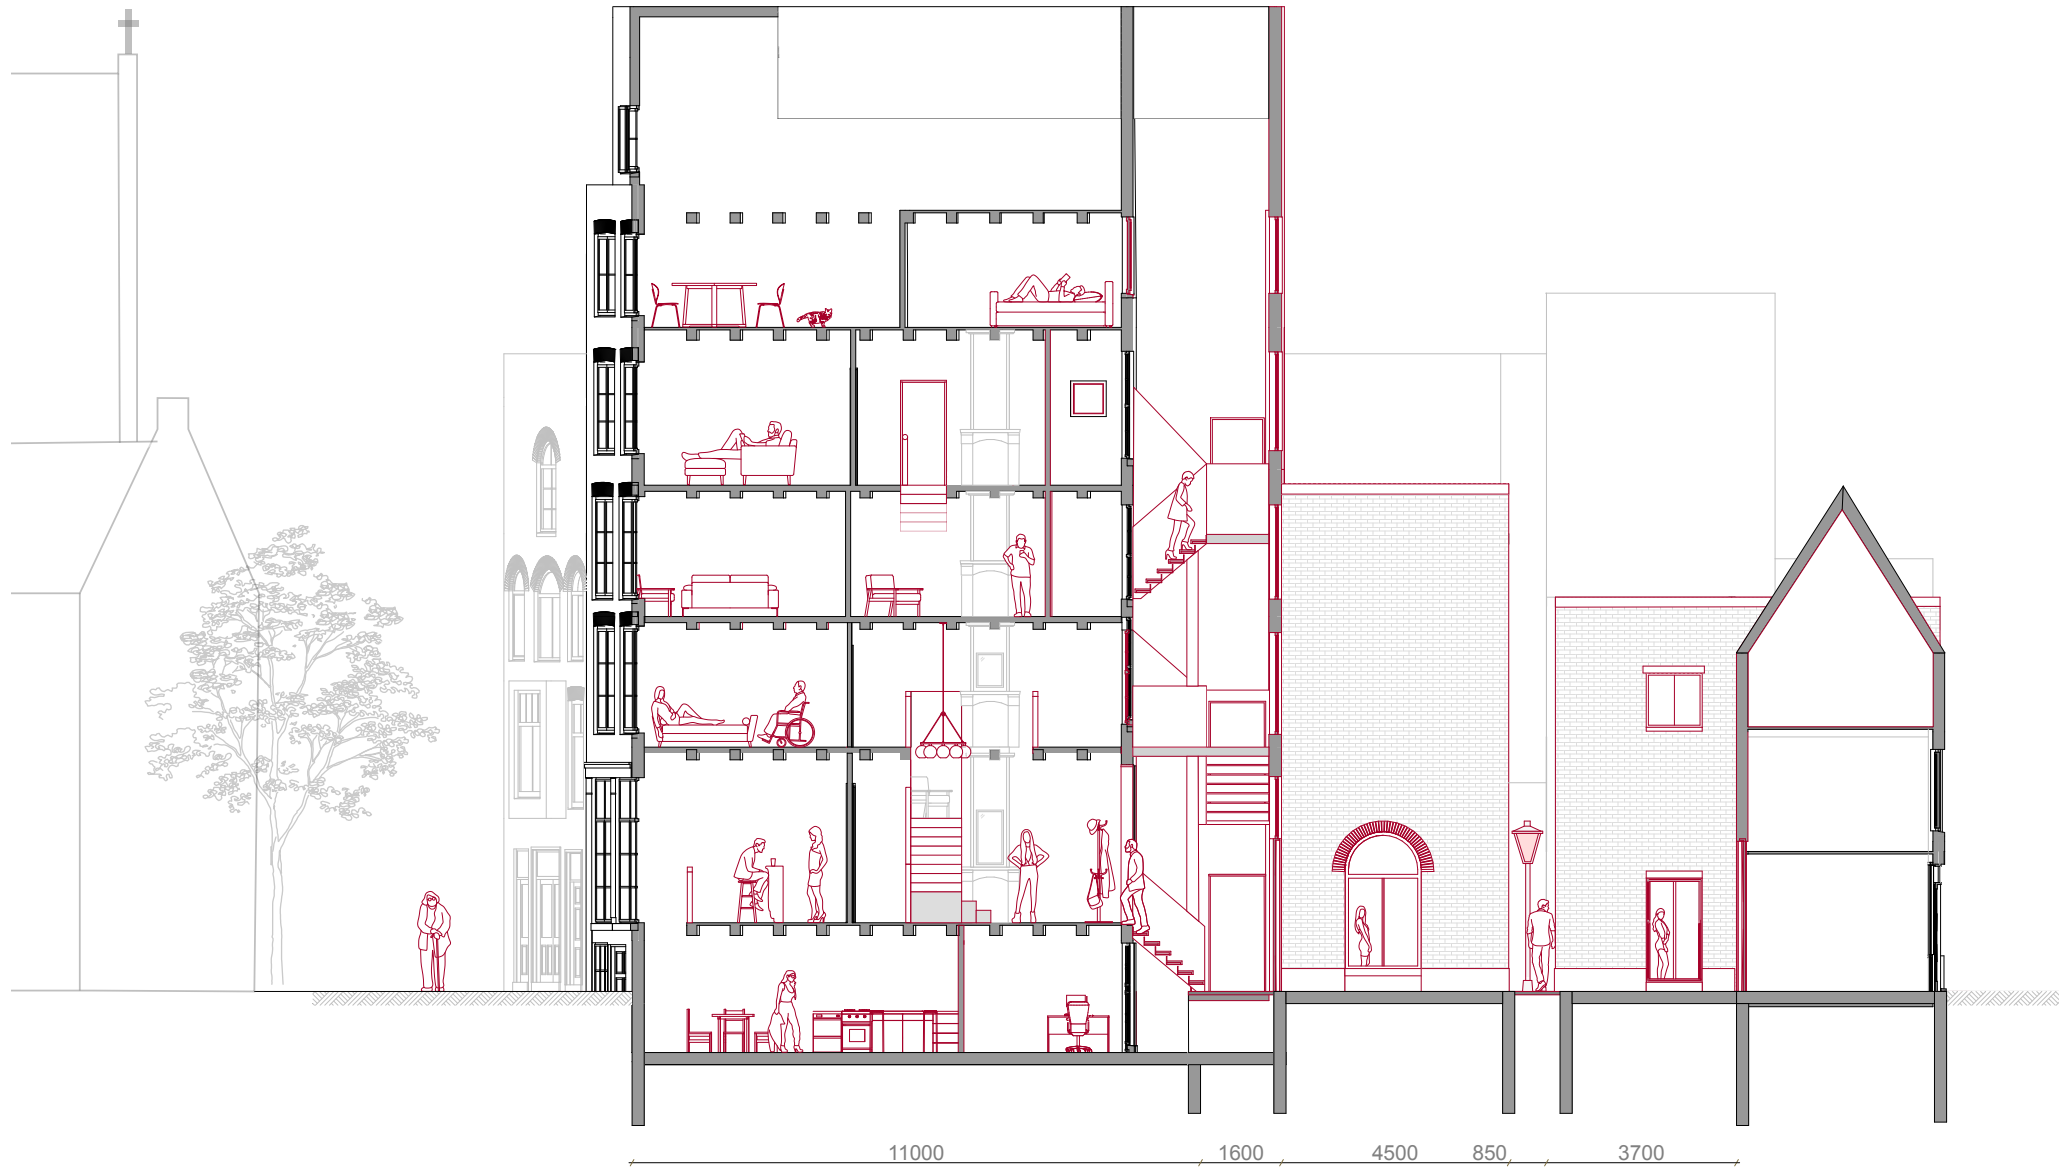
Section AA

Longitudinal Section
Window Spaces, Apartments and
Sex Work Spaces

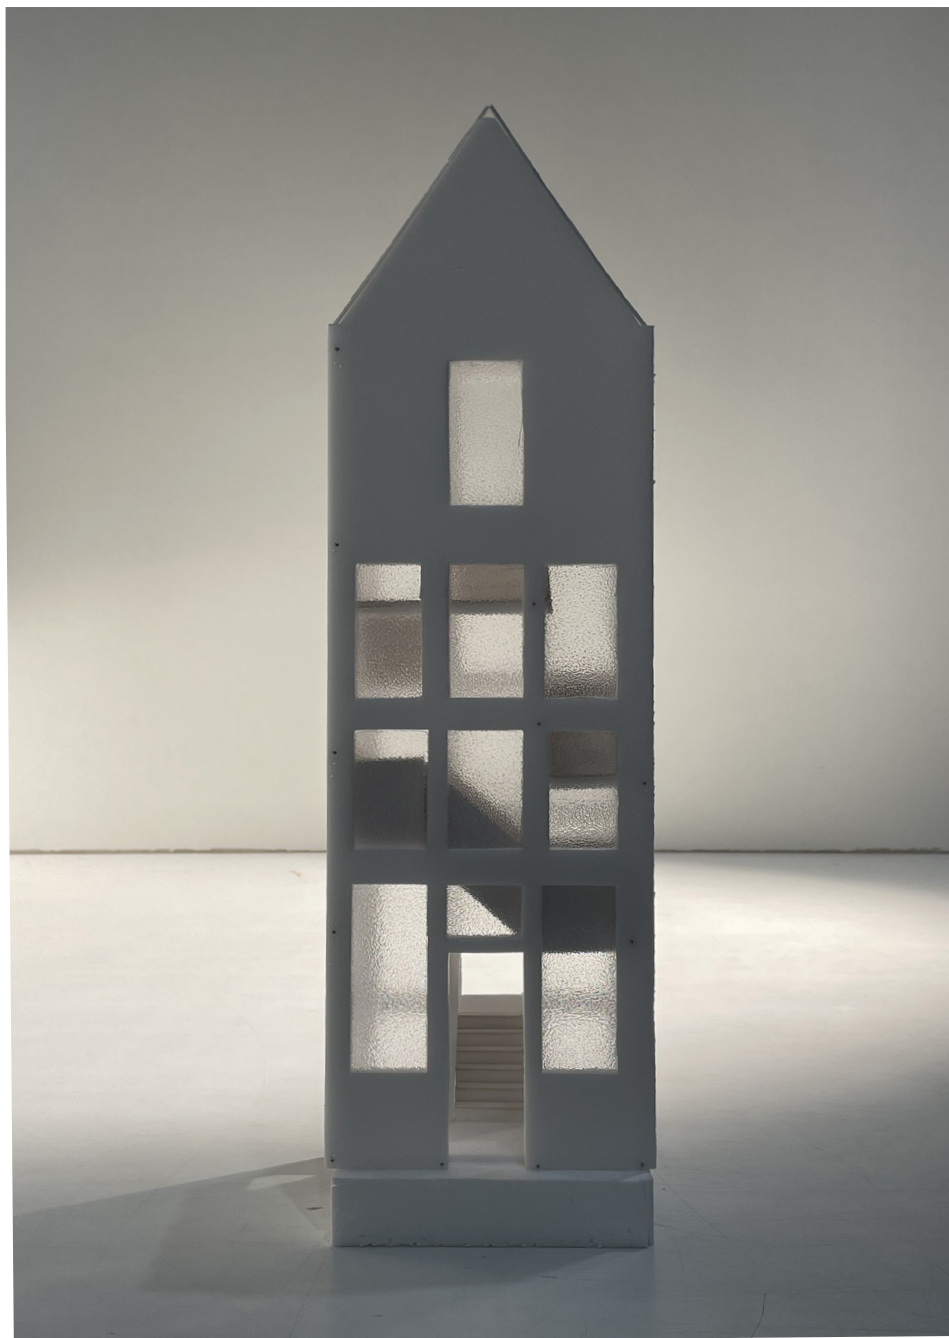
staircase model

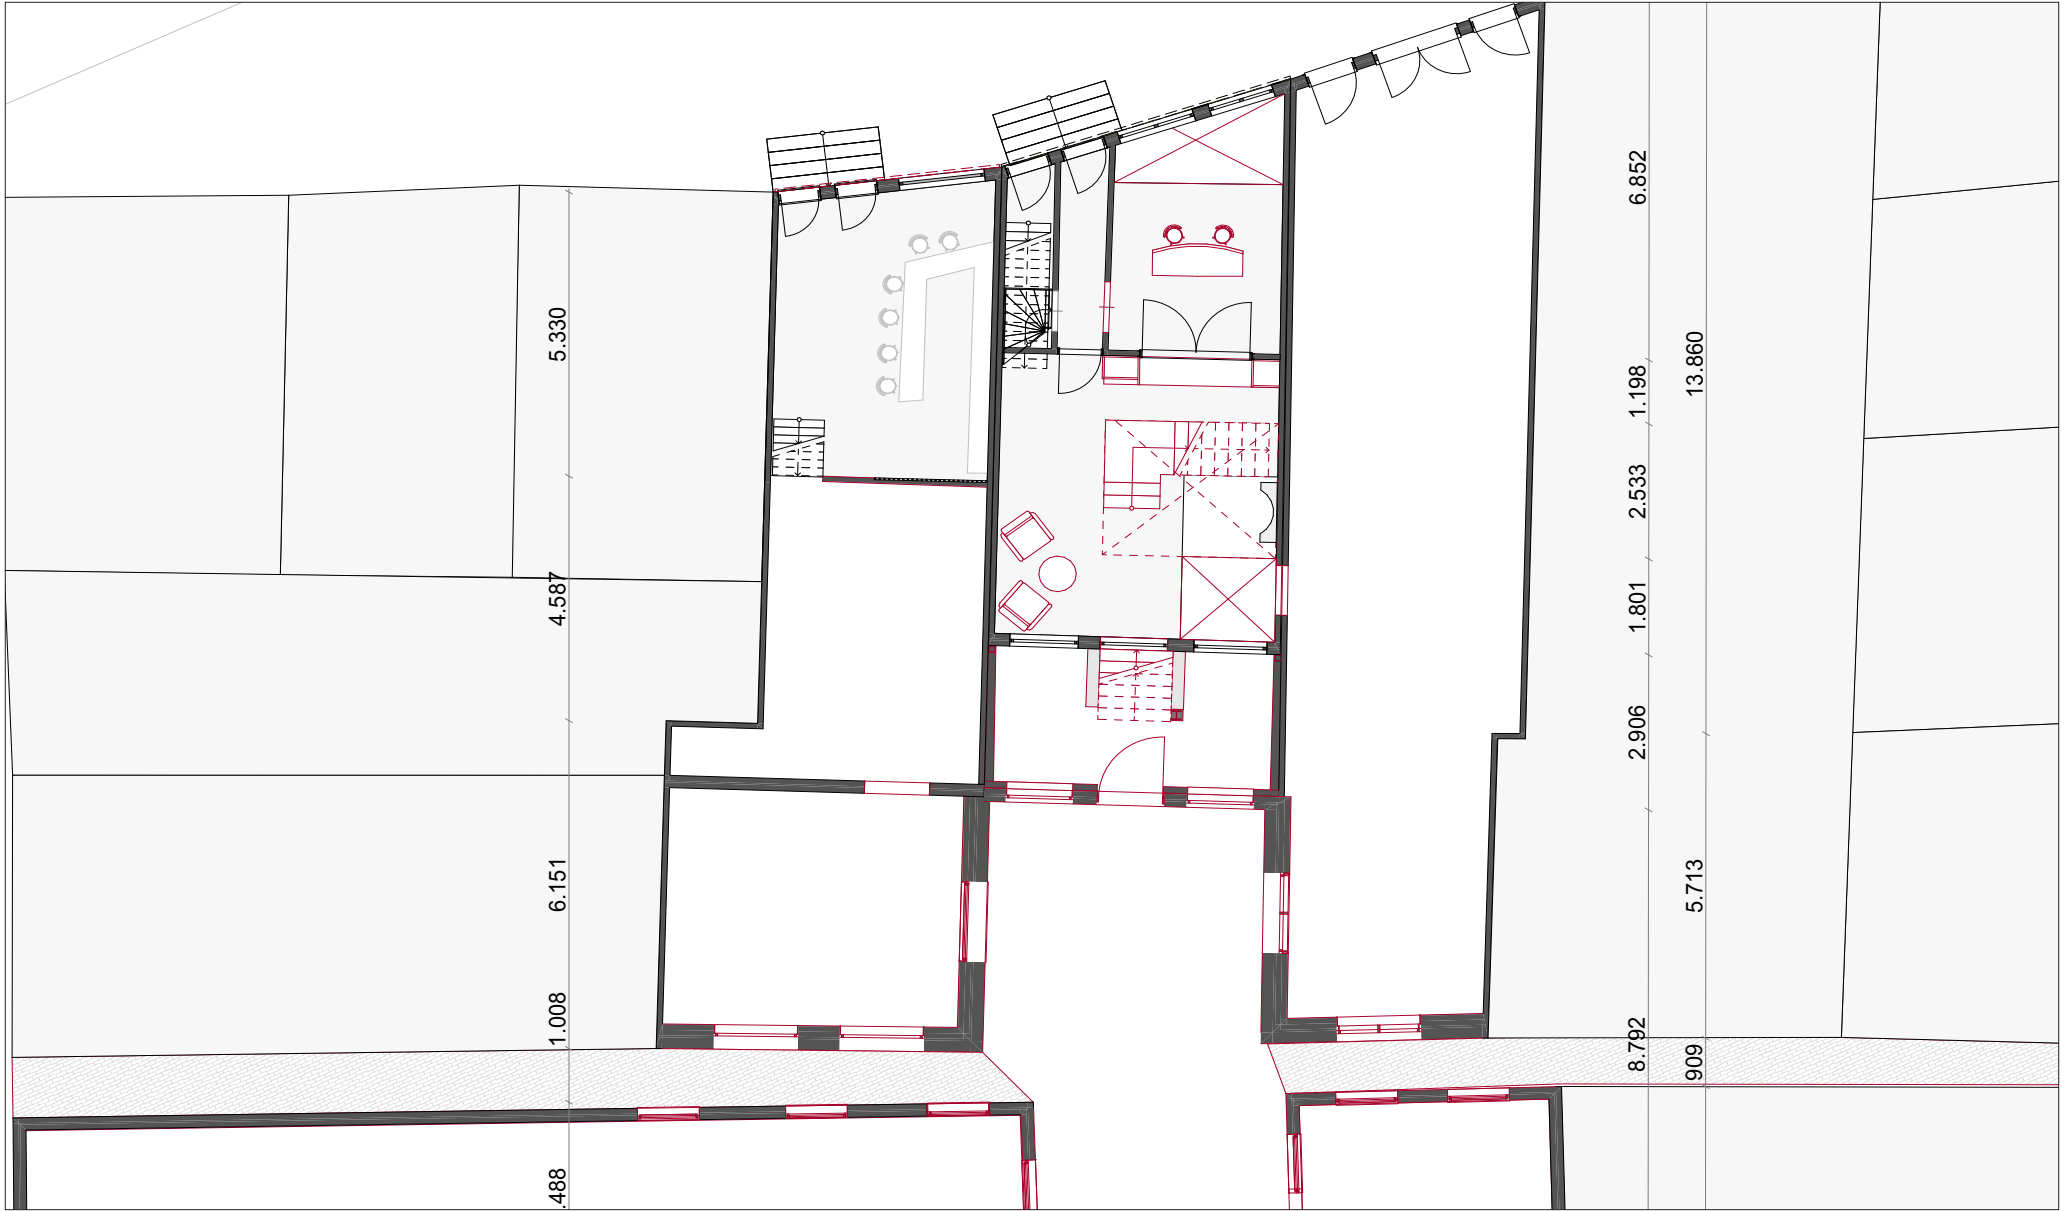
Floorplan

First Floor
Entrance and Bar
