around the window,

msc architecture graduation project, explore lab studio
january 2024

by amber sikkema
tutors: mieke vink, stavros kousoulas and jan van de voort

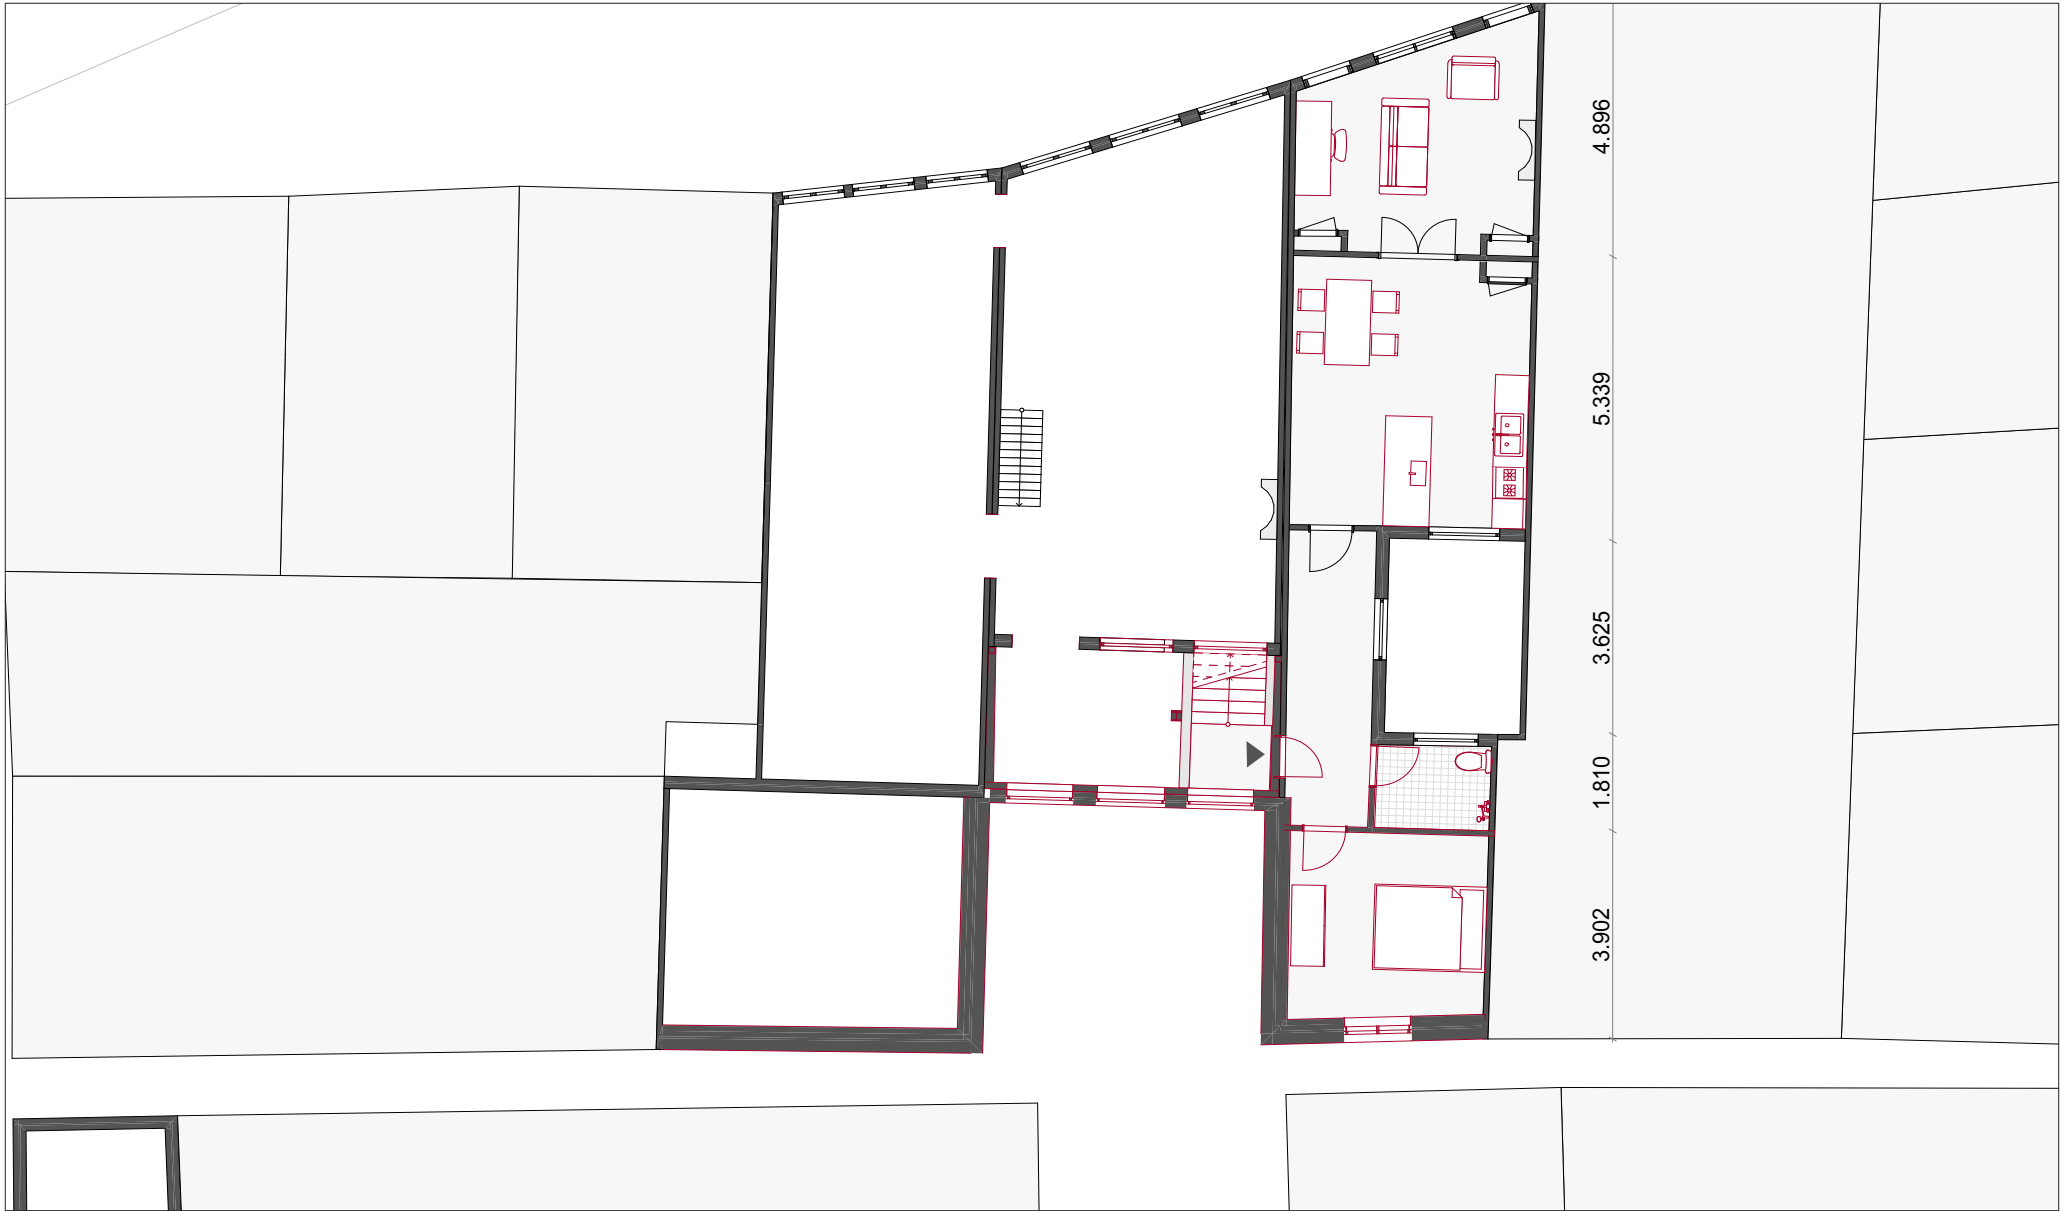
Floorplan

Fifth Floor
Appartment

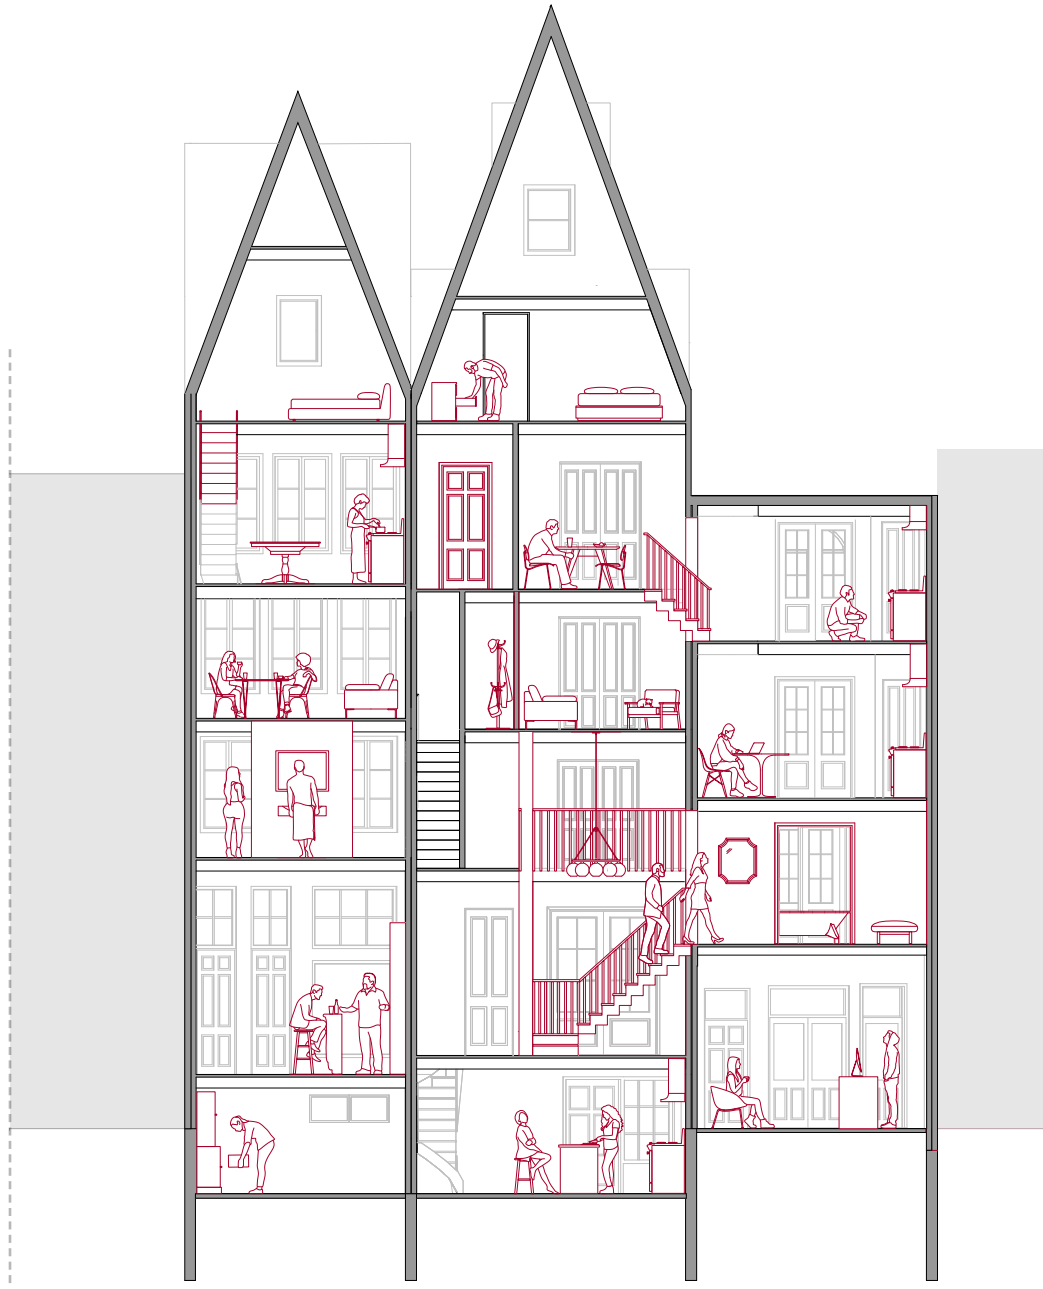
Section BB

Cross Section
Apartments and Sex Work Spaces

Scale: 1:100

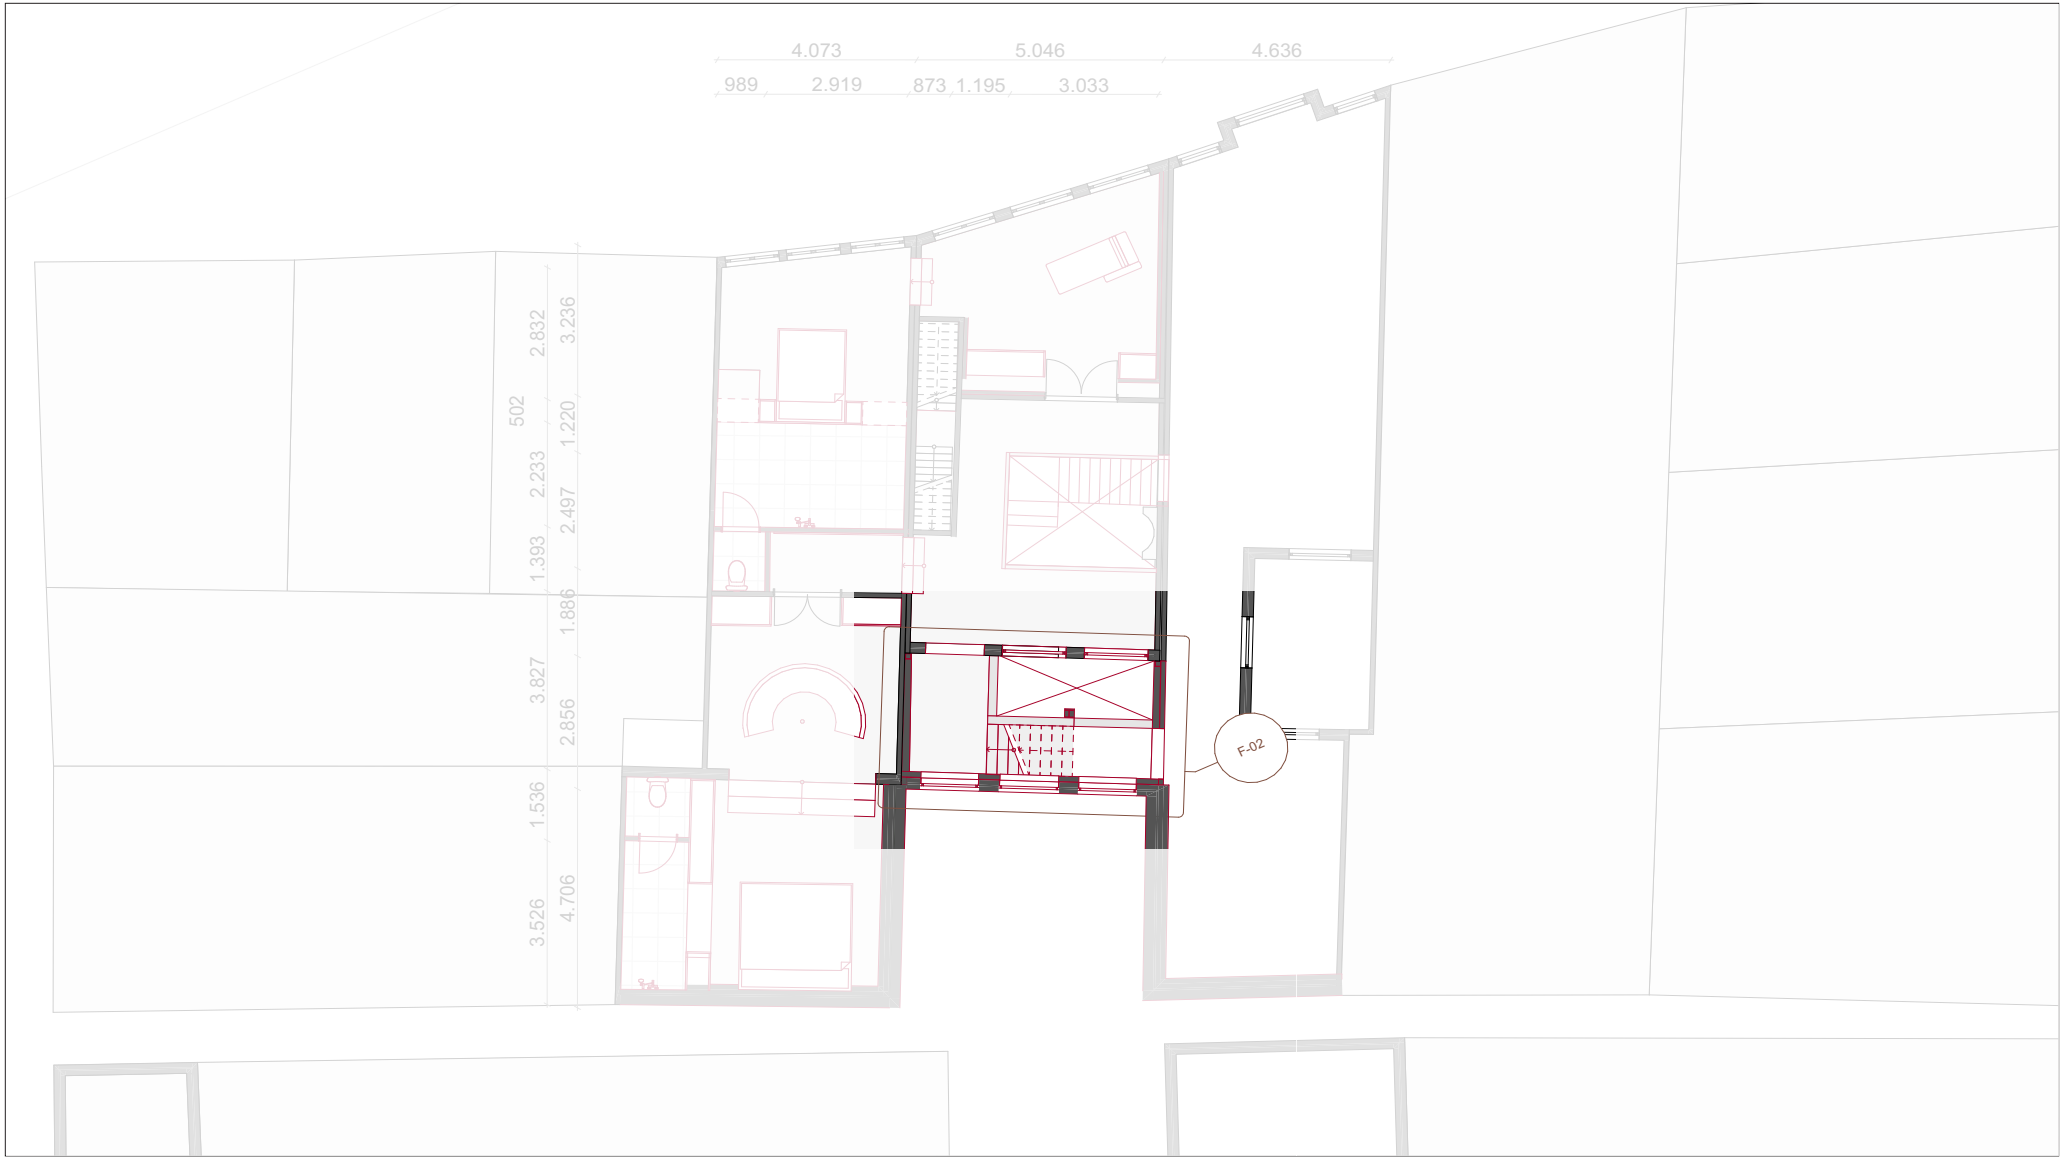
Floorplan

Fourth Floor
Sex Work Spaces

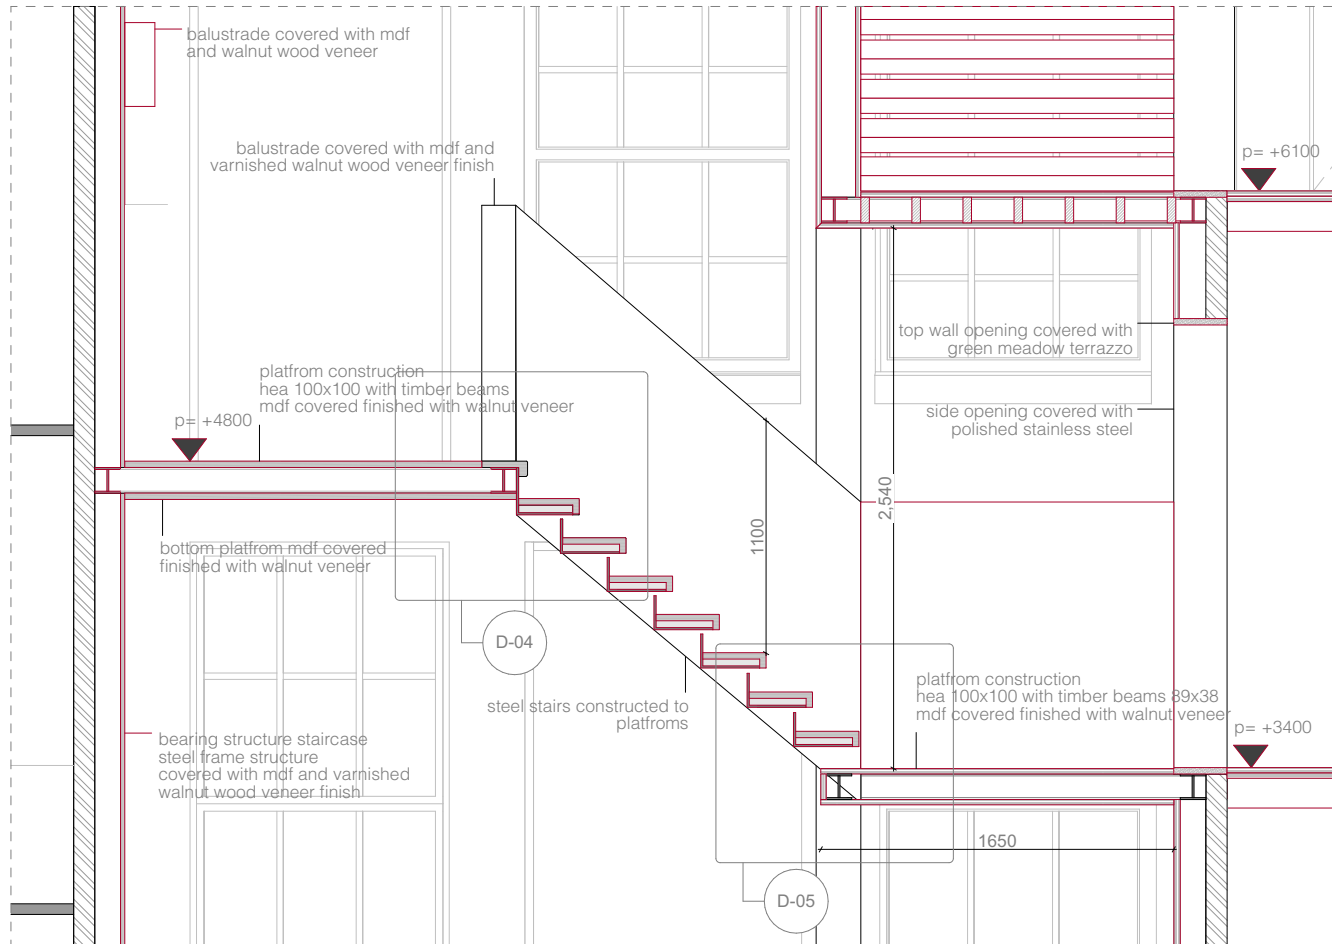
floorplan staircase 1:20

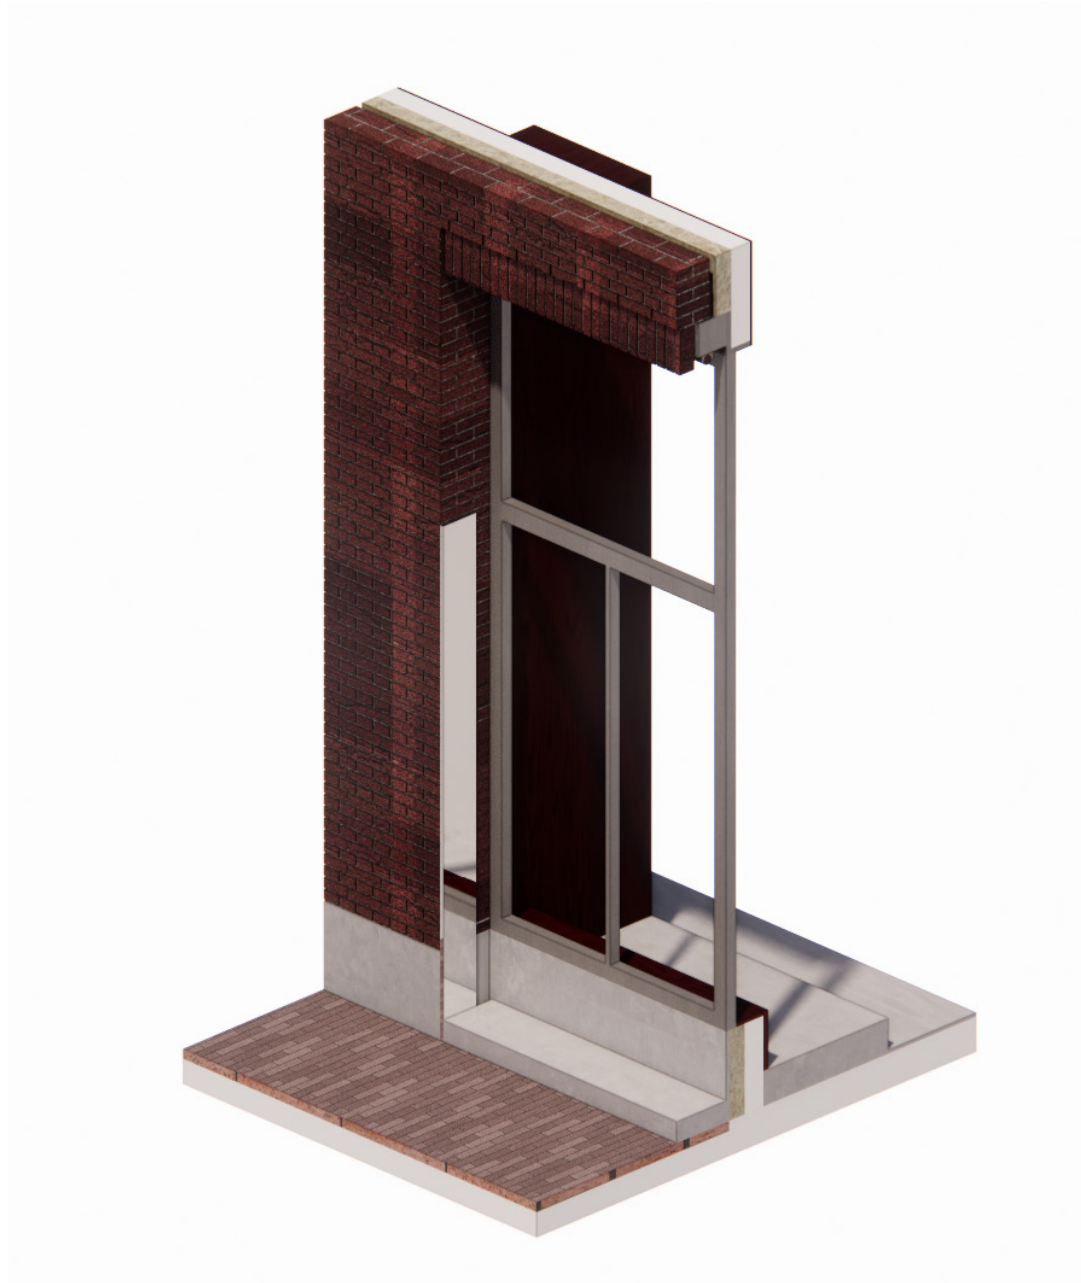
window isometric
