Static and dynamic testing of delamination in hybrid SHCC/concrete beams

Alessandro Cabboi^{*}, Othman Harrass, Sergio Sánchez Gómez, Mladena Luković

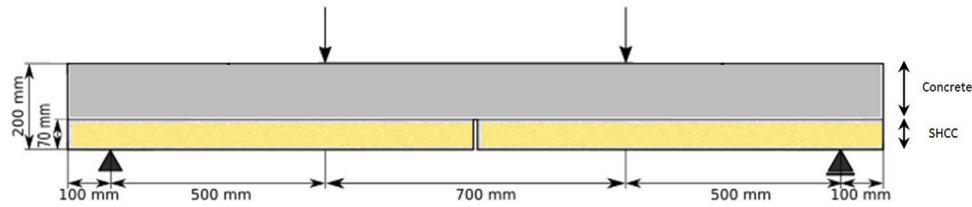
Fig. 1. Test set-up for investigating the interface behaviour in the SHCC hybrid concrete beam.

The hybrid reinforced concrete beams consists of two layers: the bottom layer, in which the reinforcement rebar is embedded, is made out of SHCC and the top one is formed by conventional concrete [11]. Since the behaviour of a hybrid structure is usually governed by the interface behaviour between the two materials, the test setup was designed in order to facilitate the investigation of the fracture behaviour of the structural interface (Fig. 1).

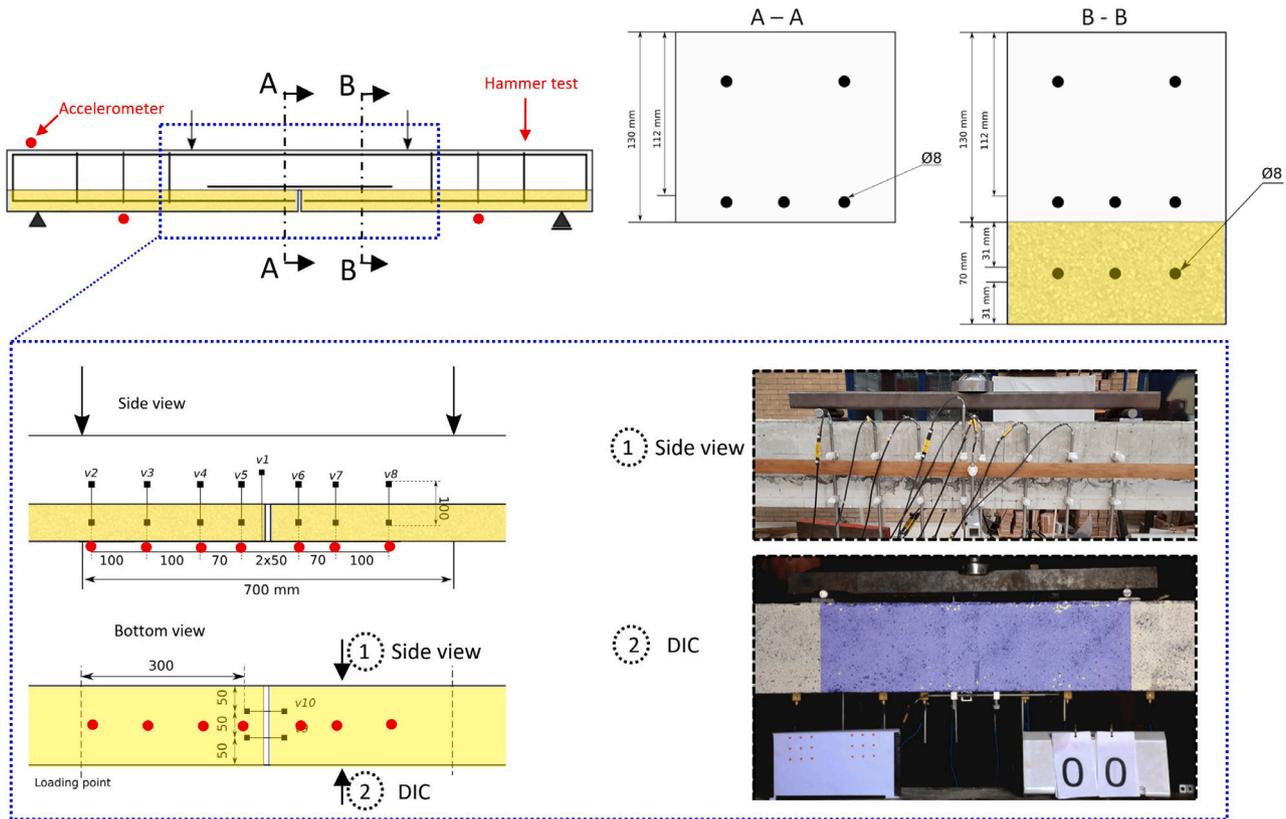
Fig. 2. Experimental setup with reinforcement design and distribution of measuring devices: accelerometers, LVDTs (labelled with v) and DIC. (For interpretation of the references to colour in this figure legend, the reader is referred to the web version of this article.)

Both the concrete and the SHCC layer were reinforced with longitudinal and vertical steel bars (see Fig. 2). First, the SHCC layer with a thickness of 70 mm was cast. A plastic spacer was placed in the middle in order to generate the aforementioned joint, separating the layer in two parts. After casting of the SHCC layer, the specimens were compacted at the vibration table for 30 s. Longitudinal reinforcement was embedded in these SHCC layers, whereas vertical stirrups were sticking out. The stirrups were placed outside the constant moment region. After 2 days of sealed curing of SHCC, the coupling reinforcement is placed and ordinary concrete was cast on top of the precasted SHCC layer.

During the tests, the DIC technique was used to evaluate the crack pattern development and crack widths [36] at each loading step (see Fig. 2). The DIC is a non-contact optical method that employs tracking and image registration techniques for accurate 2D measurements of changes in images, which allows to calculate deformations, displacements and strains on the observed surface. The technique became widely used in the concrete scientific community [37]. Besides the DIC measurements, as already pointed out, LVDTs were used for verification and to accurately measure the vertical displacements of the beams and the resulting interface and joint openings.

Fig. 12 shows the estimated frequency response functions (FRFs) from the dynamic responses recorded at location v6 (bottom side of the beam) for the Reference beam. Each FRF is estimated based on three dynamic responses triggered by hammer hits applied on top of the beam along the vertical direction (see Fig. 2). An example of a stabilization

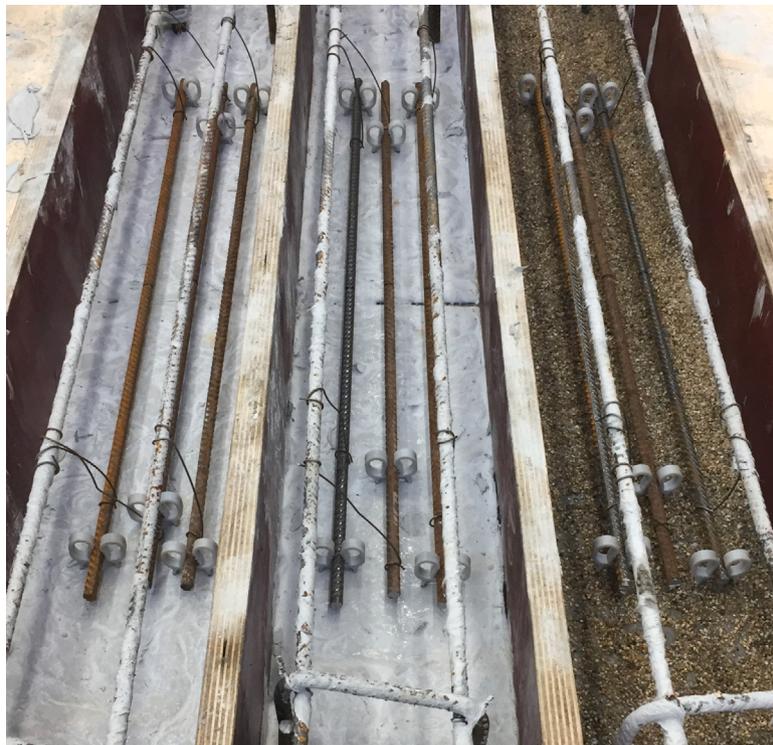
Fig. 3. Different types of interface preparation: smooth (“Reference” and “Curing”) and “Epoxy” sample with sand at the surface.

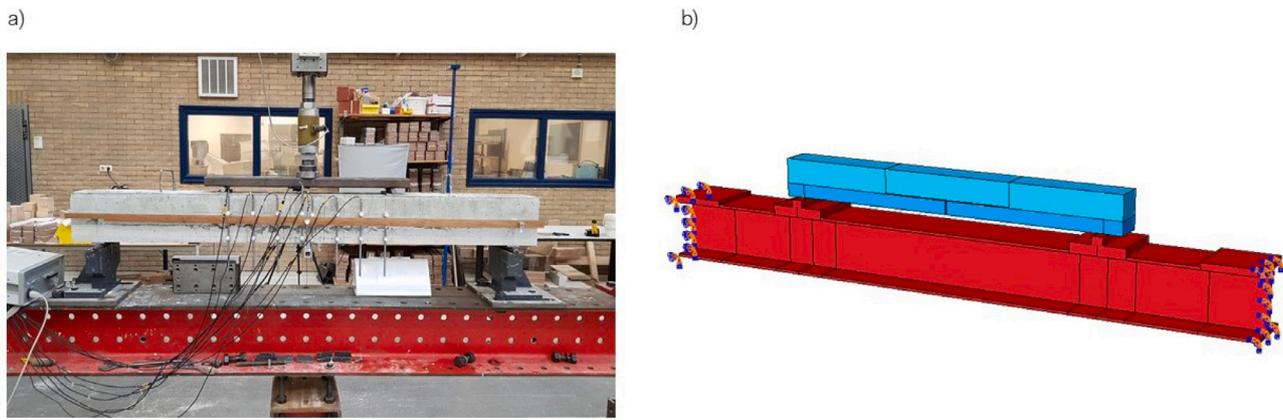
Fig. 4. Experimental setup: (a) photo taken in the laboratory of the tested hybrid beam and supporting steel beam; (b) snapshot of FE model 1.

supporting steel structure is an I-shape profile beam, 3.5 m long. The steel beam is assumed to be clamped at both ends. For the purpose of carrying out a modal analysis, the connection between the steel beam and the hybrid concrete beam is modelled by assuming an ideal bond along a line contact between two supporting rollers and the tested beams. The second FE model (model 2) simulates the tested hybrid beams only, which is assumed to be simply supported. As later explained, model 2 was used as a reference model, to mimic the effects induced by the occurrence of damage on the identified modal properties of the hybrid beams.

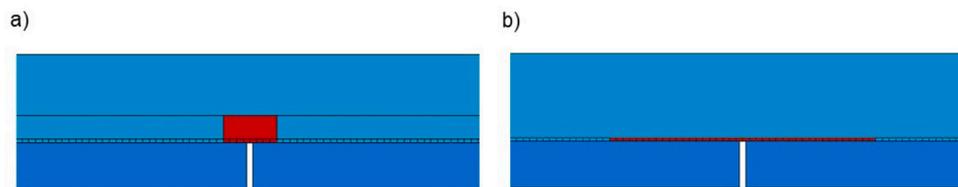
Fig. 5. Assumed damaged zone (red area): (a) FE model 2.1; (b) FE model 2.2. (For interpretation of the references to colour in this figure legend, the reader is referred to the web version of this article.)

advanced models would be necessary [42], but to use a simplified approach able to reproduce the observed damage-induced effects on the fundamental natural frequency of the hybrid beams. The advantage of mimicking the observed effect through a simplified approach, is that it can be easily implemented in larger and more detailed FE models representing full-scale structures, enabling such models to support frequency-based damage detection strategies in real-time, if needed. As mentioned above, the tuning parameter used to simulate the natural frequency variation caused by the observed delamination and crack phenomenon is the Young's Modulus of the assumed damaged zone in FE model 2.1 (Fig. 5a) and of the debonding zone in FE model 2.2 (Fig. 5b).

FE model 2.1 assumes a damaged area at the centre of the beam, as shown in Fig. 5a. This centred damaged area was approximately defined based on the significant strain concentrations that were observed in all samples within that area, especially with reference to the Epoxy sample. The size of the damaged area remained fixed, while the corresponding Young's Modulus was step-wisely reduced from 35 GPa to 35 MPa at each modal analysis run. Each reduced Young's Modulus value was kept constant throughout the modelled damaged area. The outcome of such step-wise reduction of the Young's Modulus allowed to estimate the required elastic modulus reduction of the damaged area in order to match the experimentally observed shifts of the natural frequencies. Therefore, the grey continuous line in Fig. 15a represents the simulated trend of the natural frequency reduction corresponding

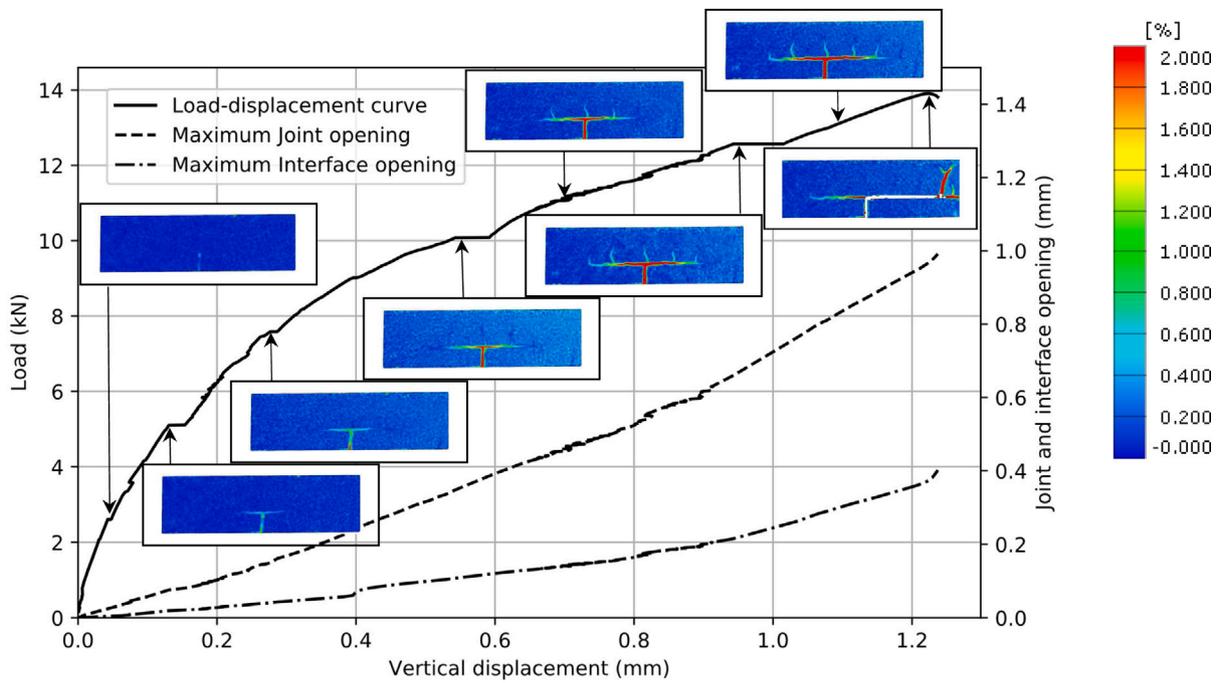
Fig. 6. Reference sample: load vs. displacement and load vs. joint and interface opening, with corresponding damage propagation obtained by the DIC. The legend on the right side indicates the equivalent von Mises strains. Note that the same legend is used in all the DIC graphs.

Fig. 6 refers to the Reference sample and provides an overview of the applied load levels, the corresponding measured vertical displacements, the joint and interface openings and the damage pattern revealed by the DIC. The measured vertical displacements refers to sensor v1, while the interface and joint openings refer to the maximum values obtained between the sensor pairs v5–v6 and v9–v10 (see Fig. 2). The DIC snapshots are linked to the legend, indicating the von Mises strains. Note that this legend is kept constant throughout the whole paper. The surface contours shown in the DIC snapshots refer to the constant bending moment region defined by the blue-marked region

in Fig. 2. It can be observed that the damage starts with a vertical crack localized at the location of the notch. Successively, delamination develops along the interface. Although delamination is the governing failure mechanism, the DIC results reveal that the sample exhibits also a combination of delamination and vertical, flexural cracking. This is especially visible for applied loads higher than 10 kN. The ultimate failure occurs due to delamination of the interface and rupture of the beam at the end of the coupling reinforcements, at a load level of approximately 14 kN, see also Fig. 7.

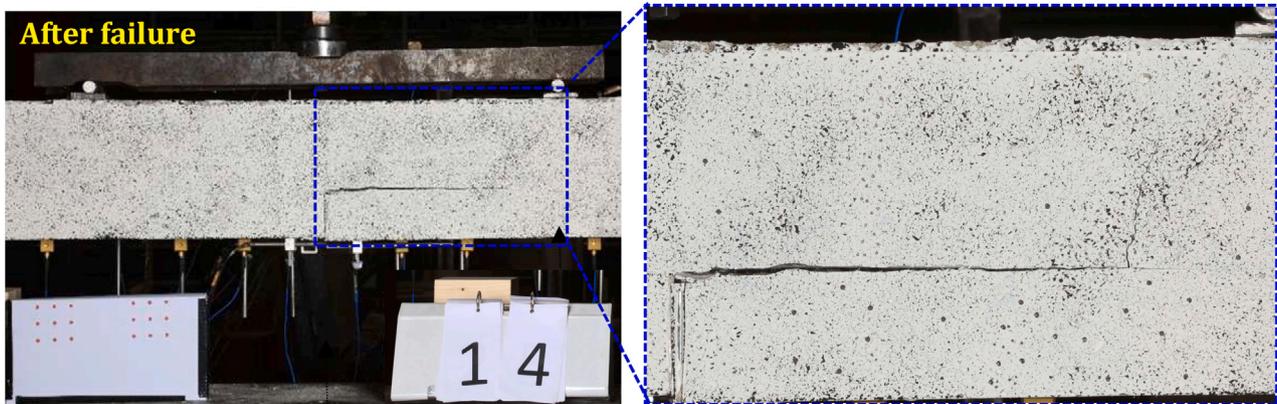
Fig. 7. Final failure in the Reference sample.

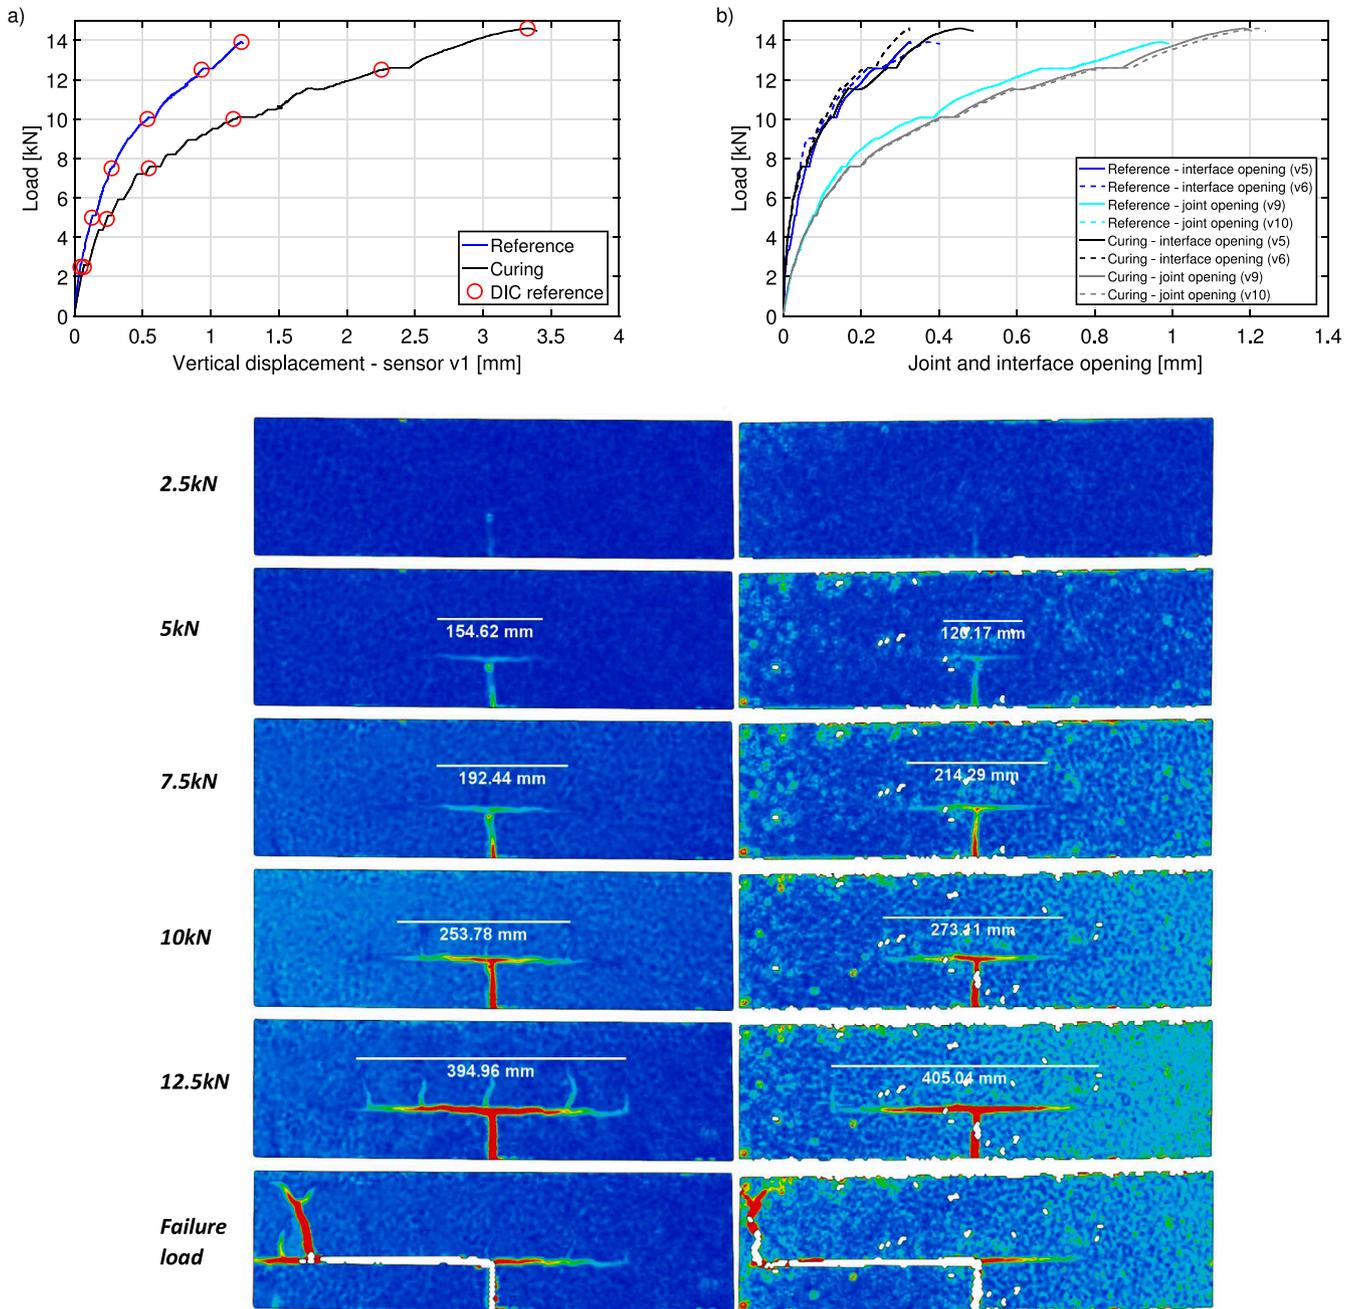
Fig. 8. Reference and Curing sample: (a) applied load vs. vertical displacement measured at sensor v1; (b) applied load vs. joint and interface opening. The figure below, shows the damage propagation in the Reference (left) and the Curing (right) beam for increasing loading steps corresponding to the red circles in (a). The same Von Mises strain legend as given in Fig. 6 is used.

In Fig. 8 the results for the Reference and the Curing beam are compared. In both load–displacement curves (Fig. 8a), the red circles indicate the points for which the DIC snapshots of the crack history are provided. In order to enable a better comparison between the two samples, at the same loading level, the length of delamination was also measured and indicated in the DIC snapshots of Fig. 8. The slope difference of the load–displacement curves in Fig. 8a shows that the stiffness of the Curing sample subjected to a shorter curing process is lower compared to the Reference sample. This might be due to shrinkage, also given the fact that some shrinkage induced cracks were observed at the surface of the SHCC layer in the Curing sample before applying the mechanical loading. Note that no additional shrinkage measurements were performed for these beams, so no further evidence is available to support the aforementioned hypothesis. Still, given that the shrinkage strain for this SHCC mix is significantly larger than that of conventional concrete [41], and that the only difference between the samples is the different curing procedure, it could be assumed that the restrained shrinkage might have had a large influence. This will be a subject of future studies. The DIC results also reveal that the Curing sample is characterized by a somewhat larger delamination length at the same applied load, exhibiting less flexural cracks compared to the Reference sample. Despite these differences in stiffness and damage propagation, the joint and interfaces openings measured for the Reference and Curing beams are fairly similar, as shown in Fig. 8b. In addition, despite the slope differences shown in Fig. 8, the type of failure and the measured ultimate load for both beams are almost identical, meaning that the different curing conditions did not alter the structural capacity of the two beams.

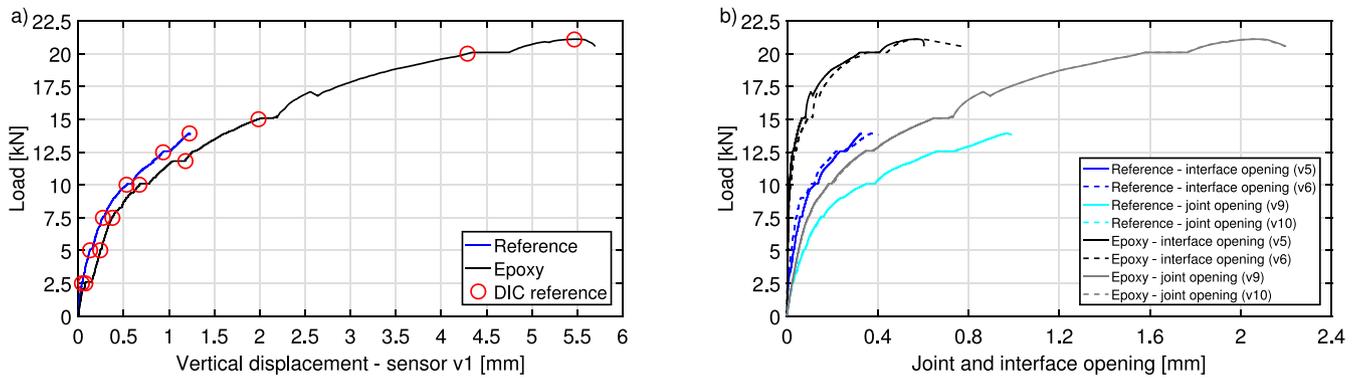
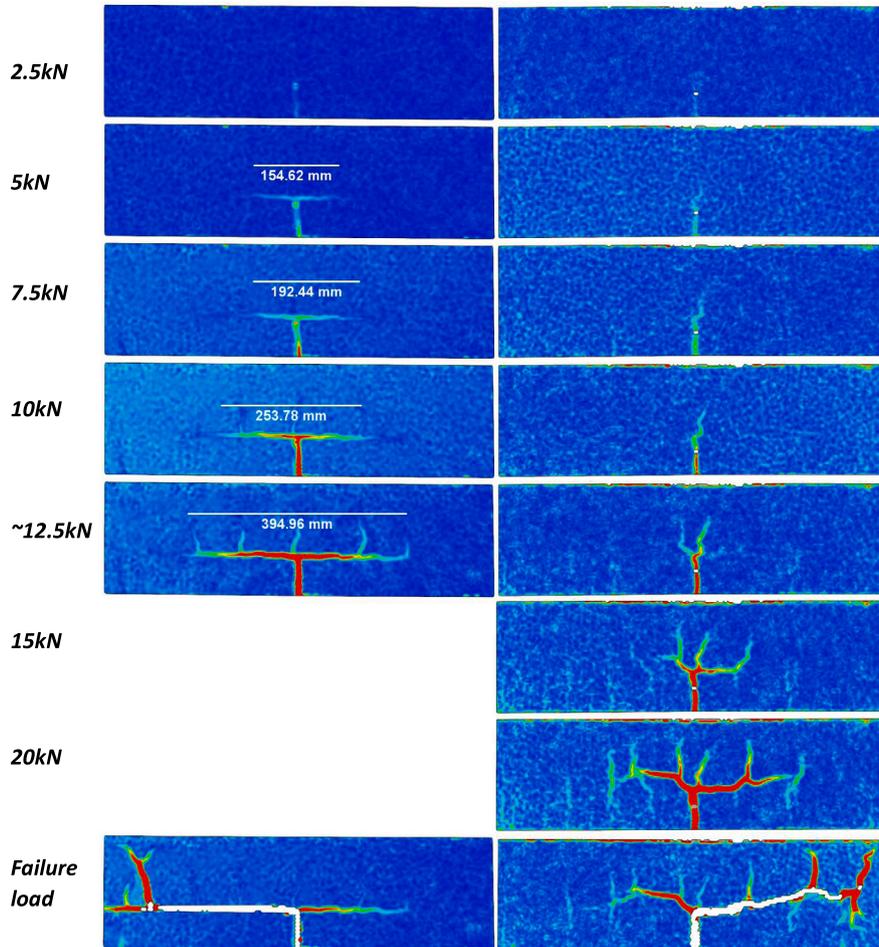
Fig. 9. Reference and Epoxy sample: (a) applied load vs. vertical displacement measured at sensor v1; (b) applied load vs. joint and interface opening. The figure below, shows the damage propagation in the Reference (left) and the Curing (right) beam for increasing loading steps corresponding to the red circles in (a). The same Von Mises strain legend as given in Fig. 6 is used.

The load–displacement curves and the load versus maximum joint and interface opening, with corresponding damage propagation for the Reference and the Epoxy sample, are shown in Fig. 9. It can be observed that, unlike for the Curing sample, the slope of the load–displacement curves of the two beams almost overlap, indicating a similar bending stiffness. However, the results indicate a significant difference in the fracture behaviour and in the structural capacity of the beams. The structural capacity of the Epoxy beam is more than 50% higher than that of the Reference and Curing sample. This can be explained by a fundamentally different failure mechanisms occurring in the Epoxy sample. Whereas in the Reference and the Curing beam the damage was triggered and driven by delamination, in the Epoxy sample a vertical flexural crack originated from the middle vertical notch, dominating the damage mechanism until a loading level of 10 kN was achieved. Subsequently, more flexural cracks, combined with limited and localized delamination occurred.

same load level is also significantly reduced in the sample with epoxy surface, as illustrated in Fig. 9b. As a final note, the crack pattern of the collapsed Epoxy sample kinked in the concrete layer (see Fig. 10). In order to better understand and characterize the propagation of this crack, after the test, the Epoxy beam was cut in the middle along its longitudinal axis. It was observed that the crack propagated along the interface only shortly in the vicinity of the notch, subsequently kinking to the horizontal coupling reinforcement in the concrete layer (see Fig. 11). The failure occurred due to the propagation of this crack along the coupling rebar. Therefore, the test on the Epoxy sample only partially provides meaningful insights into the fracture behaviour of the interface itself.

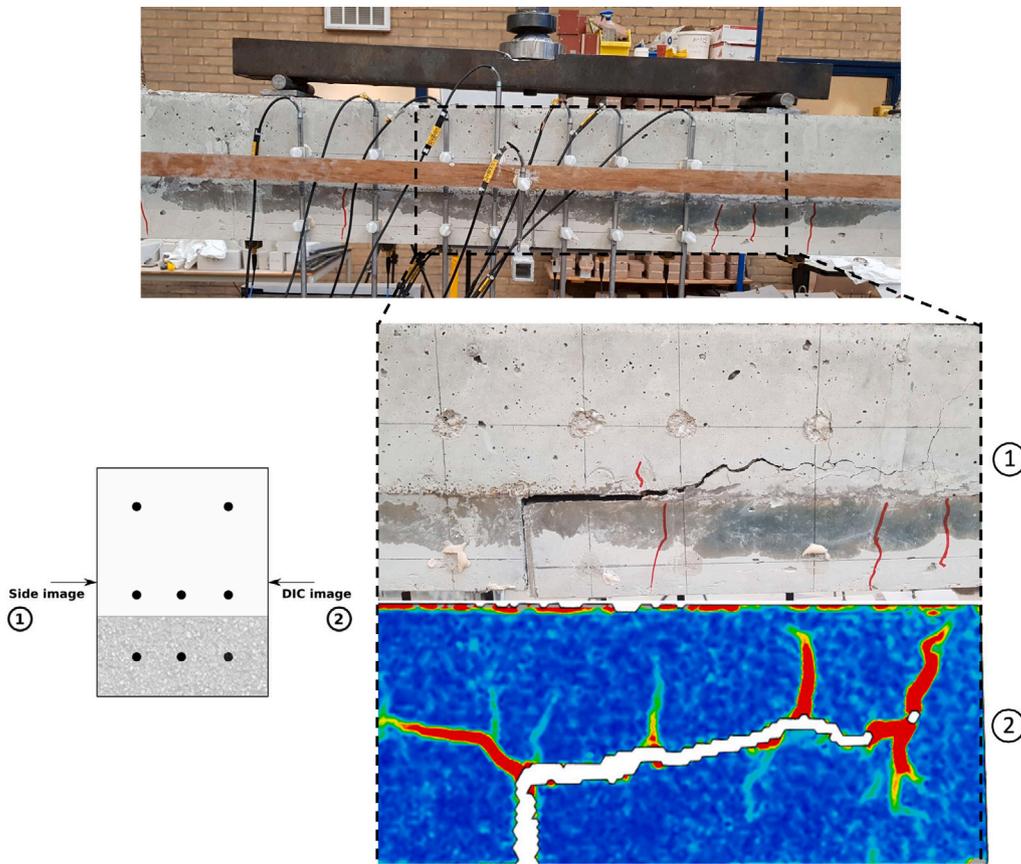
Fig. 10. Final damage in the Epoxy sample, both from the side where the DIC and LVDTs were placed. Note that, as earlier explained, the damage is not symmetrical from both sides of the beams.

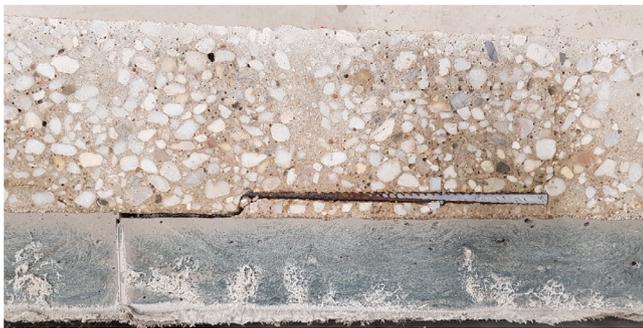
Fig. 11. Crack propagation in the Epoxy sample, within the beam, observed after cutting the sample in the middle.

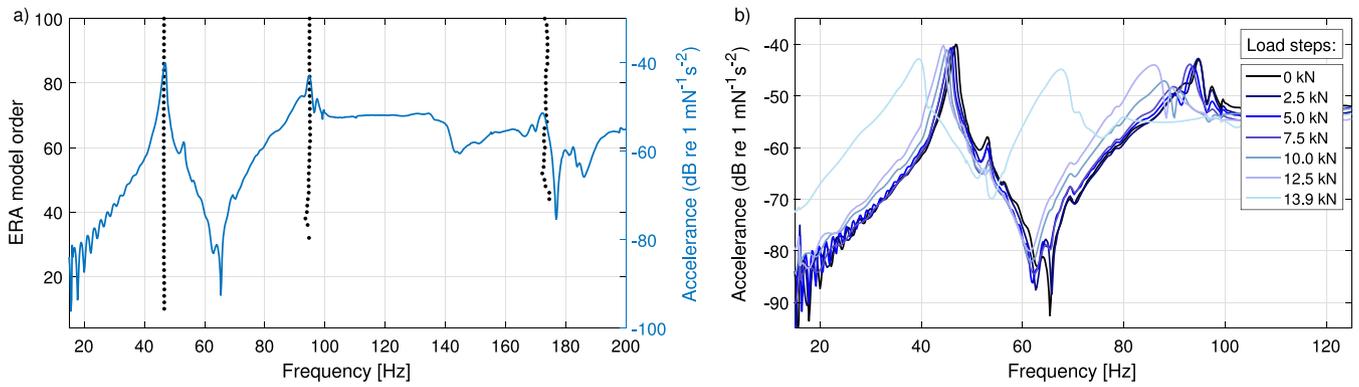
Fig. 12. (a) Identified system poles by means of the ERA method for different model orders and estimated FRF for the Reference beam; (b) estimated FRFs before and after each loading step up to failure (13.9 kN) for the Reference beam.

diagram, overlapped with one FRF to facilitate the interpretation, is shown in Fig. 12a, visualizing the identified system poles (vertically aligned black dots) for different model orders obtained through the ERA technique. Fig. 12b contains 7 FRFs referring to the dynamic responses of the same location, estimated before and in between the increasing loading steps. The effect due to the progressive damage is clearly visible through a step-wise decrease of the natural frequencies. Below 100 Hz and along the vertical direction, two frequency peaks are detectable. The first one around 47 Hz and the second one around 94 Hz. By carrying out a modal analysis of FE model 1, which simulates the whole test setup, an estimate of the mode shape corresponding to the first observed frequency peak is provided (see Fig. 13a). The identified mode shape is mainly driven by the top flange motion of the bottom steel beam. The second identified frequency peak is linked to the first

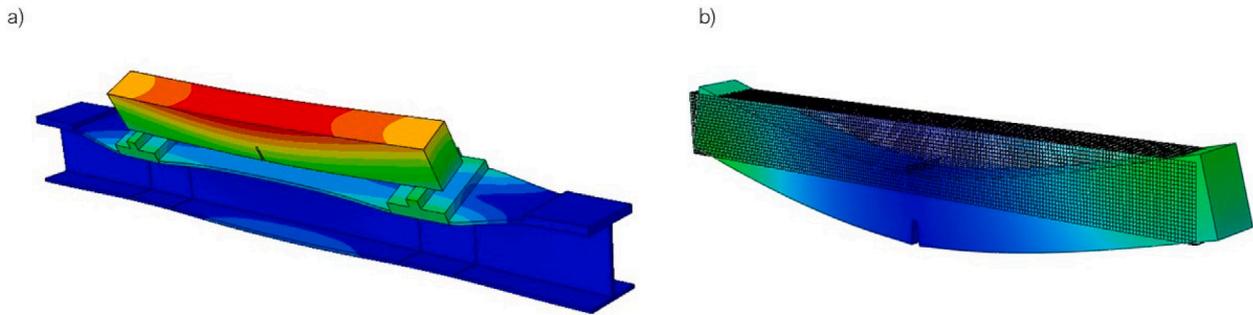
Fig. 13. (a) Simulated mode shape at 45.83 Hz (FE model 1); (b) simulated bending mode shape of the tested hybrid beam at 92.38 Hz (FE model 2).

bending mode of the tested hybrid beam. FE model 2 estimated the first bending mode at 92.38 Hz, which corresponding mode shape is illustrated in Fig. 13b. A similar bending mode around 90 Hz was also observed in FE model 1. In general, a fairly good comparison between the numerically estimated and experimentally identified bending mode shapes is highlighted in Fig. 14a. Among the few identified modes along the vertical direction (in few occasions the second bending mode was identifiable), the first bending mode of the hybrid beam turned out to be the most reliable one to capture the influence of the damage induced on the tested beams.

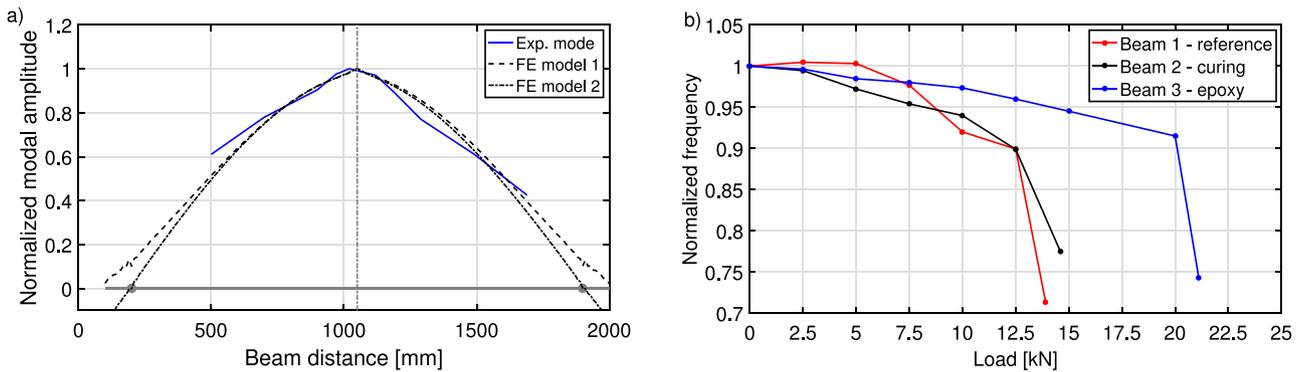
Fig. 14. (a) Comparison of the first bending mode shape between FEM and experimental result; (b) decrease of normalized frequency vs. applied load during static tests.

Fig. 14b shows the decreasing trend of the normalized natural frequency of the first bending mode of the three tested beams. The decrease is correlated to the progressive applied load. The similarities and differences in the structural capacity between the three beams

observed in Section 3.1 are also reflected in Fig. 14b. The Curing and Reference samples exhibit a comparable behaviour in terms of decrease of the natural frequency. On the other hand, the slope of the curve showing the natural frequency decrease is slightly lower for the Epoxy sample, which exhibited a higher structural capacity (Fig. 9). Interestingly, all three beams exhibited a 10% frequency reduction just one load step before failure (i.e. at a load level which is approximately 15% lower than the failure load).

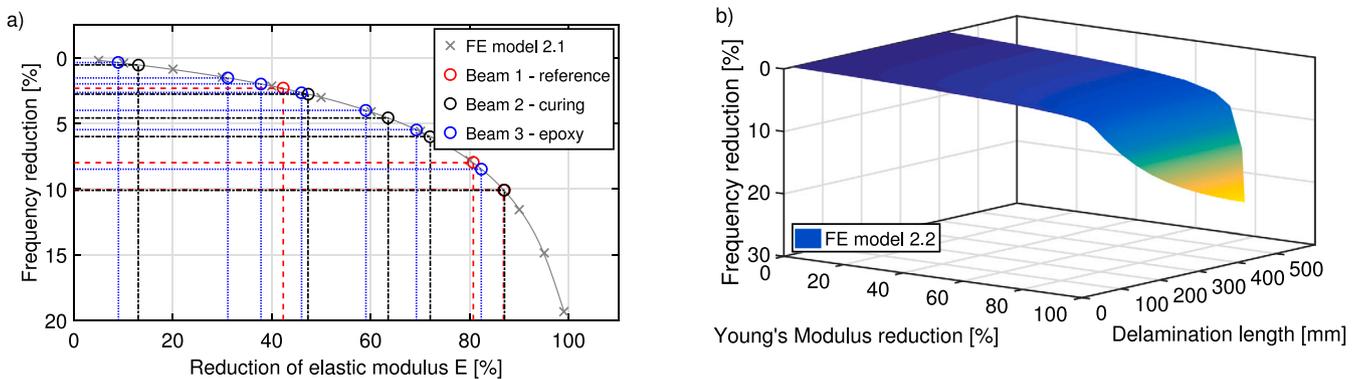
Fig. 15. (a) Delamination-induced frequency shifts simulated by submodel 2.1 due to a reduction of the Young's Modulus and measured frequency variation of the first bending mode for all three beam samples; (b) delamination-induced frequency shifts simulated by submodel 2.2 due to a reduction of the Young's Modulus and an increase of the delamination length.

FE model 2.2 is a more representative model of the delamination process since it also includes the information about the experimentally observed debonded length. This model was used to mimic the frequency shifts of the Reference and the Curing sample, since the delamination in the Epoxy sample was limited. Fig. 15b shows a 3D surface of the estimated natural frequency reduction for a given Young's Modulus reduction, considering the actual, i.e. experimentally measured, delamination length. Therefore, for a fixed delamination length, different values of Young's Modulus were ascribed (from 35 GPa down to 35 MPa) and the corresponding natural frequency reduction was evaluated. The delamination length varied between 0 and 700 mm with a step-wise increase of 20 mm. In each simulation, the reduced value of the Young's Modulus was assumed constant throughout the chosen delamination length. The 3D surface shown in Fig. 15b, was

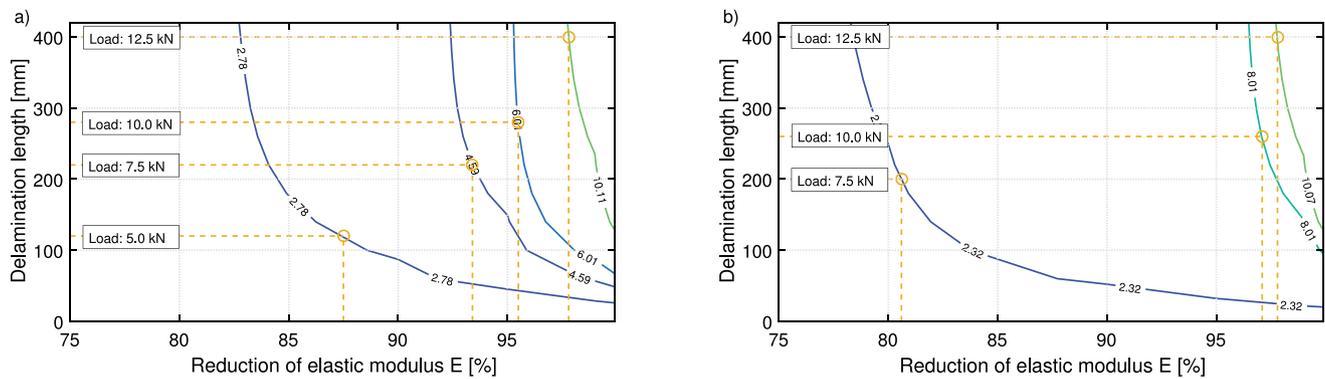
Fig. 16. Contour lines of the simulated delamination-induced frequency shifts and corresponding elastic modulus reduction for (a) Curing and (b) Reference sample.

then used with reference to the observed delamination length for the Reference and Curing beam. The contour lines in Fig. 16a and Fig. 16b correspond to the observed natural frequency reduction expressed in percentage (see text within the contour lines) of the Reference and Curing sample. The measured delamination lengths taken from both beams (see Fig. 8) were then used to intersect (see yellow dashed lines) the selected contour lines in order to pin down the corresponding Young’s Modulus reduction of the thin elastic layer representing the debonding zone.

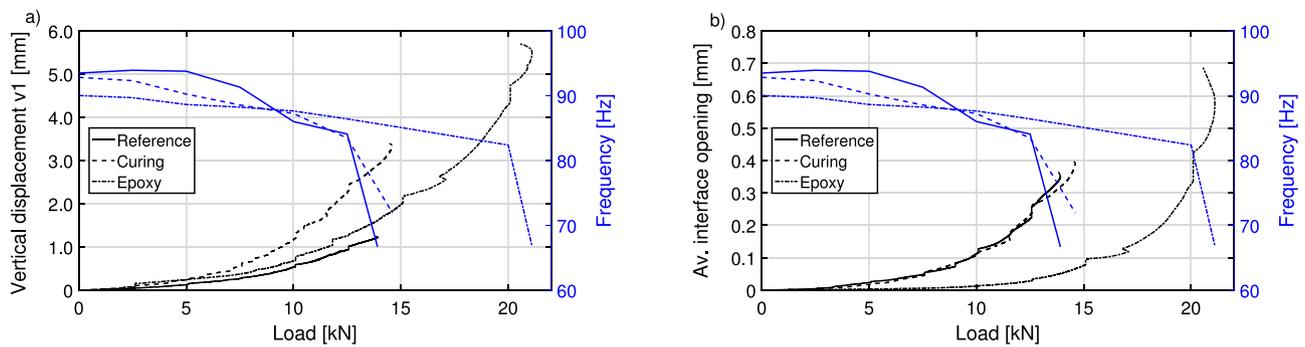
Fig. 17. (a) Vertical displacement and resonance frequency vs. applied load; (b) average joint opening between sensor v10 and v11 and resonance frequency vs. applied load.

decrease of all the beams with the measured vertical displacements (Fig. 17a) and the averaged interface opening between sensor v5 and v6 (Fig. 17b). The difference of the structural capacity between the Epoxy sample and the Reference and Curing sample can be detected in both the static- and dynamic-related properties. However, no further similarities between the two type of information can be deduced. Overall, the load–displacement curves and the DIC results provide more valuable insights with reference to the characterization of the delamination process and the structural capacity of the beams than the information retrieved by the hammer tests. The load–displacement curves, for example, exhibit a neat slope difference (after a load of 5 kN) between the Curing and the Reference (or Epoxy) beam, while the slope of the natural frequency–load curve is less clear and more scattered. This scatteredness is mainly due to the non ideal testing setup for the dynamic measurements. The hammer tests were carried out after each loading step with the beam supported by two rollers. In order to avoid excessive movements of the beam and of the rollers, which could have caused a misalignment for the static test, the hammer hits were rather gentle, inducing a moderate excitation of the beam. In addition, the location of the hammer hits was close to one of the roller supports, which is not ideal to trigger a proper dynamic response for dynamic identification purposes. The consequences of these non ideal conditions are reflected by the FRFs shown in Fig. 12, in which only the first bending mode (in addition to the steel flange mode) of the tested beam was detectable. The second bending modes of the beams were detectable only in very few occasions and were therefore neglected for this study.

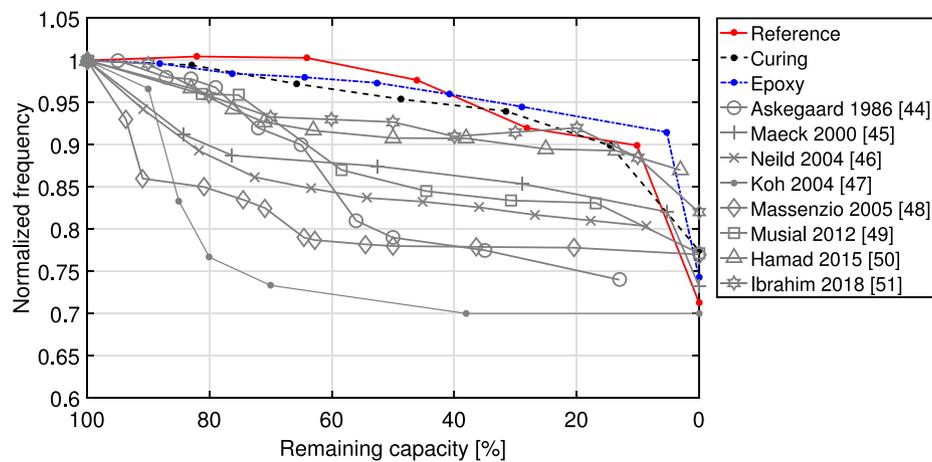
Fig. 18. Decrease of normalized frequency vs. remaining structural capacity, computed as a ratio between applied load and ultimate load. The graph compares the modal test results obtained in this paper with published results in [47–54,56].

A final analysis was carried out by inspecting the correlation between the decrease of the normalized natural frequencies and the remaining structural capacity of the beams, shown in Fig. 18. The remaining capacity is expressed in percentage, where 100% refers to the initial state of the beam and 0 to the collapsed state. The estimates of the remaining capacity are defined by the ratio of the difference between the ultimate and applied load to the ultimate load. It can be observed that the decreasing trend of the natural frequency with reference to the decreasing remaining structural capacity is strikingly

According to Fig. 18, and with respect to the Reference, Curing and Epoxy beam, a remaining structural capacity of 30% to 40% corresponds to a maximum decrease of the natural frequency of only 5%. Based on FE model 2.1, the Young's Modulus would need to be reduced by roughly 60% (see Fig. 15). A significant reduction in the resonant frequency (>5%) was observed only when the specimens were close to failure. At complete failure, the natural frequencies decreased by 20% to 30% for the different specimens. The final reduction is fairly in line with the identified variation of the first bending mode of damaged reinforced concrete beams available in the literature [47–54] (see also [55] for summary tables listing observed natural frequency variation). As shown in Fig. 18, the final natural frequency decrease is slightly higher than the 24% reduction reported in [51,52] for the first bending mode, and higher than 13% as reported in [53]. The most striking difference highlighted by Fig. 18 refers to the slope of variation of the normalized natural frequency vs. remaining structural capacity curves. The first bending mode of the three tested samples (Reference, Curing and Epoxy) seem to be quite insensitive to the induced damage, while the slope of all the other curves exhibit a higher steepness at earlier level of damage while reaching a plateau when approaching the ultimate load. The difference might be linked to the different damage mechanism the tested beam were subject to. The results summarized by the grey curves in Fig. 18 refer to natural frequency variations of reinforced concrete beams caused by the occurrence of flexural cracks finally resulting in the yielding of the reinforcement bars, while the damage and failure mechanism of the hybrid beams under investigation were driven by the interface behaviour (for the Reference and Curing sample) and by a predominant flexural cracking, combined with delamination, for the Epoxy sample. All the tested samples led to a brittle failure of the concrete at the end of the coupling reinforcement bar.
