Nature-friendly banks in the IJssel River - Measurements, analyses and recommendations

Anthropogenic Rivers: Book of Abstracts NCR DAYS 2022 13-14 April | TU Delft

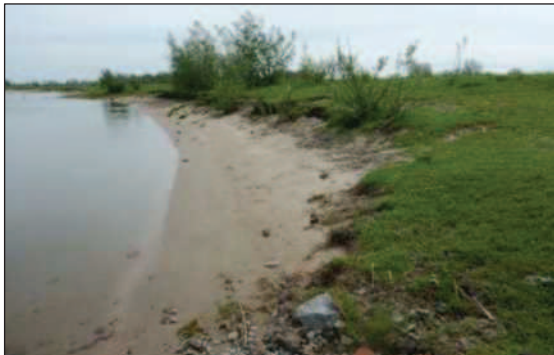
Figure 1. Nature-friendly bank at Welsumer Waarden in 2017, shortly after protection removal and excavation

RWS Oost-Nederland realised 14 new NVOs along the IJssel River in 2016 (e.g. Fig. 1). To prevent too much initial sedimentation in the fairway, the NVOs were pre-excavated during construction, with slopes between 1:10 and 1:3 (Fig. 2). A monitoring programme over 2016–2020 was implemented based on the conceptual model of Baar et al. (2014). The goal of this study was to evaluate the available data to explain differences in morphological evolution of NVOs along the IJssel and generate generic
