Corrosion Science

Molybdate as corrosion inhibitor for hot dip galvanised steel scribed to the substrate: a study based on global and localised electrochemical approaches

ABSTRACT

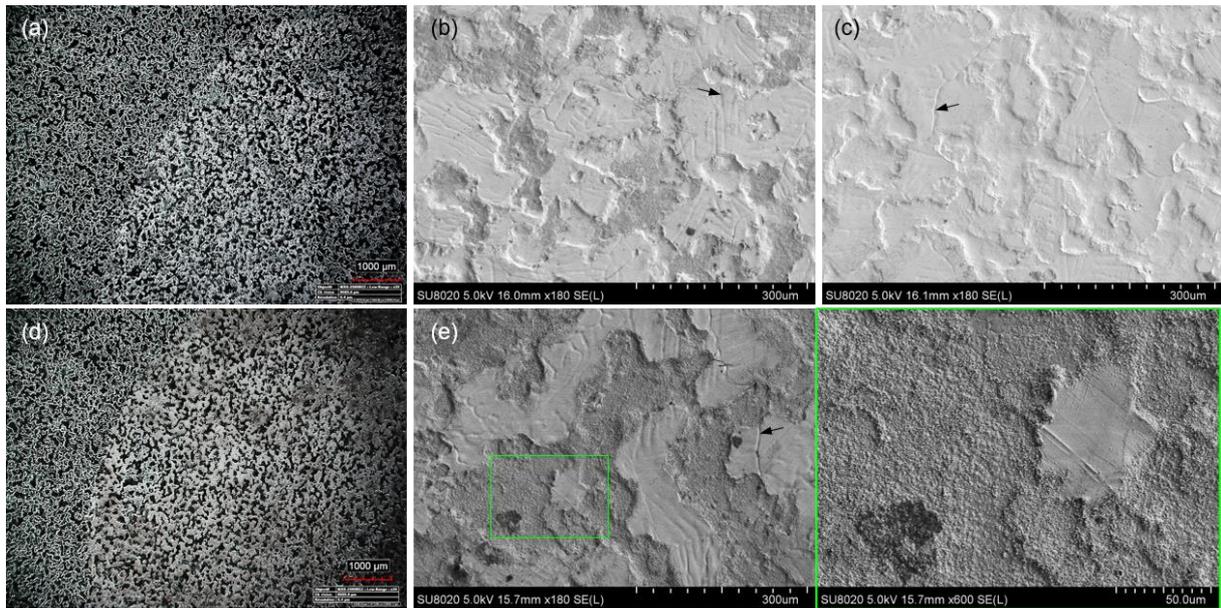
Fig. 1. (a, d) Optical and (b, e) Scanning Microscopy (secondary electron) analyses of galvanised steel surfaces from the HDG/mild steel galvanic pair after ZRA testing in (a, b) 0.05 M NaCl or in (d, e) 0.05 M NaCl + 5 mM Na₂MoO₄. (c) SEM image from a reference HDG surface. The white arrows in (b), (c) and (e) indicate roll marks from the skin-passing treatment. Inset in (e) shows a zoom of a region covered by Mo-based precipitates.

The resulting HDG surfaces after ZRA experiments performed in 0.05 M NaCl or 0.05 M NaCl + 5 mM Na₂MoO₄ solutions were compared through optical and scanning microscopy analyses (Fig. 1). First, the surface changes induced by corrosion testing were observed in the circular exposed areas delimited by protective tape (Fig. 1(a) and (d)). Secondly, in both cases, the "summits" of the skin-passed structured remained rather unaltered, and the "valleys" were preferentially affected (Fig. 1(b) and (e)). Nonetheless, while these depressions seemed corroded after immersion in NaCl solution (Fig. 1(b)), they appeared extensively covered by precipitates upon exposure to molybdates (Fig. 1(e)). As a reference, a HDG surface before corrosion testing is also displayed (Fig. 1(c)).

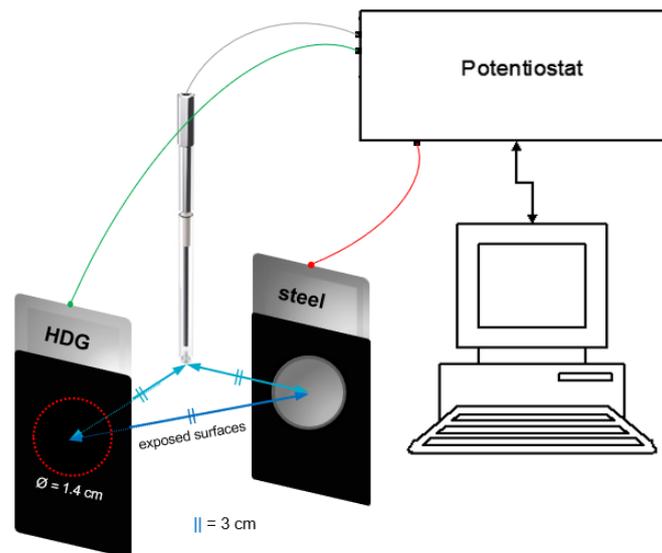
Fig. 2. Schematic representation of the HDG/mild steel galvanic coupling configuration for ZRA testing. The area ratio of the exposed surfaces ($\sim 1.5 \text{ cm}^2$) was equal to 1.

A HDG/mild steel galvanic coupling model was designed for ZRA testing. Rectangular coupons of both materials ($2 \times 7 \text{ cm}^2$) were protected using tape for corrosion testing (3M™ Scotchrap™ 50). Each tape strip was previously pierced with a 1.4 mm diameter punch tool, thereby generating samples with $\sim 1.5 \text{ cm}^2$ of exposed area. The area ratio of the electrodes was equal to 1. A schematic representation of the HDG/mild steel galvanic coupling configuration for ZRA testing is presented in Fig. 2.

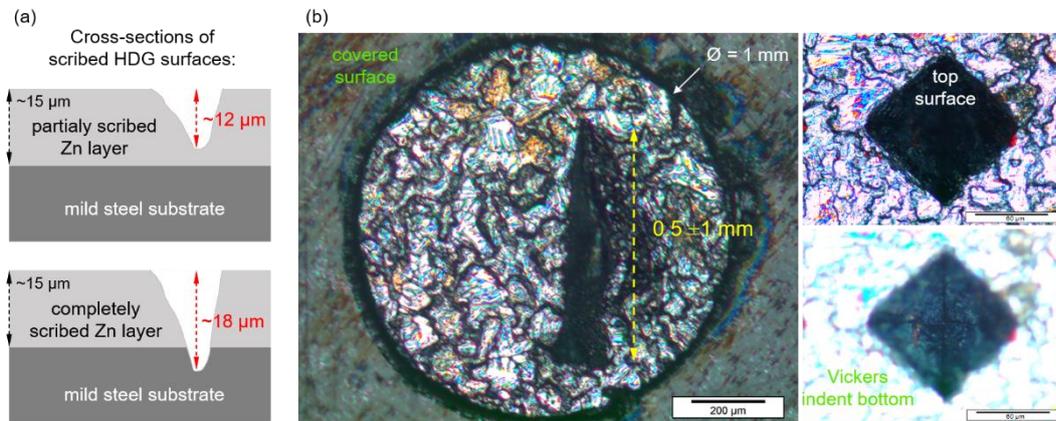
Fig. 3. (a) schematic illustration of the two types of scribed HDG surfaces analysed by SVET: scratches with ~ 12 or $\sim 18 \mu\text{m}$ in depth (partial or complete removal of the Zn-rich layers, respectively) (b) schematic representation of the optical microscopy method employed for estimating defect depths: the distances between Vickers indent bottoms and their top-surfaces (~ 12 or $\sim 18 \mu\text{m}$) were used as references for selecting scratches with ~ 12 or $\sim 18 \mu\text{m}$ in depth.

The surfaces of the HDG specimens (cleaned as previously described) were entirely covered by protective insulating tape (3M™ Ruban Polyester 8402) except on test areas of 0.78 mm² (1 mm diameter window). Next, the exposed surfaces were manually scribed using a scalpel prior to testing. The resulting scratches were about 0.5±0.1 mm in length and ~12 or ~18 μm in depth (the scribing procedure is described in detail in the topic below). The defects of ~12 μm depth partially removed the Zn-rich layer without reaching the steel substrate while those with ~18 μm depth completely revealed the steel substrate. Both types of analysed scratches are schematically illustrated in Fig. 3(a).

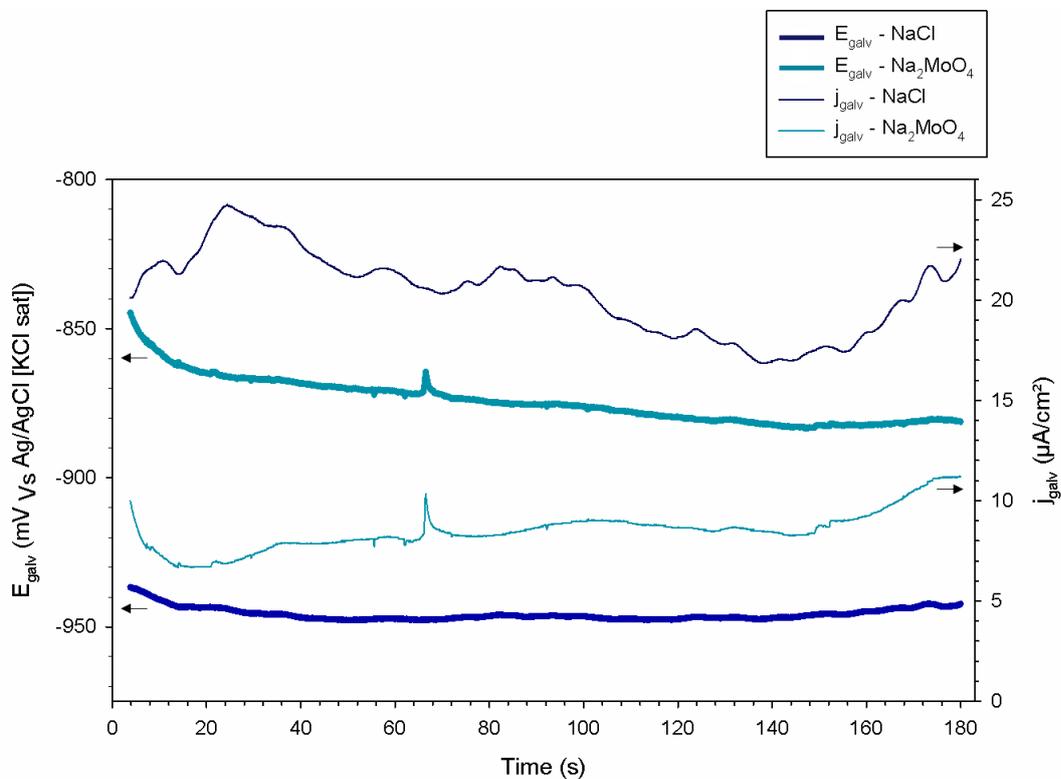
Fig. 4. ZRA curves (E_{galv} and j_{galv} evolutions) obtained from the HDG/mild steel model during 180 min of exposure in 0.05 M NaCl solution with and without 5 mM Na_2MoO_4 .

Fig. 4 presents the evolution of the j_{galv} and E_{galv} curves recorded for 180 min in 0.05 M NaCl in the absence and presence of sodium molybdate. First, an apparent increase of E_{galv} , from ~-940 mV to ~-870 mV Vs Ag/AgCl, was depicted when molybdate was present in the electrolyte (anodic inhibitor [1]). More importantly, the change in potential was accompanied by a considerable decrease of j_{galv} passing, on average (triplicate tests), from 20.9 ± 2.3 to $11.4 \pm 1.9 \mu\text{A}/\text{cm}^2$. These results highlighted the beneficial effect of Na_2MoO_4 on the galvanic corrosion of the galvanised steel/mild steel pair.

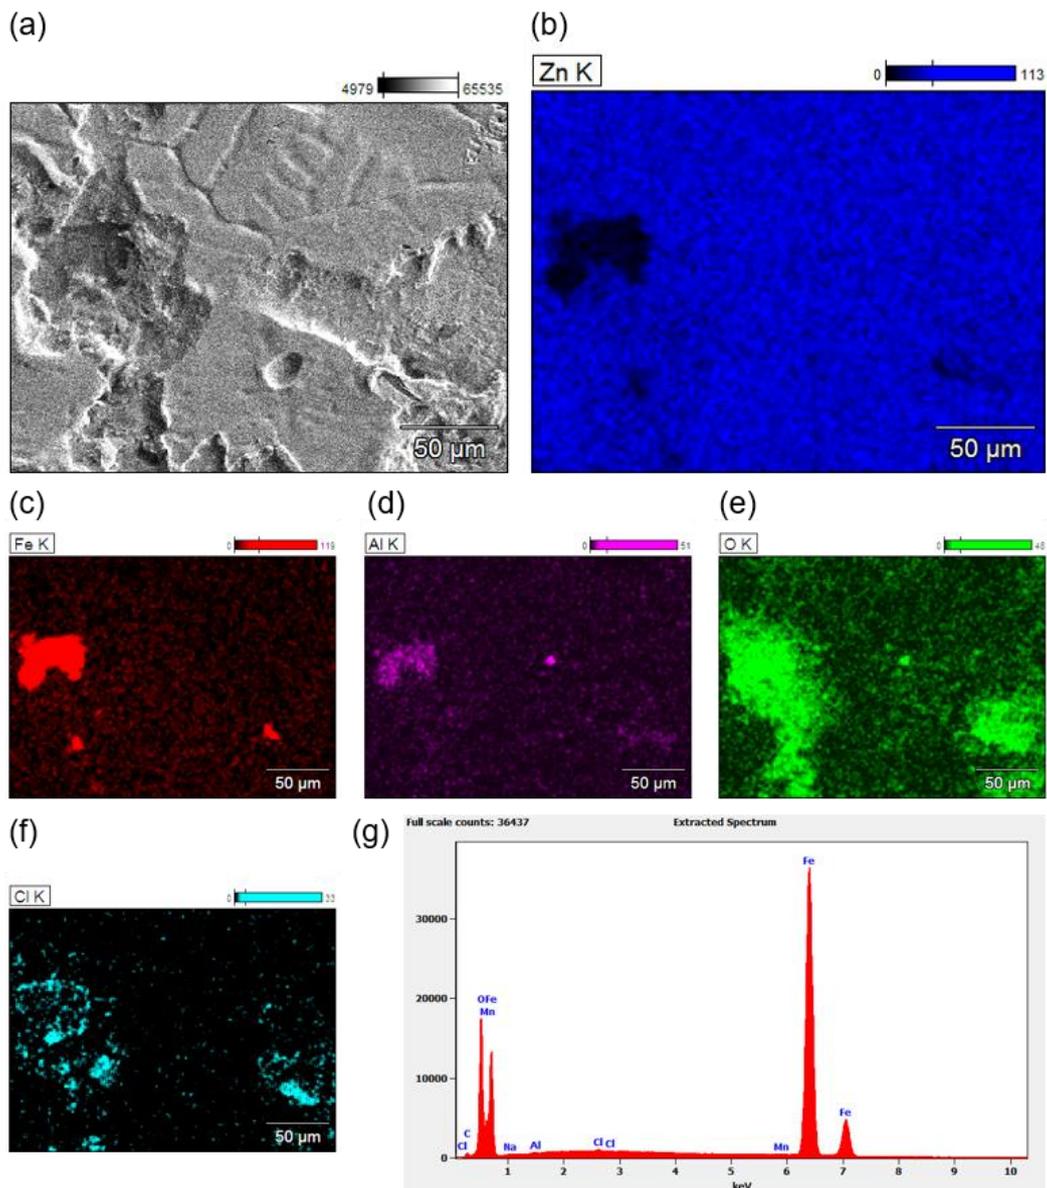
Fig. 6. SEM-EDX analysis of the galvanised steel surface from the HDG/mild steel galvanic pair after ZRA testing (180 min of immersion in 0.05 M NaCl electrolyte). (a) Secondary electron image. (b, c, d, e, f) Corresponding EDX elemental maps of Zn, Fe, Al, O and Cl. (g) Local EDX analysis of the mild steel electrode from the model after galvanic corrosion test.

To further investigate these surface modifications, SEM-EDX analyses were performed on both surfaces (Fig. 6 and Fig. 7). After testing in the NaCl reference solution, the HDG surface appeared considerably attacked, as illustrated in the secondary electron image presented in Fig. 6(a). From the corresponding EDX elemental maps obtained from the same location, it was confirmed that corrosion took place in a localised manner. From a defect of about ~50 μm of diameter it was possible to apprehend that corrosion of the Zn-rich layers was intense enough to reach the underlying steel substrate (Fig. 6(c)). Many authors consider the Zn layer so is susceptible to pitting corrosion in Cl⁻ solution [3,17,24]: partial hydrolysis of Zn²⁺ could induce localised acidification and drive pitting propagation [11,25]. The signals of Al were also higher

Moreover, the presence of corrosion products was preferentially assigned in association with the Fe-rich regions from HDG (Fig. 6(e, f)). It is important to note, however, that only a limited amount of precipitates was detected on the corroded HDG surface - which accorded well with preliminary optical microscope analysis (results not displayed). In fact, during galvanised steel/mild steel galvanic corrosion, the hydrolysis of zinc ions controls the pH slightly below a neutral value [12,14,15,27] (Eq. 2 and Eq. 3) and Zn hydroxides are soluble under near-neutral conditions (up to pH ~8) [8,28].

Although the exposed steel regions on the HDG substrate most likely acted as local cathodes, white corrosion products of Zn were barely detected, indicating that developed pH was not high enough to allow stable precipitation [12,14,29,30]. According to different works on zinc/steel galvanic coupling [15,27], sufficient high pH enabling the development of Zn(OH)₂ (Eq. 4) occurs solely on regions of the steel relatively distant from the anolyte emerging from zinc. As addressed in the following sections, the high intensity of chloride ions on the localised attacked areas (Fig. 6(f)) also resonates a limited local alkalisation effect.

accords well with the pit-like defects that reached the steel substrate of the Zn coating from the HDG/mild steel pair (Fig. 6(f)). Indeed, several authors have reported the precipitation of Cl-containing corrosion products over anodic spots on zinc surfaces [2,33,38]. For example, simonkolleite ($Zn_5(OH)_8Cl_2$) is usually stable in a pH range between 6 and 8 [11,34,39] (Eq. 6 [12]).

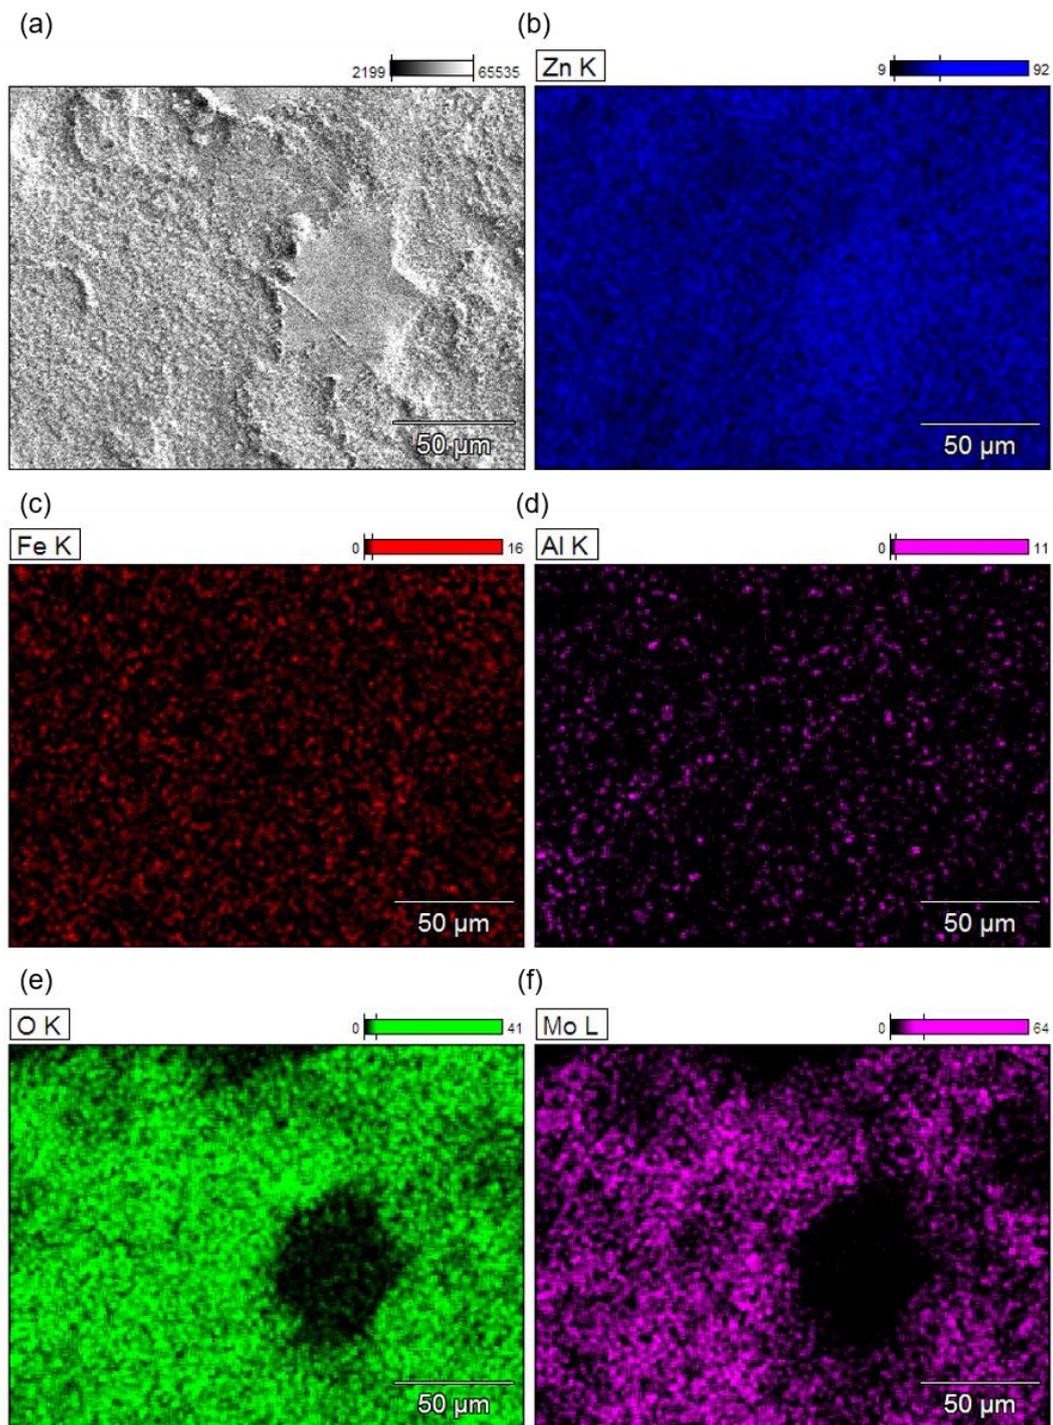
Fig. 7. SEM-EDX analysis of the HDG surface from galvanic couple model after ZRA testing (180 min of immersion in 0.05 M NaCl + 5 mM Na₂MoO₄ electrolyte). (a) Secondary electron image. (b, c, d, e, f) Corresponding EDX elemental maps of Zn, Fe, Al, O and Mo.

On the other hand, in the presence of molybdates, the SEM-EDX analysis showed that the HDG surface was significantly protected, without visible traces of corrosion (Fig. 7). Instead, the presence of a fine Mo/O-rich phase was identified. The intensity of molybdate precipitation was not equal across the surface, as further precipitation seemed to have occurred on the recesses of the skin-passed topography (Fig. 1(e)). It might be the case that the "valleys" of the roughened surface acted as a site for more intense anodes than the "summit" regions, due to their more intense local oxygen-depletion conditions. Considering molybdate as an anodic inhibitor (Fig. 4), the formation of the Mo-based precipitates would preferentially occur on these anodic regions. More importantly, the apex of the Zn surface remained quite protected. Furthermore, the signals related to Fe and Al were homogeneously distributed throughout the surface, suggesting no localised corrosion attack (Fig. 7); contrary to that observed in the absence of inhibitor (Fig. 6). The detection of Fe and Al signals did not necessarily mean that the Zn-rich layers dissolved, as the X-radiation has a micrometric penetration depth in the matter. Finally, it is worth noting that Mo was not detected on the surface of the mild steel counter electrode (EDX spectra not presented).

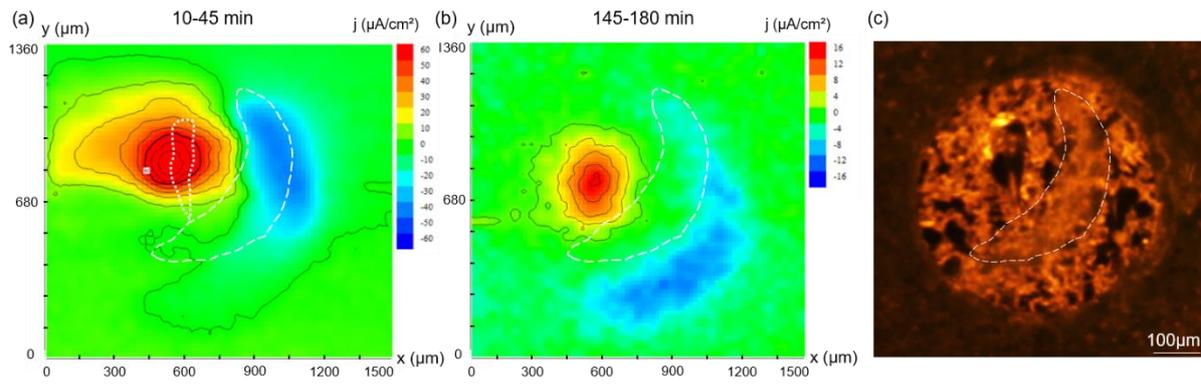
Fig. 8. Current density ($\mu\text{A}/\text{cm}^2$) maps obtained by SVET from HDG presenting a partially scribed Zn coating exposed to 0.05 M NaCl solution. Scans were obtained between (a) 10-45 min and (b) 145-180 min of immersion. The scratched zone is represented by white dots in (a). (c) the corresponding optical micrograph taken after 180 min. The dashed lines in (a), (b) and (c) delimit the region with intense precipitation of white corrosion products.

First, HDG samples presenting ~12 μm -depth defects (partial removal of the Zn-rich layers) were tested. Fig. 8 shows SVET maps obtained between 10-45 min and 145-180 min of immersion in 0.05 M NaCl solution. The scratch was located at x equal to ~600 μm and y between ~550 and ~950 μm . The SVET plots present the time-dependent distribution of current density ($\mu\text{A}/\text{cm}^2$), with anodic and cathodic activities displayed in red and blue, respectively.

The distribution configuration of anodic/cathodic cells remained similar throughout the test. An evident decrease in the magnitude of both anodic and cathodic reactions was registered from the first to the last scan (Fig. 8(a) and(b)). As the intensity of the cathodic current density also decreased, the suppression of anodic activity could not be only related to changes over time of the probe-to-sample distance upon dissolution of the anodes [27]. The achieved current density values were similar to those presented by Taryba et al. [2] working on defective primer-coated HDG using SVET-SIET.

The observed attenuation in the electrochemical activities (Fig. 8(b)) could be related to the precipitation of a protective film which progressively placed anodic and cathodic sites further apart from each other. According to Taryba et al. [2], the locations of formation of whitish corrosion products match with areas presenting decreased cathodic current density. In

the present case also, the precipitation and associated current decrease (Fig. 8(b)) occurred on a region which had presented cathodic activity at the beginning of immersion (region limited by the dashed lines, Fig. 8(a)). The protective nature of zinc (hydr)oxides is a matter of debate and it certainly depends on the local pH and chemistry conditions [3,8,9,11,15,30]. Nonetheless, different authors [12,27,35] have reported the formation of a thin and dense protective film of zinc oxide on cathodic sites distant from an active Zn surface. For instance, the barrier effect of Zn coatings is also often credited to the formation of stable corrosion products [30,35,37].

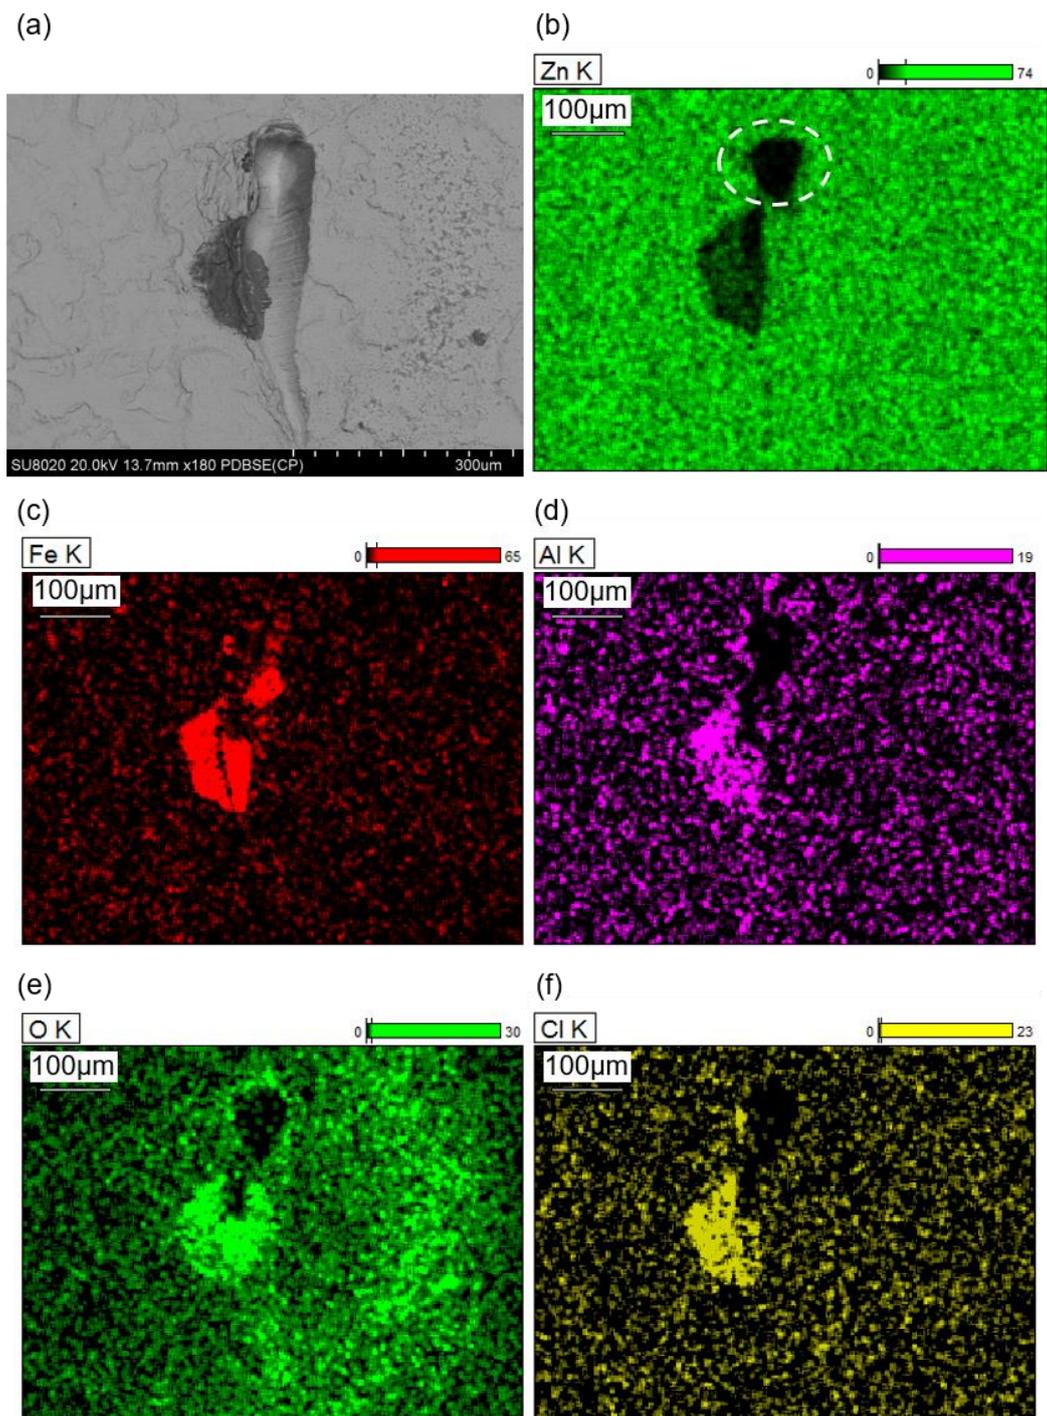
Fig. 9. SEM-EDX analysis of the moderately scribed HDG surface ($\sim 12 \mu\text{m}$ -defect depth) after 180 min of immersion in 0.05 M NaCl electrolyte. (a) Backscattered electron image electron image. (b, c, d, e, f) Corresponding EDX elemental maps of Zn, Fe, Al, O and Cl.

The scratched and corroded HDG surface was examined employing SEM-EDX after the SVET tests. The backscattered electron image displayed in Fig. 9(a) highlights evident precipitation of white corrosion products around the scratch, in concentric rings centred on the defect - as often observed for cut-edge HDG systems [34]. The location of these products (region limited by dashed lines in Fig. 8(c)) mainly corresponded to the frontier between regions presenting anodic and cathodic activity (Fig. 8(a) and (b)). Similar frontier regions exhibiting intense precipitation of products and absence of activity have been reported [2]. The minor occurrence of white corrosion products directly over the anodic sites is supported by Salgueiro et al. observations [35]: precipitation requires a sufficiently intense associated cathodic process. Furthermore, partial hydrolysis of Zn^{2+} prevents the anolyte pH from increasing (Eqs. 2 and 3) [14,15,30,36], resulting in conditions not alkaline enough to promote precipitation of $Zn(OH)_2$ [13,14].

Concerning the elemental maps presented in Fig. 9 from (b) to (f), a few points should be addressed. First, proper EDX signals could not be detected from the upper side of the scratch. This artefact (indicated by a circle in Fig. 9(b)) was related to the topographic features combined with the position of the X-radiation detector. Except for this relatively inaccessible portion of the defect, the EDX signals arising from the other regions could be appropriately detected. Secondly, the precipitates located far from the scribed surface (concentric rings) most likely constituted Zn (hydr)oxides (corresponding high intensities of Zn and O signals).

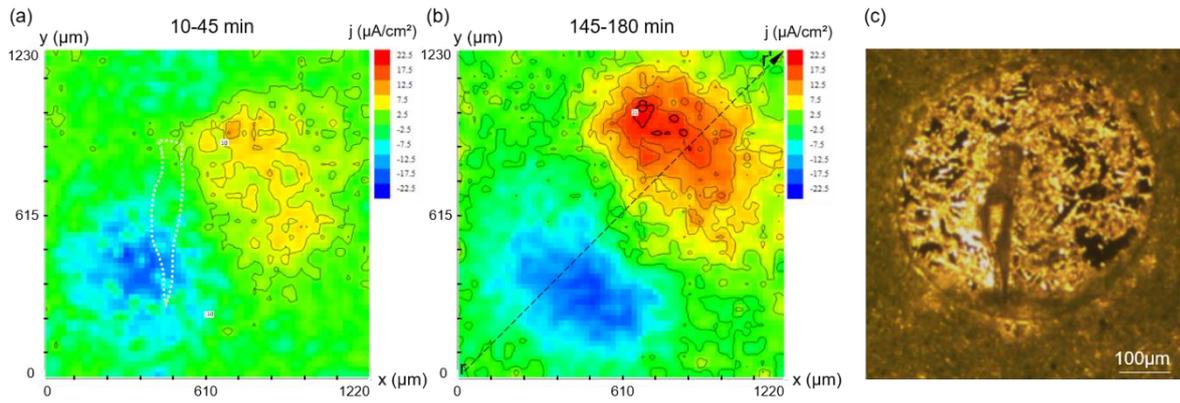
Fig. 10. Current density ($\mu\text{A}/\text{cm}^2$) maps obtained by SVET from HDG presenting a completely scribed Zn coating ($\sim 18 \mu\text{m}$ -depth defect) exposed to 0.05 M NaCl solution. Scans were obtained between (a) 10-45 min and (b) 145-180 min of immersion. (c) corresponding optical micrograph taken after 180 min. The scratched zone is represented by white dots in (a). The r-r' line in (b) indicates the direction used for constructing j_z line profiles.

Here clearly, the corrosion products formed could not attenuate corrosion rates over time (Fig. 10(a) and (b)). The white precipitates comprised loose/flocculent particles that were not effective in covering the surface (Fig. 12(a)) [17,27,36]. In the case of cut-edge corrosion, Zn products have been considered either as protective [17] or as non-protective phases [14]. Anyway, the alkalinity produced in the present case was expected to be lower than in the case of HDG cut-edge, as a result of the considerably higher cathode/anode area ratio of the latter [12,17,27,31,34,38,54].

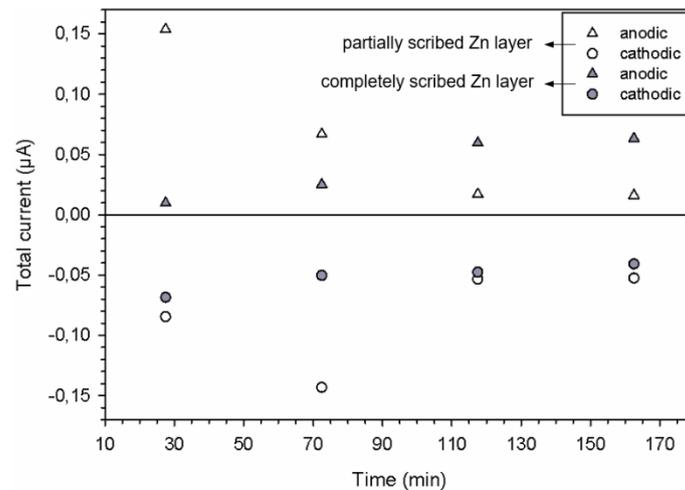
Fig. 11. Total currents obtained from integrating SVET current densities for both types of scribed HDG surfaces (partial or complete removal of Zn-rich layers) tested in 0.05 M NaCl for 180 min.

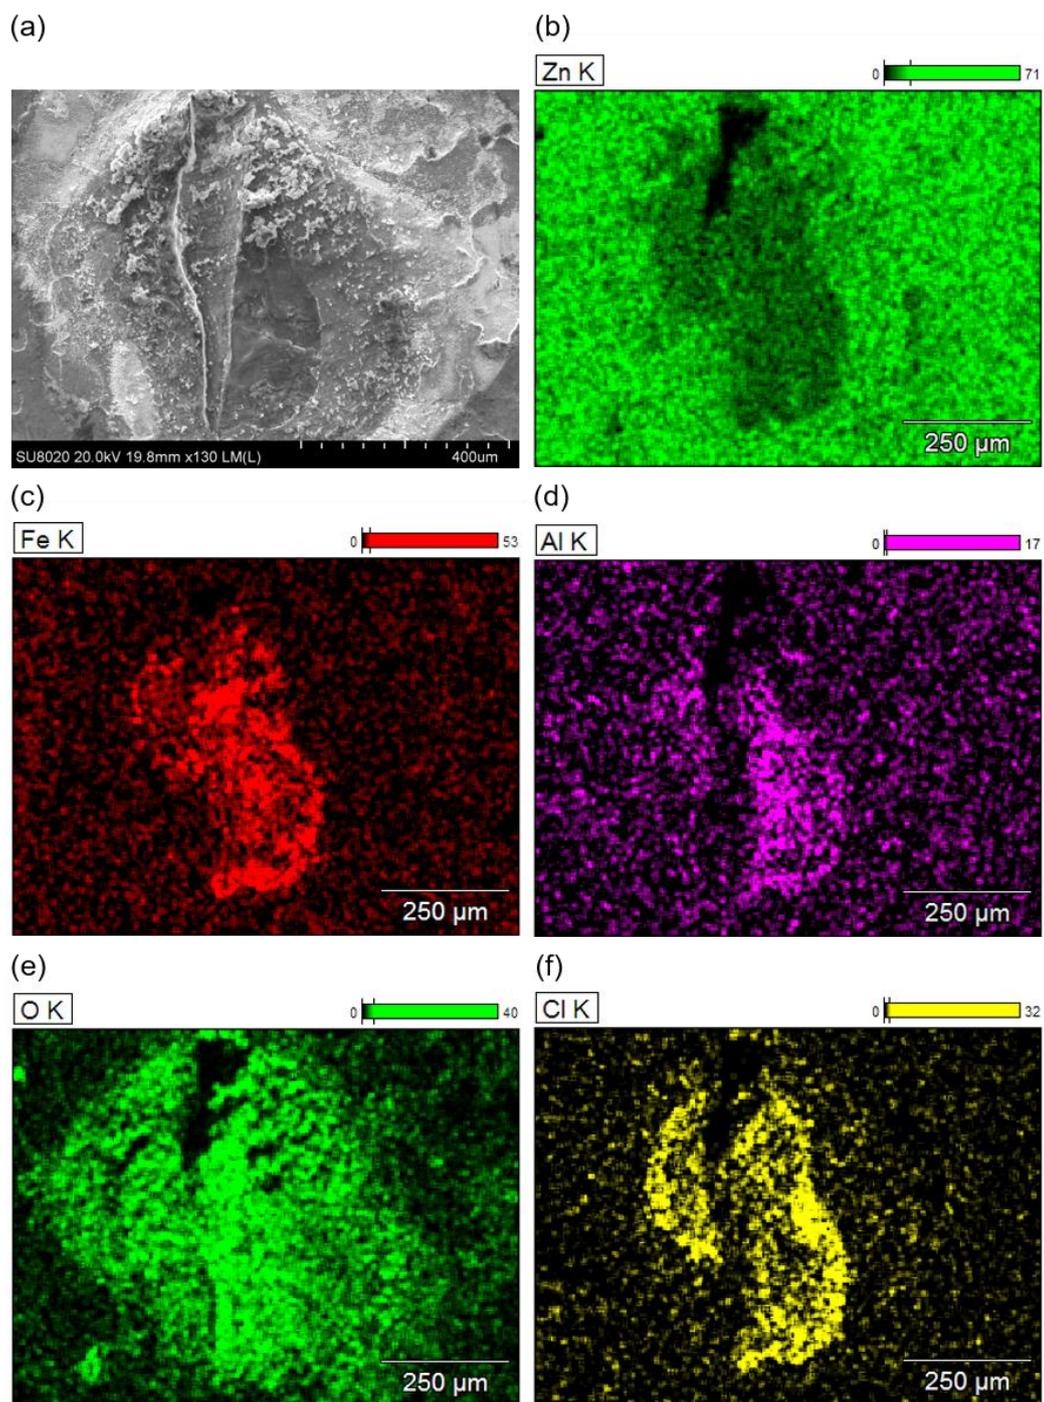
Fig. 12. SEM-EDX analysis of the severely scribed HDG surface after 180 min of immersion in 0.05 M NaCl electrolyte. (a) Secondary electron image. (b, c, d, e, f) Corresponding EDX elemental maps of Zn, Fe, Al, O and Cl.

The SEM-EDX investigation (Fig. 12) revealed that much higher amounts of corrosion products were generated for this HDG sample presenting a deeper scratch. Moreover, intense Fe signals were assigned to the entire scribed surface (except on the upper side of the scratch

subjected to detection artefacts) and to the surrounding external regions as well (Fig. 12(c)). The final distribution of corrosion products was similar to the two-region pattern often observed for cut-edge corrosion [15,27,31], in which visible white precipitates only partially cover the more active (anodic) zones. According to different studies that addressed the distribution of corrosion products and corresponding pH stability ranges, precipitation of Zn cations as insoluble species [13,31] often occurs at intermediate pH zones between the increased OH⁻ and Zn²⁺ concentrations produced by the cathodic and anodic reactions, respectively.

The coincident depletion of Zn and enrichment in Fe (Fig. 12(b) and (d), respectively) confirmed the hypothesis of increased Zn dissolution nearby the cathodic defect. The direct exposition of the steel substrate seemed responsible for the enhanced corrosion products precipitation over and around the defect. The composition of these compounds was mainly based on Zn, O and Cl, as indicated by the respective elemental maps.

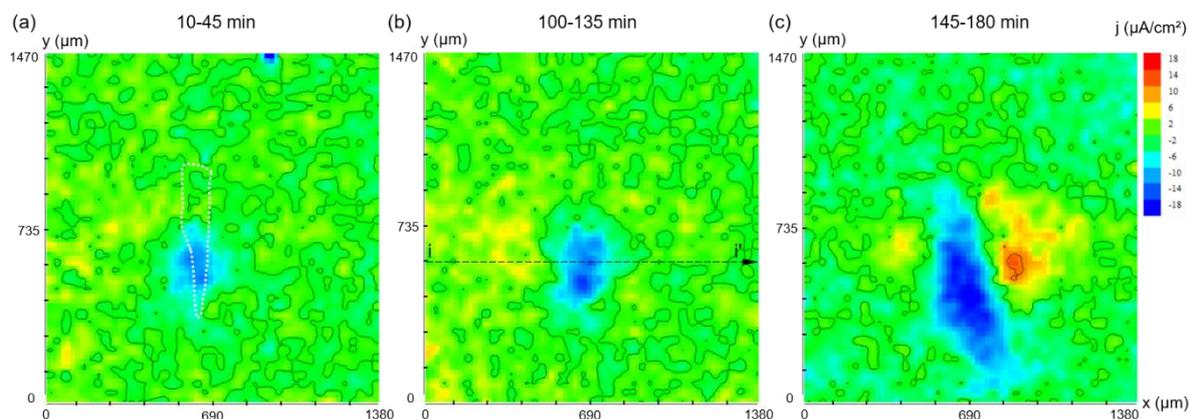
Fig. 13. Current density ($\mu\text{A}/\text{cm}^2$) maps obtained by SVET on severely scratched HDG (~ 18 μm -depth defect) exposed to 0.05 M NaCl + 5 mM Na_2MoO_4 solution after (a) 10-45 min, (b) 100-135 min and (c) 145-180 min of immersion. The j scale is the same for all maps. The scratched zone is represented by white dots in (a). The 'i-i'' line in (b) indicates the direction used for constructing j_z line profiles.

At the beginning of immersion, only minor cathodic activity emerged from the scratch region (Fig. 13(a)). Next, as shown in Fig. 13(b), the cathodic response from the same location became relatively more pronounced, while an anodic process with low intensity spread out around the defect. By the end of the test (Fig. 13(c)), a larger area seemed to support cathodic activity, and anodic reactions appeared more concentrated closer to the scratched zone.

The presence of Cl was not detected on the exposed surface, suggesting the protective behaviour of the molybdate film concerning chloride-induced corrosion attack (and eventual formation of insoluble zinc chloride hydroxides). The mismatch between the distributions of Fe and O is also worth mentioning: this fact suggested that dissolution of the steel substrate did not take place. This is an essential point because inhibitive species of Zn might eventually extinguish its sacrificial character and in turn, drive corrosion of steel [2,17]. Nevertheless, the patchy and heterogeneous character of the molybdate film was not ideal for extended protection [4] – which might explain the increase of corrosion activities eventually depicted after 3 h of immersion (Fig. 13(c)).

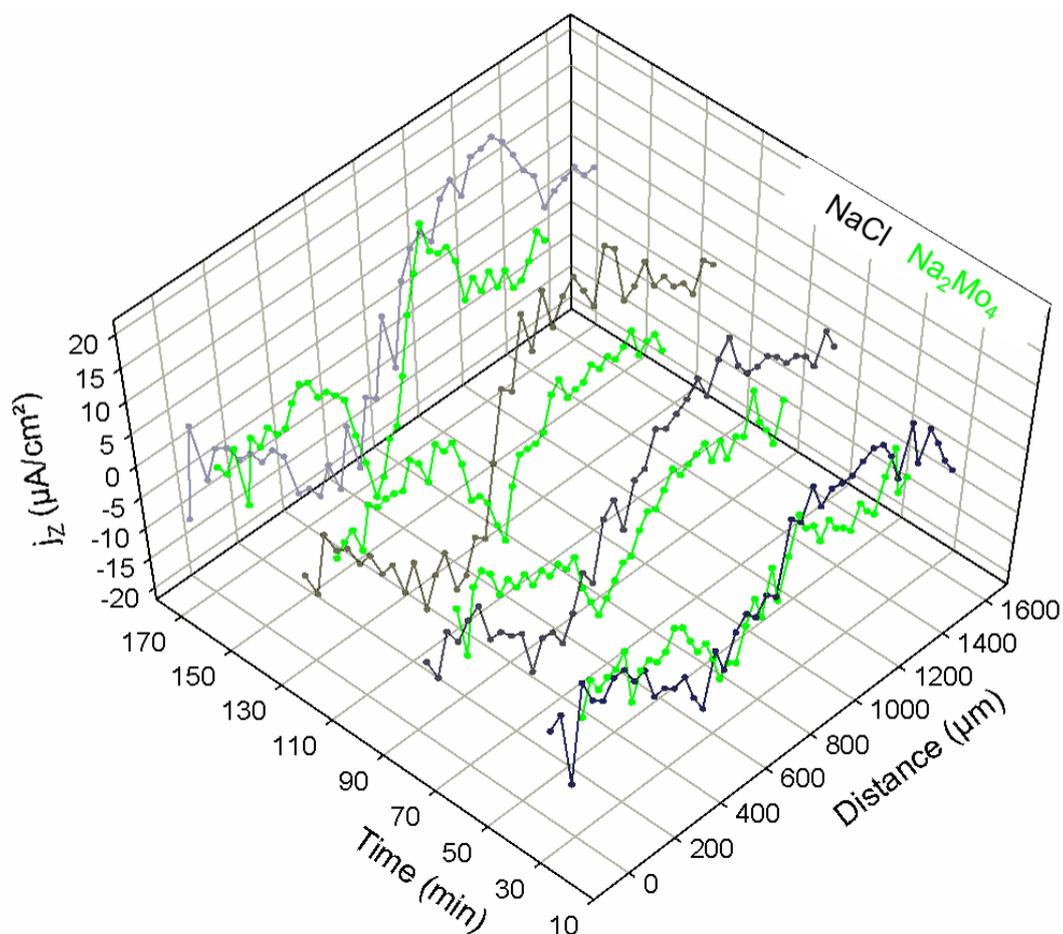
Fig. 14. *jz* line profiles constructed from the 4 consecutive SVET scans obtained in 0.05 M NaCl or 0.05 M NaCl + 5 mM Na₂MoO₄ during 180 min. The directions considered are indicated by lines r-r' (Fig. 10(b)) and i-i' (Fig. 13(b)) for the reference and the inhibitive solution, respectively.

The time-resolved inhibition effect of molybdate was highlighted from 4 consecutive SVET scans. Line profiles of current density were constructed crossing the active surfaces exposed to 0.05 M NaCl or $0.05 \text{ M NaCl} + 5 \text{ mM Na}_2\text{MoO}_4$ (Fig. 14). The directions of the line profiles (respectively indicated by the lines r-r' and i-i' in the SVET maps for the reference (Fig. 10) and inhibitive media (Fig. 13)) were chosen to maximise the information of the collected j_z . The magnitudes of j_z related to the cathodic defects were quite similar in both cases, but considerably more spatially confined in the molybdate electrolyte. Furthermore, the intensities of anodic j_z from the Zn-rich outer surfaces were visibly higher in the NaCl than in the NaCl + Na_2MoO_4 solution, over the entire testing duration.

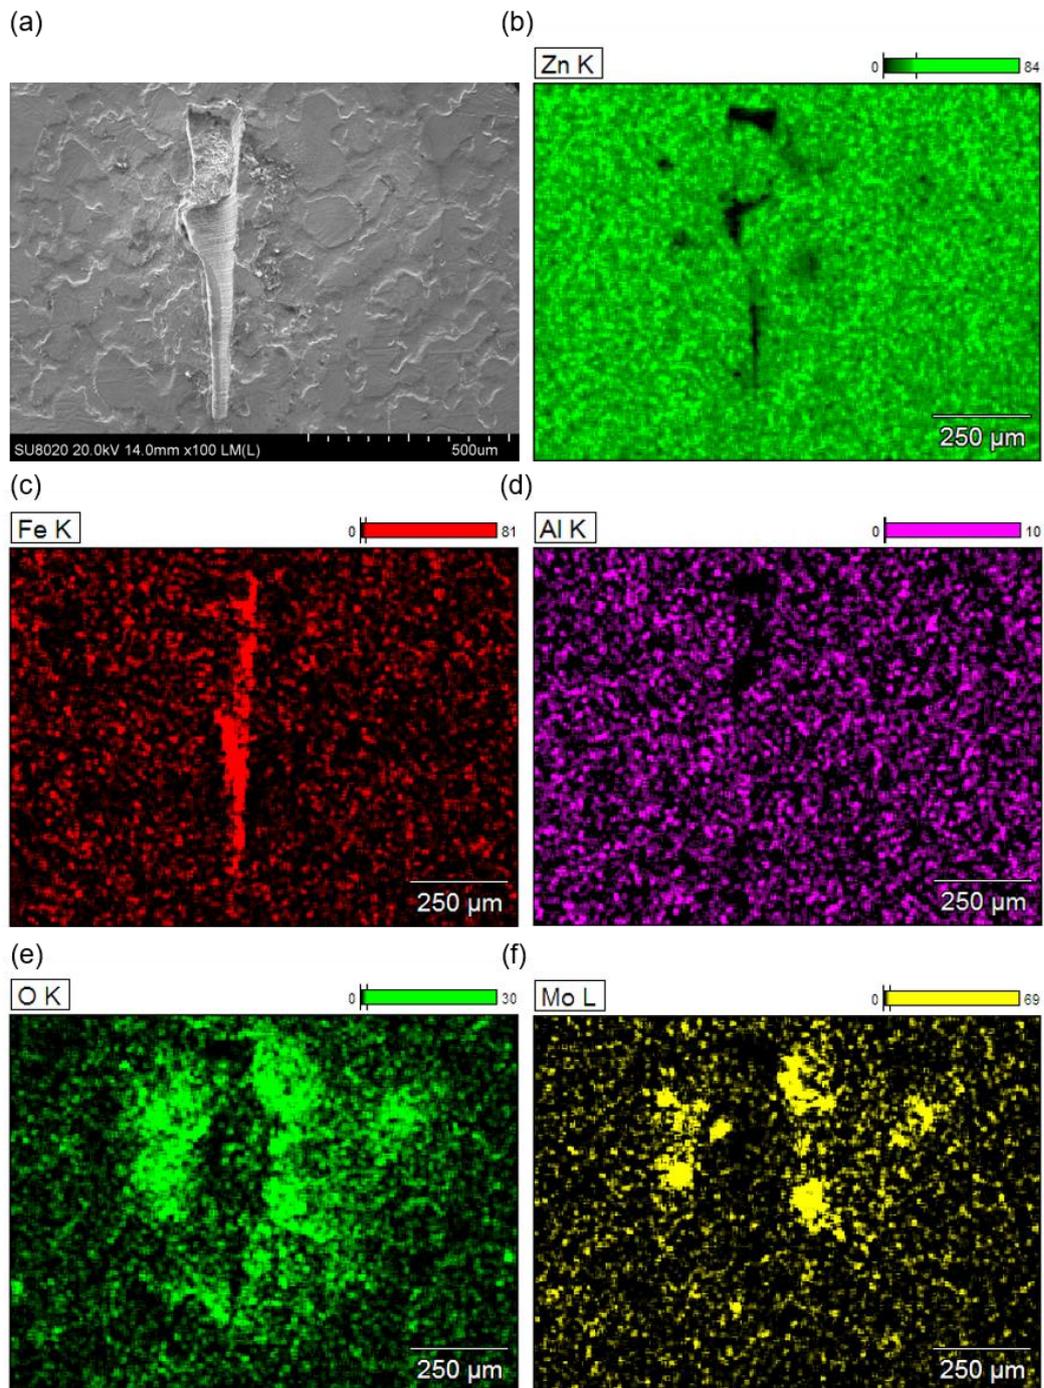
Fig. 15. SEM-EDX analysis of the severely scribed HDG surface after 180 min of immersion in 0.05 M NaCl + 5 mM Na₂MoO₄ electrolyte. (a) Secondary electron image. (b, c, d, e, f) Corresponding EDX elemental maps of Zn, Fe, Al, and O and Mo.

Fig. 15 presents a SEM image (and corresponding elemental maps) of the resulting HDG surface after exposure to the NaCl/Na₂MoO₄ electrolyte. According to the secondary electron image (Fig. 15(a)), the galvanised steel seemed considerably protected, including both scribed and non-scribed regions. The Fe signal appeared particularly intense over the scratch, testifying the mechanical removal of the Zn-rich layers (Fig. 15(b)). In addition, precipitate layers appeared associated with the defect region. These products consisted of a molybdate-based film, as the associated locations were depleted in Zn and enriched in O and Mo (Figs. 15 (b), (e) and (f), respectively). The distribution of the O and Mo signals was closely related to each other. By taking Eq. 5 into account, some acidity is needed for the formation of the molybdate polyanion; which might be a reason for the preferential precipitation of the protective layer directly over the spots of the Zn surface subjected to anodic dissolution. Most importantly, the molybdate was able to prevent the process of local dissolution of Zn from the regions neighbouring the scratch – as opposed to that observed in the inhibitor-free medium (Fig. 12(b)).
