Forensic Analysis of Levee Failures: The Breitenhagen Case

International Journal of Geoengineering Case Histories

ABSTRACT: *Forensic analysis of past failures is valuable to improve our understanding of levee behavior. In this article a new systematic approach of forensic analysis for levee failures is proposed and applied to the Breitenhagen levee breach that occurred along the river Saale in Germany in 2013. The purpose of this study is to identify the cause of the breach based on the proposed approach, even though limited data is available. Based on the information prior, during and after the breach of the levee, a slope stability model is developed for the entire event. First, results from this model are obtained based on the expected values of the uncertain parameters and the best estimates of the situation. Uncertainty of the model is included in the calculation subsequently by defining possible failure scenarios. The most likely failure scenarios are derived from the data and included into the model so that it is possible to eliminate or validate all possible causes by means of a sensitivity calculation. It is concluded that the levee breach is likely caused by locally we

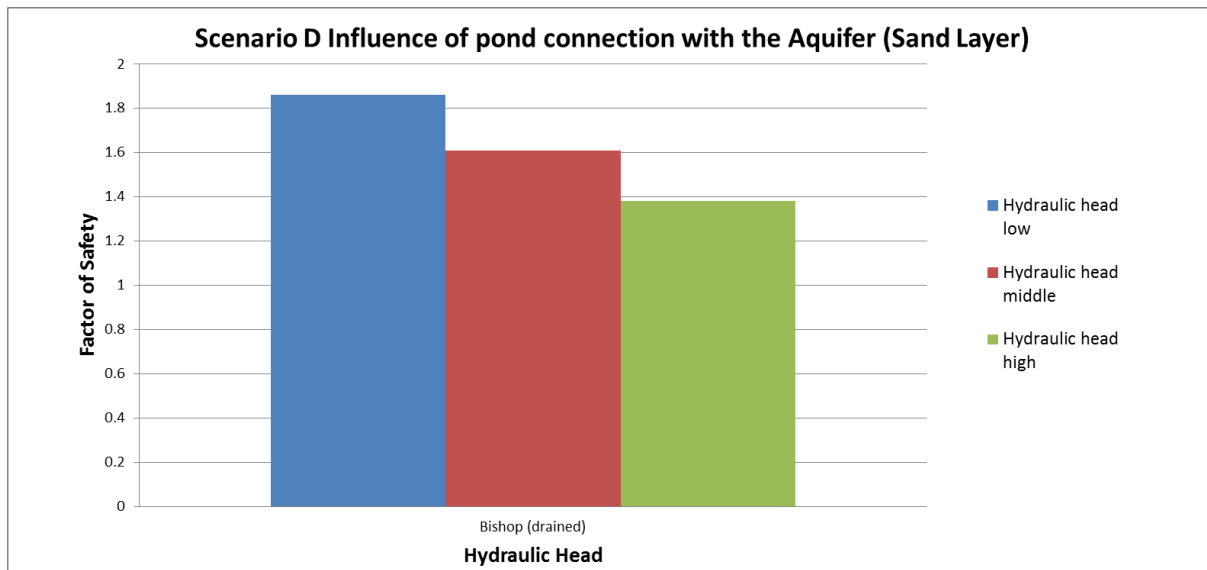
The stratigraphy shows an aquifer below the levee which might be in direct contact with the water level at the riverside by means of a pond in front of the levee (Figure 10). Similar to the phreatic line, the different water pressures in the aquifer influence the shear strength as well. For the analysis of the contribution of the aquifer to the cause of failure, the model uses three scenarios for the water pressure. The results are shown in Figure 13.

Figure 13. Influence of the rise of the hydraulic head in the aquifer with three different levels in hydraulic head in scenarios D.

Due to the rise of the hydraulic head in the aquifer, the range of the FoS overall is between 1.86 and 1.38. The shape of the slip circle shows realistic similarities with the actual slip circle. However the slip circle still intersects the levee crest instead of starting from the landside of the levee.
