INDUSTRY

WINTERSWIJK

Analysis Report
Heritage & Architecture

"DEPOL"
1913

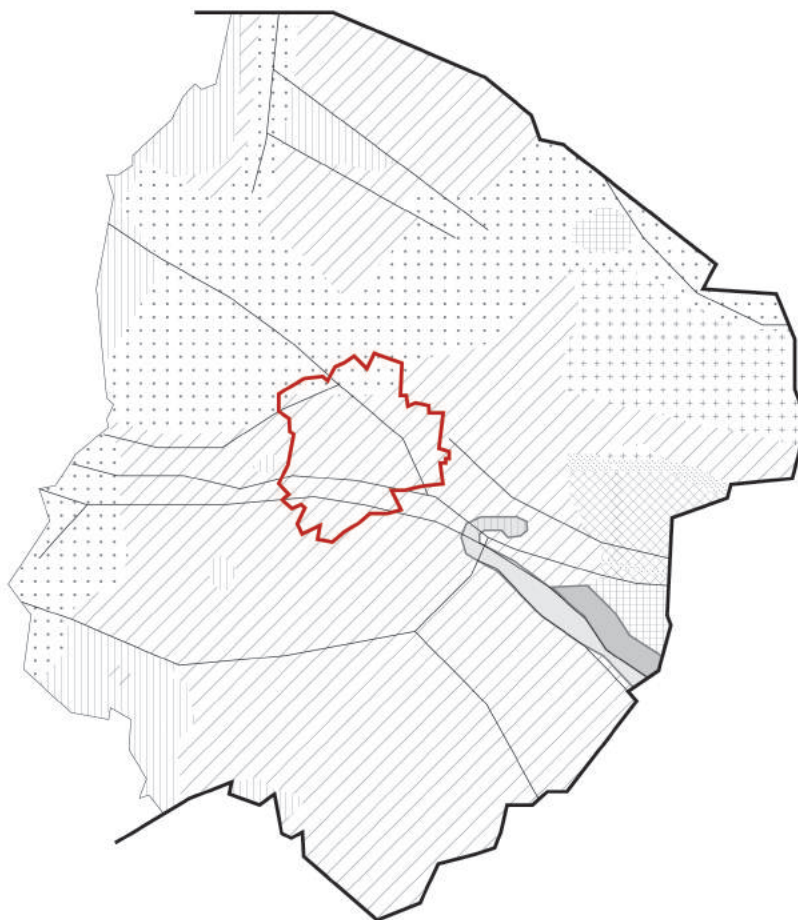
Figure 15 Soil cracks and movement. (Own image based on J. Neefjes & N. Willemsse, 2009)
 Figure 16 Soil mosaics of Winterswijk and surroundings. (Own image based on W. Peletier & H.G. Kolstee, 1986)

The area of Winterswijk and its surroundings is characterized by layers of centuries old soil which stay very close to the surface. This unique situation is caused by locally moving pieces of the earth shell, pushing and pulling land up and down (W. Peletier & H.G. Kolstee, 1986). The complex soil structure of the area contains much clay and therefore natural

water drainage is very difficult. To control the water, people from Winterswijk and surrounding areas have been digging ditches and canals for ages. Formerly, a river branched towards the Slinge (nowadays Whemerbeek) which became Winterswijk's main waterbody. Although, the creek was very important for the village, sometimes it flooded bringing

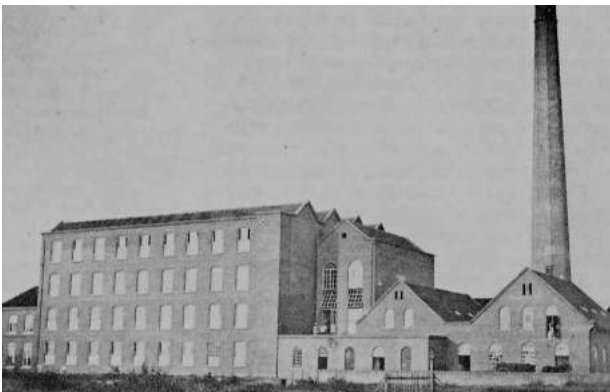
The Fairbairntype factory. Instead of timber beams, cast iron was used for construction. Factories were better protected against fire.

Figure 24 Fairbairntype. Gelderman, Stork en Eekhout in Oldenzaal. (Tuinstra, 2006)
 Figure 25 Lancashiretype. (Tuinstra, 2006)
 Figure 26 A.G. Beltman, spinning factory Oosterveld. (Tuinstra, 2006)
 Figure 27 A.G. Beltman, spinning factory Almelo. (Tuinstra, 2006)

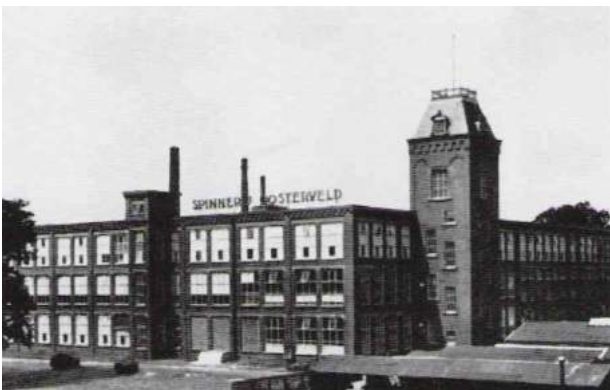
The Lancashiretype factory. This one in Oosterhout was the last building of this type. It still had cast iron columns and steel beams.

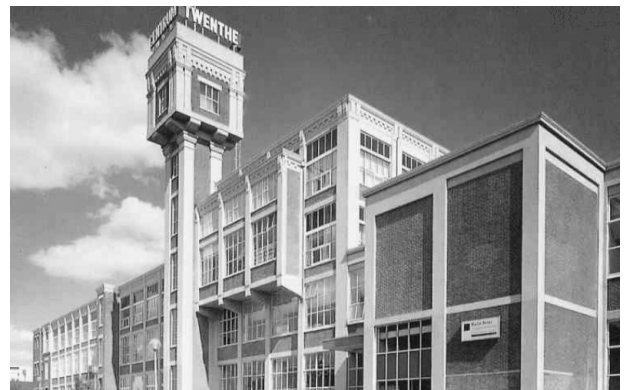
Concrete as a building material was introduced. A column-beam structure provided for big openings and a lot of glass.

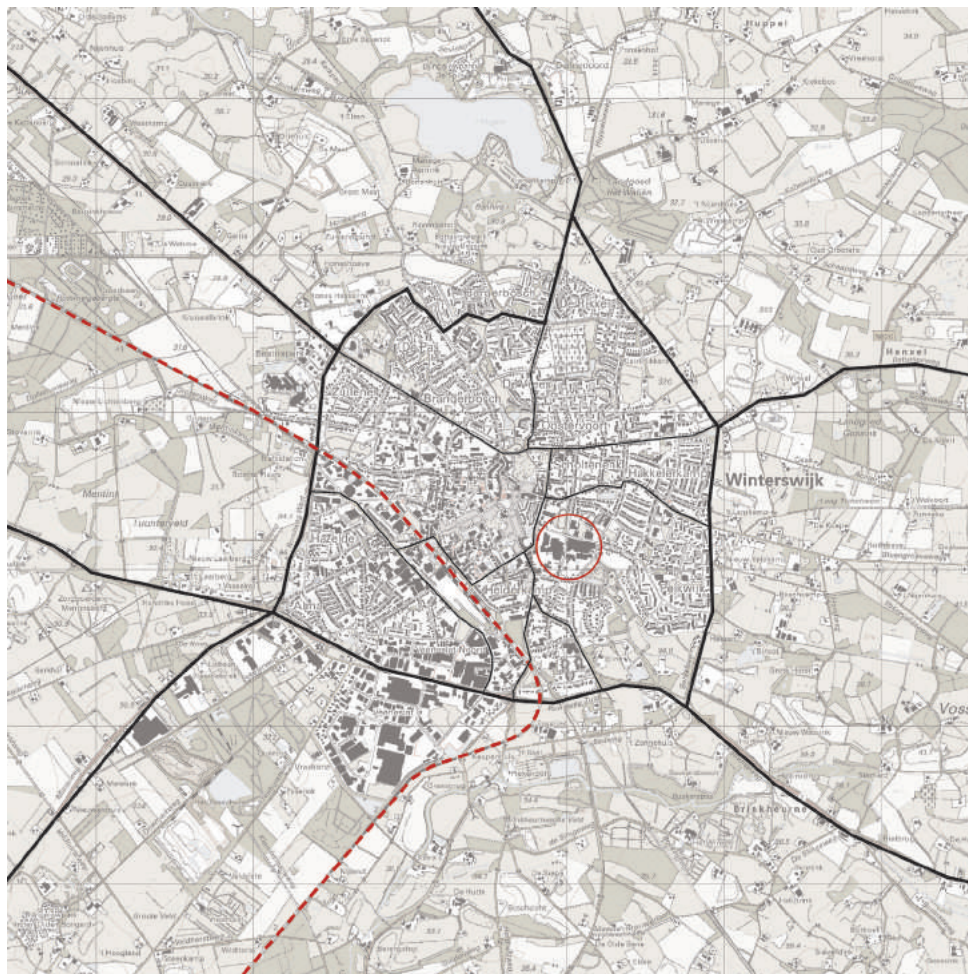
Figure 38 Accessibility and infrastructure. (Own image based on Kaartenkamer TU Delft, 2019)

Winterswijk itself is easy to reach by car, train and bike. It is completely surrounded by provincial roads with branches inwards, even almost touching the centre of the village. The train station is located close to the centre creating a connection for public transport.

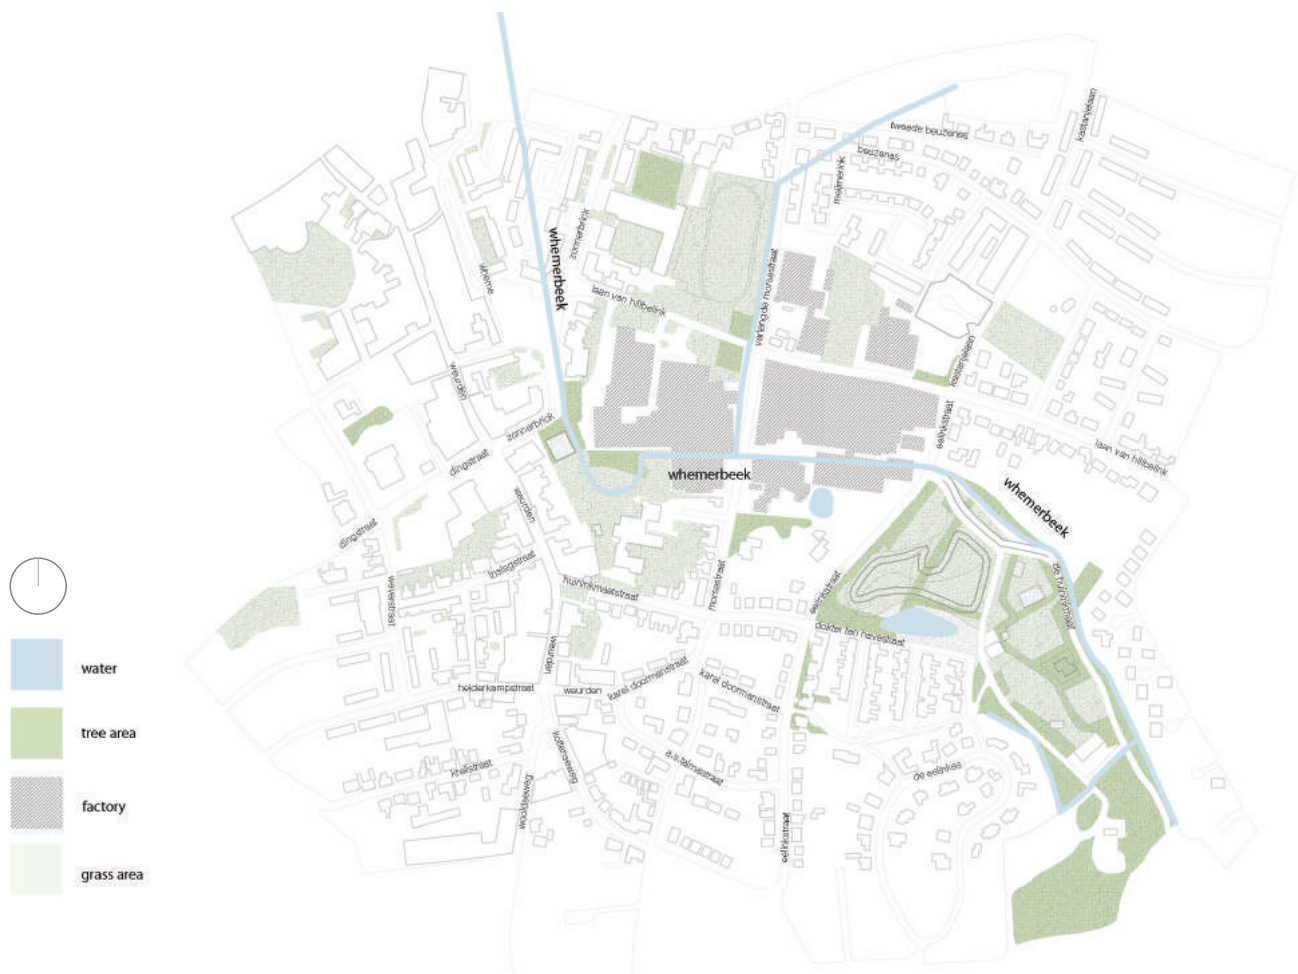
Figure 41 Green and water structures of the surroundings. (Own image based on EduGIS, 2019, Global Surface Water, 2019 & Google, 201941)

Zooming more into the surroundings of the site, bodies of water and green are also visible. Especially the Whemerbeek stands out, crossing the site, where it is covered and not visible, and running towards the green area South-East of the site.

As for green, the area is surrounded by open grass areas. Some of these areas also contain qualitative green, like trees and other greenery.

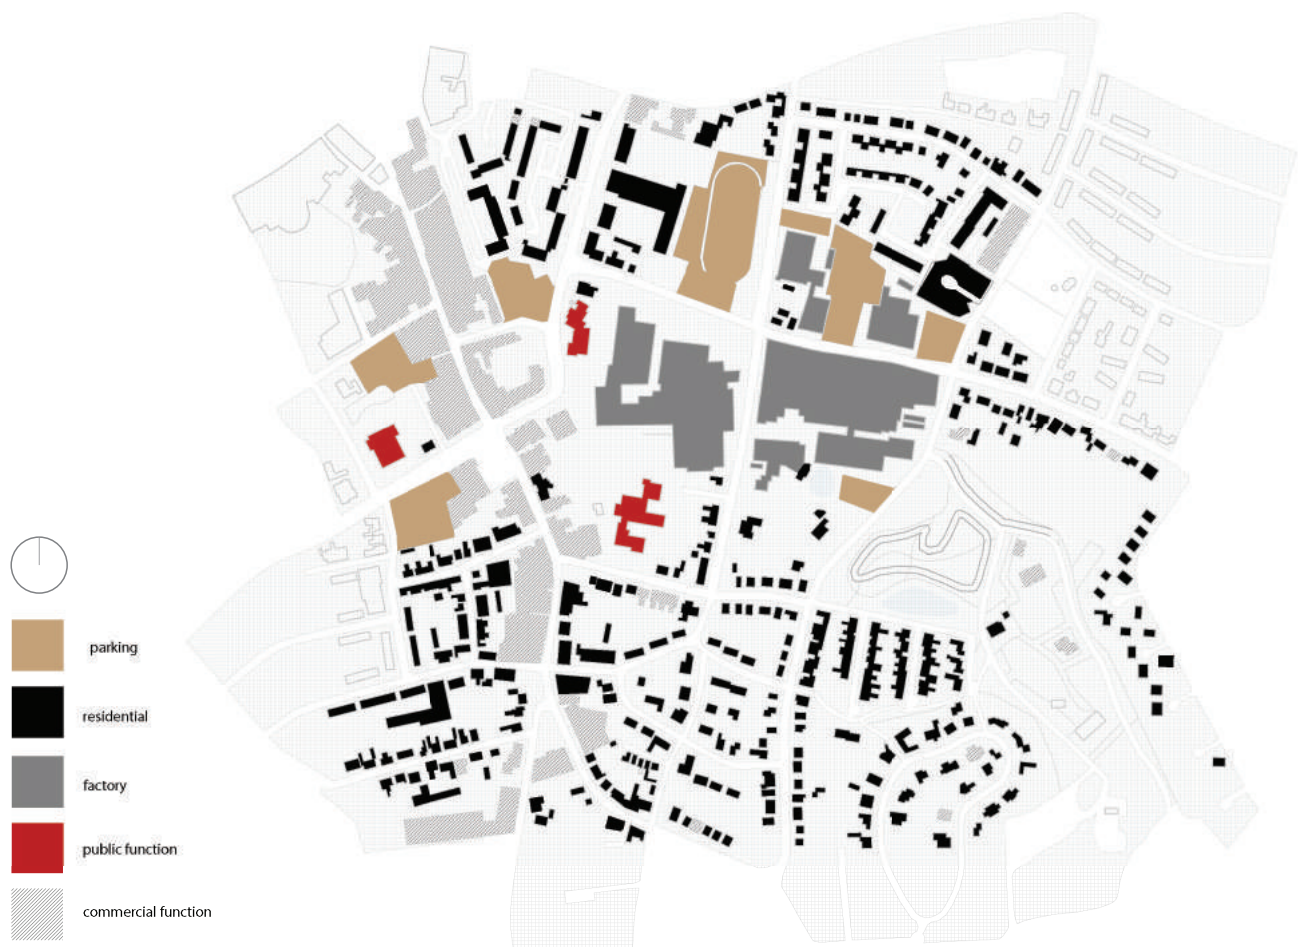
Figure 42 Functions of the surroundings. (Own image based on EduGIS, 2019 & Google, 2019)

The industrial area holds a unique spot in the urban fabric of the village, also because of its function and the contrast with its surrounding functions. The abrupt change from the residential area towards the industrial causes an undefined border between the two. The image also shows the popular shopping area

which more or less ends at the border of the industrial area. Some public functions are situated close to the shopping street and the industrial area. Remarkable is the amount of parking space next to the site. The municipality of Winterswijk values free parking space and would like to keep as much of it as possible.

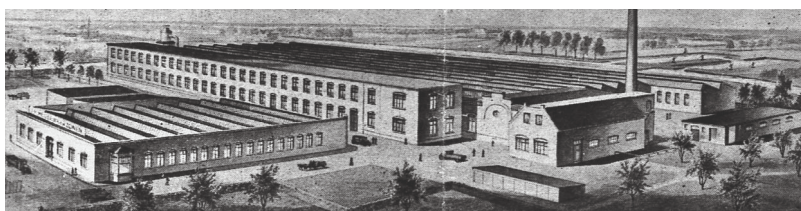
Figure 47 Meijerink & Co between 1920-1935. (Unknown)

5 Between 1921 and 1927 the boiler house was made. The buildings which surround the boiler house functioned as small storages, which created an inner courtyard for the workers of Meijerink & Co. The illustration below shows the building ensemble probably during 1930-1935, because the Morsestraat is visible. The Morsestraat was paved between 1935-1936 (Beltman, 1921) (Beltman, 1927).

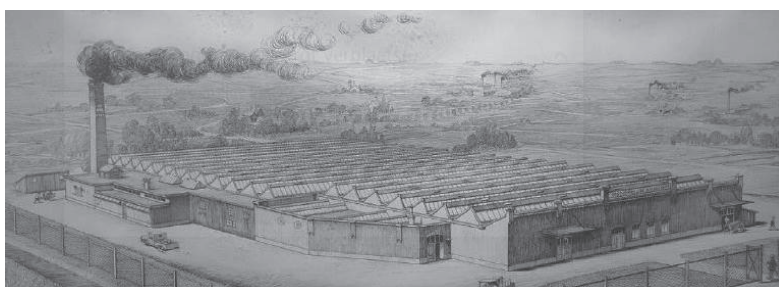
Figure 60 Drawing De Pol 1928. (van Dugteren, 1928)

two houses had any link with the industrial activities at the site. This also applies for the triangle shaped extension on the left site of the old core. In a historical drawing of M.J. van Dugteren is visible that it had an entrance, assumed is that it was in relation with the boiler house (van Dugteren, 1928).

2 The boiler house also dates from approximately 1913 and is partly present nowadays. For every industrial company the boiler houses were situated alongside the creek, the Whemerbeek. For the reason that the creek provided the industrial activities for cooling water (Nibag, 2015).

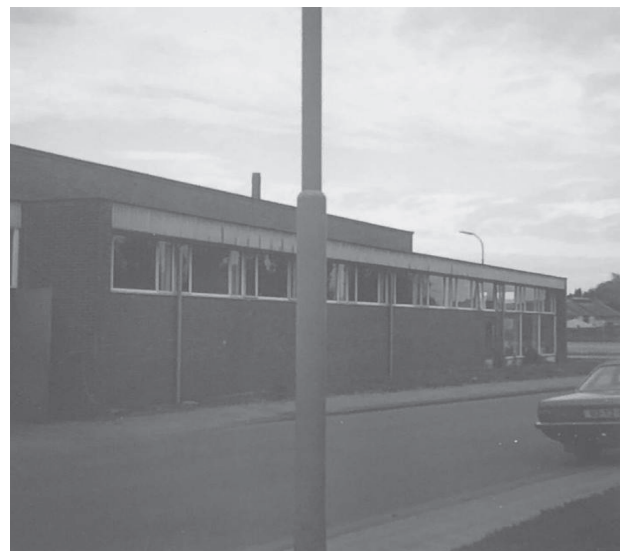
11 Around the 80’s a powerplant was added with additional transformer room against the former carpet hall. Probably building ensemble number 11, provided the electricity for the Gaudium (WAM bouwonderneming, 1980) (Nibag, 2015).

Figure 65 Picture former carpet hall De Pol 1999. (Huitink, 1999)

14 In the following years around 2000, the former carpet hall and powerplant of Gaudium was demolished because Janfleur invested in a major expansion. Because of this brand new warehouse the entrance replaced from the Morsestraat towards the Eelinkstraat alongside the entrance of Gaudium. Therefore, a parkinglot was added for visitors to improve the accesability (Huitink, 2000) (Nibag, 2015).

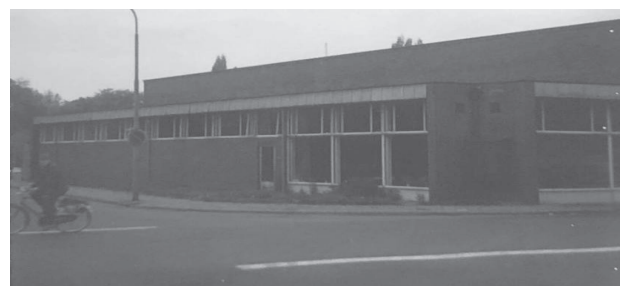
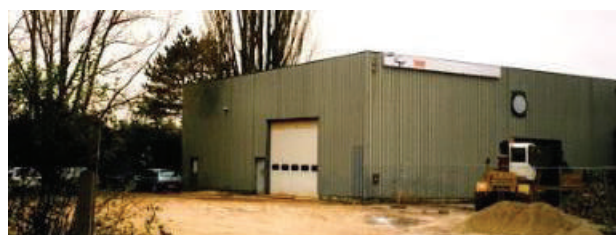
10 Again the cantine and dressing rooms needed more space and thus the former building expanded towards the Eelinkstraat. Moreover, the current wardrobe transformed to office space (WAM bouwonderneming, 1980) (Nibag, 2015).

Figure 66 Pictures 1980 transformation to office space. (Not known, 1980)

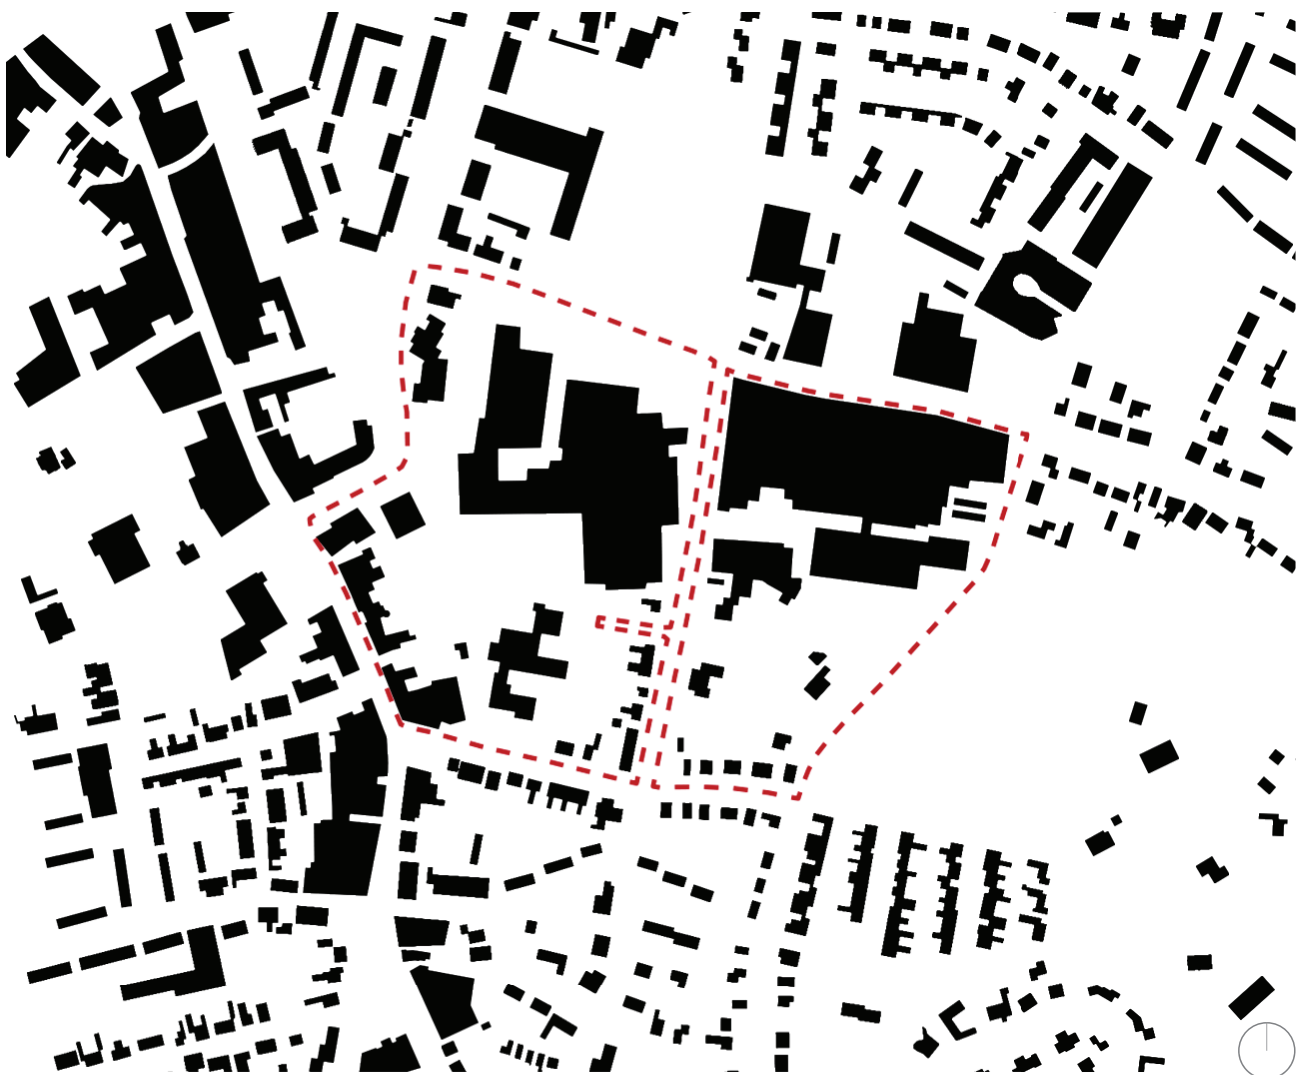
Figure 73 Built surface. (Own images based on Google, 2019)

On the map, built plots are highlighted. It shows a large area of buildings and quite some density on the plot of the site. From this map the conclusion can be drawn, that there are almost no public connections throughout the area.

Also the site consists of one very dense core with the buildings organically grown from it. The outside edges of the plot have no clear definition. There is also no transition from the road to the 'interior' of the factories.

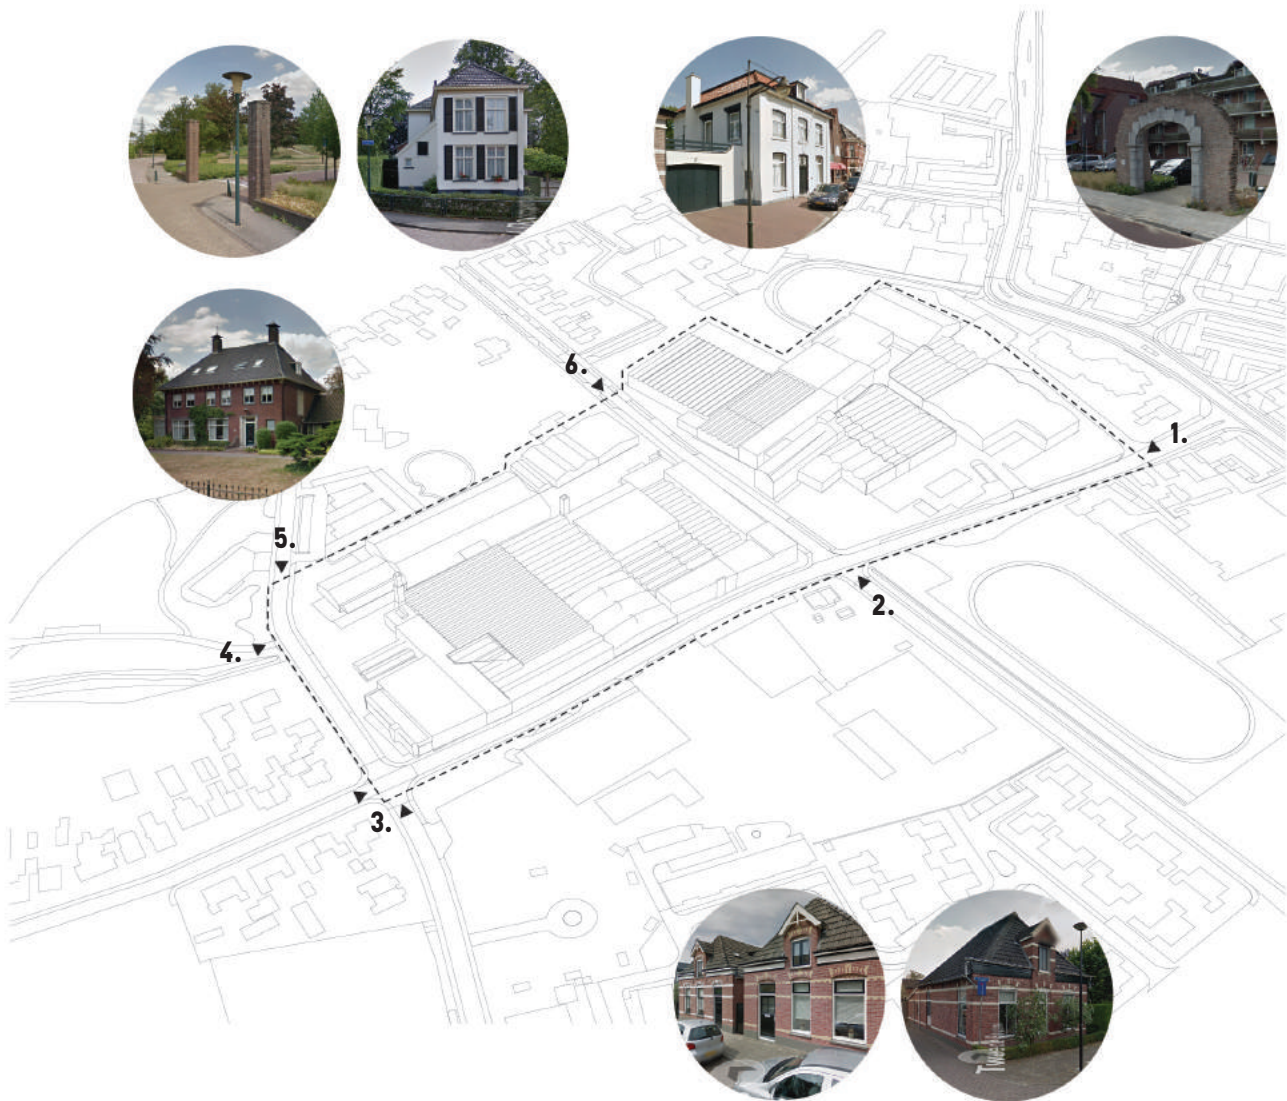
Figure 74 Accessibility and landmarks. (Own image based on Google Maps, 2019)

The site is well accessible from multiple sides, especially from the South-East. There are some accessibility problems in the West, where only one road connects to the site.

In the close surroundings of the site, some historical landmarks which relate to the textile industry are still visible. Old gates, factory owner villas and worker houses are shown.

The different entrances towards the area are not well defined. There is no clear sign of entering the site, nor items that mark it.

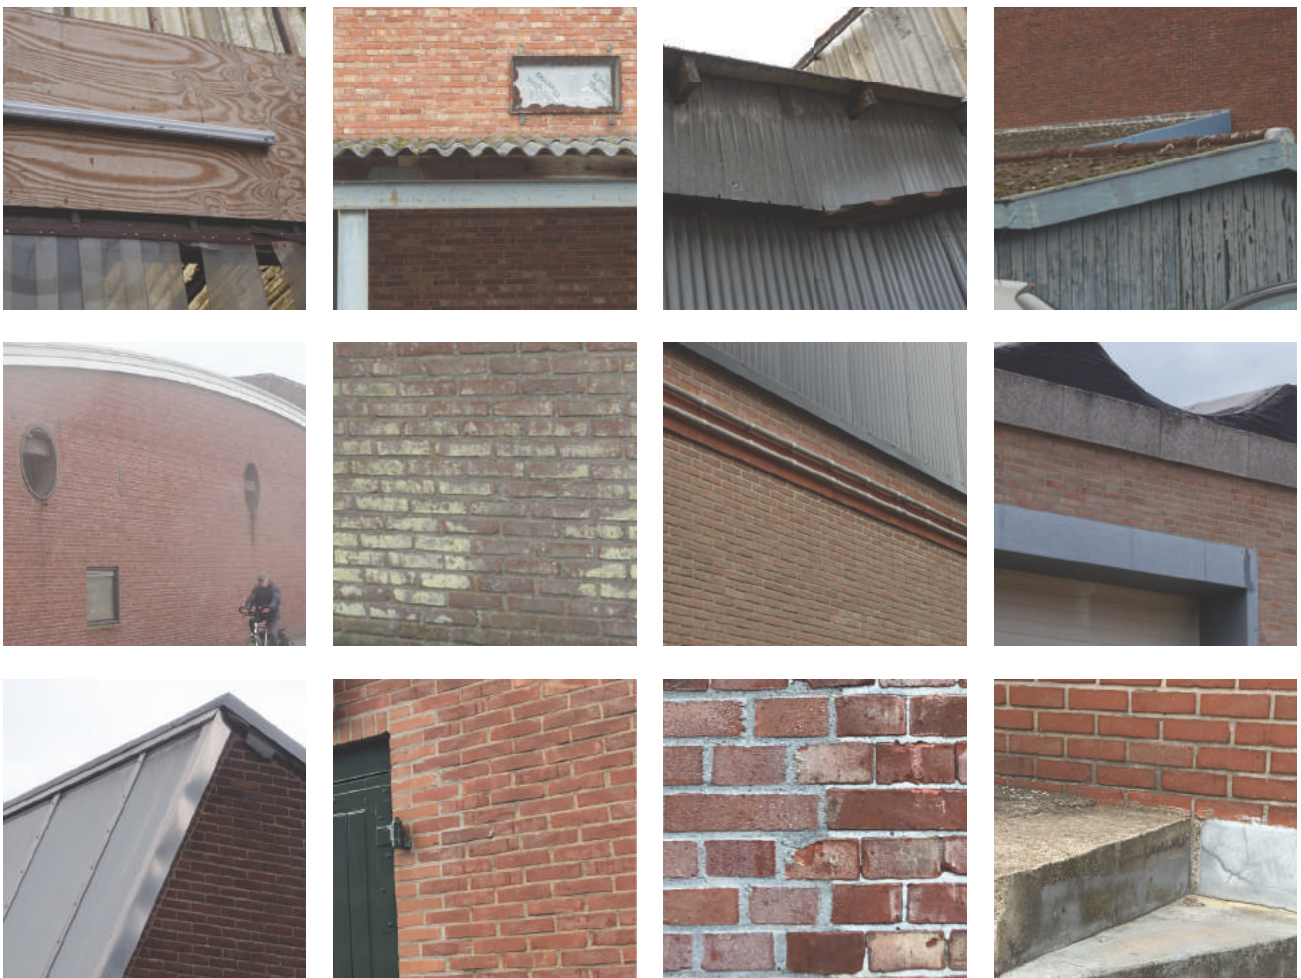
Figure 86 Façade colours. (Photos by various students, 2019)

Pictures from the multiple façades of the ensemble show a wide range of materials. The most dominant material which is used is brick: all original façades are made out of

brick. All the materials belong to a similar colour palette. Interior finishes are characterised by light colours which bring a bright atmosphere.

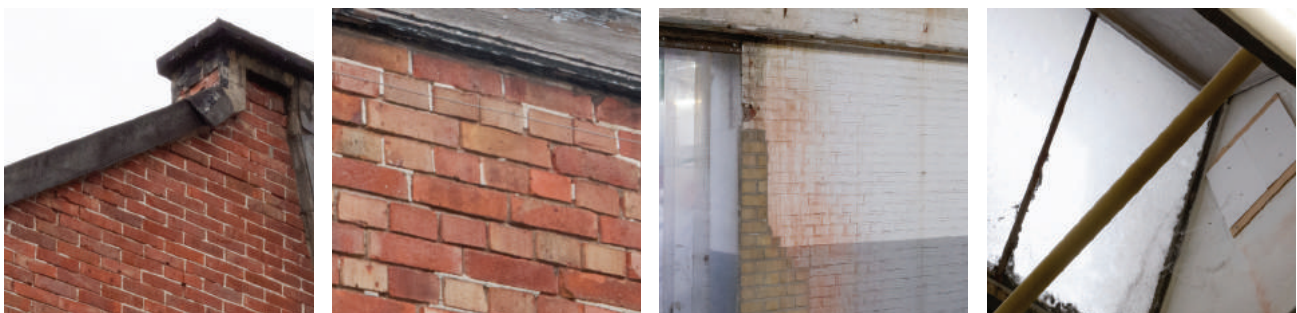
Figure 101 Façades. (Own images based on Beltman, 1913)
 Figure 102 Materials. (Photos by Dinand Kruize, 2019)

This façade of the saw-tooth roof structure shows clear marks of aging. Sometimes old brickwork has been replaced by new to fix it.

Almost no openings are visible in the façade, since daylight comes from the characteristic rooflights.

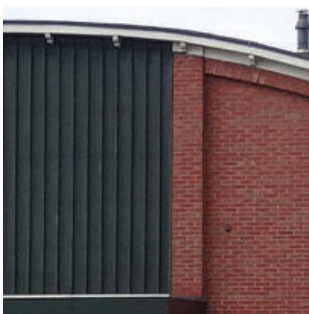
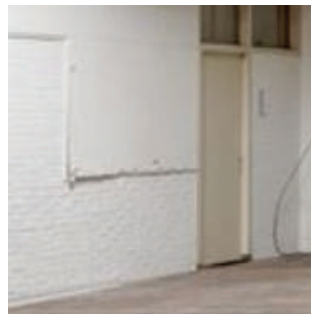
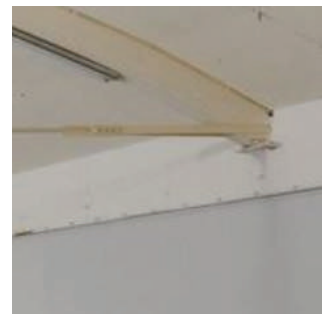
Figure 103 Façades (Own images based on Bouwk. Ing. Bureau Beltman, 1955)
 Figure 104 Materials (Photos by Joost Joosse, 2019)

This façade has been changed over time, although the original façade is still there. Some installations were placed which had big ducts sticking through the façade. These

ducts nowadays are not there anymore, but they still leave their traces. Their position is still visible from the different brickwork in the façade. None of the curtain walls are original.

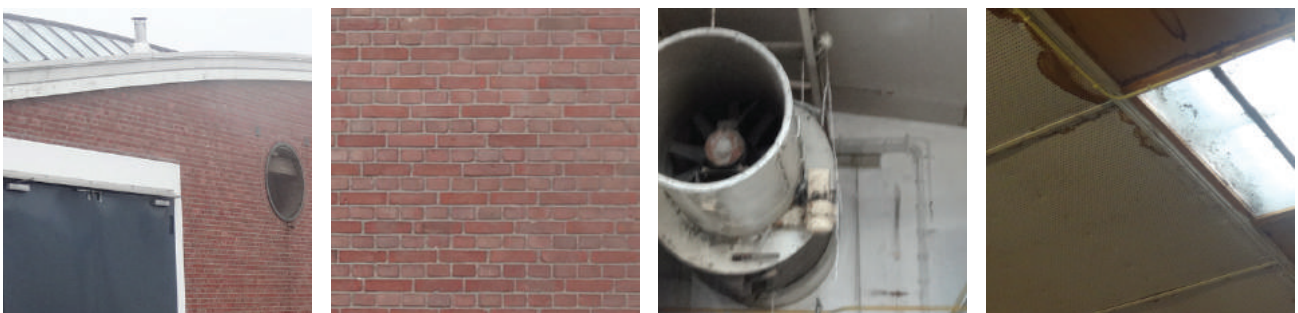
Figure 105 Façades (Own images based on Pannekoek, 1957)
 Figure 106 Materials (Photos by Joost Joosse, 2019)

This façade is also not in its original condition. The current holes (which have no glass in it whatsoever), were originally not there. The big door on the left was designed in the

middle. This one could also have been moved, although there are no clear traces of this. The façade shows no openings. The only incoming daylight comes from the rooflights.

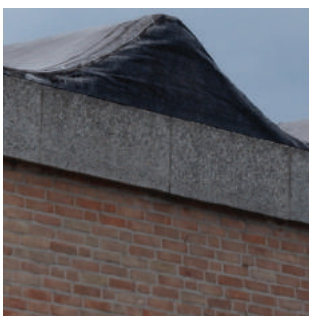
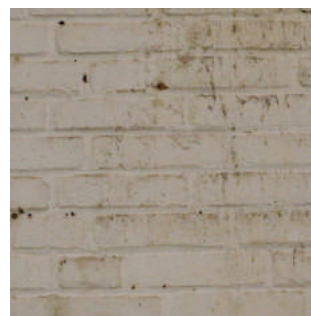
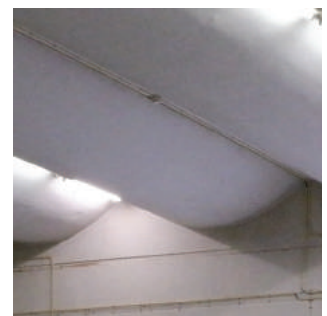
Figure 107 Façades. (Own image based on Bouwkundig Ingenieurs en Adviesbureau Sassen, 1960)
 Figure 108 Materials. (Photos by Dinand Kruize, 2019)

This façade knows some interventions, whereas the big garage doors are of a later date than the building itself. The Morsepoort addition on the right doesn't belong to the

building and disturbs its continuous façade. The glass part on top of the small part of the building is not original. It is almost the only part which has openings.

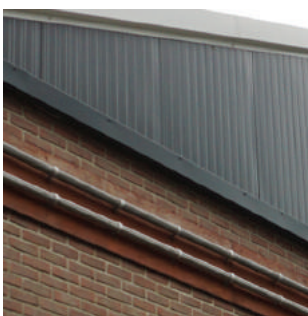
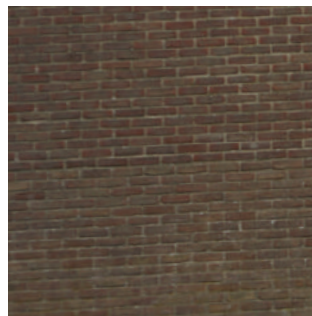
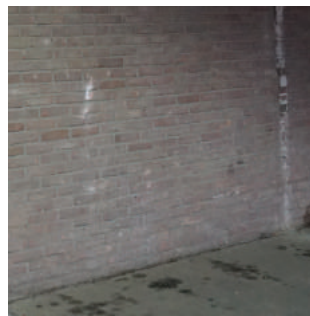
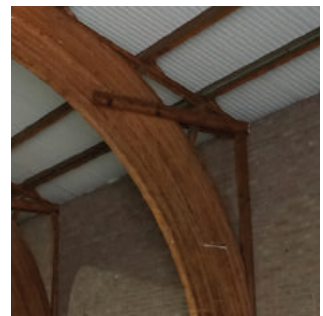
Figure 109 Façades. (Own image based on Bouwkundig Ingenieurs-en Adviesbureau Sassen, 1960)
 Figure 110 Materials. (Photos by Chen Zhu, 2019)

The façade of this building presumably is not original, since old drawings and pictures

show differently. The façade has no window openings at all.

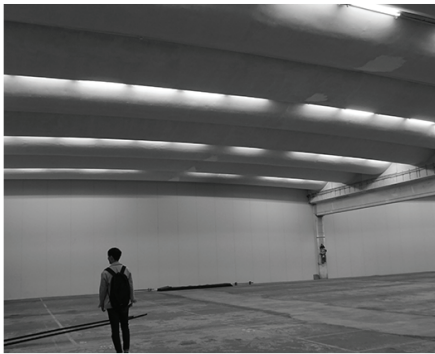
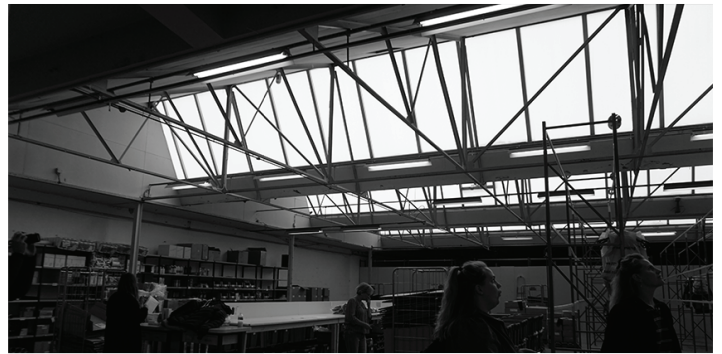
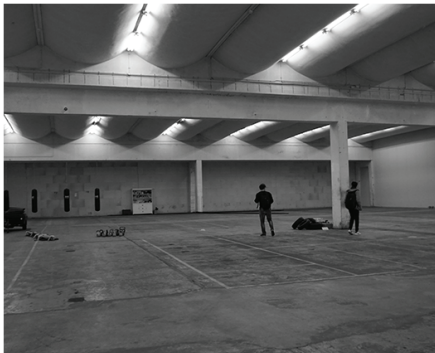
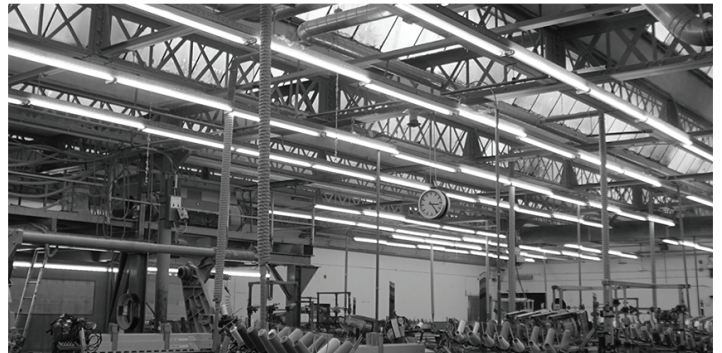
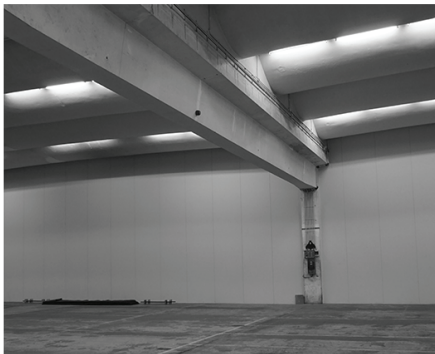
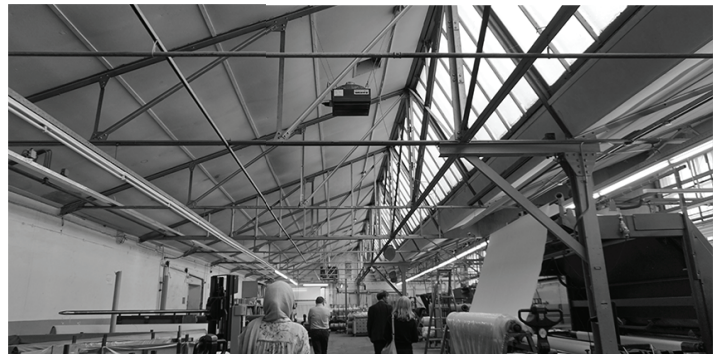
It is being very obvious that a lot of factories in this area doesn't have efficient or enough lighting. A lot of rooms are dark and empty, which in the architectural aspect creates certain atmosphere.

Figure 112 Integrated lighting. (Own image based on fieldwork, 2019)

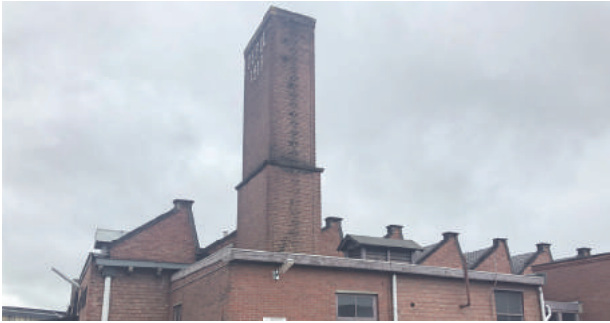
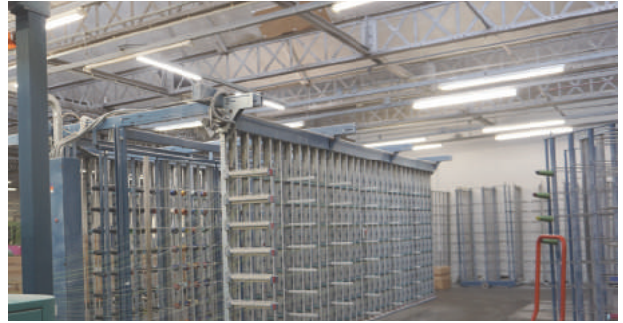
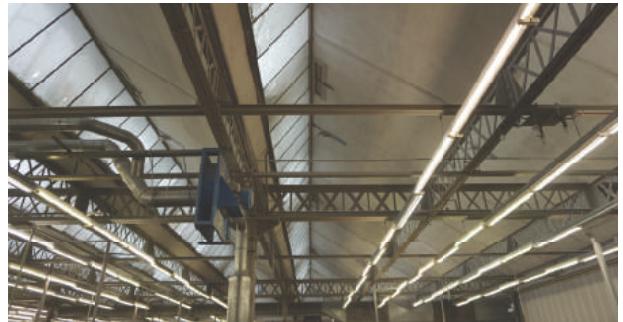
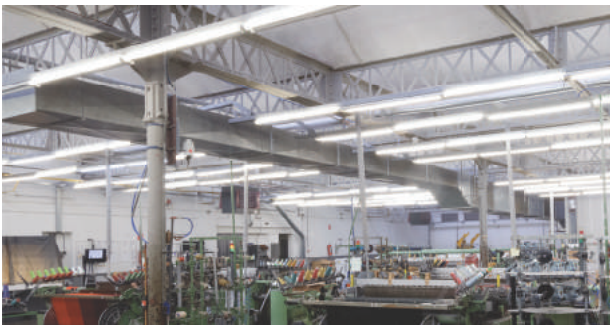
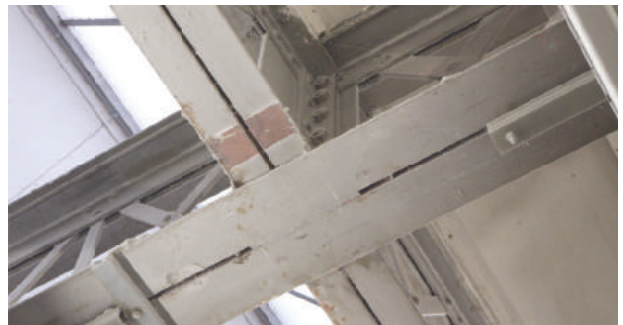
Figure 122 Building A. (Photos by Samantha Elschoot, Chen Zhu, Dinand Kruize & Juliëtte Zegers, 2019)

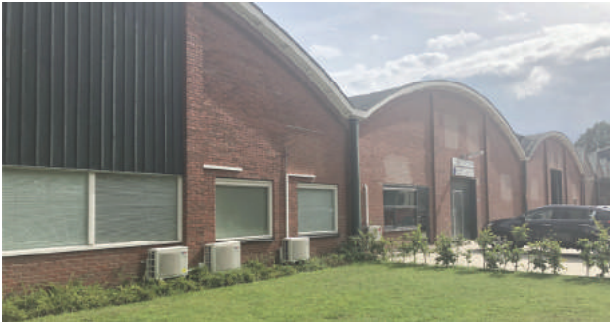
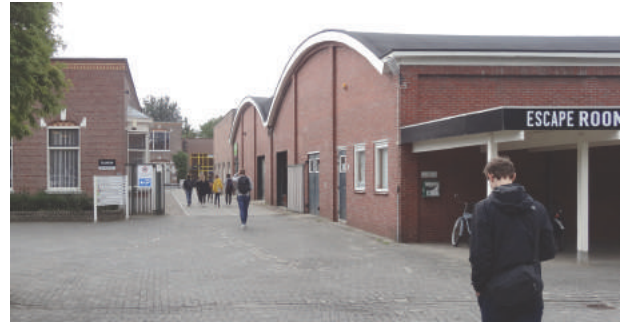
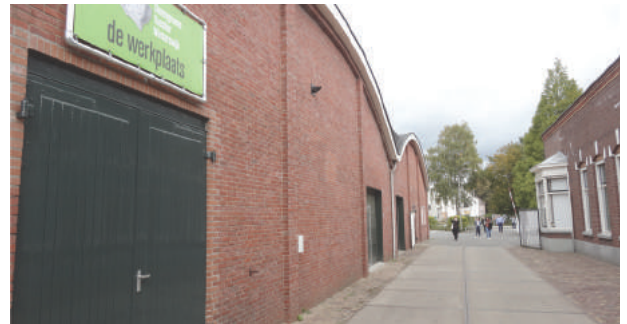
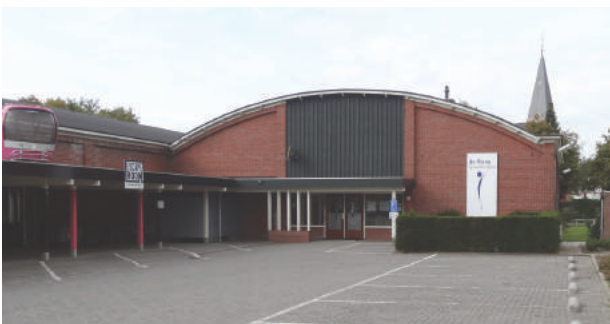
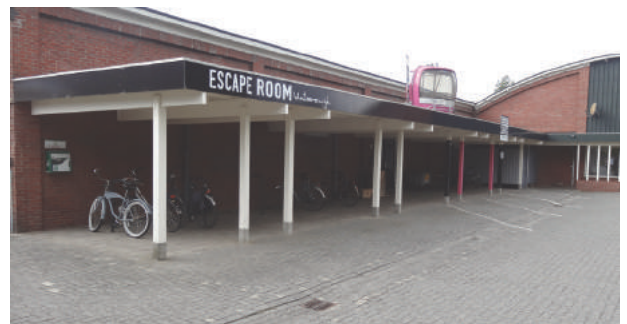
Figure 124 Building B (Photos by Samantha, Elschot, Chen Zhu, Dinand Kruize & Juliëtte Zegers, 2019)

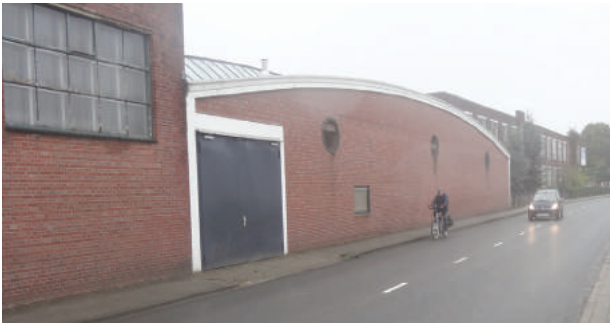
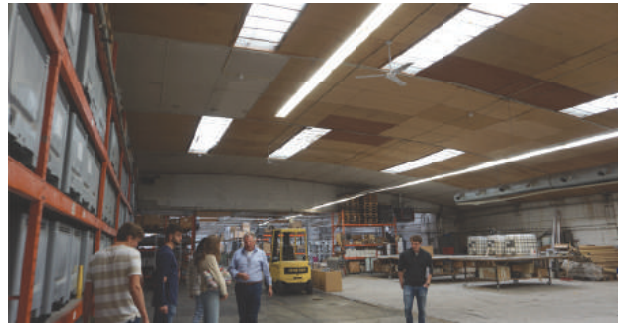
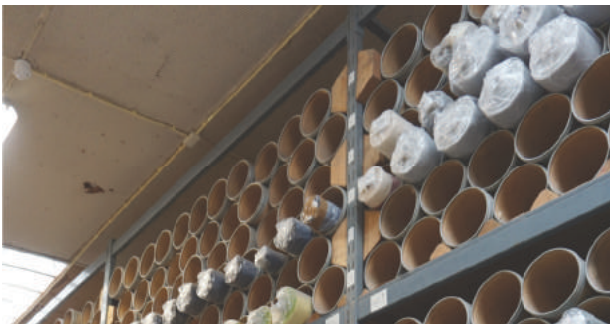
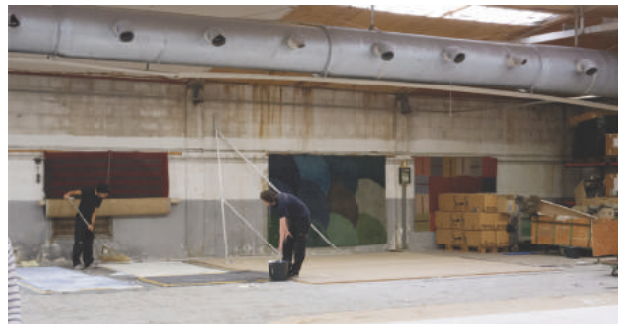
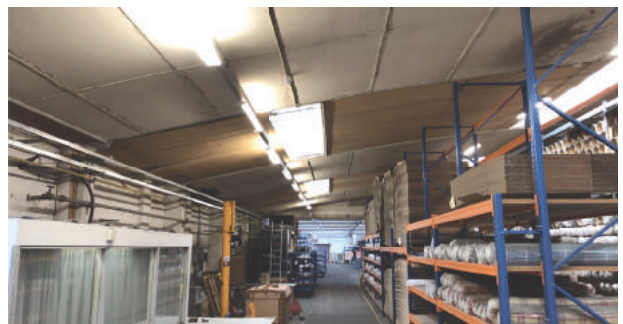
Figure 126 Building C (Photos by Samantha Elschot, Chen Zhu, Dinand Kruize & Juliëtte Zegers, 2019)

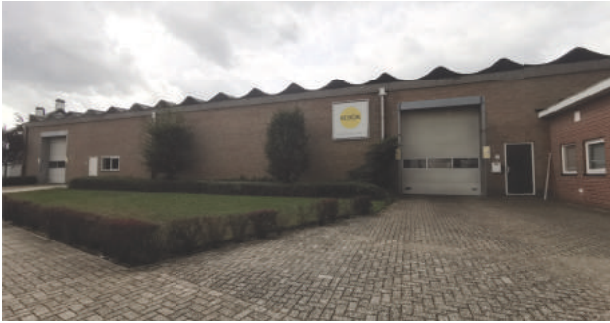
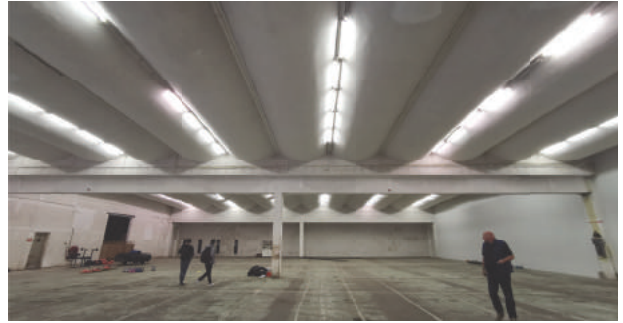
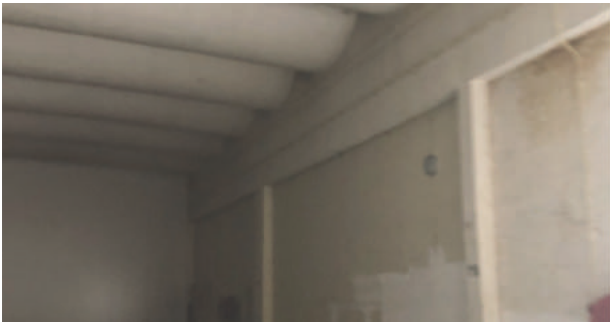
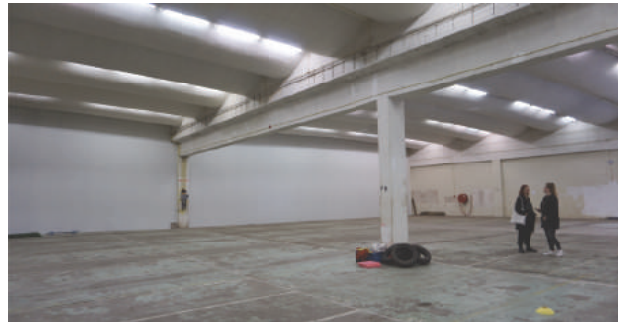
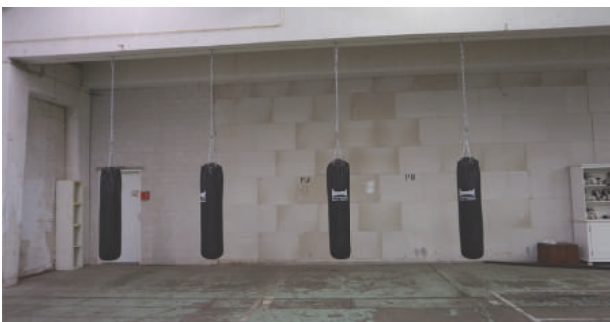
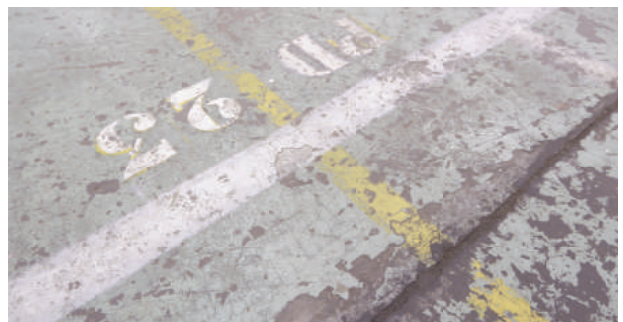
Figure 128 Building D. (Photos by Samantha Elschoot, Che Zhu, Dinand Kruize & Juliëtte Zegers, 2019)

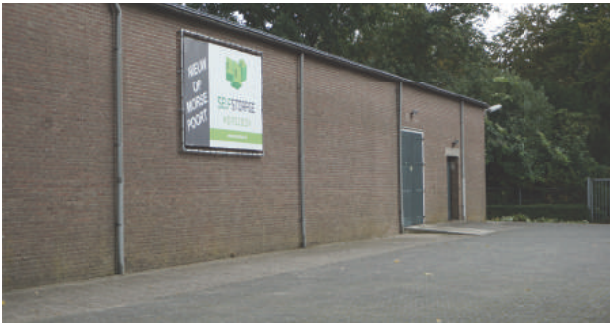
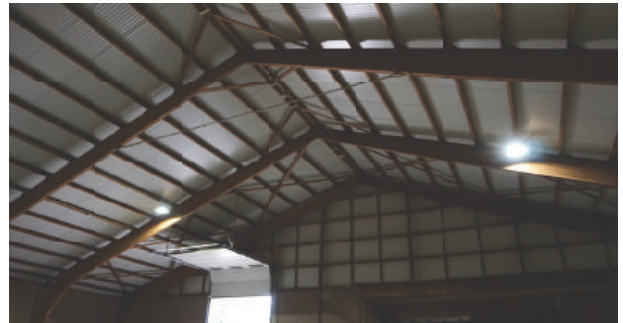
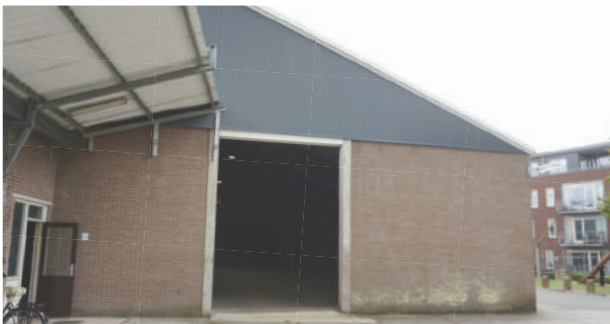
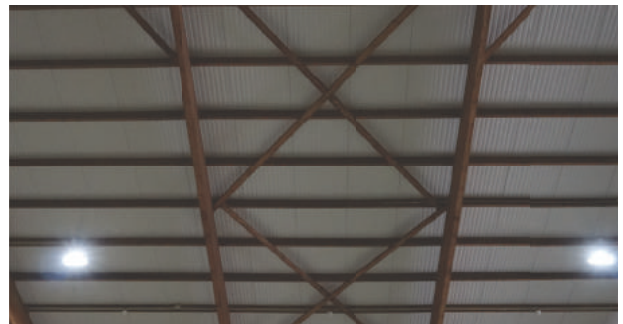
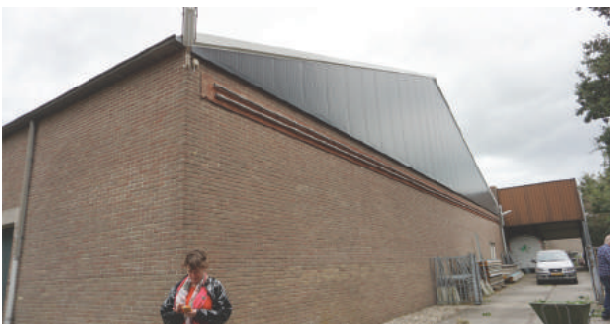
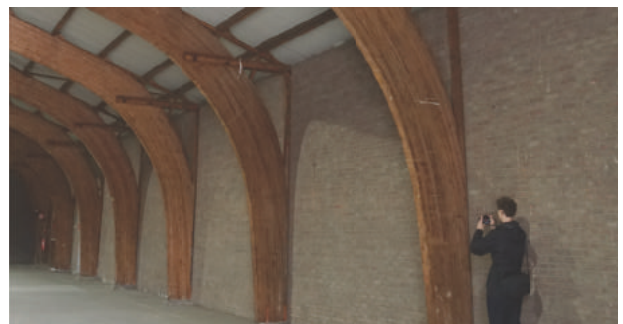
Figure 130 Building E. (Photos by Samantha Elschot, Che Zhu, Dinand Kruize & Juliëtte Zegers, 2019)

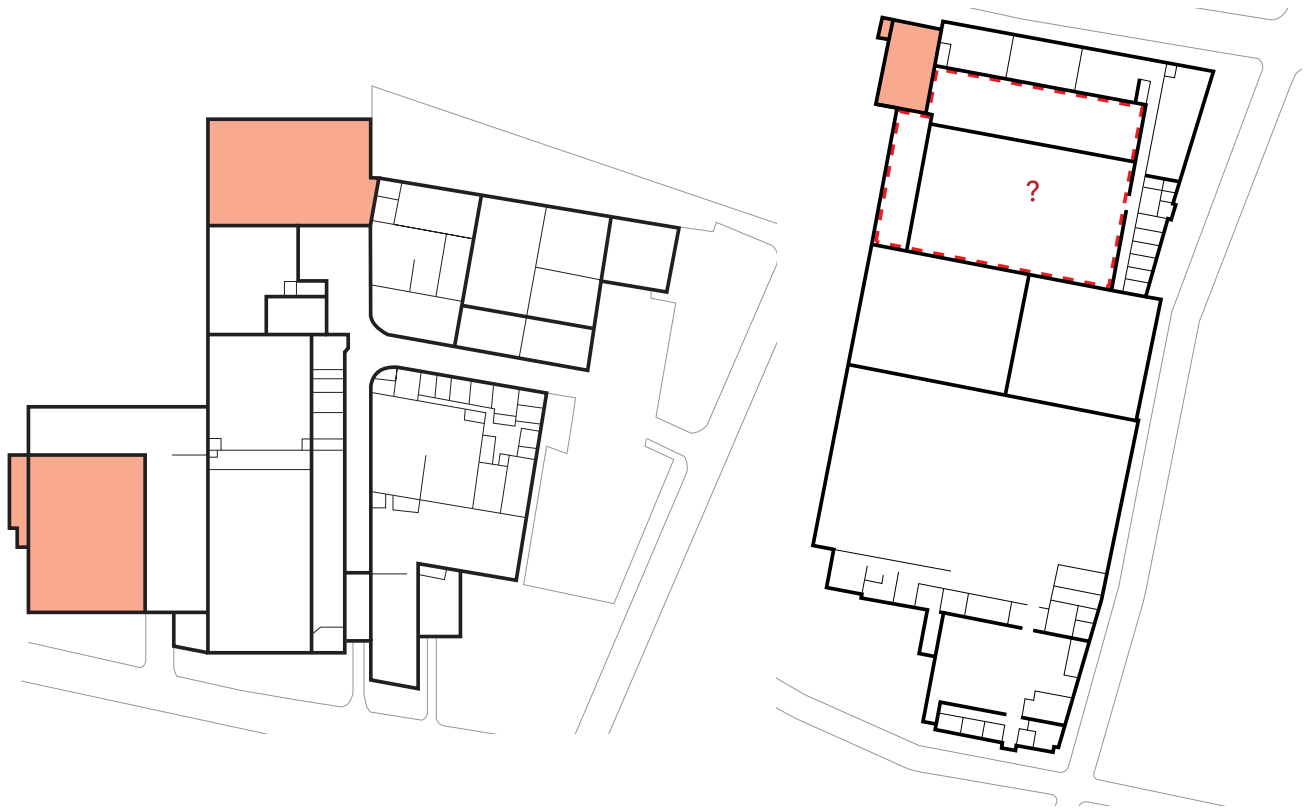
Figure 148 Floorplan layout Hazewind and Gaudium. (Own drawing, 2019)

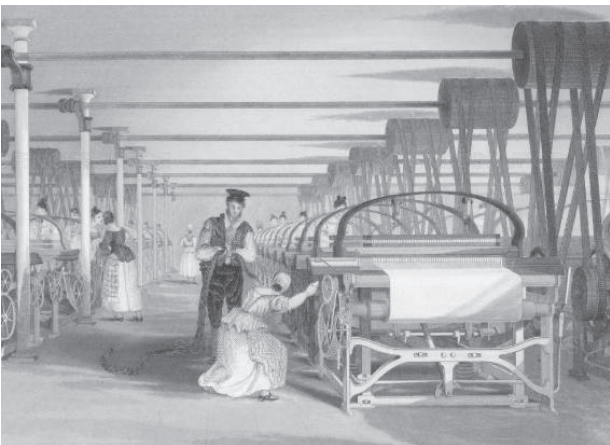
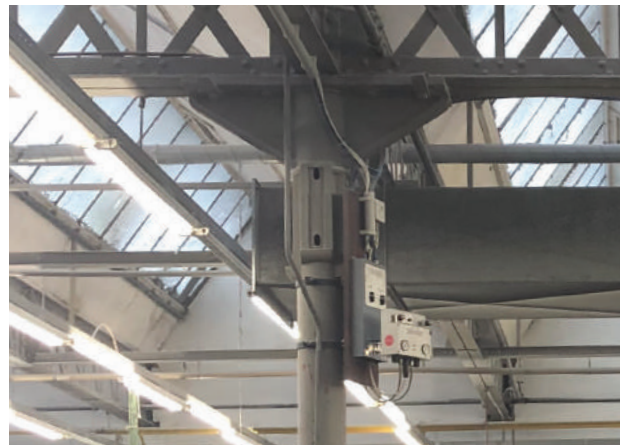
Traces of old weaving techniques are still visible in the factory halls. For example the columns of the saw-tooth structure played a significant role within the process of the steam driven machines. From the main machine room, moving cables run through

holes in the walls towards the halls where they are connected to axles. These axles were connected to the columns: the prefabricated holes are still visible. The moving axles actuated the individual weaving machines.

Figure 152 Scheme of steam driven engine and factory (Canon van techniek in Twente, n.d.)
 Figure 153 Steam engine cables (Canon van techniek in Twente, n.d.)
 Figure 154 Power looms (Science Source, n.d.)
 Figure 155 Connection holes in structure of saw-tooth roofs. (Juliëtte Zegers, 2019)
