INDUSTRY

WINTERSWIJK

Analysis Report
Heritage & Architecture

"DEPOL"
1913

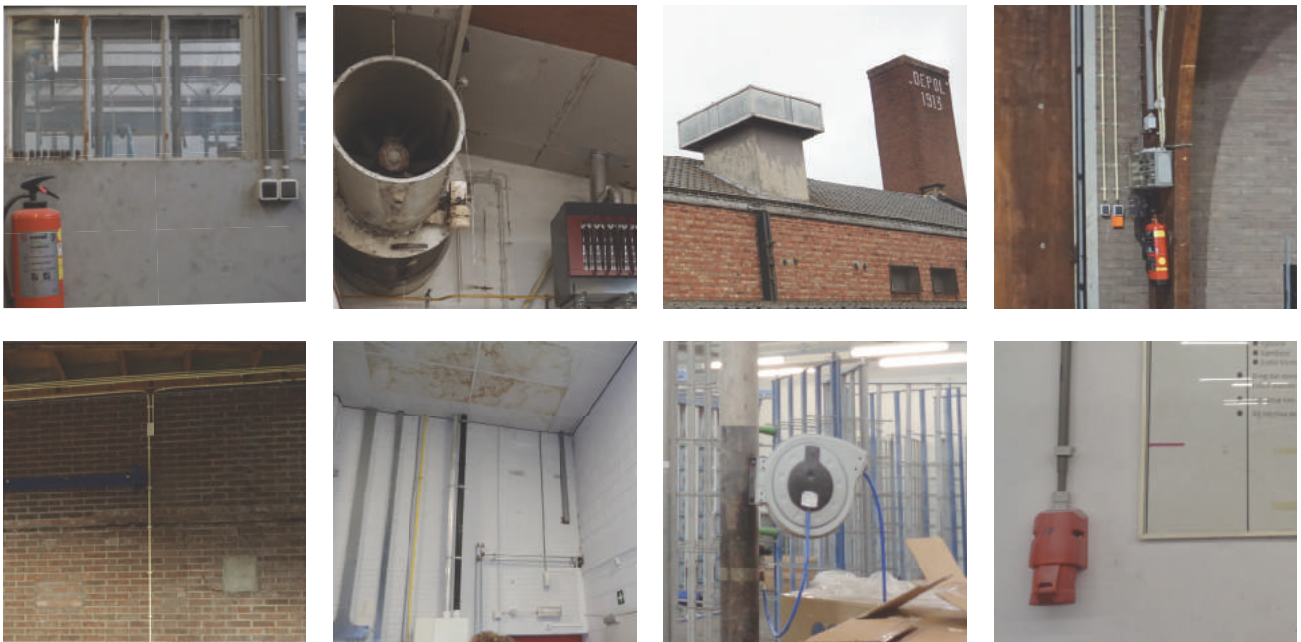
Morsepoort would also still contain some services, but this was incorrect. It seems to be that these services are that much connected to the production process and events that they were taken out when this was not the case anymore. Some services are pictured.

Figure 156 Services. (Photos by various students, 2019)

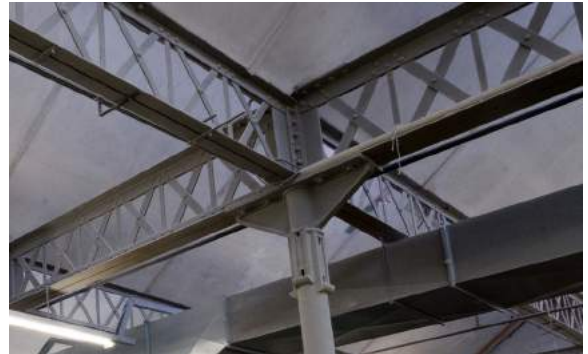
Building year and architect: 1938, Beltman
 Structure type: Steel/glass roof, steel trusses, cast iron columns
 Connections: welded and dry with rivets, girders on columns
 Span: 9500 mm x 12500 mm
 Stability: Steel trusses with fixed connection to columns
 Roof type: Saw-tooth
 Roof material: Steel

Figure 172 Truss connection (Photo by Dinand Kruize, 2019)
 Figure 173 Structural axonometric view (Own image based on Bouwkundig Ingenieurs Bureau Beltman, 1938)

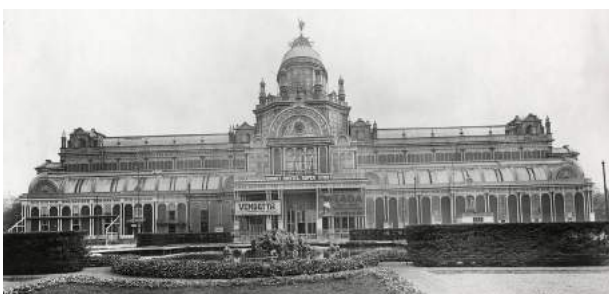
Figure 175 Palace of Volksvlijt, 1864. (Broekema, 2016)

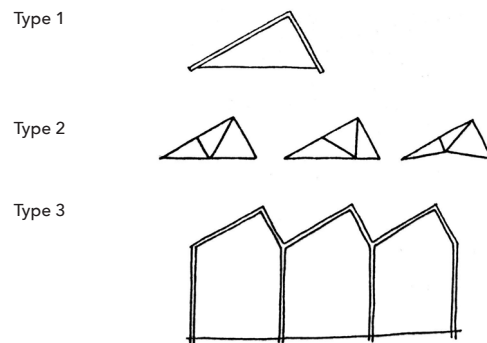
There are four types of this saw-tooth construction:

1. On all of the intersections of the axes columns are present. The saw-tooth trusses rest on these columns.
2. The columns in the middle in the longitudinal direction are not present. The saw-tooth elements are constructed in the transverse direction, which can be trusses or beams.
3. The columns in the middle of the transverse direction of the sawtooth constructions are missing. The sawtooth elementen are constructed in the longitudinal direction by most of the time beams or trusses.
4. This is a combination of type 2 and 3, whereby all columns of the two axes in the middle are not present. In terms of the sawtooth elements, in both directions a supporting element is introduced.

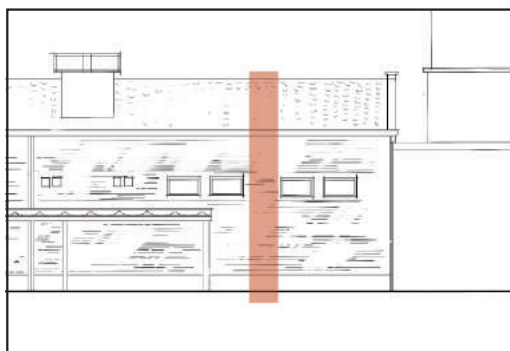
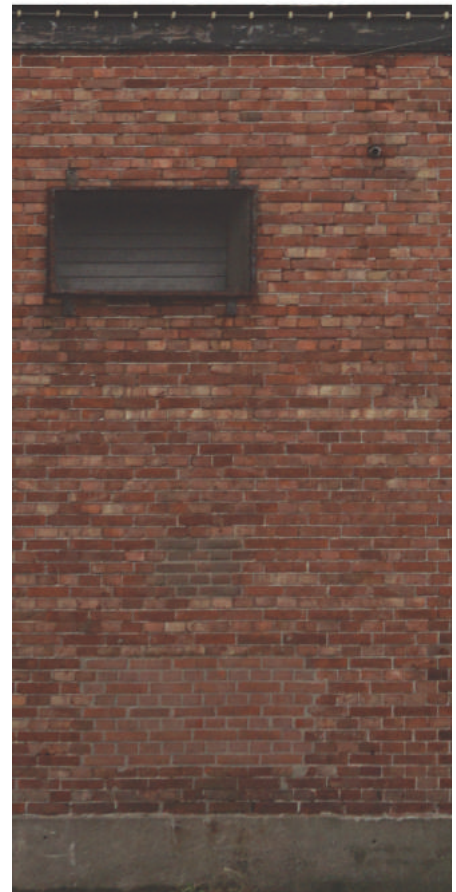
Fragment East

The section shows the steel truss which doesn't end with a column, but is partly supported by the brick wall. This exterior masonry of the cavity wall has a cross bond.

Figure 180 Brick pattern and position section (Own images based on Bouwkundig Ingenieurs Bureau Beltman, 1938)
 Figure 181 Façade (Photo by Dinand Kruijze, 2019)

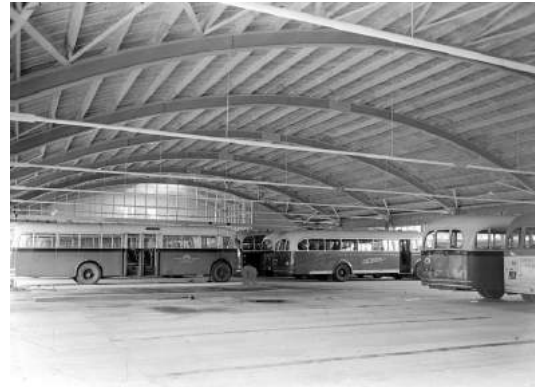
Building year and architect: 1955, Meijerink / Nemaho
 Structure type: primary prefabricated CLT-beams (tension bars) with secondary timber purlins, concrete and steel columns
 Connections: bolted and welded
 Span: 6000 mm x 17775 mm
 Stability: stability crosses and steel truss
 Roof type: Arched with pulling bars
 Roof material: CLT and timber

Figure 185 Example of Nemaho CLT beams. (Willemskwartier Nijmegen, 2017)
 Figure 186 Structural axonometric view (Own image based on Bouwkundig Ingenieurs Bureau Beltman, 1955 & N.V. Verbeco Ede, 1955)

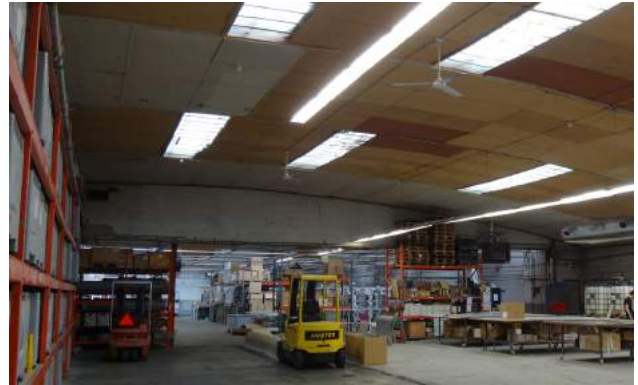
Building year and architect: 1957, Pannekoek
 Structure type: steel primary trusses and timber secondary trusses, concrete columns
 Connections: welded and steel plates
 Span: steel trusses 32000 mm, timber trusses 5000 mm
 Stability: stiff slabs and fixed joints
 Roof type: 'Pannekoek' (patented)
 Roof material: Steel and timber

Figure 196 Ceiling (Photo by Joost Joosse, 2019)
 Figure 197 Structural axonometric view (Own image based on J.C. Pannekoek, 1956/1957)

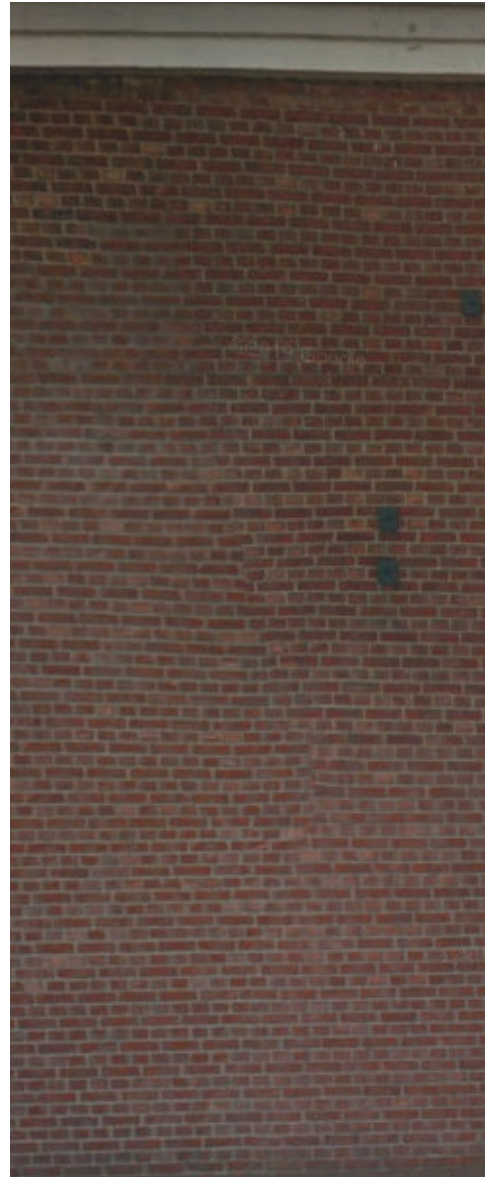
Fragment North

The section shows the timber trusses in the exception part of the building, they are connected to steel I-beams. The exterior masonry has a cross bond.

Figure 199 Brick pattern and position section (Own image based on J.C. Pannekoek, 1956/1957)
 Figure 200 Façade (Google Maps, 2019)

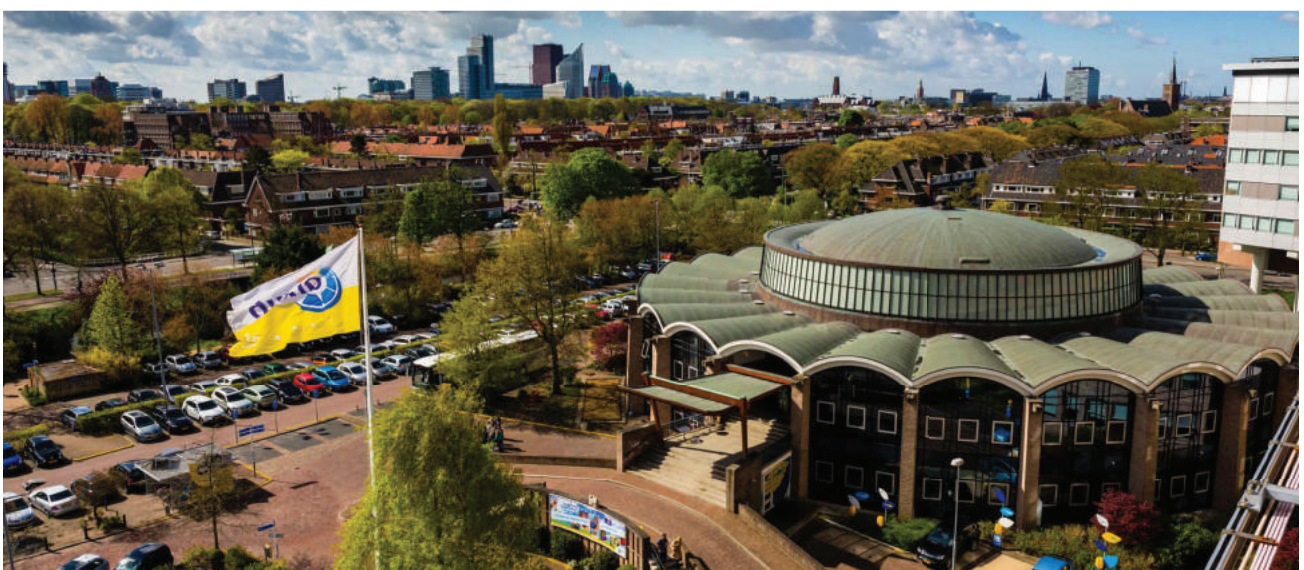
complex and very thin reinforced concrete shells was possible. After 1975 it disappeared as a construction type. In the few decades the type of construction has been applied, concrete shells were used for a lot of different functions, from factories to train stations and even theatres and churches. extraordinary and futuristic, this can be seen in the works of Félix Candela and in some projects of Oscar Niemeyer. There were and are some examples of concrete shells built in the Netherlands; the former Rotterdam station and platform roofs by Sybold van Ravesteyn in 1957, the main building of the ANWB in Wassenaar, built in 1959 and ofcourse the weaving building on the site of the Morsepoot. (I.T., 1968)

Figure 204 ANWB office Wassenaar (ANWB, 2019)

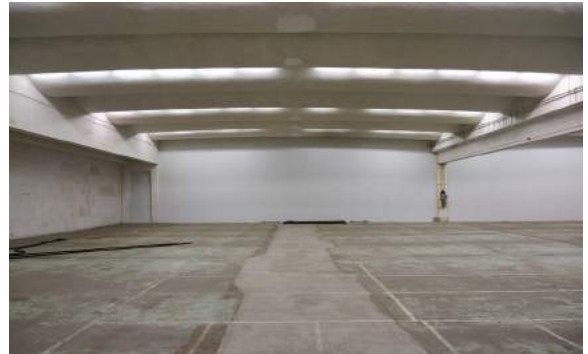
Building year and architect: 1960, van Linge
 Structure type: concrete columns and concrete roof
 Connections: pre-fab
 Span: 15550 mm x 19400 mm
 Stability: stiff slabs and fixed joints
 Roof type: double curved concrete roof slabs (HP shells)
 Roof material: concrete

Figure 209 Structural axonometric view (Own images based on Architectenbureau van Linge, 1960)
 Figure 210 Roof structure visible (Photo by Dinand Kruize, 2019)

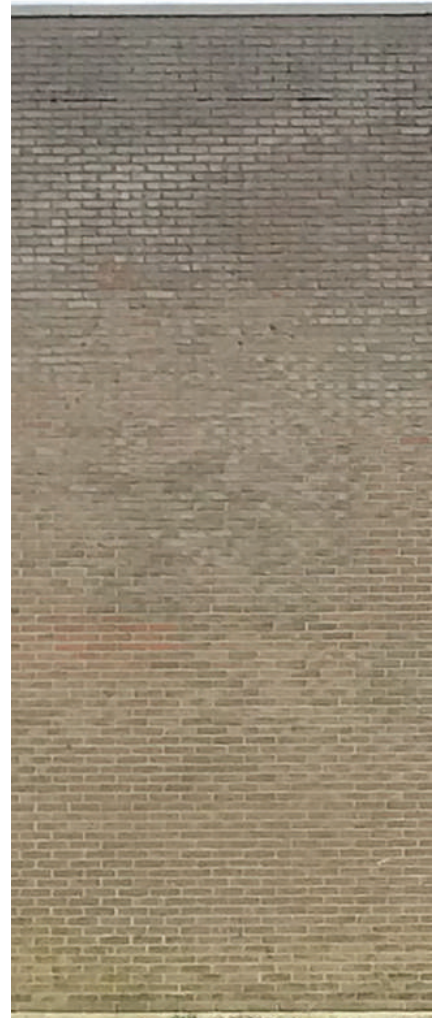
Fragment East

The section shows the roof slab which is supported by portals.

Figure 212 Brick pattern and position section (Own image based on Architectenbureau van Linge, 1960)
 Figure 213 Façade (Photo by Juliëtte Zegers, 2019)

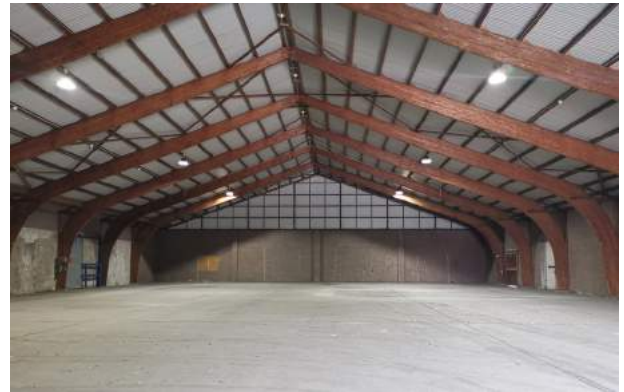
Building year and architect: 1963, Sassen / Nemaho
 Structure type: primary prefabricated CLT-beams (tension bars below the ground) with secondary timber purlins
 Connections: Bolted
 Span: 28510 mm x 4630 mm
 Stability: timber crosses and brick walls
 Roof type: Pitched barn roof
 Roof material: CLT and timber

Figure 217 Structural axonometric view (Own image based on Bouwkundig Ingenieurs en Adviesbureau Sassen, 1960)
 Figure 218 CLT beams visible (Photo by Chen Zhu, 2019)

A tension bar underneath the floor is used to ensure the strength of the beams. To put the bars under the ground is a well thought choice and makes way for free space in the structure itself.
