A comparative study between low- and high-tech methods for the detection and mitigation of illicit connections in stormwater systems

Water Science and Technology

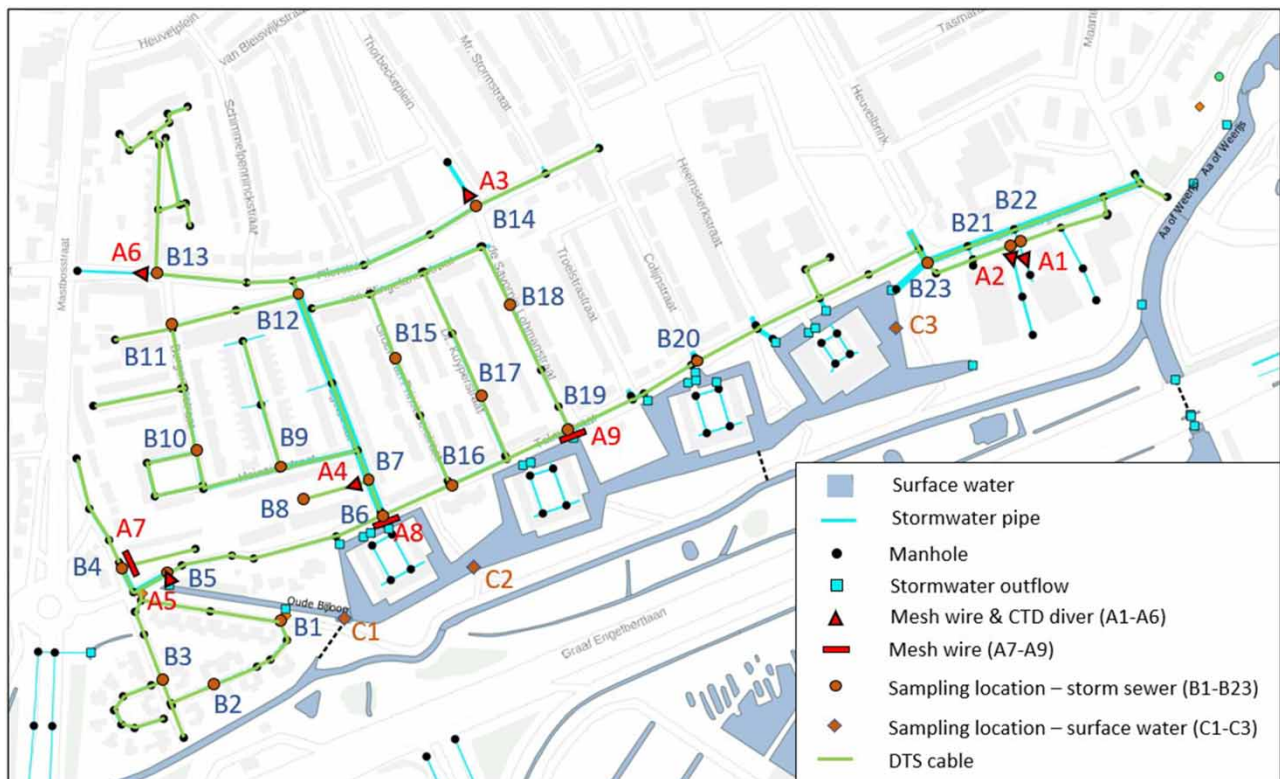
Figure 1 | Catchment area De Heuvel with type and locations of the applied methods/techniques.

The study was conducted in the stormwater system of catchment De Heuvel in the municipality of Breda, the Netherlands. The catchment is a residential area of 15 ha with storm sewers discharging to a local pond in the southern part of the catchment (Figure 1). The stormwater system has a length of approximately 5.5 km and consists of several parts. The central section (4.5 km) drains under gravity to one of the nine outlets of the central pond. The outlets are fitted with nonreturn valves to prevent inflow from the pond into the system. The southwest part of the system consists of an infiltration transport sewer (0.5 km) with an internal overflow to the central section of the system and an external outfall to the receiving pond. Furthermore, four ‘islands’ in the area each have their own stormwater system (in total 0.5 km) and outlets; these sewers are not connected to the municipal system and were not included in the study.

Six conductivity sensors (CTD divers[®], van Essen Instruments) were utilized, measuring high-frequency conductivity and temperature at various locations in the stormwater system (Figure 1). The idea behind the use of CTD divers in the search for illicit connections is that, due to a different composition, wastewater discharges may be observed as a temporary increase in conductivity and/or temperature. The CTD divers were attached to (a selection of) the same setups as used for the wire screens, hence measuring at the same locations (A1–A6).

from the pond (C1–C3) are shown in Figure 1. The DTS monitoring was performed between October and December 2019 yielding a total of 26 days of data fit for data analysis (DTS data collected during storm events are not suitable for analysis). The wire screens and CTD divers were installed on 28 October 2019. The screens were inspected on 7 November and prior to their removal on 20 November 2019.

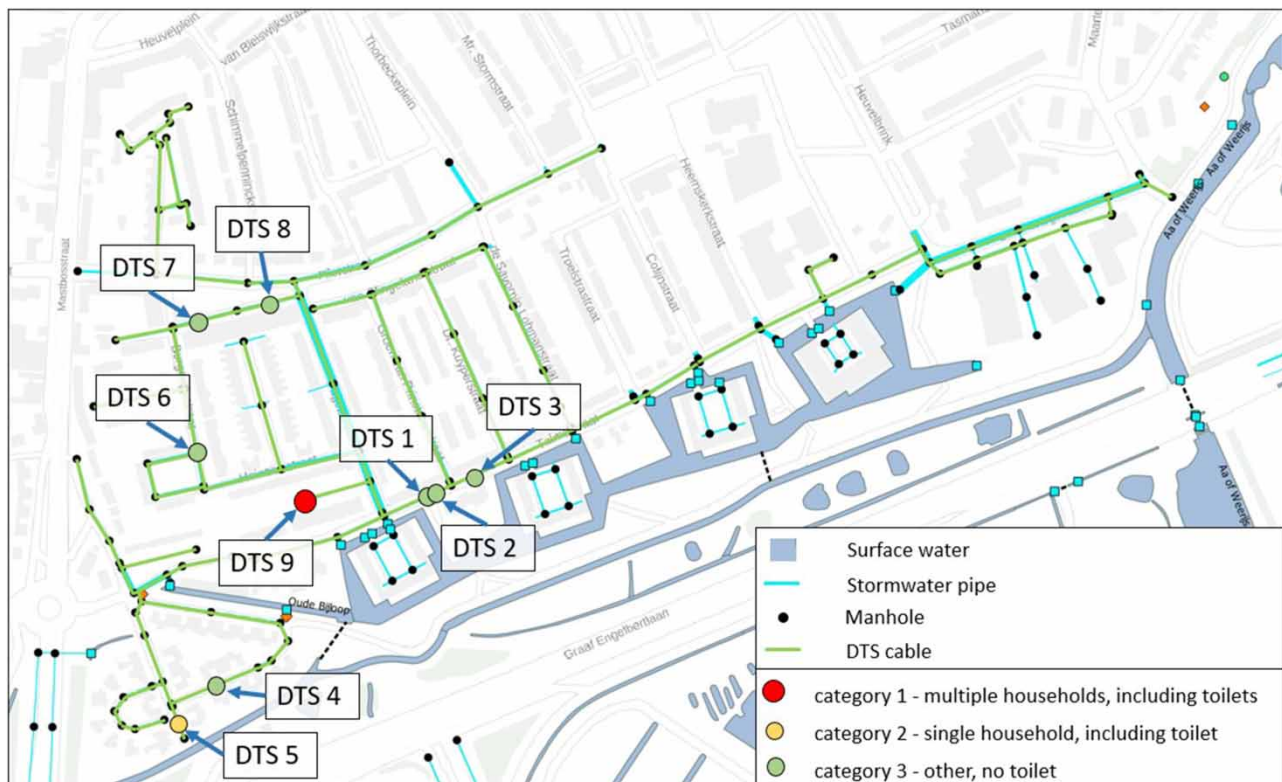
Figure 2 | Results of DTS monitoring with categorization of illicit connections.

Frequent and/or large temperature deviations in the DTS measurements were found at nine locations in the sewer system (Figure 2). These locations were further examined by conducting systematic appliance discharges (e.g. in toilets, bathrooms, washing machines) in the houses around the detected discharge points.

Location DTS 9 proved a large illicit connection with all wastewater from a three-storey building (three households) misconnected to the storm sewer. This illicit connection was repaired in March 2020. At location DTS 5, a visual inspection of the manhole revealed that wastewater (including fecal material) was present in the stormwater system, but the exact source could not be determined during the site visit. As a result, this illicit connection was not (yet) repaired by September 2022.

The other seven locations proved to be misconnections in the in-house plumbing, resulting in nonfecal discharges (e.g. washing machines) to the stormwater system. Locations DTS 7 and DTS 8 were repaired, and the other locations were not due to the practical (in)feasibility of repair (as judged by the municipality).

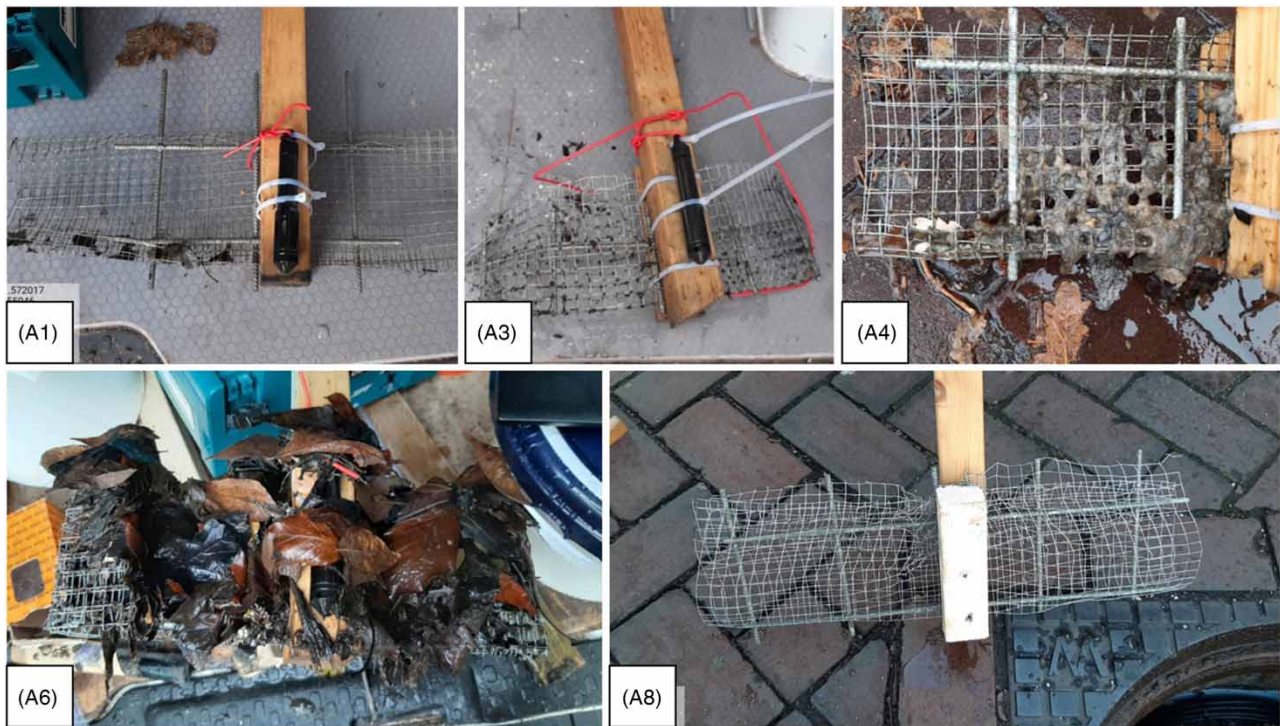
Figure 3 | Mesh wire screens during inspection in November 2019.

Figure 3 shows a selection of results of the wire screens. No signs of fecal contamination (i.e. no toilet paper or fecal matter) were found on the majority of the inspected screens, although (remnants of) leaves were found at some locations. Only the screen at location A4 (downstream of DTS 9 where sewage was detected) showed clear traces of greasy contamination and a distinct sewage smell during the inspections.
