# INFLUENCES IN TRANSFORMATION PROJECTS

*An investigation into the factors that influence the performances of a transformation process of building projects.*

Delft University of Technology  
Construction Management & Engineering

*Master of Science Thesis  
Construction Management & Engineering (CME)*

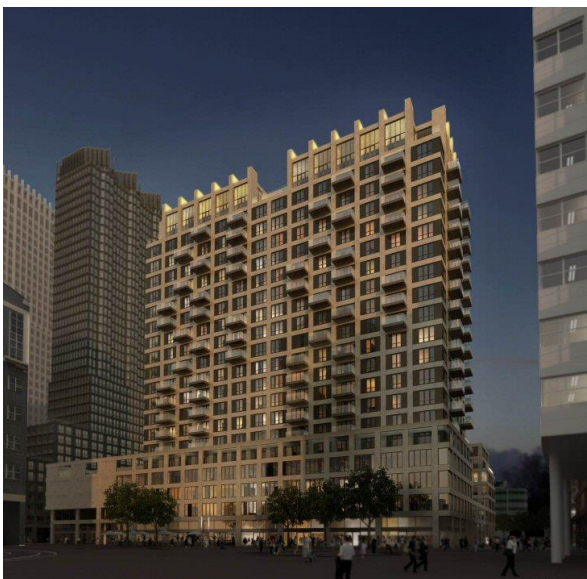
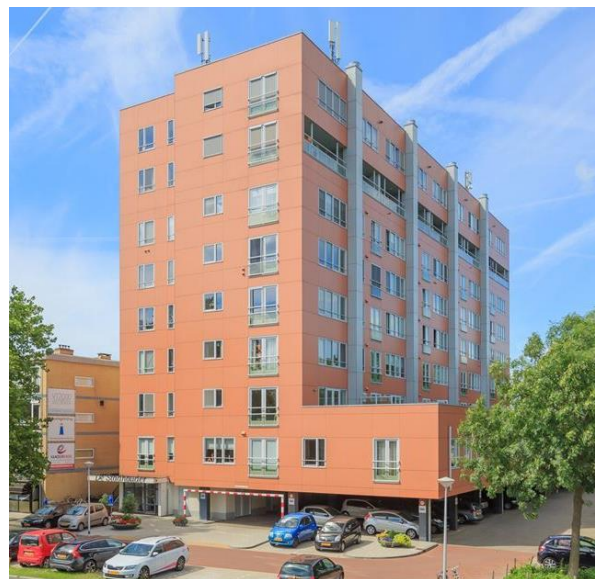
FIGURE 1: LEFT WIJNHAVENKWARTIER (LBP SIGHT, 2018) RIGHT DE STADHOUDER (FUNDA, 2018)

*Won the architecture price called the Berlagevlag*

*Positive financial endresult, with airshafts on the facade of the building*

Companies which are moving from an old office to an office on a more favourable location with better facilities are leaving behind a building that is hard to rent. Instead of demolishing and building a new office on this location, there is also the option to transform the building (Van der Voordt T. , 2007). Transformation has a variation of definitions, according to *Transformatieadvies (2018)* transformation means change of the physical appearance. Transformation has two different ways, one is the transformation wherein the current function is preserved and the other way is the transformation wherein the function is changed into another function. The most common herein is the function of an office that is changed into houses. In the period between 2011-2015 almost 26.000 houses are realised due to transformations (Centraal bureau voor de statistiek, 2018). Some succesful transformation of buildings are shown in Figure 1.

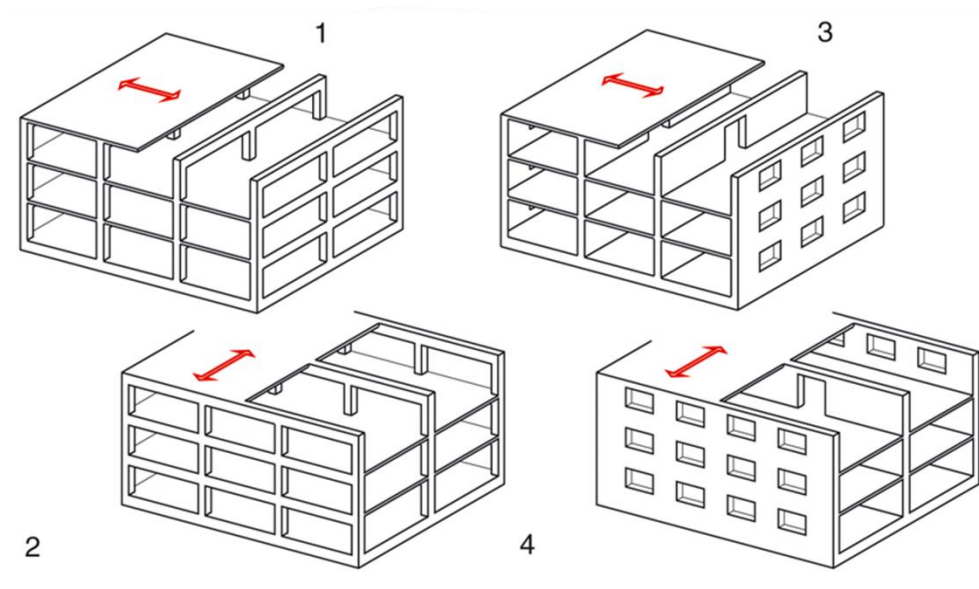
FIGURE 5: ONE DIRECTION BEARING CONSTRUCTION (KAMERLING & KAMERLING, 2004)

The bearing construction that is carrying the load in one direction exists out of floor- and roof elements whose span is in one direction and the load is also worn out in one direction. The floor- and roof elements are supported with walls or columns and walls. For buildings that have the shape of a rectangle the following skeleton forms can be divided, see Figure 5 (Kamerling & Kamerling, 2004).

1. Column skeleton with cross beams
2. Column skeleton with side beams
3. Skeleton with cross walls
4. Skeleton with side walls

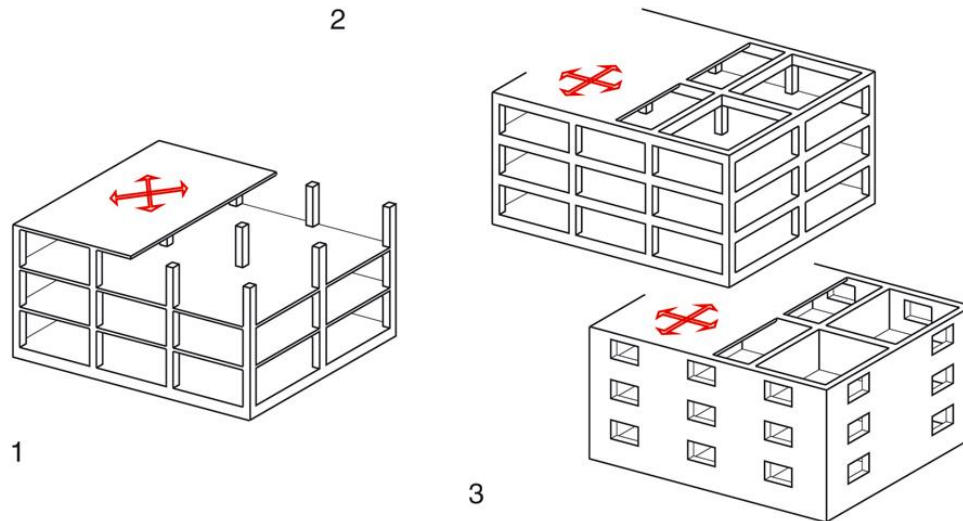
**FIGURE 6: TWO DIRECTION BEARING CONSTRUCTION (KAMERLING & KAMERLING, 2004)**

The second main group that is carrying the load in two or more direction exists also out of floor- and roof elements but it is supported by point shaped elements or supported by linear elements on each side. A linear supporting element exists out of columns and beams and the point shaped elements exists only out of columns. In this main group buildings that have the shape of a rectangle the following skeleton forms can be divided, see Figure 6 (Kamerling & Kamerling, 2004).

1. Column skeleton with point shaped supporting plates
2. Column skeleton with linear- and side beams
3. Column with linear- and side walls

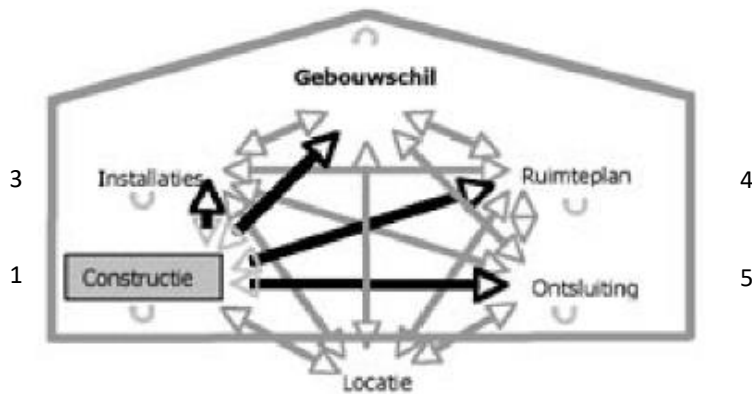
FIGURE 7: BUILDING MODEL WITH LAYERS (VAN DER VOORDT T. , 2007)

To judge the characteristics of the construction in more detail a simple building model (Figure 7) can be used. In this model the following building layers are divided Blok & Oudenaarden (2007):

1. Construction: columns, beams, carrying floors, foundation etc.
2. Building shell: façade, roof, separation between inside and outside
3. Installations: pipes, systems for energy, water etc.
4. Space plan: separation walls, doors, ceilings, establishment and finish
5. Access: stairs, elevators, corridors and galleries

In this model the incoming arrows stand for the extend of active flexibility of the building layer. Active flexibility of the construction stands for the transformation capacity of the construction itself. The departing arrows stands for passive flexibility of the construction. This stands for the power to make changes to other building layers without changing the construction itself.

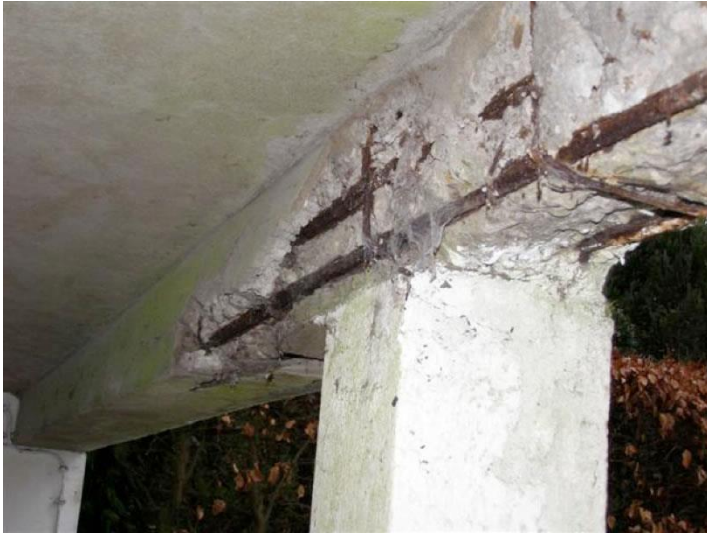
FIGURE 8: CORROSION OF CONSTRUCTION (DE BETON GROEP N.V., 2018)

According to Massari in Douglas & Noy (2005) damp penetration is one of the most damaging failures that can occur whether the construction is old or new build. It can damage the construction by saturating it (Trotman et

al. in Douglas & Noy (2005). When a construction is build there is made use of a lot of water. It is estimated that a avarage house will contain a tonne of water in the brickwork alone. Some of this water will vaporize before the house is occupied. However most of the water used in the constructional process will dryout slowly. The ground around the foundation of a construction is always damp, moisture infiltrates into the construction unless a dampproof course is provided above ground level the moisture will rise causing dampness to walls and floors.

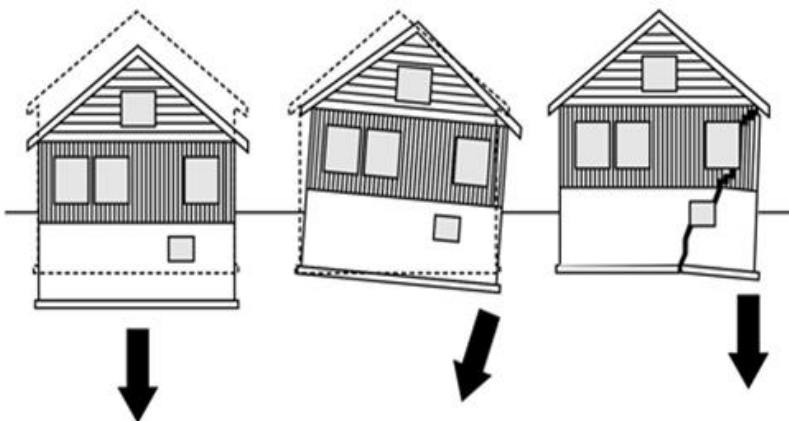
FIGURE 9: FOUNDATION SETTLEMENTS (PREETHAMBUILDERS, 2017)

Foundations of the construction can move over time because of load applied causing downward movement known as settlement. Settlement can be tolerated by the construction if they do not exceed the allowable bearing pressure. Other possible causes of foundation movement known as subsidence caused by activity in the ground are:

- Soil erosion caused by flowing water
- Changes in ground water level
- Buildings on made up ground
- Movement associated with mining activities
- Movement due to shrinkage or swelling of clay soils (this is the most common cause of foundation movement)
- Uneven bearing capacities of differing subsoils

Foundation repairs to existing constructions of buildings are generally the most difficult and costly to effect, which is a good reason for a thorough investigations.

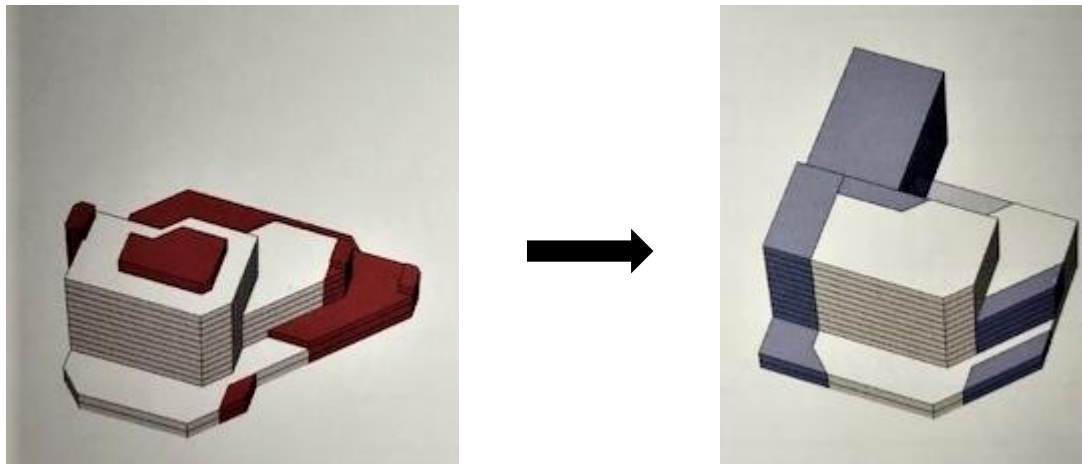
FIGURE 15: LEFT OLD BUILDING AND RIGHT NEW BUILDING (PPS RIJSKANTOOR DE KNOOP UTRECHT, 2015)

This Case is about the governmental office De Knoop in Utrecht on the Mineurslaan 500, see Figure 13 for the exact location. This office is a former military barrack what was built in the late eighties. When it was used for a long time for military purposes it became vacant for a while, till the client directorate-general and the tax administration asked Rijksvastgoedbedrijf to develop the former military office in to a governmental office. The project was awarded on the base of EMVI criteria on June 23, 2015 to the Consortium Rcreators in a DBFMO contract for a NPV of €129 million and it is expected that the project will end in the spring of 2018. After the completion of the project it will be exploited for 20 years. In this project sustainability has always been elaborated on three key pillars: less consumption, sustainable production and healthy work. The project includes also a part demolition and a part new build. The starting point of the building is to demolish as less as possible and to reuse as much as possible. This has made changes in the floor area of the building. The gross floor area of the old building is 20.614 m<sup>2</sup>, from this 3.803 m<sup>2</sup> is demolished what left 16.811 m<sup>2</sup>. The part that is new is 13.375 m<sup>2</sup> what makes a total with the old building a gross floor area of 30.186 m<sup>2</sup>. In Figure 14 the old and the new building is shown and in Figure 15 a sketch is shown of the old and new building.

The construction of the building exists out of a concrete skeleton that is poured during the work with a floor thickness of 250mm. It is build up out of a column structure wherein the columns carry the construction, this creates flexibility in the building. The grid of this column structure has a distance of 5,28m. The stability of the building is taken care by a concrete core in the middle of the building and two walls on both sides of the building, the elevators and stairs are also located in this core. The complete building is founded on piles. The constructive floor ceiling height over the difference floors of the building has a distance of 2,85m. In the basement of the building the ceiling is a bit higher with 4,85m. The building is accessible by a main entrance and has a horizontal strip over the ground level that is connected to four vertical shafts divided over the building wherein the elevators and staircases are located.

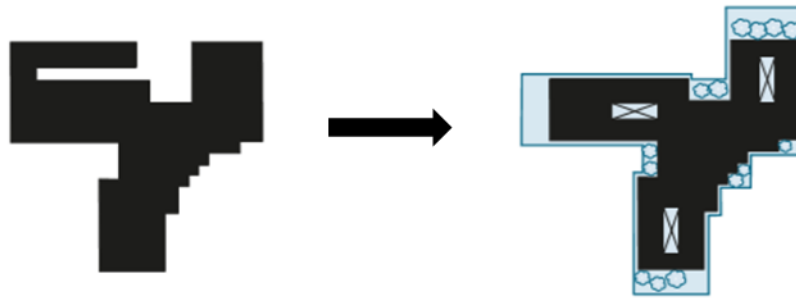
FIGURE 18: LEFT OLD BUILDING AND RIGHT NEW BUILDING (DE ARCHITECT, 2018)

The second case in this research is the head office of the company ASR securities. It is in Utrecht on the Archimedeslaan 10 next to the highway junction between A27 and A28, see Figure 16 for the exact location. In June 2009 the board of directors of ASR has decided to bring all the company activities into one building. This decision is made to decrease the housing cost of the company and to strengthen the collaboration inside the company. After an extensive study the choice is made to transform the existing office of ASR on the Archimedeslaan. After it got awarded to the building combination Archimedes, they started in 2012 with the execution of the transformation. This happened in three phases, because there were still people of ASR working during the execution phase. In the new design of the building a part of the building is demolished and there is also a part new build in the basement what serves as a meeting centre, which gets daylight by the new atriums. In Figure 17 the old and the new building is shown and in Figure 18 a sketch is shown of the old and new building.
