KATOENVEEM

FUNCTION vs. AESTHETICS

P1 Research Report

Heritage & Architecture
MSc3 'Rotterdam Harbour Heritage'
TU Delft

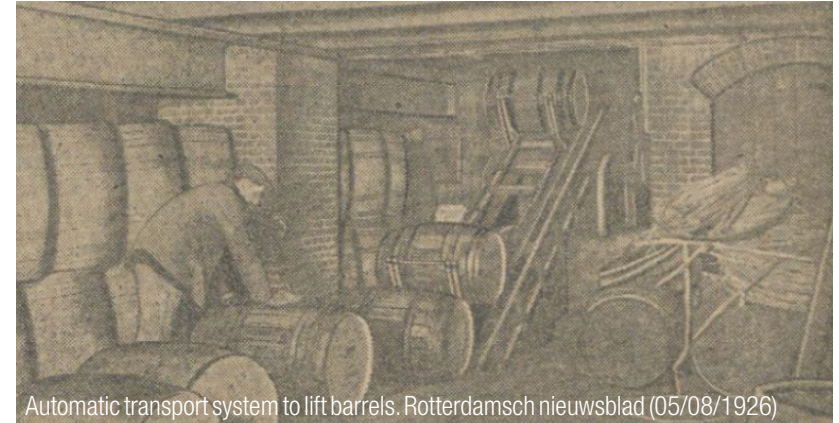
Automatic transport system to lift barrels. Rotterdamsch nieuwsblad (05/08/1926)

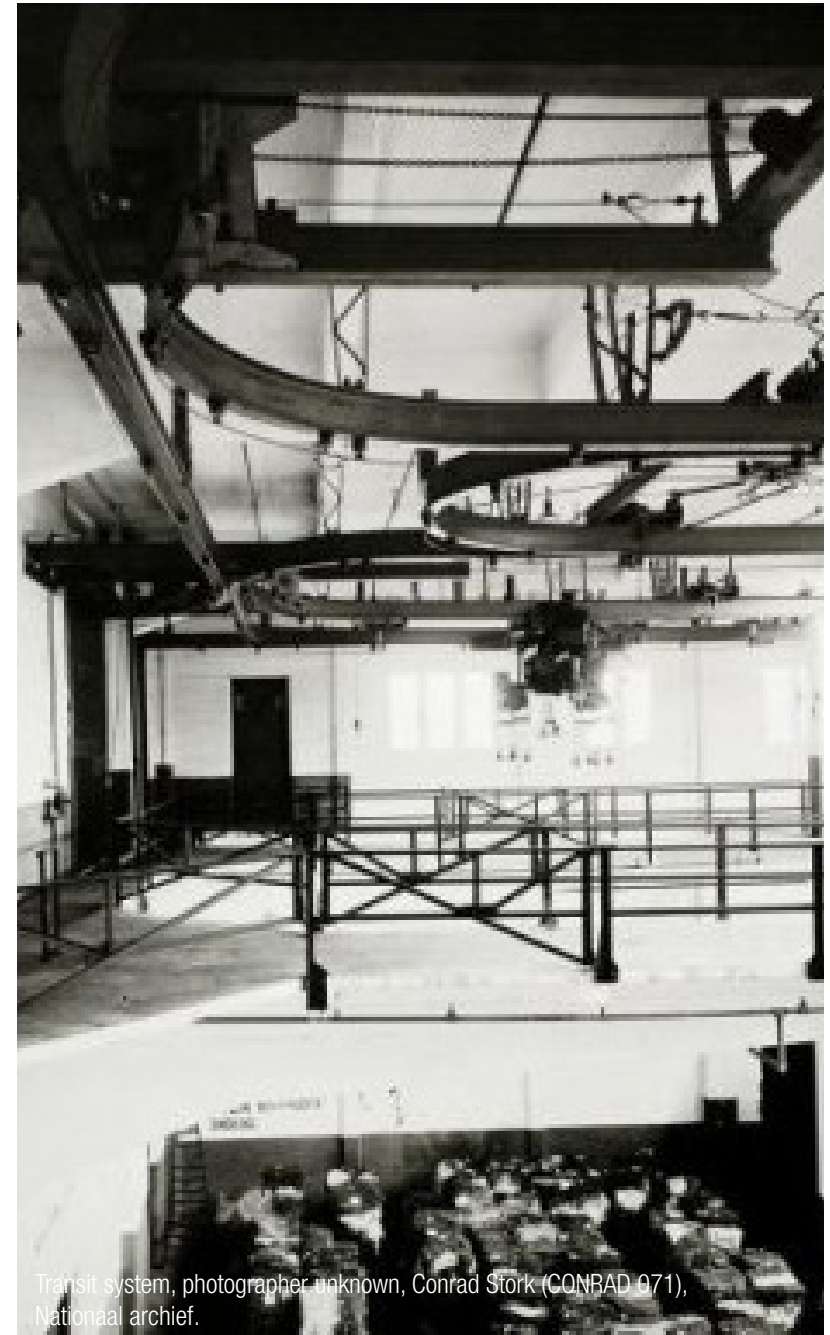
Transit system, photographer unknown, Conrad Stork (CONRAD 071), Nationaal archief.

As a conclusion, the function of the Katoenveem has indeed influenced its appearance. First of all, the building was adapted to the specially designed transit system which would optimize the transshipment of the cotton bales. Secondly the organization of the Katoenveem is also adapted towards the functioning of the transit system, storing the cotton on the ground floor and using the first floor to control the system. This also resulted in a balcony which wraps around the entire building and a roof which extends above the balcony to assure an optimized transshipment of the bales as well as preventing the bales from getting wet. Last of all, the entire building is constructed out of concrete to assure a safe fireproof storage building, and the small windows and diffused light which enters from above to assure that the cotton bales would not dry out or develop mold and lose value.

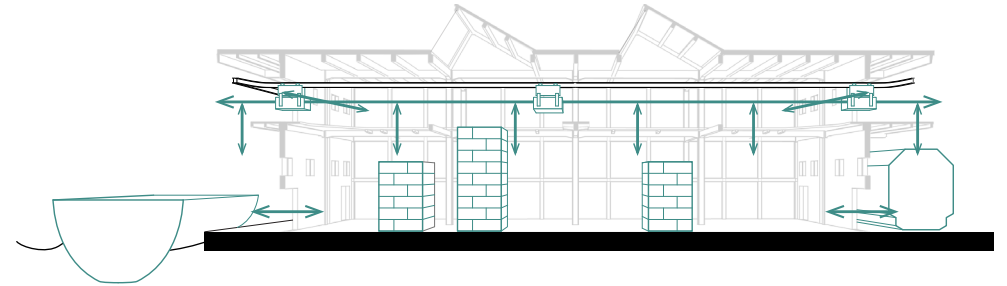
Movement of the people, illustrated by Jelmer van der Poel

Movement of the cotton bales, illustrated by Jelmer van der Poel

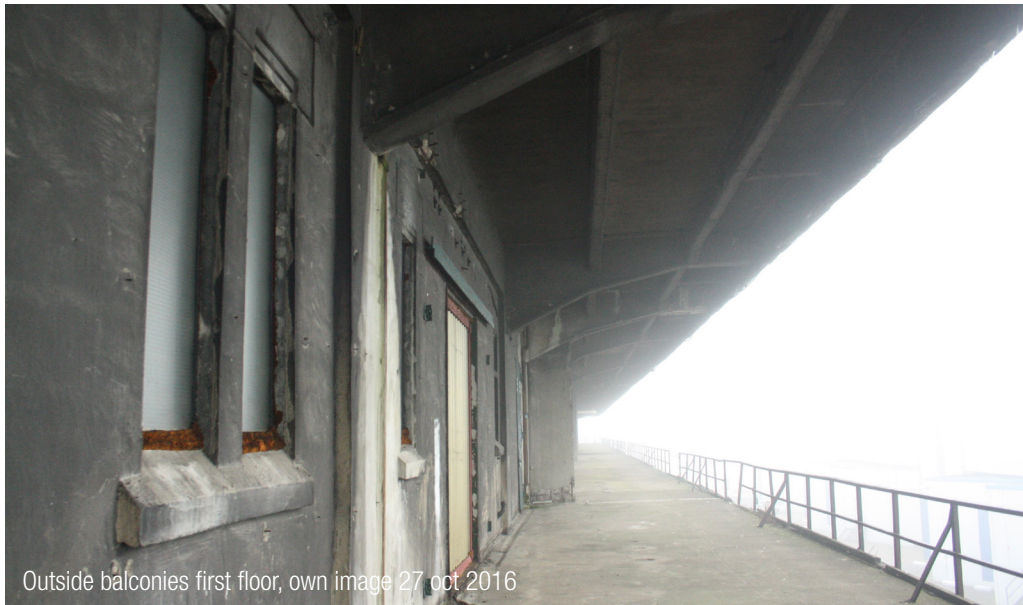
Outside balconies first floor, own image 27 oct 2016

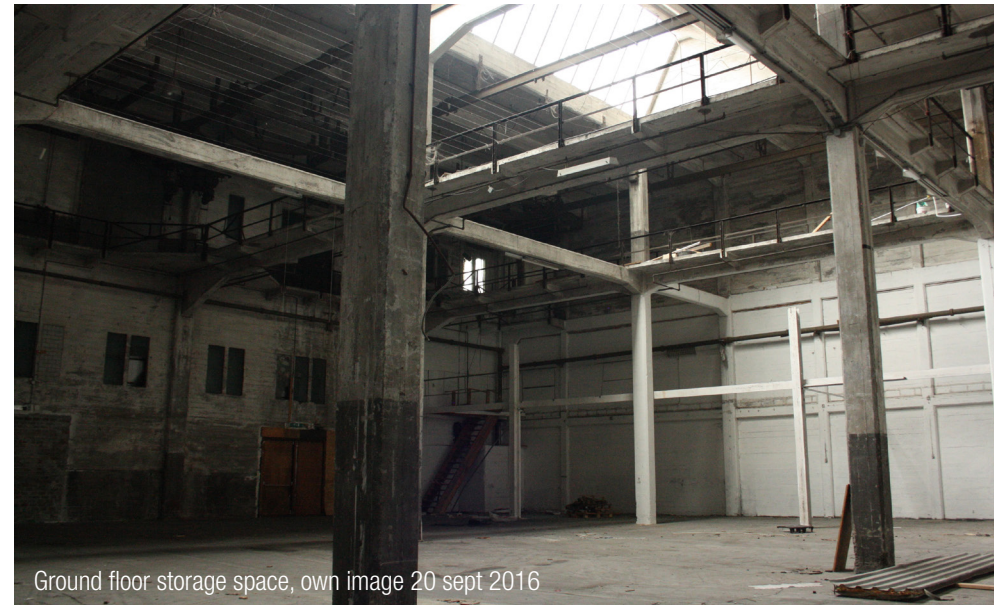
Ground floor storage space, own image 20 sept 2016

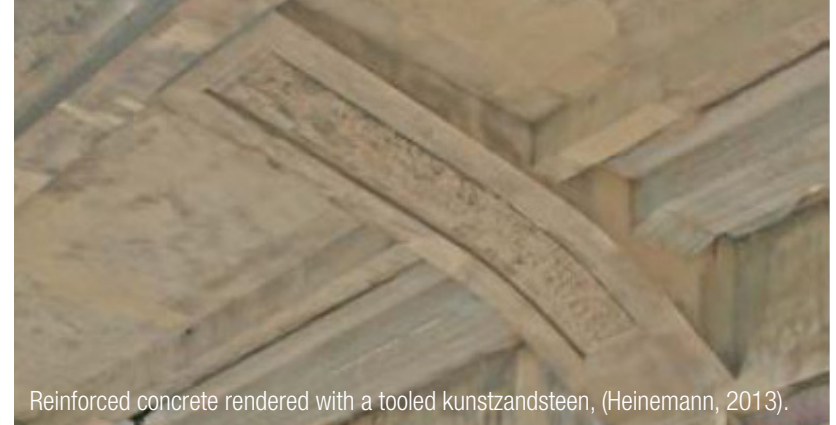
There were two ways the exposed concrete surface could be rendered. (1) With a kunstzandsteenpleister (“artificial sandstone render”) which included adding ground natural stone to the mortar to imitate the colour of natural stone. (2) By applying a beton-emaille which is a special plaster type applied to walls. Beton-emaille was commonly used for interior spaces exposed to wear and moisture, such as bathrooms and stairwells. Surfaces could be rendered to improve its water-tightness, smooth the surface or to improve the aesthetics of the exposed concrete.(Heinemann, 2013)

Reinforced concrete rendered with a tooled kunstzandsteen, (Heinemann, 2013).

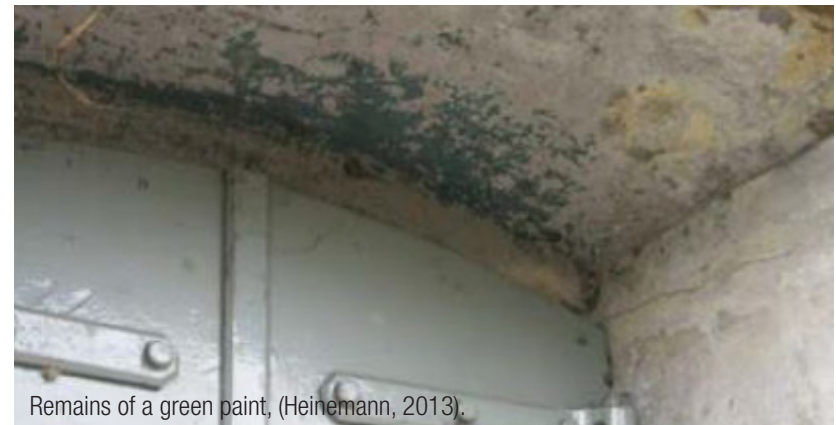
Remains of a green paint, (Heinemann, 2013).

Painting concrete surfaces was technically not easy until the development of special cement paints in the 1930's. Traditional oil-based paints could not be used without any pretreatment of the surface. A more traditional method was to lime wash the surface with the option to add pigments or to use cement instead of lime, known as 'grijzen'.(Heinemann, 2013)

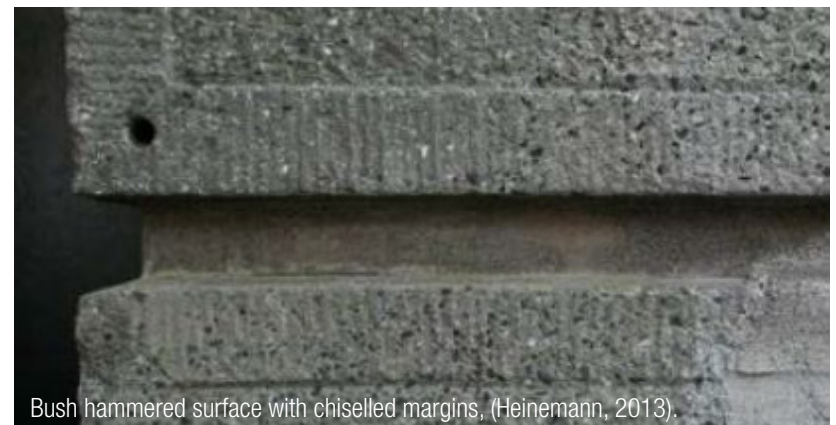
Bush hammered surface with chiselled margins, (Heinemann, 2013).

Tooling is one of the earliest surface finishes of concrete. The technique removes the undesired grey cement film of the hardened concrete through mechanical techniques such as bush-hammering, point-tooling and chiselling. In the process the colour and texture of the aggregates were exposed. This technique was often combined with coloured aggregates or cement to alter the grey appearance of the concrete.(Heinemann, 2013)

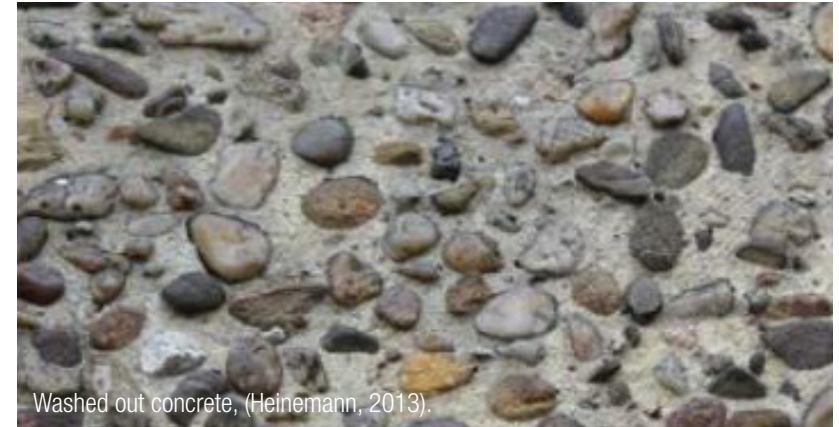
Sand blasting or washing out is a technique which exposes the coarse aggregates of the concrete. It removes the outermost cement paste after its hardening. This technique differs from the tooling technique because it also takes away the cement in between the aggregates (see image ...).(Heinemann, 2013)

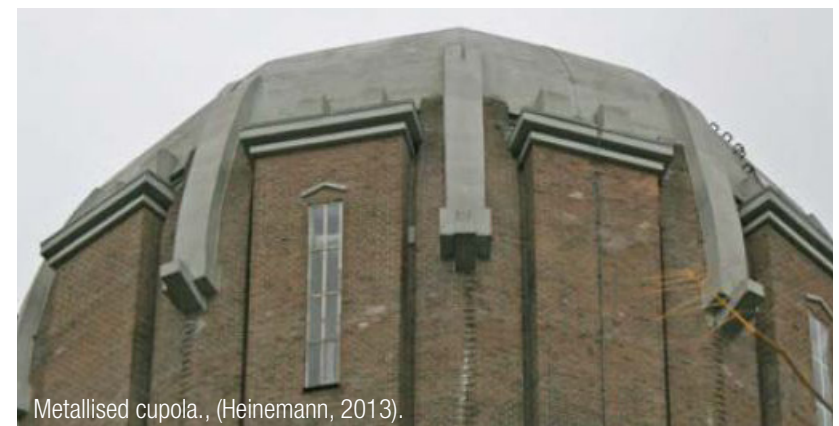
Metallizing the concrete was used to alter the colour of the concrete and was mostly used in the Netherlands between 1910-1930. During this time the grey colour of the concrete was not yet appreciated and specific concrete paints had not been developed yet. By applying a solution of metal salts (sulphates, acetates, chlorates, nitrates or chlorides) onto the hardened concrete with a brush, a reaction of the salts with the cement caused a colour change. A range of 35 colours could be obtained. Metallizing the concrete was a very Dutch surface finish and was patented by the Dutch brothers L. A. Sanders and A.J. Sanders in 1917. (Heinemann, 2013)

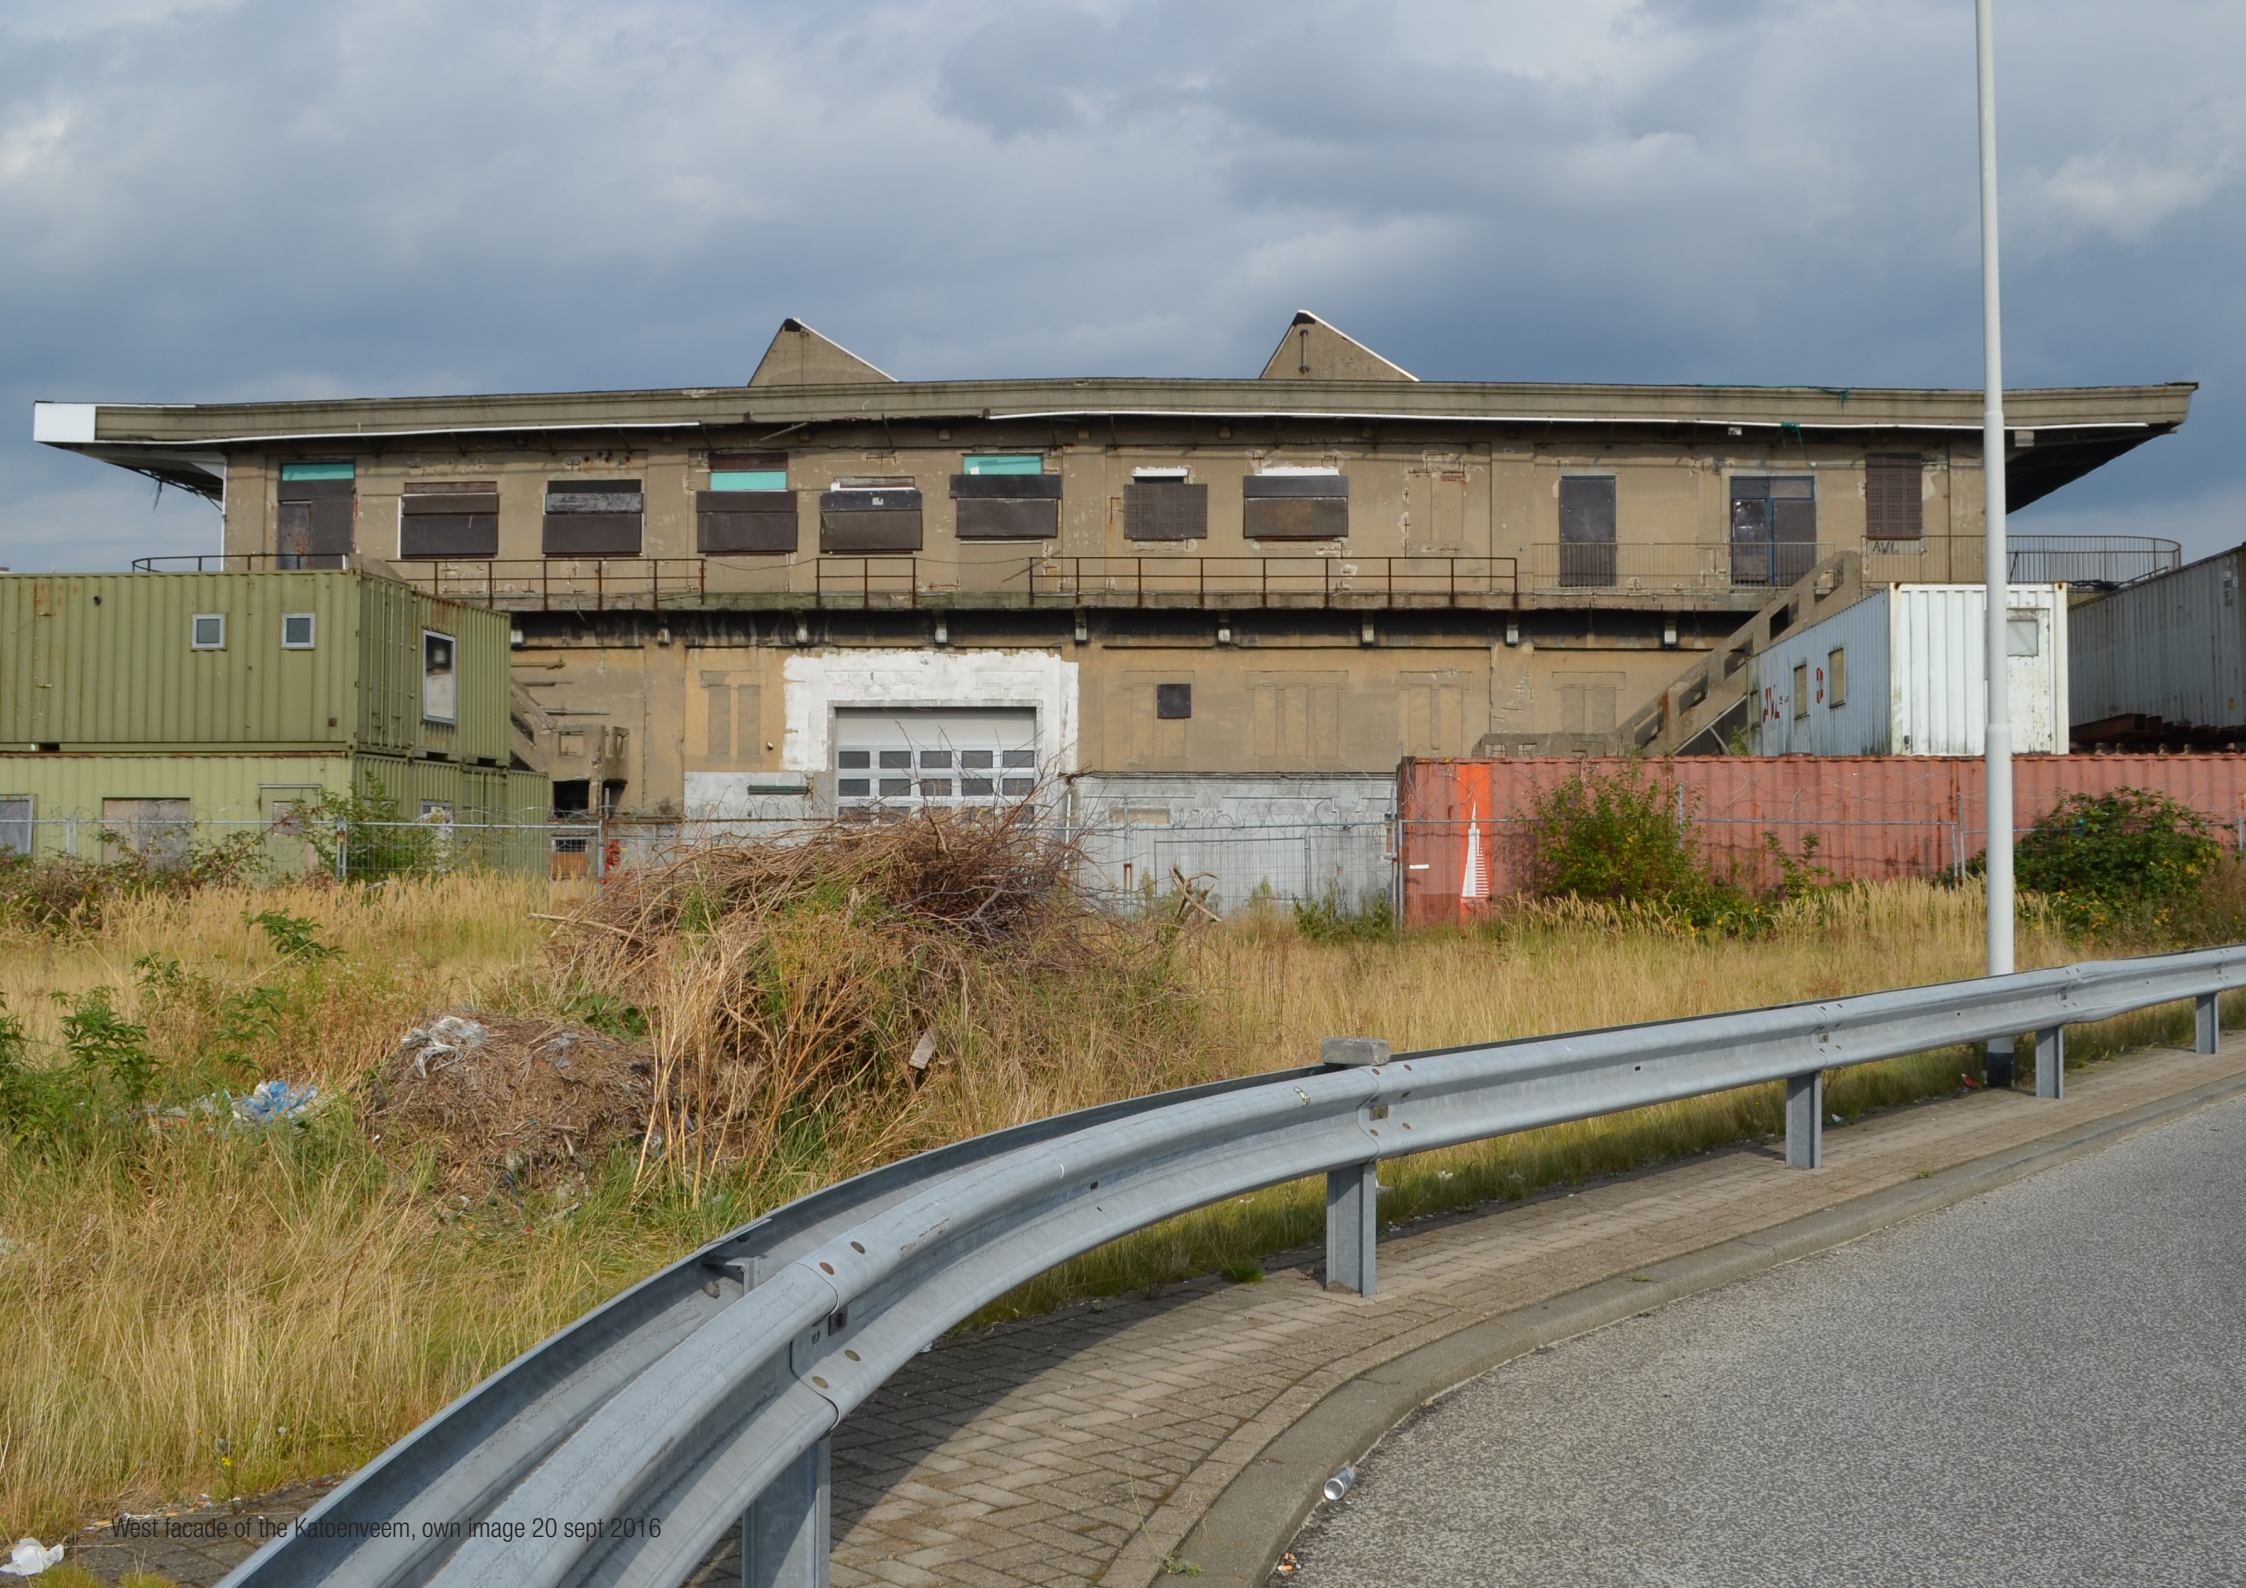
West facade of the Katoenveem, own image 20 sept 2016

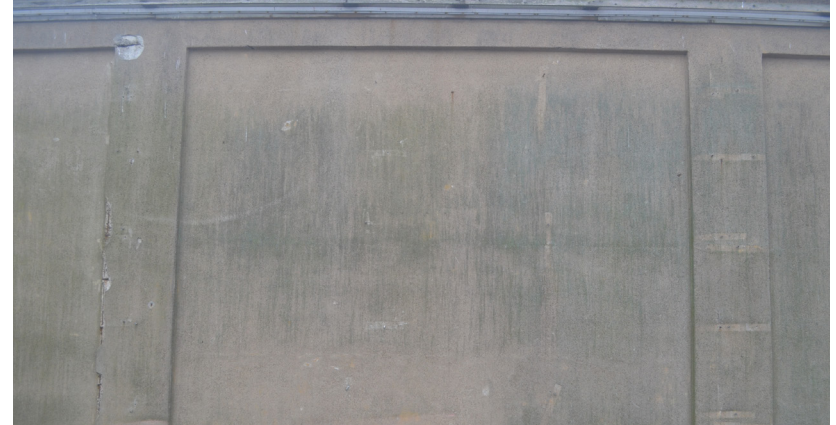
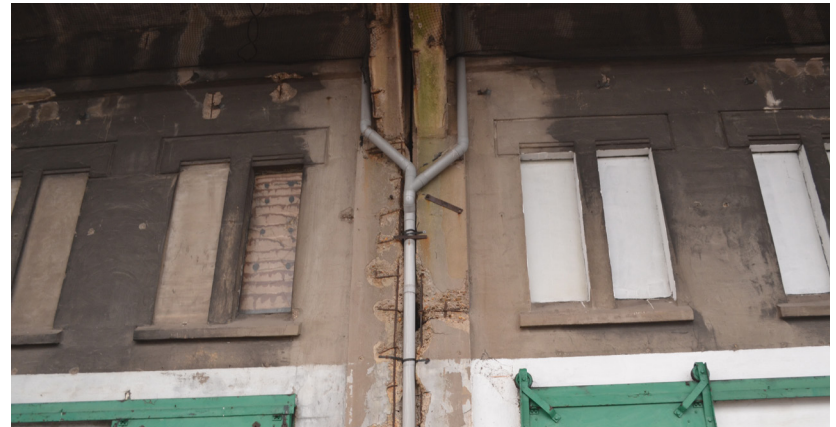
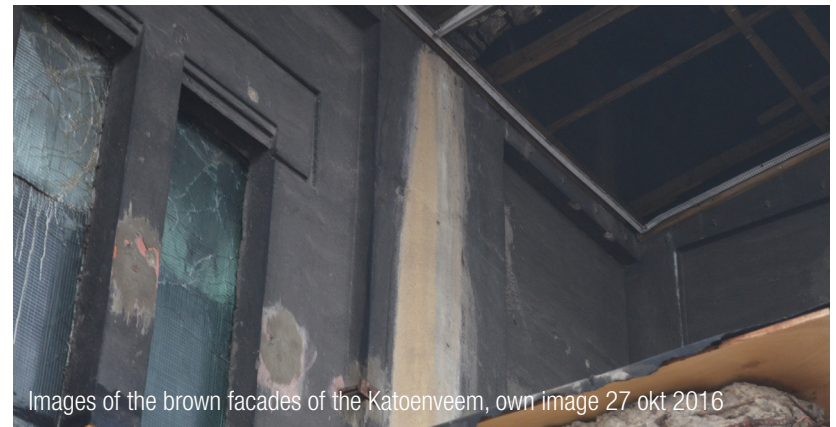
Images of the brown facades of the Katoenveem, own image 27 okt 2016

Interesting is to see how this architectural discussion has influenced a building which is completely constructed out of concrete, such as the Katoenveem. In the early years, the aesthetic quality of the concrete surface being exposed to the public, showing the imprint of the timber formwork, was considered only for industrial buildings. Considering the Katoenveem being an industrial building it would be likely if the Katoenveem was not treated with a surface finish. When observing the Katoenveem it appears that the building has a brownish colour. At first glance it is uncertain if this is a surface finish, if it's the original colour or if it is discolouration. Observing the surface closer up by investigating the damages we can clearly state that the exterior surface of the Katoenveem has indeed been treated with a surface finish. The damages reveal a very coarse concrete underneath two layers of cement. The first bottom layer is assumed to be added to smooth down the coarse concrete of the construction and the second thin layer above is assumed to be added to add colour to the building. A possible reason for the two separate layers could be financial as it was expensive to add coloured supplements to the cement. This way less coloured cement was needed.

Considering the possible historic concrete surface finishes, we can make an assumption which surface finish has been used on the exterior of the Katoenveem. Having already observed that the exterior of the Katoenveem has been treated with two layers of cement, we can assume that the Katoenveem has been treated with an artificial sandstone render.

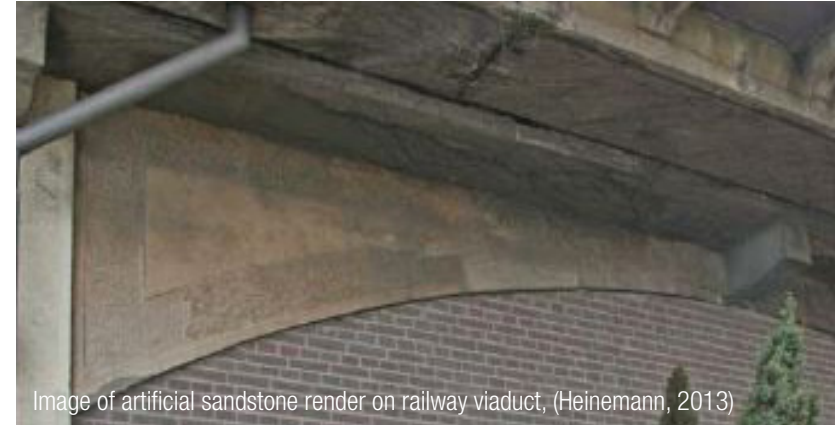
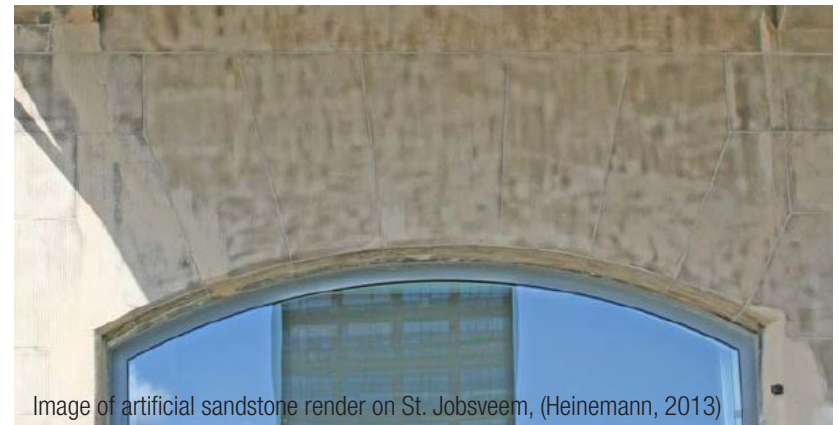
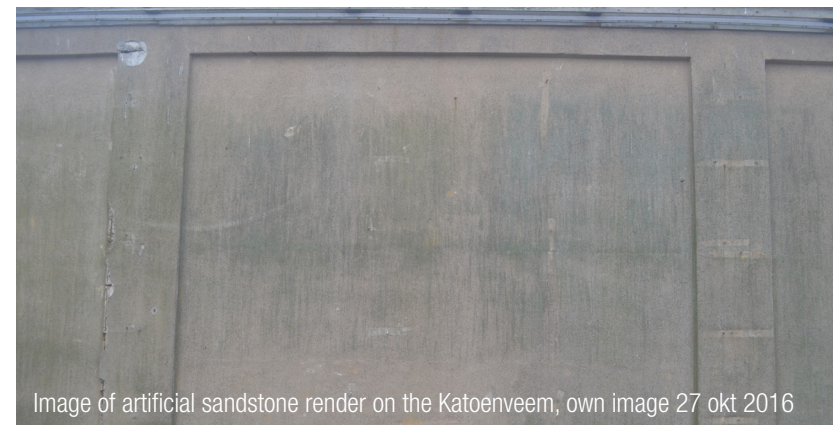
Two earlier examples for the application of an artificial sandstone render in the Netherlands are both found in Rotterdam. The first example is the Hofplein railway viaduct built between 1905 and 1908 and designed by civil engineer Alphons van Hemert. The viaduct was attached to the former Hofplein station designed by architect J.P. Stok in 1908, an old companion of J.J. Kanters. (www.retours.eu) The second example is the plinth of the warehouse St. Jobsveem, also designed by J.J. Kanters in 1914. Both buildings/structures were treated with the same technique, imitating the appearance of a tooled sandstone facade with or without imitation joints. (see images on the right)

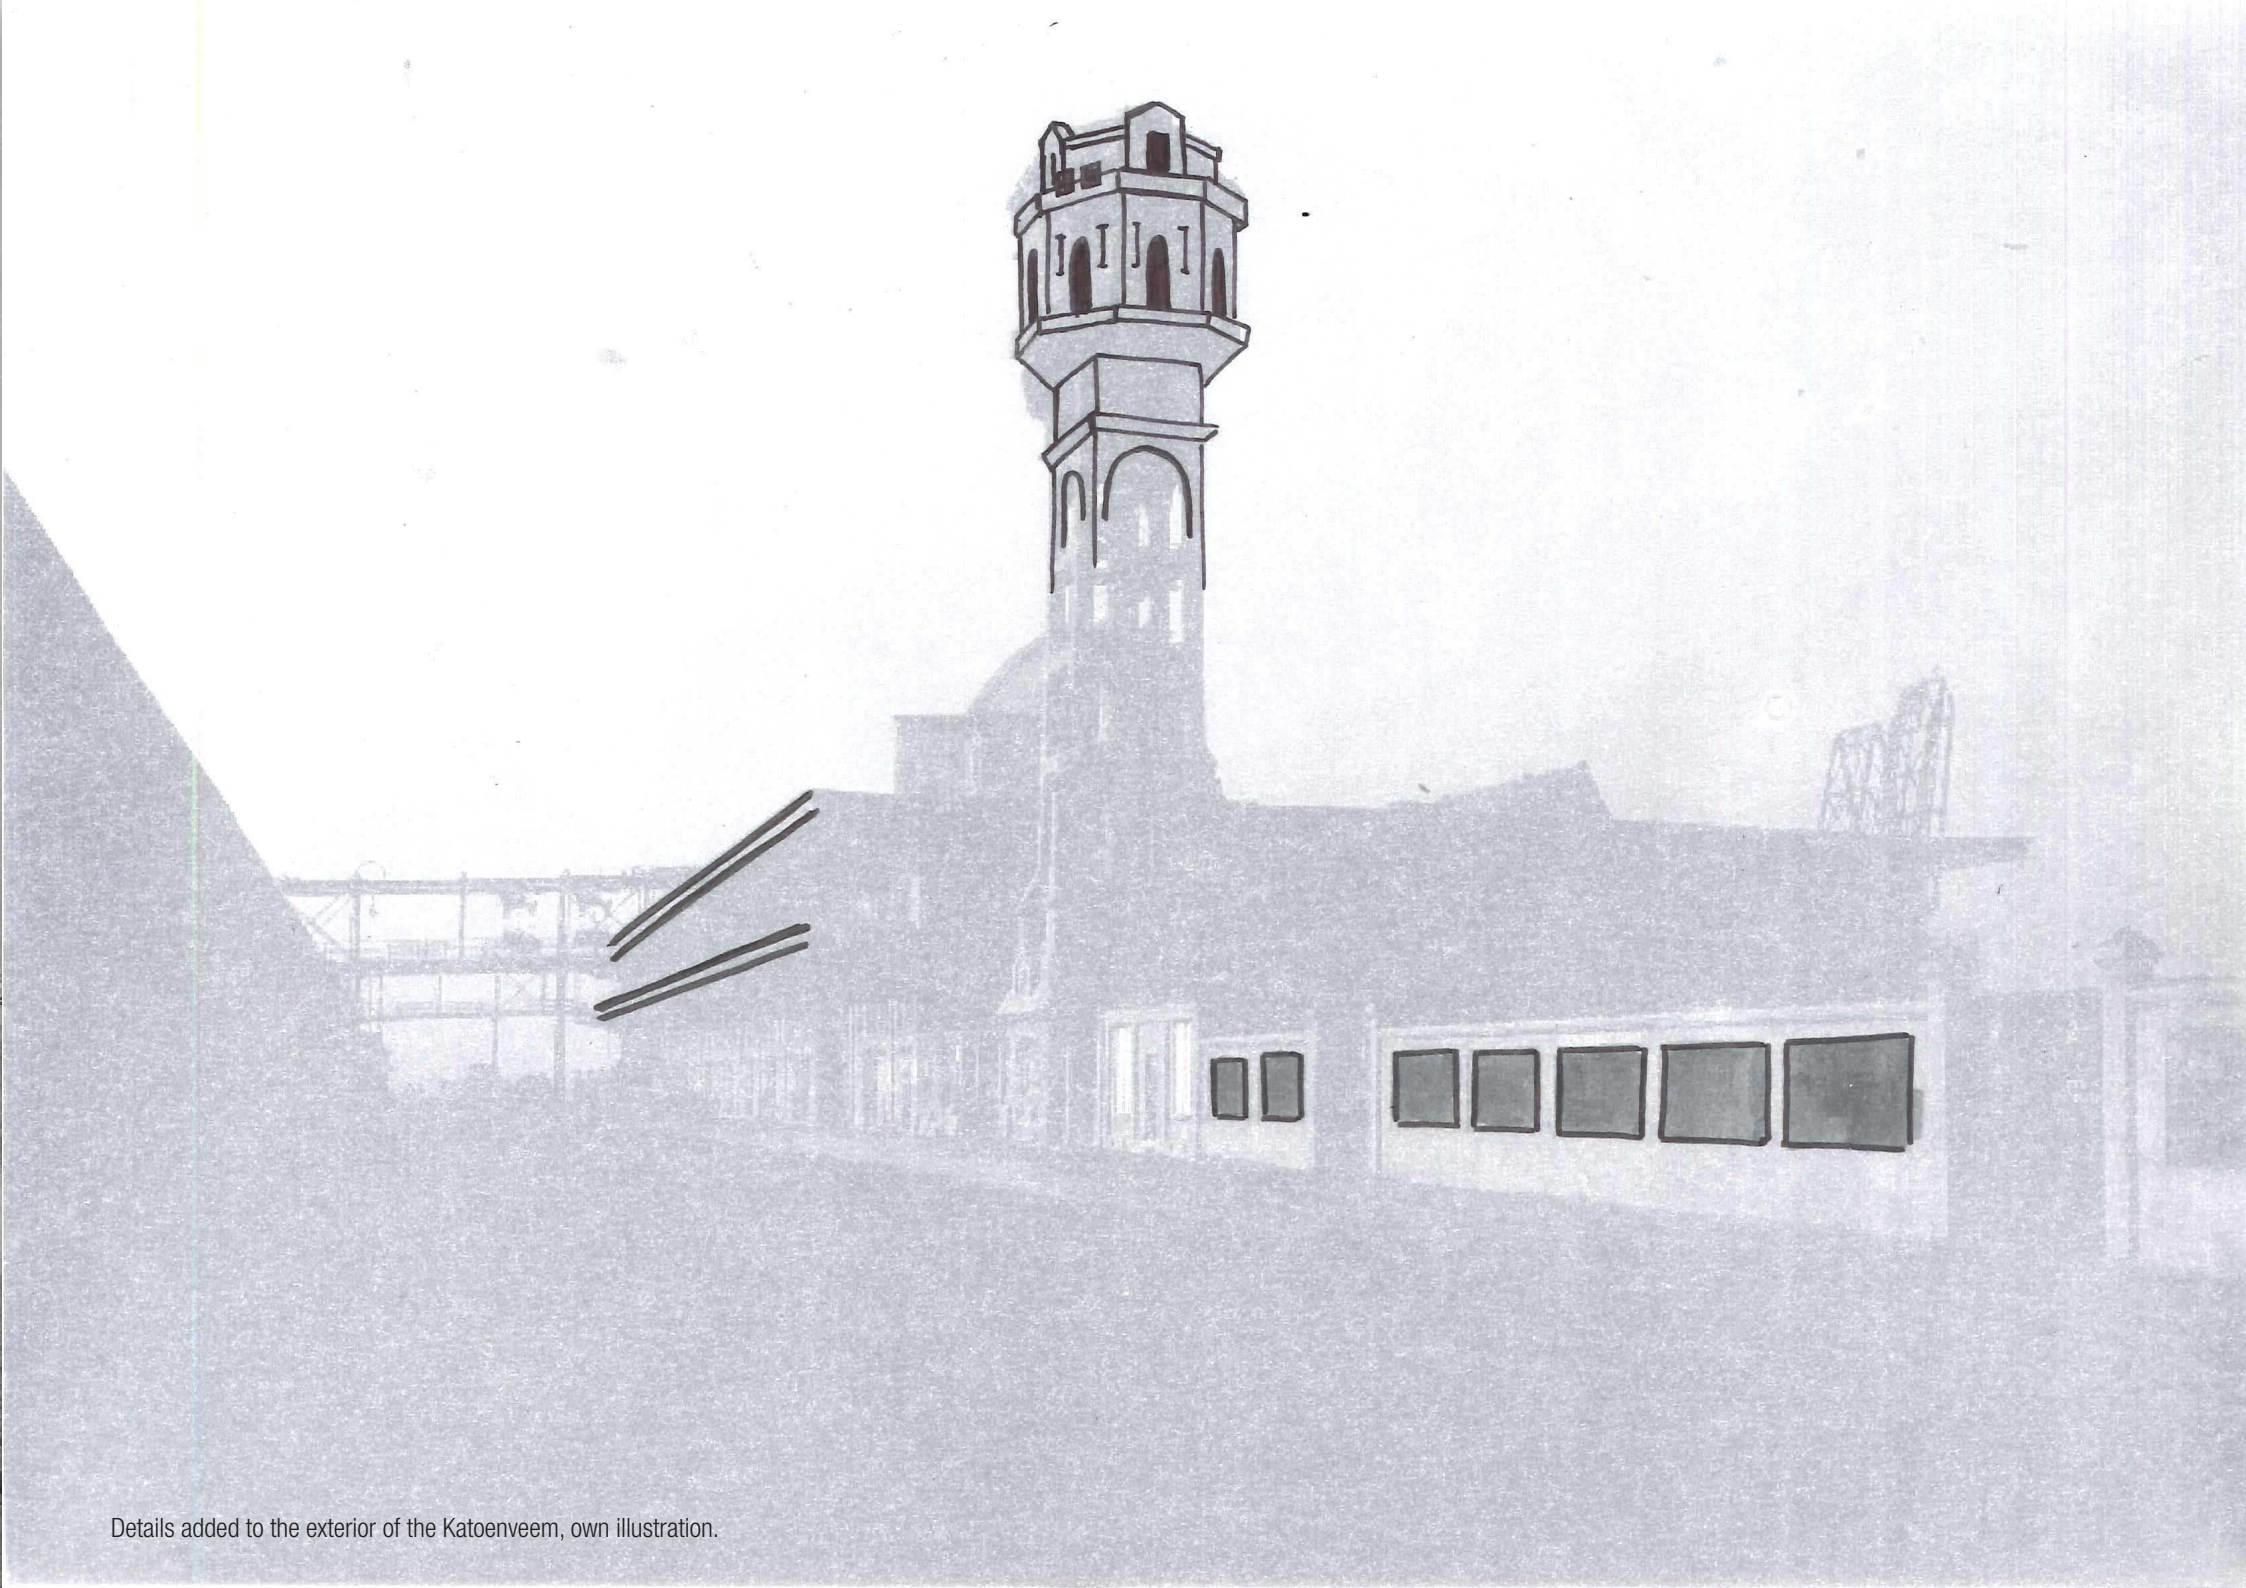
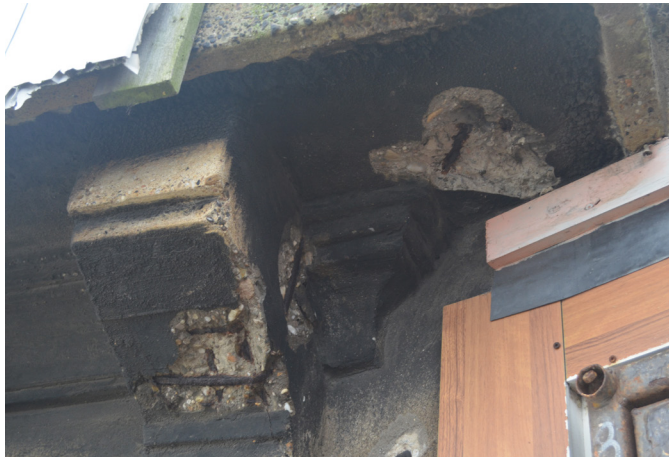
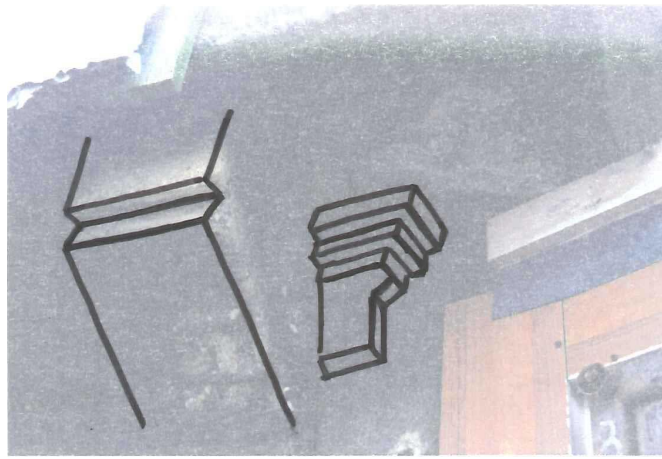
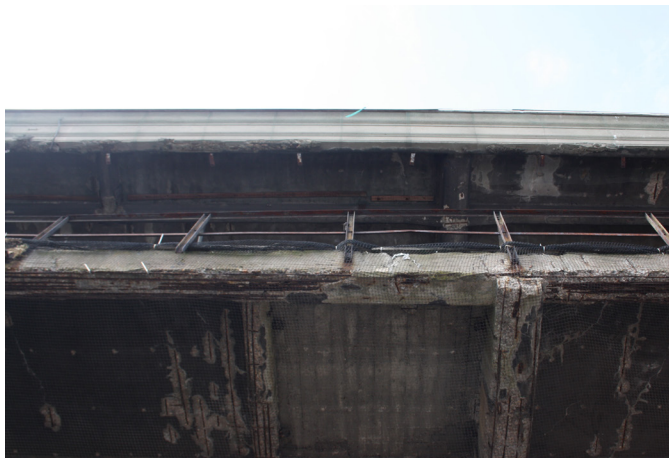
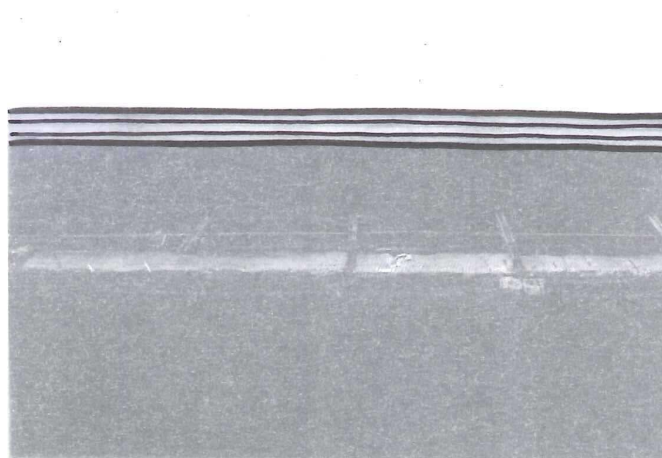
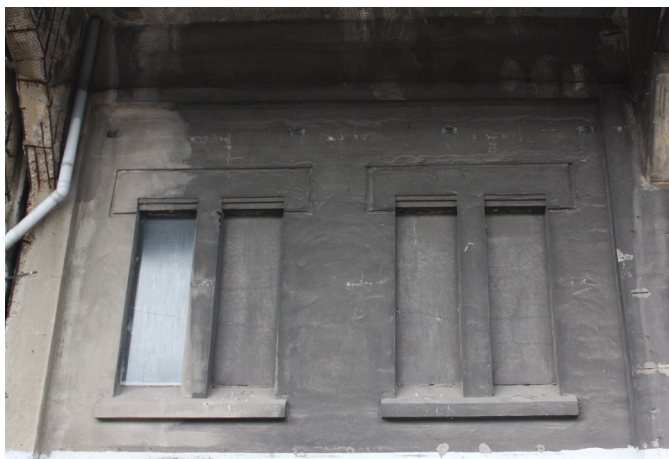
Details added to the exterior of the Katoenveem, own illustration.

Exploring the exterior of the Katoenveem, it appears that a lot of detail has been added onto its exterior. Starting with the details around the windows imitating a natural stone lintel, the detailed cornice which suggests a natural stone roof edge and most off all the details used in the water tower which is most detailed of all and instantly makes it the focal point of the entire building. Unfortunately the water tower was demolished in 1966 due to its bad concrete conditions.

The used artificial sandstone render surface finish gave architect J.J. Kanters the opportunity to add more detail to the facade. The thicker bottom layer of cement provided thickness to add grooves into the cement to create the detail around the windows. Therefore, another assumption is that the bottom layer could have also been used to add aesthetic details. (see detail below)

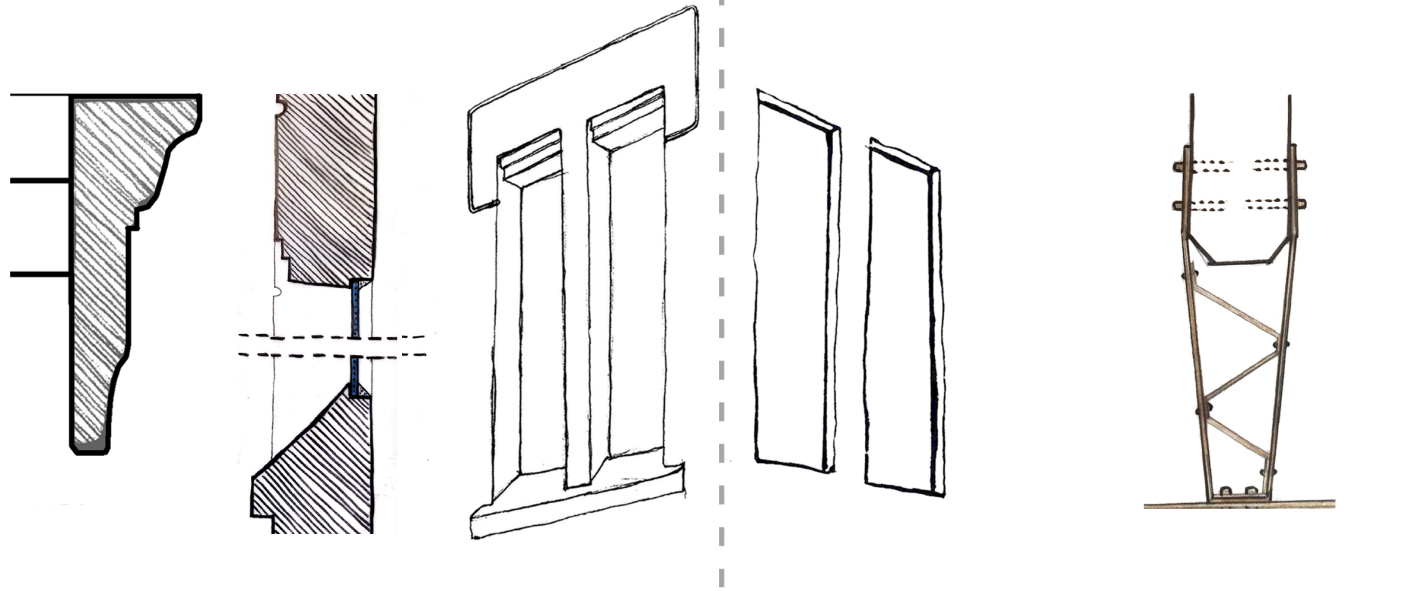
FACADE INTERIOR

When we compare the exterior of the Katoenveem to its interior we find out that they are very contradictory to each other. While the exterior has been treated with a surface treatment and details, the interior is the complete opposite. The walls are left untreated, the formwork is highly visible on all the walls, beams, columns and roof and the concrete still has its normal grey colour. Compared to the window details on the exterior, the interior windows have no detail at all. Also the detailing elements such as the railings along the walkways on the first floor and hooks to hang up the transit system are just designed to function.

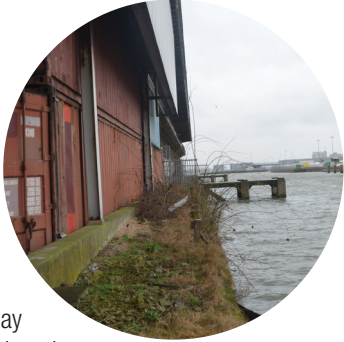
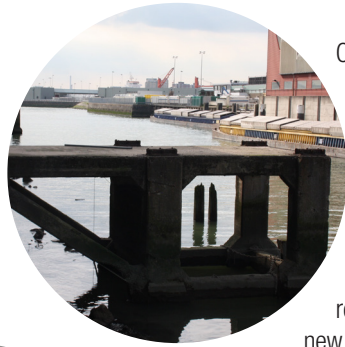
Cranes were used on the side of the Keilehaven to lift goods from the ship onto shore. The cranes were demolished in 1966, but the concrete piers still remain. It is important that the bases remain and are used for a new function.

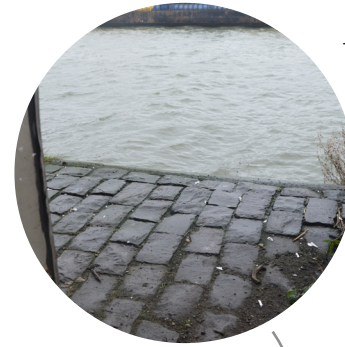
There is a little bit of original pavement left at the quay side.

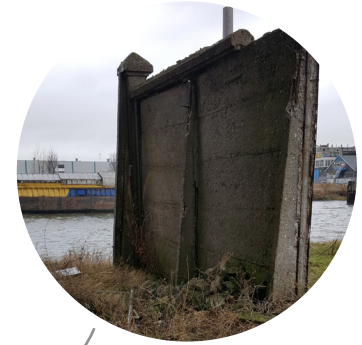
The entire terrain was enclosed with a concrete wall. This is the only piece that remains from the original wall.

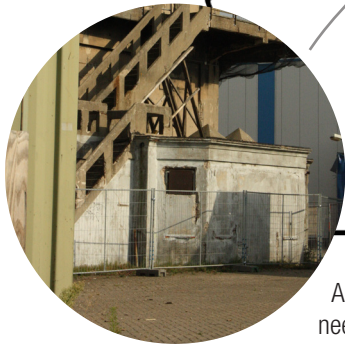
All the extra functions needed in the warehouse, such as a sampling room, offices and toilets, were added to the building as separate volumes. This was done so that the internal processes inside the warehouse could be as efficient as possible and are a result of form follows function. Therefore the added volumes are important and should remain in place.

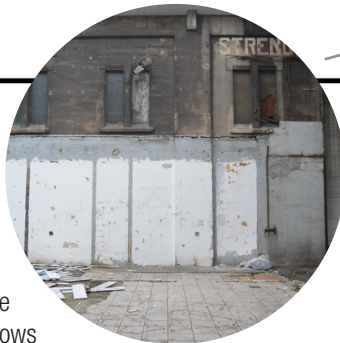
Next to the pumping station there is also some original pavement left.

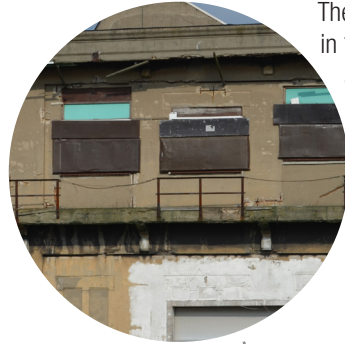
The windows added during the renovation in 1986 are boarded up with steel material at an unknown date. Both the steel material as well as the windows are of no heritage value as they are not original.

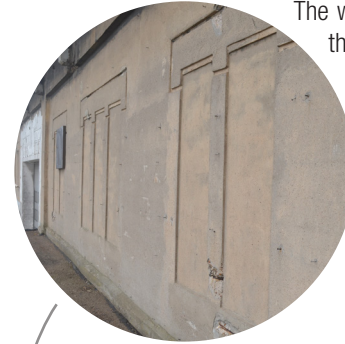
The windows on the ground floor on the west facade are filled in with cement, concrete or brick at an unknown date. The detail and shape of the windows still represent the original windows and therefore get a great heritage value.

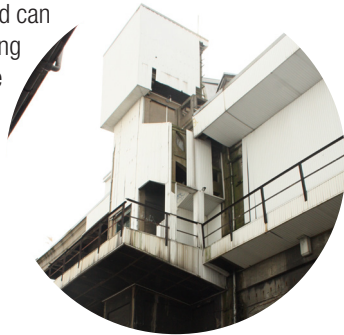
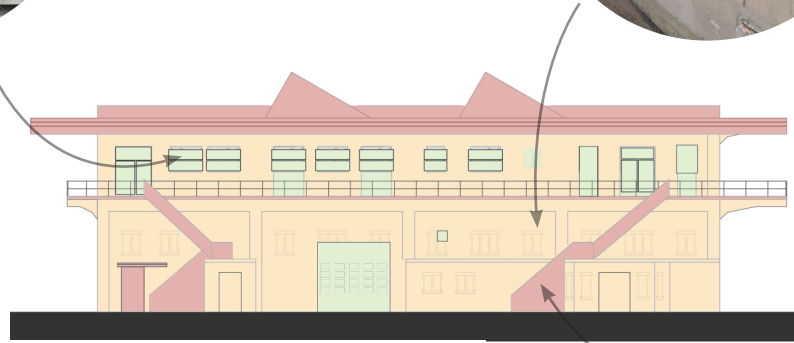
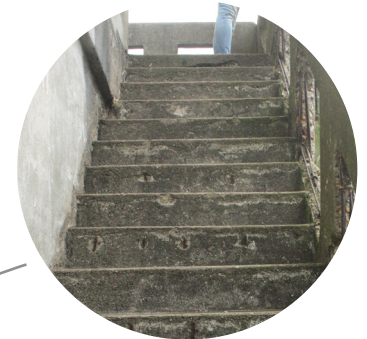
The cladding applied in 1987 on the exterior of the lift shaft has no heritage value and can be removed. Removing the cladding should reveal the original concrete exterior of the Katoenveem.

The stairs towards the balconies are of high heritage value. They are the only original vertical connection (apart from the elevator).

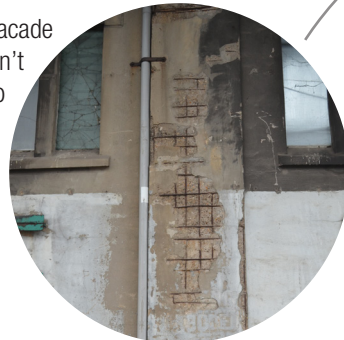
The east facade has been altered many times throughout its use. The original offices and the offices built in 1990 have been removed and multiple passages have been made in this facade.

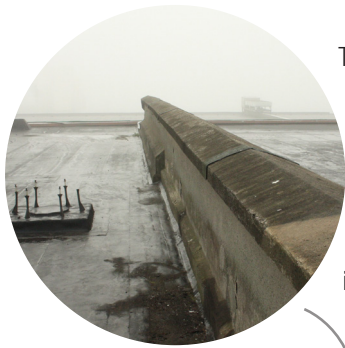
The fire walls are of essential heritage value. They refer back to the function of the Katoenveem and are of big significance to the story of the building. There have already been connections made in the fire walls, this is allowed as long as the five compartments remain individual.

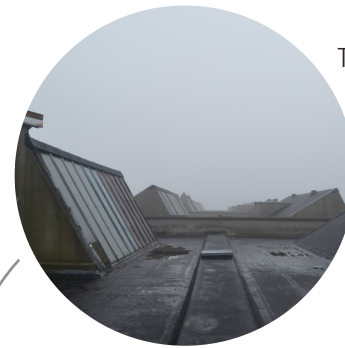
The skylights are of high value. They are the main source of light and refer back to the function of the Katoenveem.

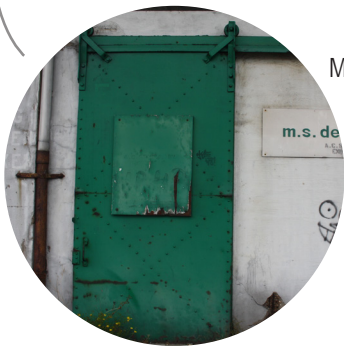
Most of the original doors are still remaining and should stay in place or be reused. They get a high heritage value.

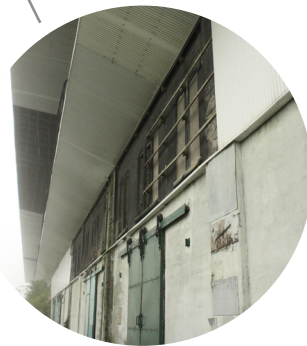
The glass of the windows is in very poor state. Numerous windows have been boarded up and some window glass has been painted over. Even Though some of the glass is still original, it is not of value anymore.

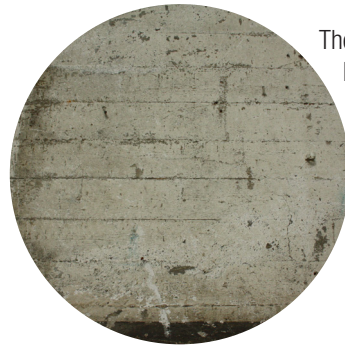
The interior of the Katoenveem has a rough exposed concrete surface compared to the exterior. Its important to keep this contrast as it is part of the exposed concrete discussion during the 1920's.

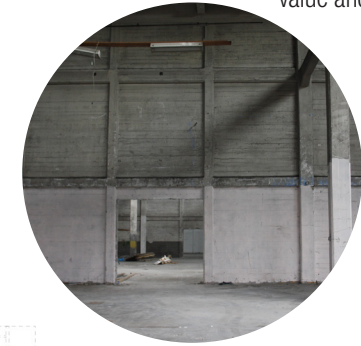
The paint added onto the walls in a later stadium of the building has no value and can be removed.

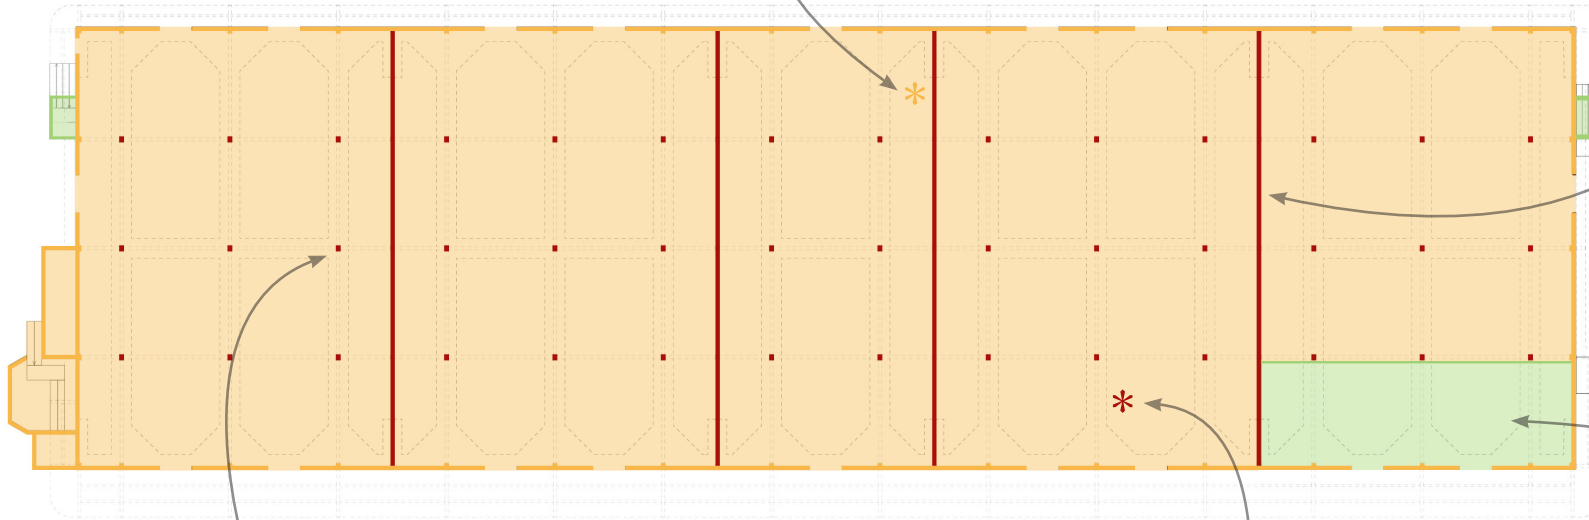
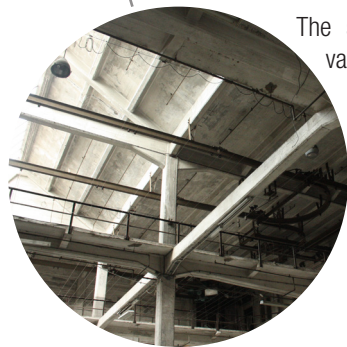
The structure has a high heritage value. It is an early example of a monolith concrete structure and remains in good condition on the interior of the building.

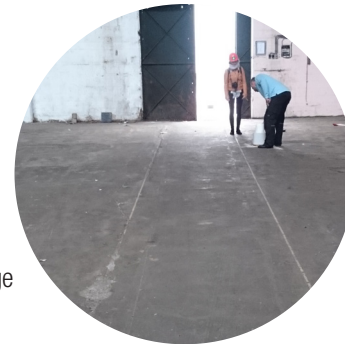
The details in the floor are of high value as they refer back to the main function of the Katoenveem, the storage of cotton.

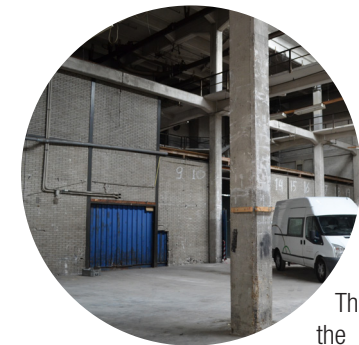
The added office in the 1990's have no value and can be removed.
