KATOENVEEM

FUNCTION vs. AESTHETICS

P1 Research Report

Heritage & Architecture
MSc3 'Rotterdam Harbour Heritage'
TU Delft

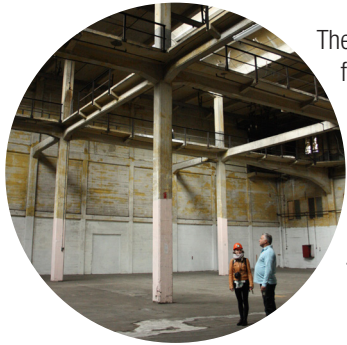
The connection between the ground floor and the first floor refers back to the optimization of the cotton transshipment. It is therefore of importance that this connection will still be evident at some parts of the building when it gets transformed.

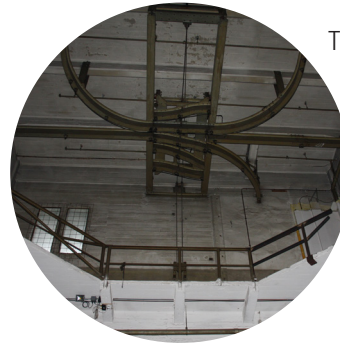
The ceiling of the Katoenveem still includes most of the original transit system. It is important to keep the system in the building as it is part of the entire construction and tailor made building. It can either be reused or used somewhere else.

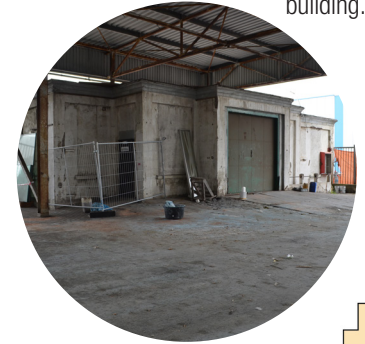
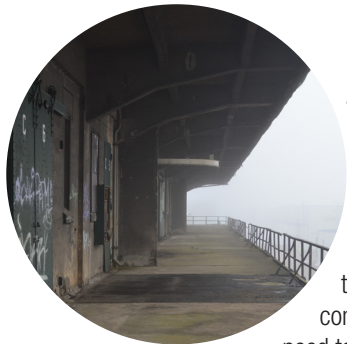
The Balconies have a high significance value due to their important transfer function when the Katoenveem was in use. Unfortunately the balconies are not safe due the poor condition of the concrete and therefore need to be restored.

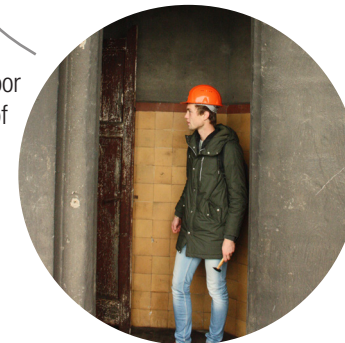
The workers toilets on the first floor (accessible from the balcony) are of no use anymore. The toilet is already missing.

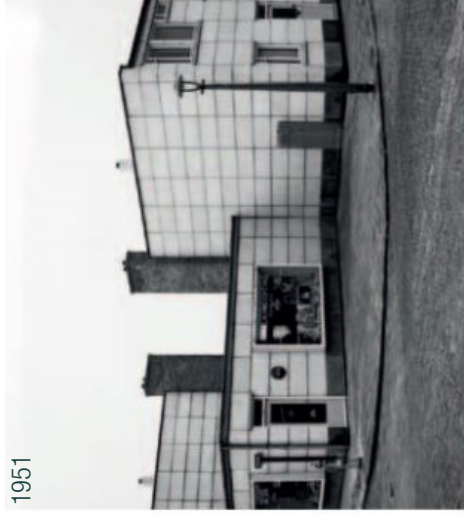
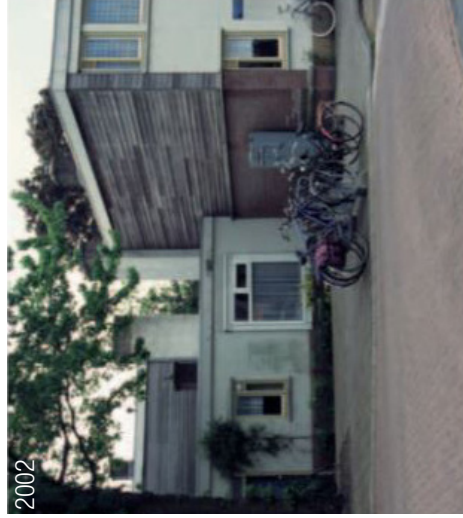
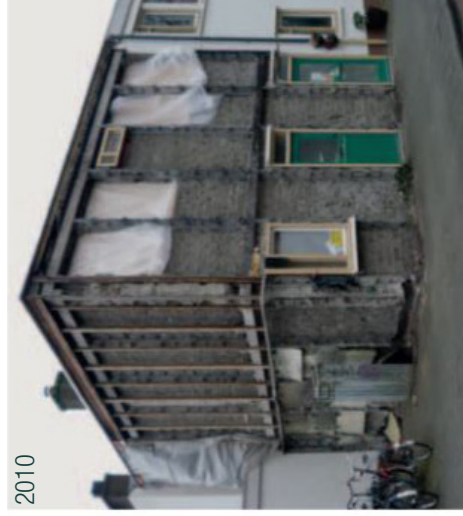
Four images of the transformation of one of the corner dwellings attached to a small local store.

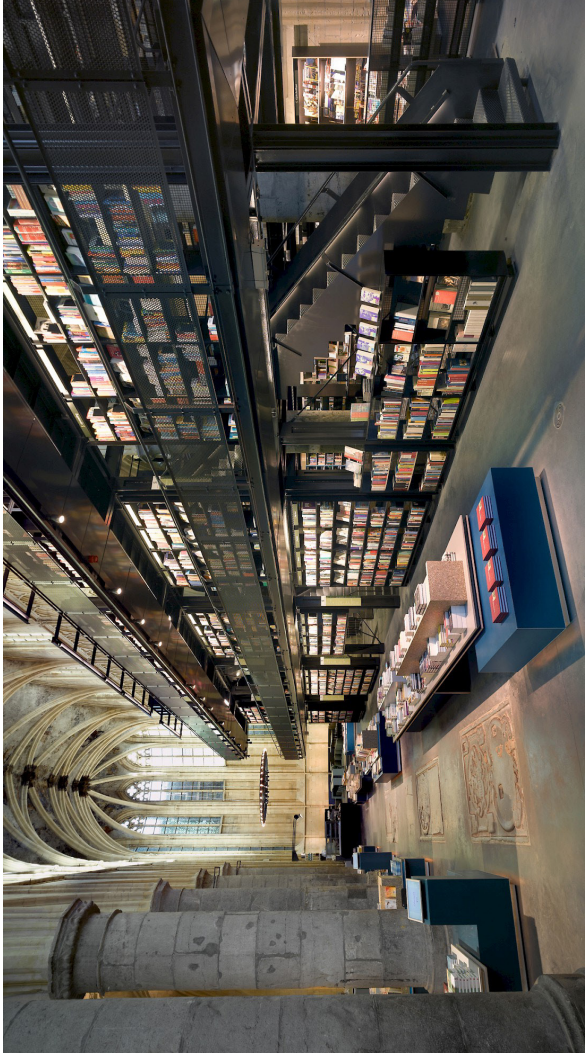
Interior of the Dominican
Church after transformation.
Photo taken by Roos Aldershof
Copyright © 2015 Merk-X

transforming a church to suit a new function, one way to take its religious value into account is by creating a reference to its former function by making use of its spatial interior. *"A good design focusses on the spatial organization of the original church's length, width and height to come forth to its full right as much as possible."* (Rijksdienst voor het Cultureel Erfgoed, 2011) In the Dominican Church, the spatial organization of the church was respected by placing smaller, separate units for specific functions within the larger space of the church. This limited the impact of the smaller units on the spatial experience of the interior of the old church. The carefully designed freestanding installation does not distract from the spatial splendor of the interior by keeping its religious value and referring to its former religious function.

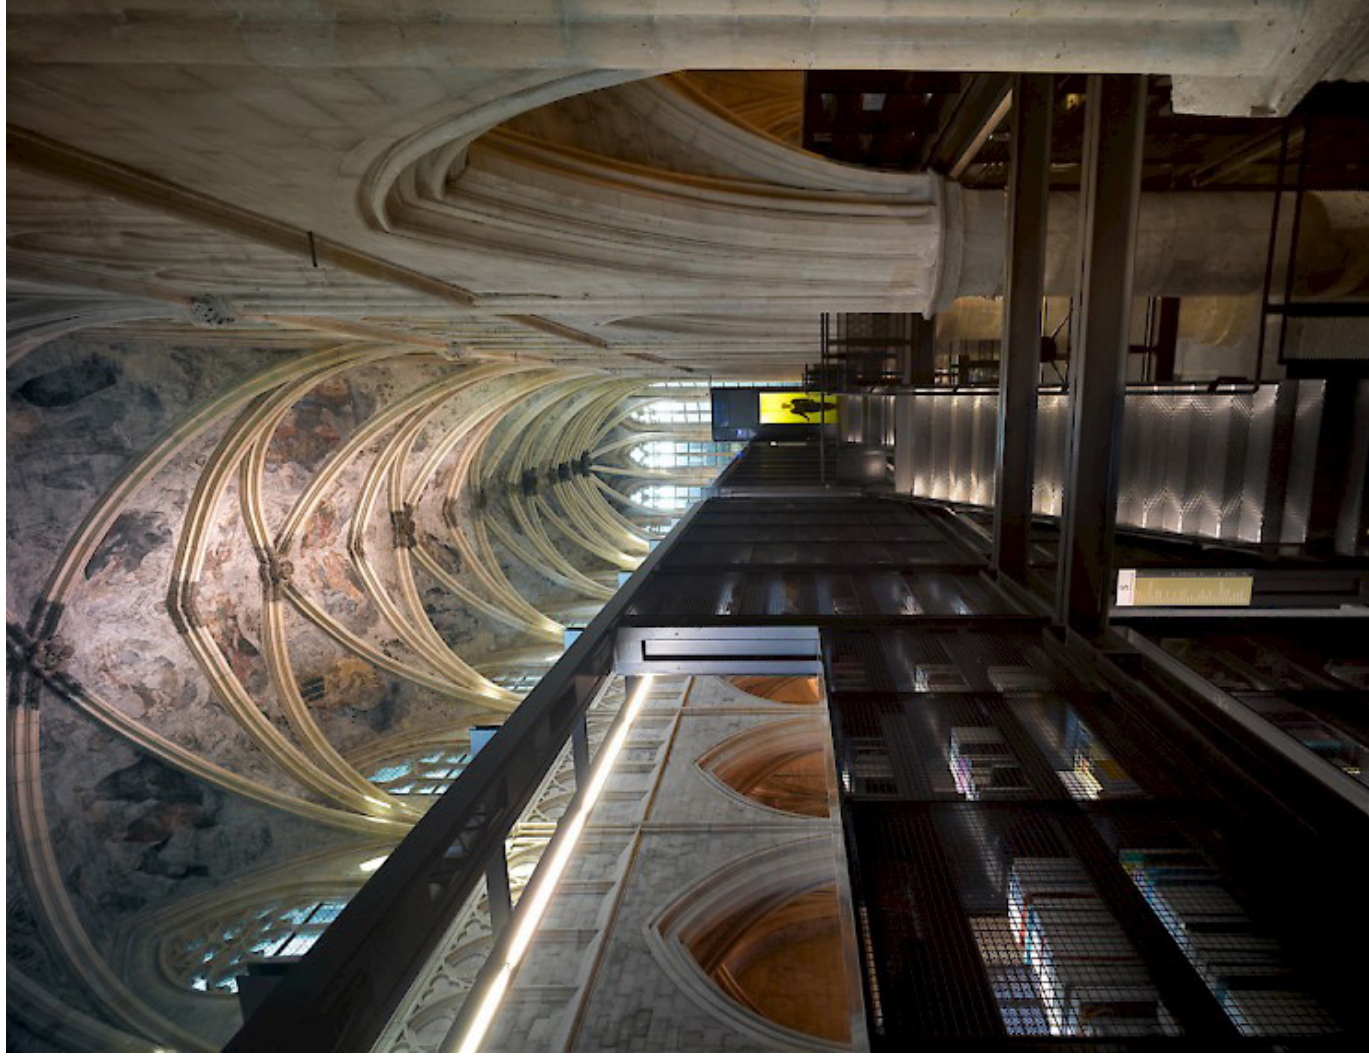
Interior of the Dominican
Church after transformation.
Photo taken by Roos Aldershof
Copyright © 2015 Merk-X

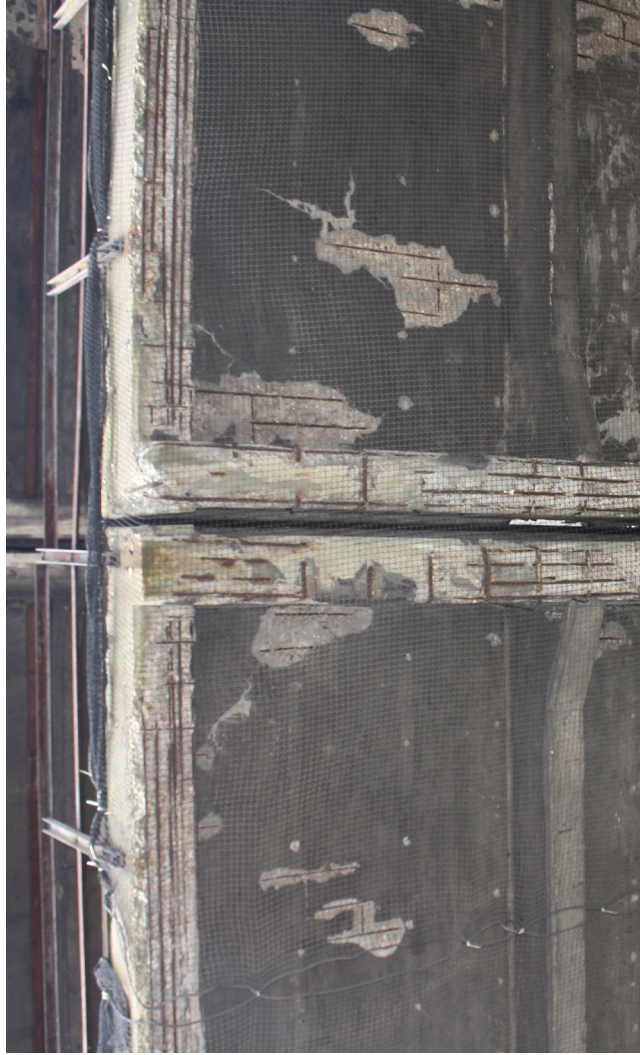
Damage on the exterior of the Katoenveem including the netting put up by the municipality. Own image 2016.

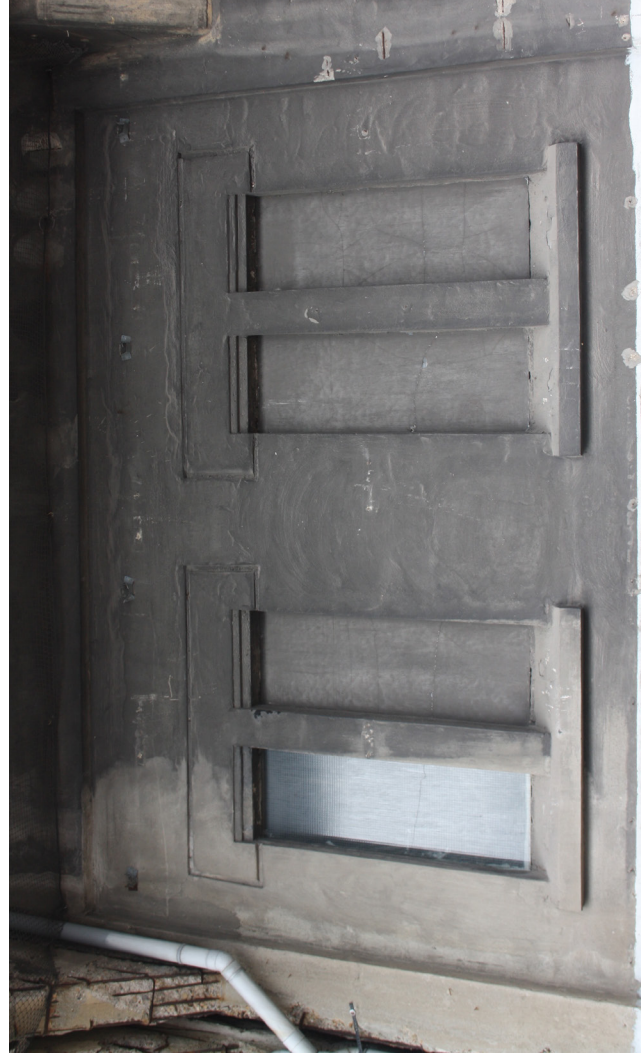
Exterior of the Katoenveem with the lintel detail around the windows. Own image 2016.
