CHANGE ANALYSIS OF LASER SCANS OF LABORATORY ROCK SLOPES SUBJECT TO WAVE ATTACK TESTING

Yueqian Shen^{a,b}, Roderik Lindenbergh^b, Bas Hofland^c, Roy Kramer^c

KEY WORDS: Coastal Engineering, TLS, Change Analysis, Water Flume, Wave Attack, Breakwater

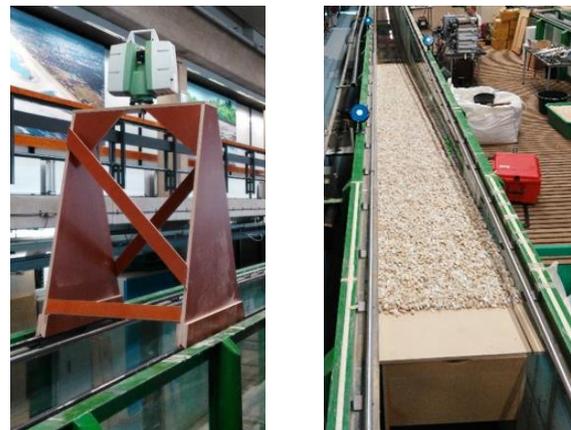
Figure 2. Left. Special wooden construction for mounting the laser scanner above the flume. Right. Scanner view of the scene. The along flume direction is denoted Y in this work, and the across flume direction X, in the local slope coordinate system.

The location of the scanner was at the top side of the slope. Note that this placement is not optimal, as it results in less favorable incidence angles. During the experiment, also point clouds were obtained from an opposite position, with more favorable measurement geometry, but these scans could not be used in this analysis as the measurement scene was disturbed by an external agent. In order to guarantee accurate registration, three targets were positioned along the water flume frame. The positions of scanner, targets and slope are shown in the scanner view of the experiment scene, see the right figure 2 (taken from the scanner centre).

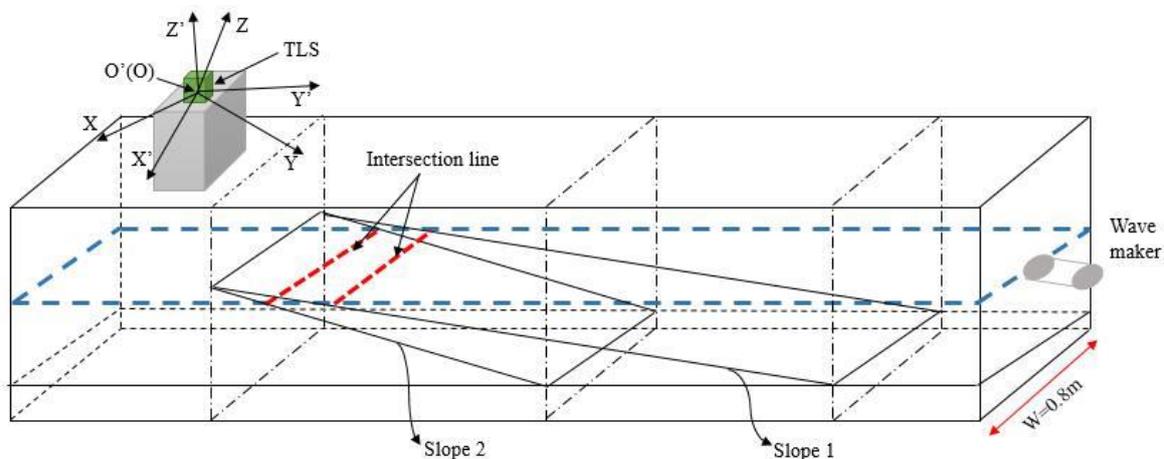
Figure 3. Sketch map showing the test scene observed by laser scanner. The map also indicates the $X'Y'Z'$ coordinate system in which the observations are obtained, and the XYZ slope coordinate system, in which changes are discussed in this work.

compare Figures 3, will inevitably result in variations in quality and point density of the acquired point cloud in notably the along flume direction (Soudarissanane et al., 2011). Therefore, the number of points in each pixel is determined. Figure 8 shows the raster image colored by the number of points per pixel for Slope 1. As the scans were made from the top side of the slope, number of points per pixel is higher close to the scanner than it is further away. At larger distances to the scanner, the number of points per pixel is dropping dramatically. But, as the figure 2 shows, change at larger distances is very limited, therefore we conclude that the measurement geometry has little influence on the results. Another effect that should be noted is that near the edges of the flume, the number of points per pixels also drops, which is caused by the grid dimension, relative to the dimensions of the flume, often resulting in incomplete pixels.

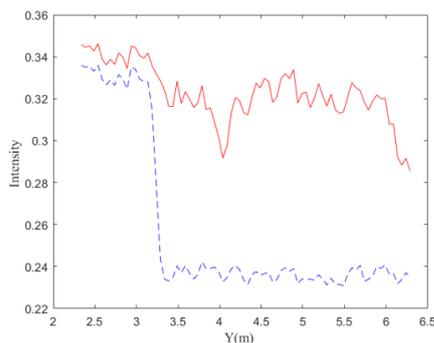
Figure 4. Intensity profiles along the Y axis, i.e. the along flume direction. The red solid line is the profile of the dry point cloud; the blue dashed line is the profile for the corresponding wet point cloud. A intensity value at a given Y location is obtained by averaging intensities for all corresponding X values.

The experiment was performed from 14 August to 28 September 2016. Scanning was carried out before and after the wave testing. After the wave tests, always two scans were obtained, one was obtained just after the flume water got drained, therefore the stones on the bed were still wet. The second one was obtained after the stones had dried up. Laser scanners not only provide information about the 3D location of object surfaces but also store the amount of reflected energy as an intensity value. Often a color camera is integrated to obtain true RGB colors of the object surface. For interpreting the influence of moisture on the quality of the point clouds, a figure showing the intensity profile along the flume direction is plotted, as shown in figure 4: the red solid line represents the intensity profile for a dry point cloud while the blue dashed line represents the intensity profile for the corresponding wet point cloud. It is apparently that a sudden jump of intensity occurs in the wet point cloud. The position of sudden change is located near the intersection line: on the left of that area the stones are always dry. Therefore, the influence of moisture on the intensity of point cloud is easily obtained by comparing the intensity difference on the right of intersection area. This experiment shows that the wetness of the rocks has a serious negative effect on the intensity. A lower intensity also implies a lower Signal to Noise ratio, which will in turn affect the precision of individual points. In order to avoid the influence of moisture on the quality of the point clouds, in the following analysis scans are used that were obtained after the rocks turned dry.

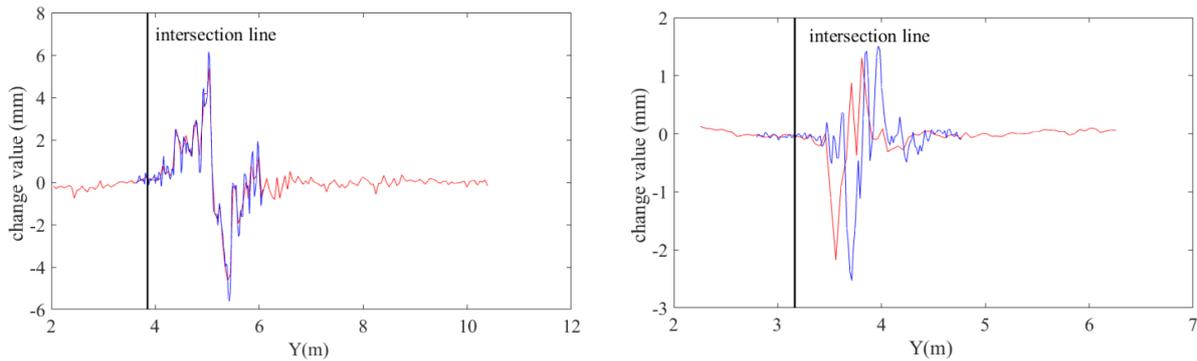
Figure 5. Change profile along the Y axis (left for slope 1 and right for slope 2), i.e. the along flume direction. A change value at a given Y location is obtained by averaging all changes for the corresponding X values. The red line represents the slope change profile for the entire flume obtained with a pixel size of 0.05 m. The blue line is the change profile restricted for the ROI obtained with a smaller pixel size of 0.016 m.

The red lines in figure 5 show the change profile of the two slopes (1:10 and 1:5) along the Y axis. The maximum and minimum values of change of slope 2 (1:5) are about 1.5 mm and -2.2 mm respectively. The maximum and minimum change of slope 1 (1:10) are more significant with values of about 6.0 mm and -5.0 mm. These two figures indicate that most change happened at the area around the coast line. A possible explanation is that this is the location where runup and rundown velocities are highest; In the other areas, changes are relatively small with an average value is around 0 mm. The changes at slope 1 (1:10) more frequently fluctuate compared to those of slope 2 (1:5). The difference between the two slopes corresponds well to the practical situation: in figure 3, it is noticeable that the points in rock slope 1 (1:10) are always more close to the wave surface compared to the points in rock slope 2 (1:5), which indicates that the amount of change is related to the distance to the waves. Note that in Figure 5, right, a shift appears to occur in the Y direction from the red line (5 cm grid) to the blue line (1.6 cm grid). As both profiles represent the same signal but sampled at different intervals, we interpret this shift as caused by this sampling difference.

damage happened. From the change profile along the Y axis (Figure 5) and the raster image (Figure 7), the erosion area can be easily identified. For better understanding the change in this area, we select the points of this for an extended analysis of this

The blue line in figure 5 shows the change profile of the two ROIs (1:10 and 1:5) along the Y axis. For the steeper Slope 2, change only has a greater fluctuation in the ROI; For milder Slope 1, the absolute change values are larger. The maximum and minimum change along the Y direction for mild Slope 1 are 6.15 mm and -5.61mm; while for Slope 2 these numbers are 1.51mm and -2.53 mm. The mean change of the two slopes in the Y direction are 0.26 mm and -0.10 mm respectively. Note that, the maximum change, minimum change and mean change of the ROIs are approximately equal to the full slope results discussed above which indicates that the pixel size has little

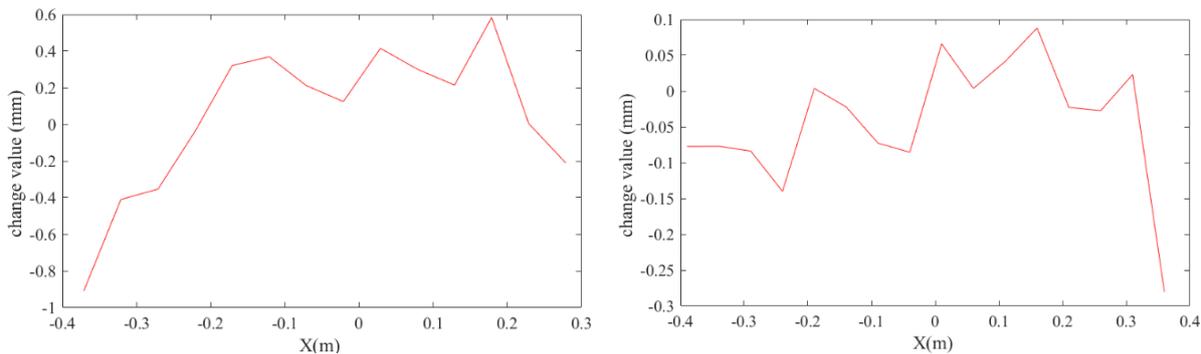
Figure 6. Change profile along the X axis (left for slope 1 and right for slope 2), i.e. the across flume direction. A change value at a given X location, is obtained by averaging all changes for the corresponding Y values. It is assumed that these profiles are affected by some leakage that took place at the side of the flume.

Figure 6 show the change profile of two slopes (1:10 and 1:5) along the X axis. It is evident that the change in the middle of the flume is positive (gained material), while near the two edges the change is negative (lost material). We hereby draw the conclusion that the rocks move from the edges of the flume to the centre area after the wave attack. This is an important factor when porting conclusions from this laboratory flume experiment towards real field situations: In reality, a coastal protection construction is in most cases not constrained by edges on the side, as this flume is. Therefore, the apparent significant effect of these edges should be taken into account when drawing conclusions from this experiment. In addition, some mistake was made in the setup: the edges of the slope were not watertight, such that some water flew in an out. This has had some effect on the results.

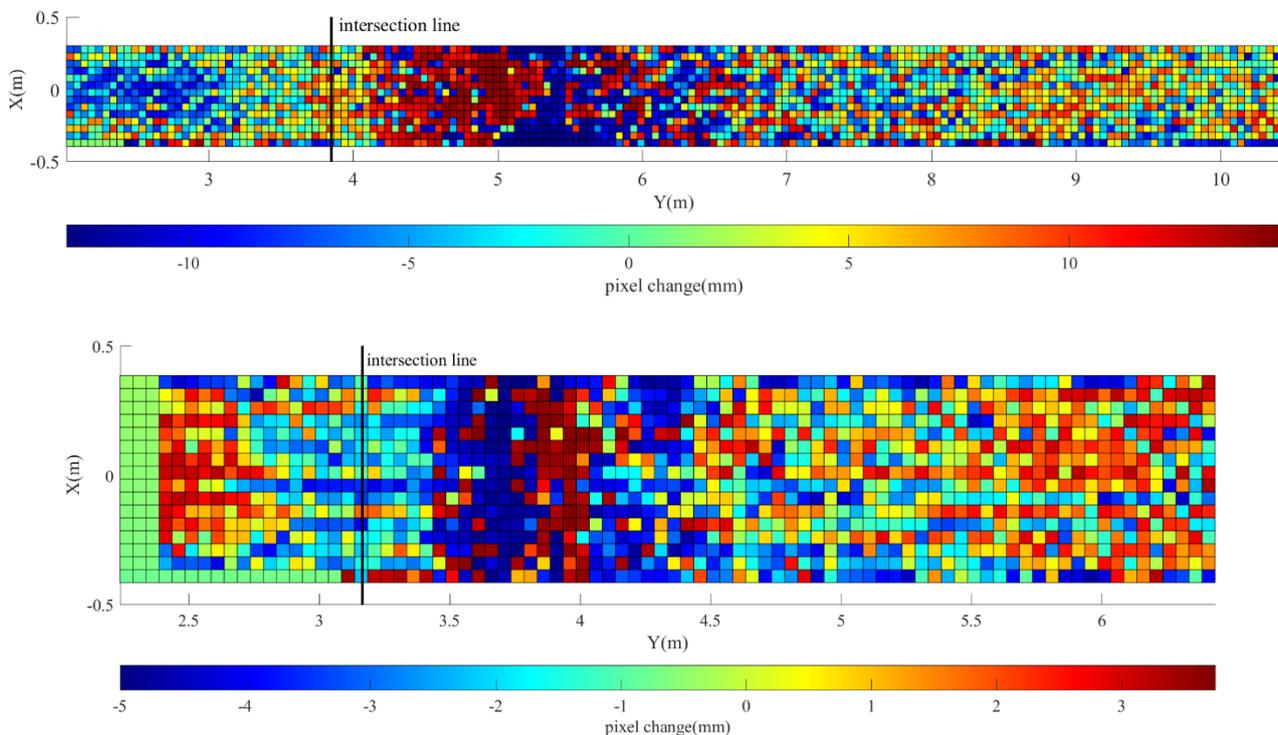
Figure 7. Raster image colored by pixel change for both slopes (top for slope 1 and bottom for slope 2). A pixel change value is obtained by differencing the mean of the Z values for the corresponding pixel in two epochs. Negative pixel change values indicate that erosion happened in a pixel while positive pixel change value indicates. Note that the area covered by Slope 1 is longer as the slope grade is more gentle and therefore covers a longer area.

For a detailed interpretation of the change, we plotted the full raster image colored by the pixel change, see figure 7. The intersection line, or coast line, between the still water level and the slope is depicted in the figures as well. The distance of these coast lines for these two slopes to the origin are about 3.85m and 3.17m respectively, in the slope coordinate system. The greatest pixel change of slope 1 happened between [4,6.5] m in the Y direction while the greatest pixel change of slope 2 happened between [3.5 4.5] m in the identical direction. The pixel change values of the two slopes are in the ranges [-12.77 14.83] mm and [-5.01 3.75] mm, respectively. (within the symbol [], the left value represent the minimum value and the right value the maximum value). The mean pixel change values of the two slopes are 0.04mm and -0.04 mm. Here we conclude that the amount of change for mild slope 1 is a factor 2 to 3 times higher as for the steeper slope 2, which can again be explained by the higher proximity of the waves to the rocks for the mild slopes. The total volume changes on the left and right of the coast line in slope 1 are -191.36 mm^3 and 454.29 mm^3 respectively, and the mean volume change for each pixel on the left and right of the coast line in slope 1 are -0.37 mm^3 and 0.25 mm^3 . For slope 2, the corresponding total volume change value for slope 2 are 5.1 mm^3 and -144.2 mm^3 respectively, and the mean volume change value for each pixel is 0.017 mm^3 and -0.015 mm^3 . Note that the direction of transport changes between the two tested slopes. Indeed, for the steeper 1:5 slope, transport is mostly seaward, that is towards the positive Y direction, while for the less steep 1:10 slope, transport is in the opposite direction, the negative Y direction. The way the laser scanner is operating from a fixed position,

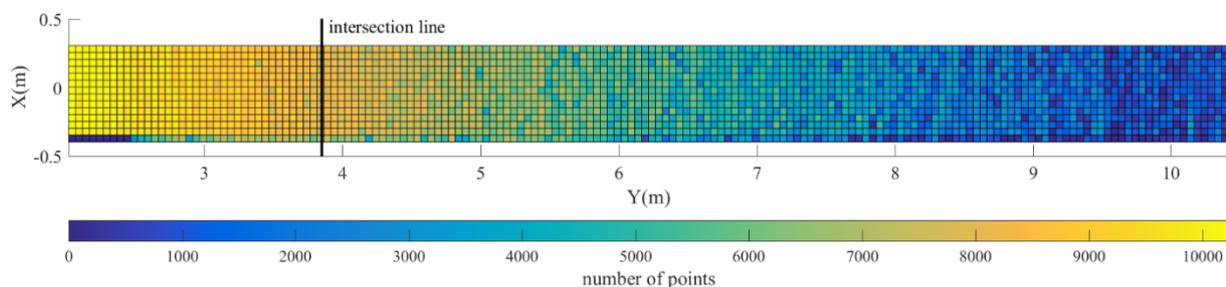
Figure 8. Raster image of Slope 1, colored by number of points in each pixel . The attribute of each pixel is determined by counting the number of points in that pixel. The closer the distance to the scanner, the higher the number of points per pixel.

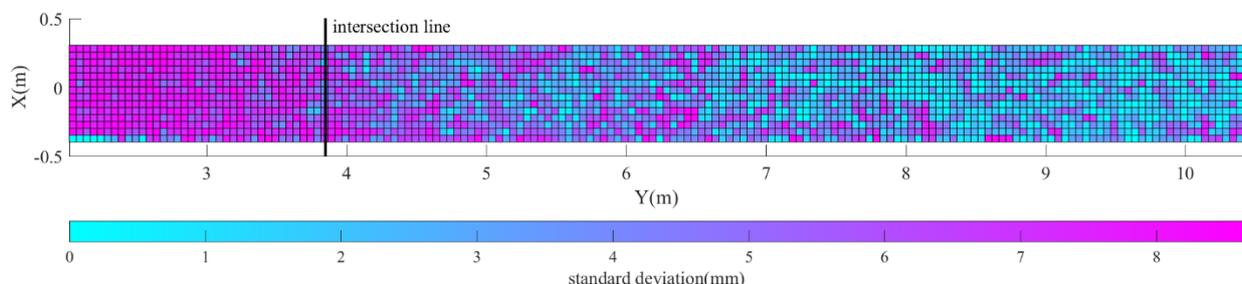
Figure 9. Raster image for Slope 1 colored by the standard deviation per pixel. A pixel standard deviation is obtained by computing the standard deviation of all Z values in the pixel.

Further insight in the quality of the detected changes can be obtained by considering the standard deviation of the Z values of the points per pixel. The standard deviation for each pixel is computed as follows: first to search all points in the current pixel, and second, determine the standard deviation of the Z values of the found points. The point cloud after the wave attack testing is used to plot the raster image for Slope 1, colored by standard deviation, see Figure 9. The standard deviation per pixel drops from $\sim 8 \text{ mm}$ close to the intersection line to values in the order of 3 mm at distances of 10 m from the intersection line. This variation is believed to be caused by the actual variation in bed levels due to the irregular rock surface and a decrease in the number of points per grid cell with increasing distance to the scanner. An effect that was not quantified in this study but could play a role is the shadowing effect. Because of the incidence angle, the laser ray will look

deeper' between the rocks close to the scanner than at larger distances. Therefore, more variation with respect to the average

bed level is expected at shorter distances to the scanner.

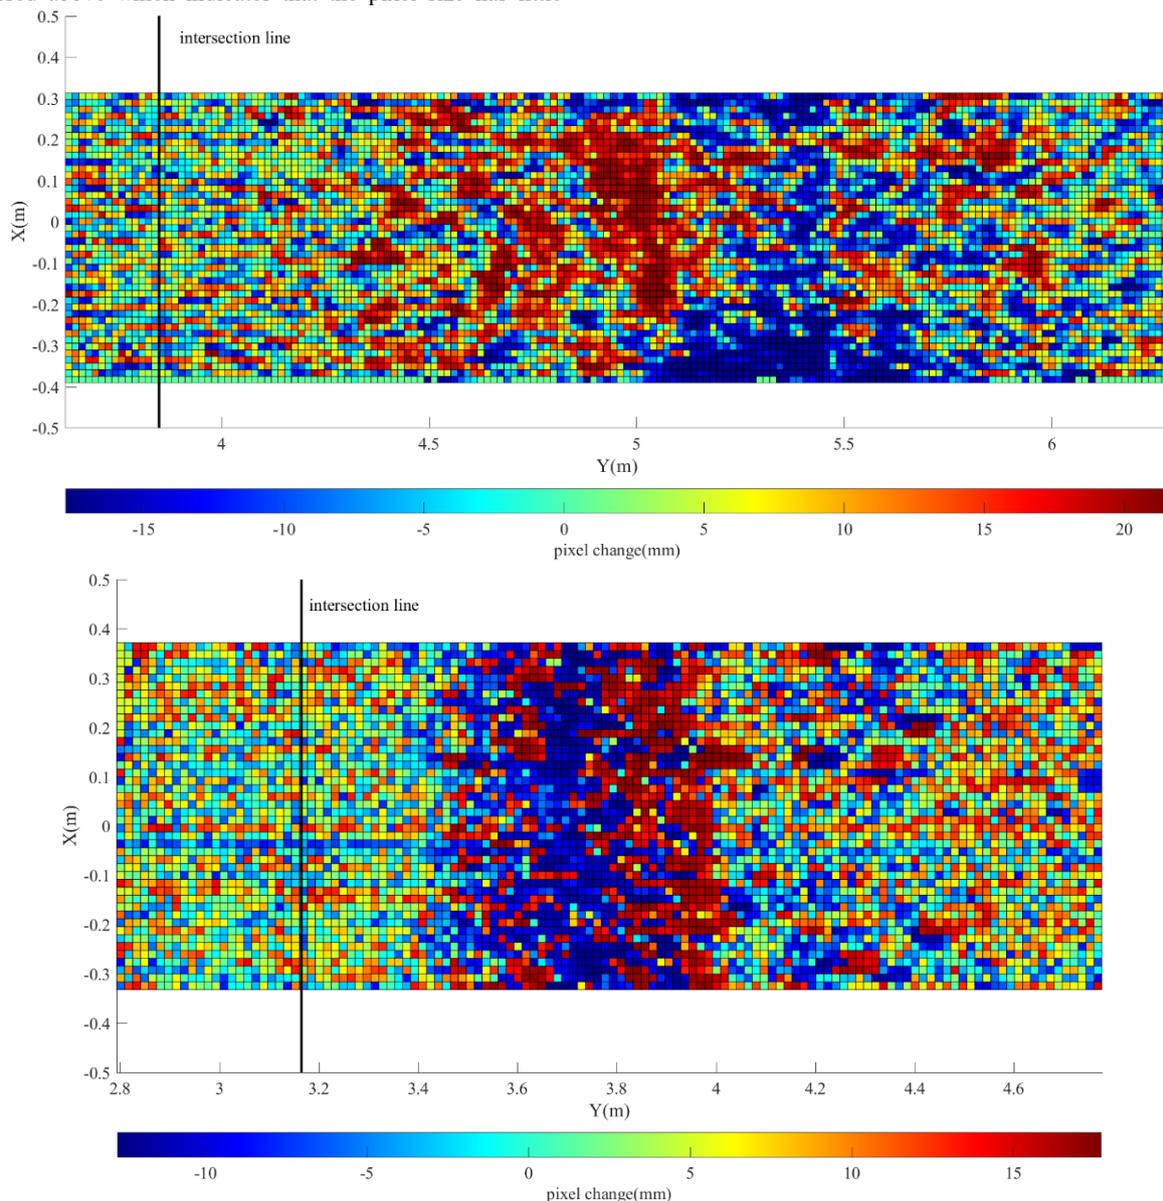
Figure 10. More detailed raster image of changes before and after the wave attack (top for slope 1 and bottom for slope 2). Pixels are colored by the change value

influence on the absolute change profile along the Y direction. Figure 10 show the pixel change of ROI belonging to the slope 1. The maximum pixel change values (maximum accretion) of the two slopes are 21.58 mm and 17.71 mm while the minimum pixel change values (maximum erosion) are -17.80 mm and -12.72 mm respectively Note that, compared to the pixel change value for the full area introduced in section 3.1, the absolute maximum change, minimum change and mean change values are all smaller which result from the pixel size, namely the greater the pixel size the absolute pixel change value is smaller. Obviously, if the pixel size is greater than the nominal diameter of the stone (i.e. 16.20mm), one pixel covers more than one complete stone and it causes the accretion or erosion of the current pixel averaged by the region outside the stone.

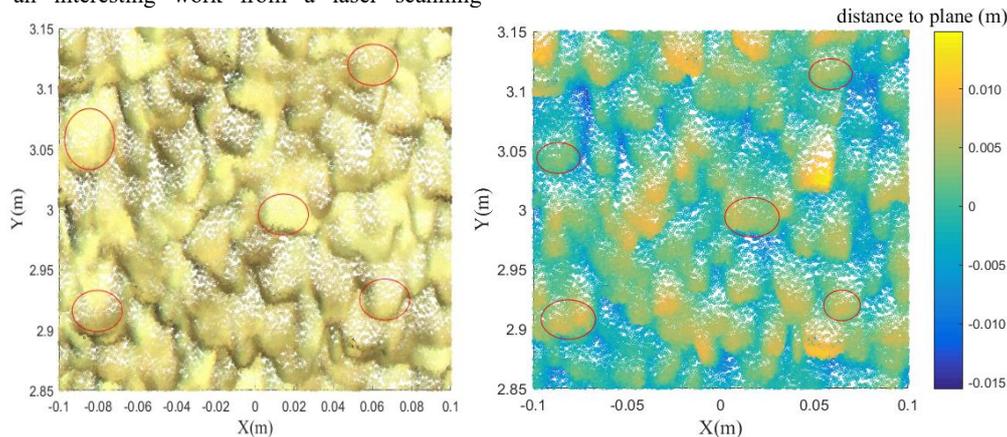
Figure 11. Raw data of the stones, left colored by RGB and right colored by the distance to the slope plane. 'Negative' distances up to 15 cm represent points below the slope plane; positive distances come from points above the slope plane: several single stones are highlighted.

As future work, we would recommend to study a more detailed quantitative analysis of the surface change, by incorporating single rock extraction (as marked in Figure 11). This will definitely be an interesting work from a laser scanning
