What can we learn from a photographed B-17 “Flying Fortress” in-flight structural failure?

2018 AIAA Aerospace Sciences Meeting 8–12 January 2018, Kissimmee, Florida

Reengineering history: What can we learn from a photographed B-17 “Flying Fortress” in-flight structural failure?

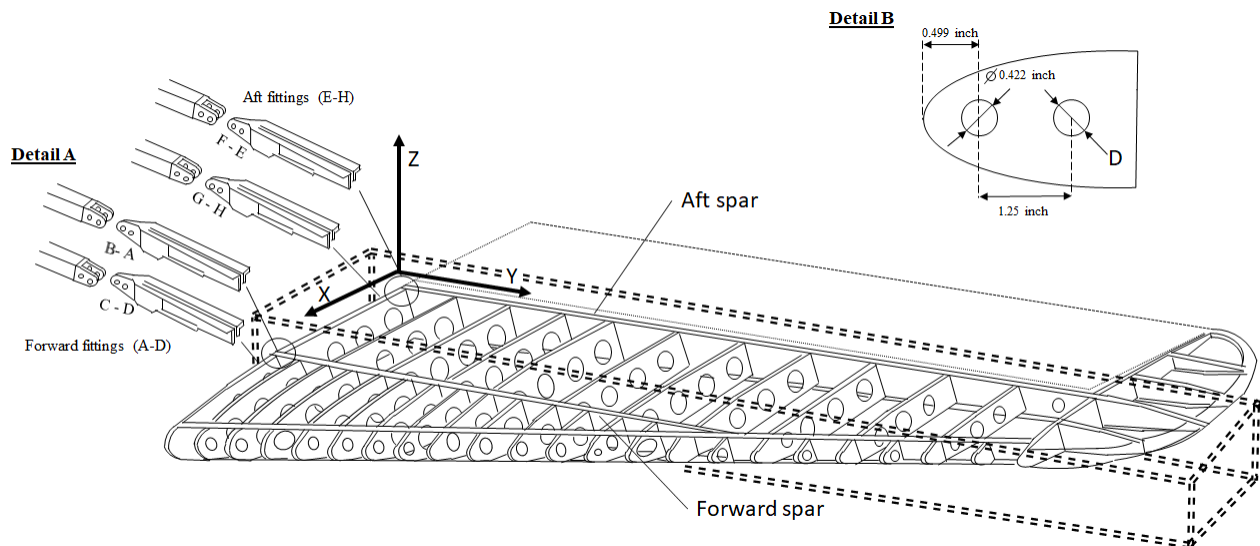
The B-17 horizontal stabilizer Fig. 2 has an area of 250.6 sq. ft. and is set at 0° relative to longitudinal axis. The front spar extends 19.167 feet to within 8 feet of tip end. The longer rear spar extends to the tip joining point. From the point where the front spar stops to the end of the tip, the leading edge and rear spar take over as the torsion-carrying structure. The two I-type spar beams have hydro-pressed webs with at the end a steel male attachment fitting. These end fittings can be joined with a steel taper pin onto bulkhead section 8 and 9 of the rear fuselage which has a female type fitting. The stabilizer has a NACA 0012 symmetrical profile which allows the stabilizer to be interchangeable on the left and right hand side. The flying characteristics of the B-17 were good as it was designed as a bomber flying long missions. The B-17 was not designed for spins and steep dives care must be taken to recover the aircraft [8]. A limit load factor of 3 is given for a design gross weight of 48,726 pounds [9].

Fig. 2 Horizontal stabilizer assembly B-17 with fittings (Detail A) and lug measurements (Detail B).

The third scenario that is considered is a partial separation of the left stabilizer due to bomb impact. By reviewing the B-17 stabilizer design the four terminal fittings (stabilizer-to-fuselage connection points), see 2, have been identified as the weakest link. Examination has shown that at this point all the forces and moments are transferred into the fuselage. It is proposed that the bomb impact could break one or more but not more than three terminal fittings. This failure scenario would break the two upper attachment points and the two lower attachment points would have sufficient strength to carry the stabilizer weight and aerodynamic loading. The sequence of this failure mode would be very elaborate as aerodynamic twisting and force loading may cause a multiple breaking scenario. Similar to scenario B the belly turret gunner who witnessed the event did not mention or provided any information pertaining to the stabilizer after it was hit by the bomb. Examining the post impact photograph Fig. 4b, 4c and 4d a black (shadow) structure, resembling part of the stabilizer can be seen hanging downwards from the tail section 4c. Subsequently, photographic evidence suggest a partial failure of the left hand stabilizer as a likely scenario and should be investigated further.

The two-spar horizontal stabilizer consists of a center structural box section with two outer sections, the leading edge section and aft elevator section. The aft spar serves as the connection point for the elevator. The leading edge consists of the ribs shaping the nose which are connected to the forward spar and the skin. It is assumed no major structural load can be carried by leading edge because it is designed for much lower loads than the bomb exerts during impact and thus would fail immediately. The elevator is a separate element connected by two hinges and a torsion bar for elevator and trim control. Similar to the nose section the elevator is considered to be able to carry a bomb impact load and would fail immediately. As such this approach uses a symmetrical structural box section consisting out of the forward and aft spar to assess the forces and moment at the stabilizer root to fuselage connection. As a result, the bomb impact location (X and Y-direction) which is a model input should be within the wing box outline shown in Fig. 2. This is supported by close examination of Fig. 4a.

The horizontal stabilizer is in principle designed to withstand the lift force and is connected to the fuselage by two terminal fittings on each spar. Each terminal fitting consists of a male and female lug system with two holes for a taper pin Fig. 2 detail A. The fittings have lug holes which are individually designated from A-H. Using the wing box dimensions the reaction forces F_x , F_Y and F_z of each individual lug hole can be calculated following the aerodynamic (A) and bomb load (B) inputs.

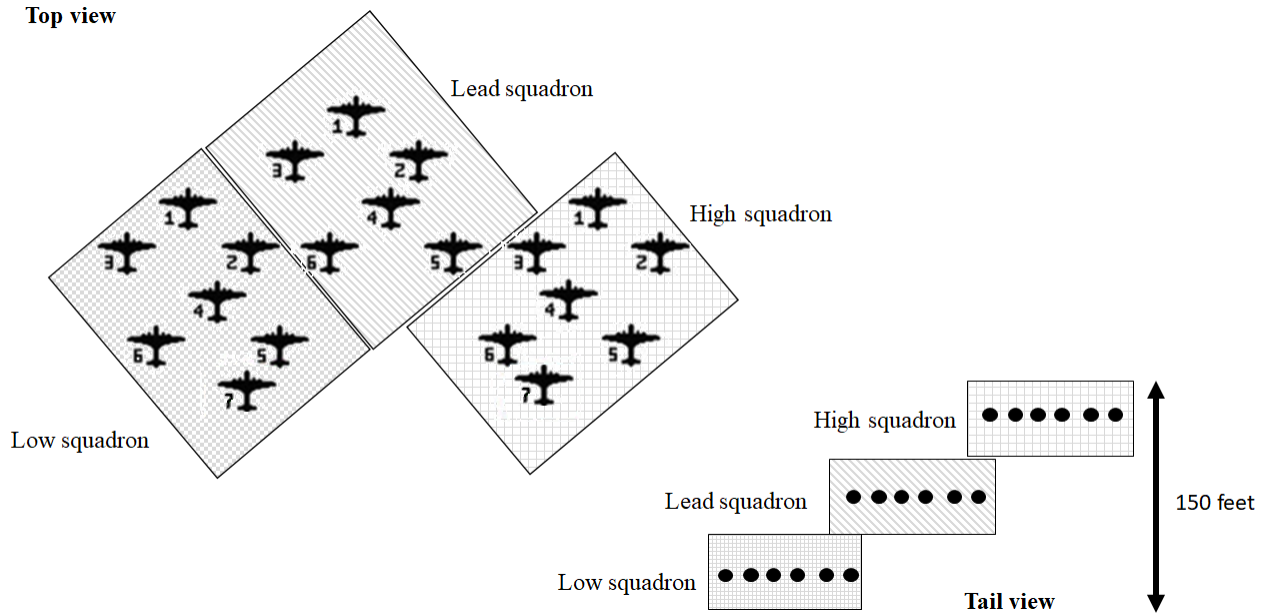
In January 1944 the box formation was adopted as general practice and was used for missions. The box formation was tuned to best use the B-17 armament and defend the formation. The formation also needed to be close together to give a better bomb pattern and minimize the time over heavy flak defenses and anti-aircraft guns which could only fire on a few number of the units at the time. The three squadrons element flew in a box of 160 feet wide by 150 feet high, the distance was close and staying in formation was essential Fig 3.

Fig. 3 “Box formation“ flown by the B-17s with aircraft position numbers.

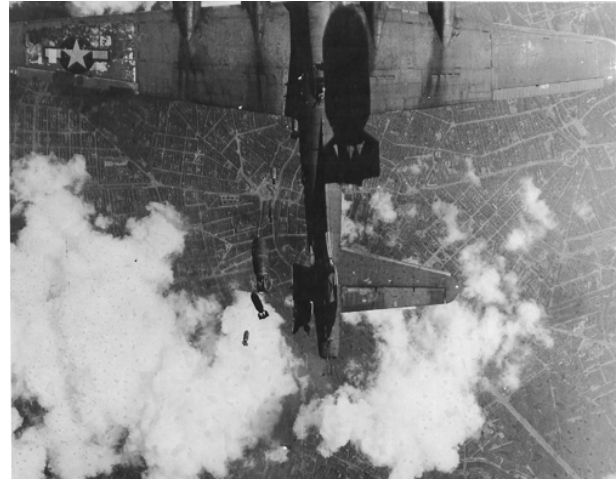
Fig. 4 Photographs (a)-(d) showing the B-17G "Miss Donna Mae II" left horizontal stabilizer hit by bomb [17].

(b) Photograph 1 showing stabilizer after bomb impact.

(c) Photograph 2 showing stabilizer after bomb impact.

(d) Photograph 3 showing stabilizer after bomb impact.

After reviewing the photographs in Fig. 4 three main scenarios were developed which could explain the stabilizer failure. The first scenario will look at the possibility of an explosion of the bomb when it hit the stabilizer. The second and third scenario will look at the failure caused by bomb impact, where the distinction is made between a partial and a full separation of the horizontal stabilizer.

The second scenario that will be looked at is a full separation of the left stabilizer due to the bomb impact. This scenario has been suggested by several sources including the MACR[18] report and the original photograph descriptions Fig. 4. Following this scenario and given the time interval between the photographs it would be likely to observe the separated stabilizer falling down. Examining the three post impact photographs Fig. 4b, 4c, and 4d no debris can be observed. Evaluating this information Scenario B – full separation of the left stabilizer by impact is possible but given photographic evidence unlikely.

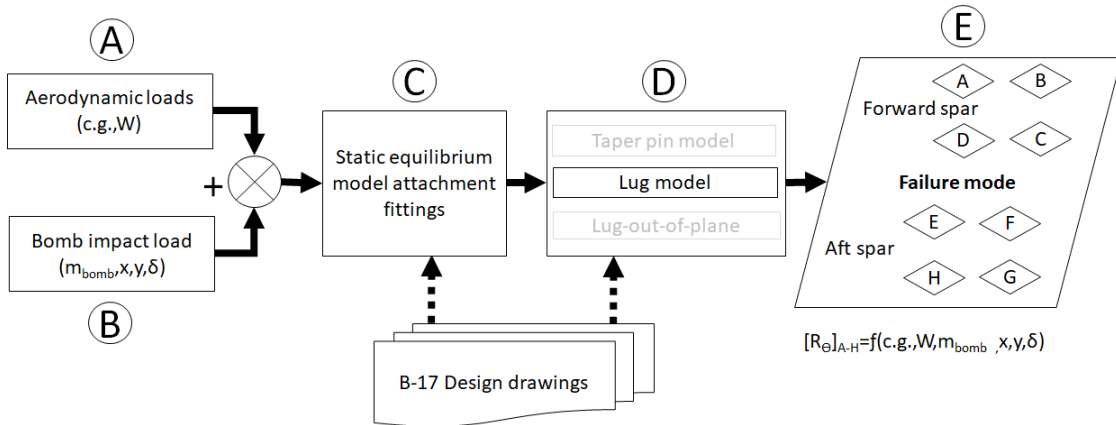
Fig. 5 Structural modeling approach diagram.

Figure 5 shows the model setup with the inputs consisting out of the estimated aerodynamic loads (A) and the force resulting from the bomb impacting the stabilizer (B). The stabilizer static equilibrium model for the connection points (C) represents the mechanical characteristics of the stabilizer connection points to the main fuselage. In the failure model (D) the taper pin, lug and male fitting connection base maximum forces are calculated. The analytical model was created using B-17 design drawings and component specifications [23]. Given model inputs an assessment of possible failure mode(s) (E) can be evaluated. A more detailed description of the modeling approach is provided in the next sections.

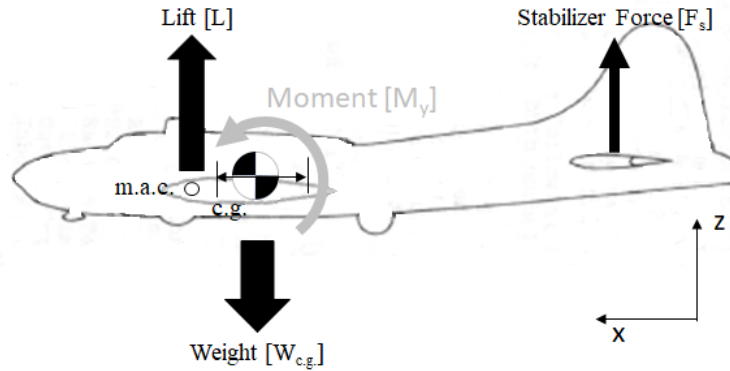
For a balanced flight condition, the external forces and moments acting in the vertical plane on an aircraft can be determined using the simplified scheme depicted in Fig. 6. The B-17 aircraft can be simplified to a fuselage, main wing and stabilizer. The aircraft weight ($W_{c.g.}$), lift (L) and the stabilizer force ($F_{stabilizer}$) are assumed to be aligned in the Z-direction. A balancing calculation can be executed to determine the stabilizer vertical force or lift. Using the aircraft weight and balance data the center of gravity (c.g.) and mean aerodynamic chord (mac) are described [24]. As the B-17s' center of gravity and weight range are known the load balancing calculation Eq. (1) and Eq. (2) yields the stabilizer vertical force for its full operational flight range. The balancing calculation output is the total stabilizer force or vertical force created by the stabilizer during flight.

Fig. 6 The vertical forces and moment for the B-17 weight and balancing calculation

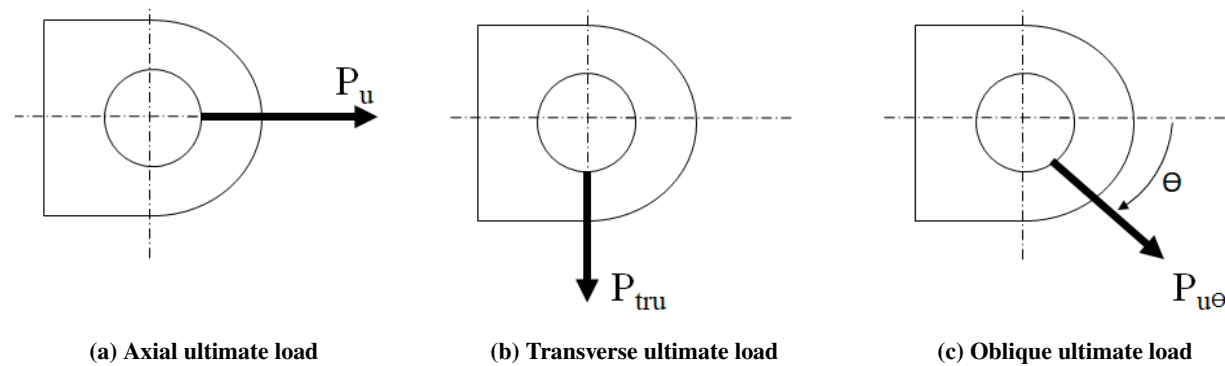
Fig. 7 Lug loading.

The maximum load able to be carried by the lug connection can be calculated using standard calculation methods [26–28]. Three different load cases can be distinguished an axial, transverse and an oblique load failure Fig. 7. For axial load failure three failure modes can be distinguished, a net section failure which can be described by Eq. (8), a shear-out or bearing failure which can be calculated by Eq. (9).

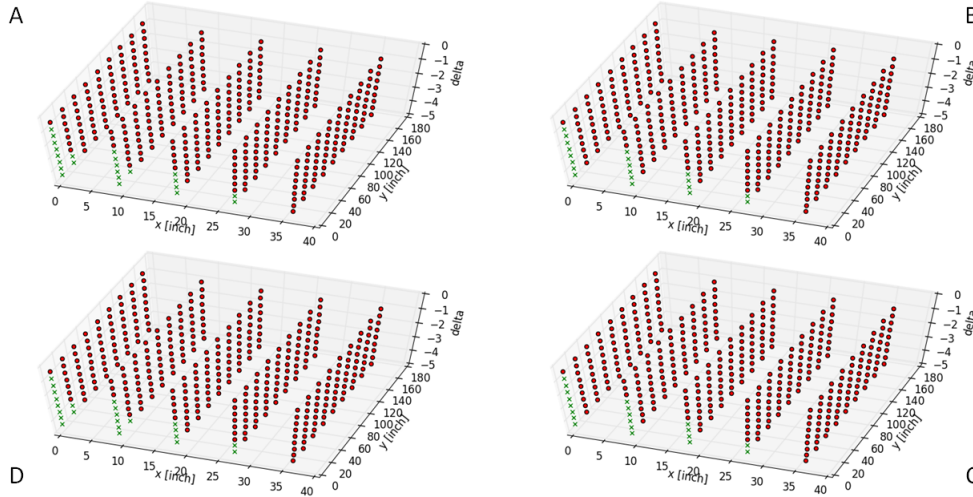
Fig. 8 Oblique load failure for lug element A-B-C-D ($m_{bomb} = 1000lb$, $F_s=2000N$).

As can be seen from the Fig. 8 and 9 where $m_{bomb} = 1000lb$ a small area exists where the oblique lug load is not exceeded, this is near the root at large δ values. Reducing the bomb mass to $m_{bomb} = 100lb$ shows an increase in area where the lug load is within the R_θ threshold as shown in Fig. 10 and Fig. 11. This is also the case when the bomb is dropped at $y = 35$ inches, the estimated impact location from Fig. 4c. In this case however the calculated resultant F_x for fitting D and E are beyond the established normal load threshold for impact distance $\delta = 0.5$ and a failure would still occur.

The model results show that in most cases a $m_{bomb} = 1000lb$ would separate the stabilizer as shown in Fig. 8 and 9. This finding is not entirely consistent with the photographs of the event Fig. 4. By reducing the bomb mass to $m_{bomb} = 100lb$ the same study was performed. What one concludes from 10 and 11 is a relatively narrow range of impact locations exist where R_θ is above the threshold and the stabilizer would separate. A reverse outcome compare to

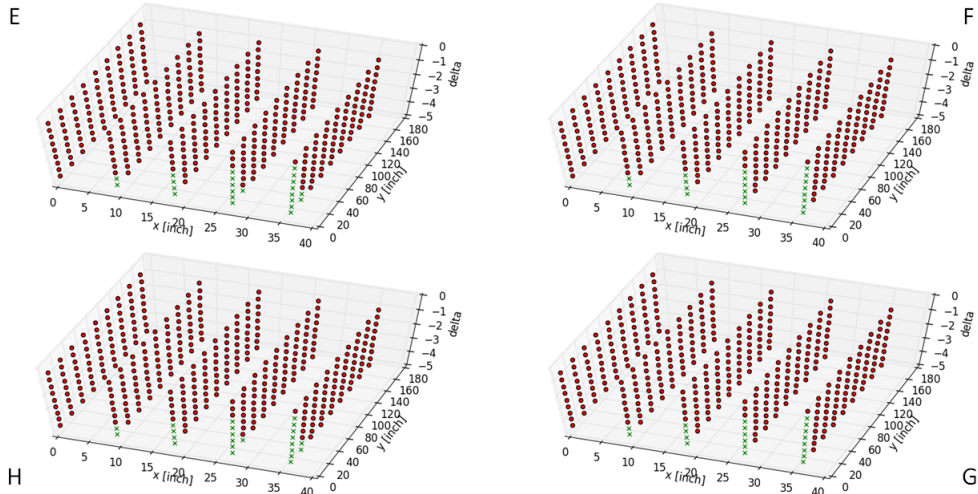
Fig. 9 Oblique load failure for lug element E-F-G-H ($m_{bomb} = 1000lb$, $F_s=2000N$)).

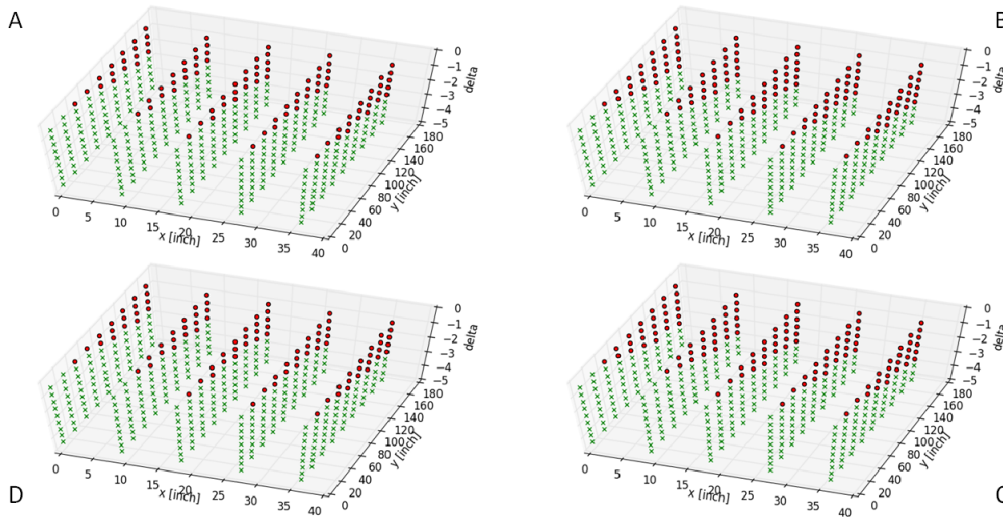
Fig. 10 Oblique load failure for lug elements A-B-C-D ($m_{bomb} = 100lb$, $F_s=2000N$)).

$m_{bomb} = 1000lb$, which shows that m_{bomb} mass influences the lug failure mode. Similar to Fig. 12 where the bomb mass m_{bomb} was simulated to vary the study outcome shows a small area where the stabilizer would not shear off. However this calculation shows the result of the forward spar when the bomb impacts the aft spar. This is an ideal case which is not consistent with Fig. 4a where it was estimated that the bomb impact was at $y=35$ inches between the forward and aft spar. Figure 8 and Fig. 9 clearly show that in that case the R_θ threshold was exceeded. Thus for the vast majority of cases it is expected that the stabilizer would separate.

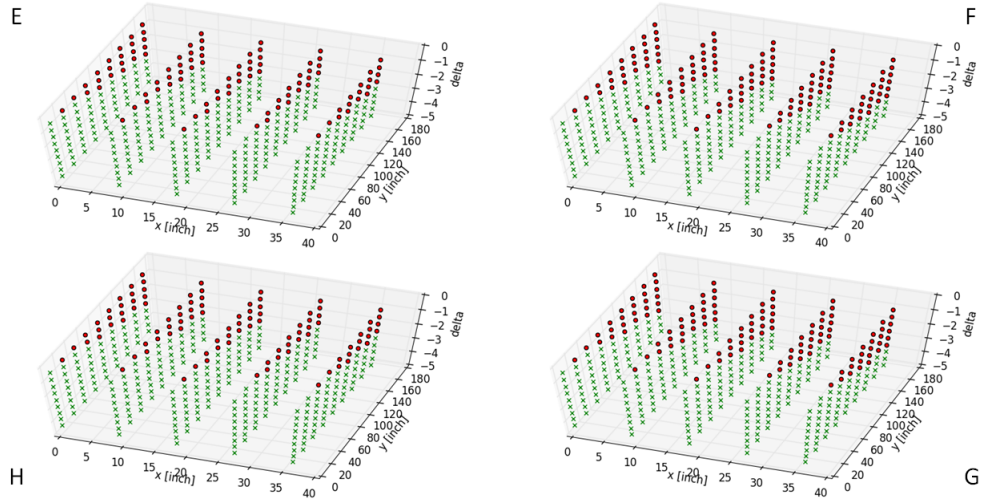
Fig. 11 Oblique load failure for lug element E-F-G-H ($m_{bomb} = 100lb$, $F_s=2000N$).

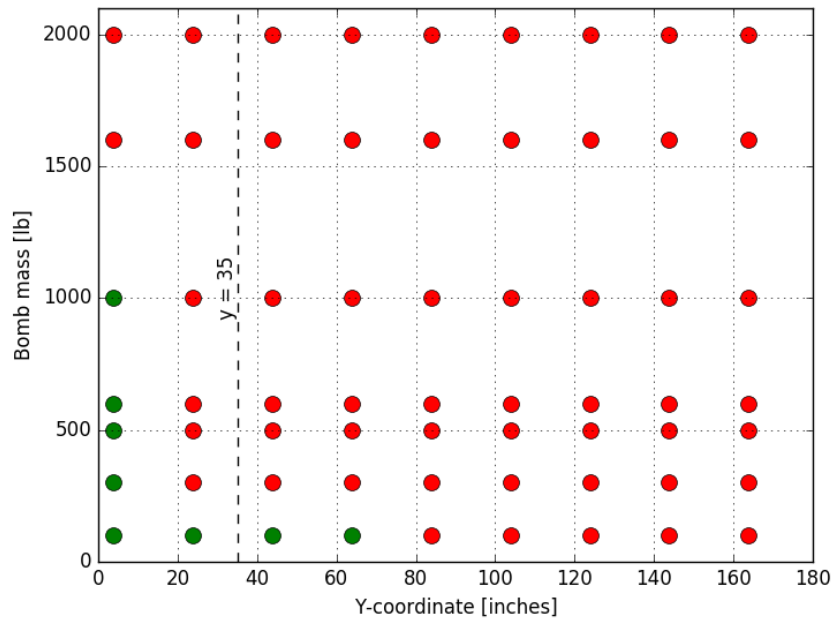
Assuming a bomb impact location on the forward spar $x = 36$ inch, an impact distance $\delta = 1$ and varying the bomb masses m_{bomb} which can be carried by the B-17 will result in Fig. 12. It can be concluded that a small area will not result in failure of the horizontal stabilizer and the lug load is within the R_θ threshold. What should be noted is that in this case the R_θ threshold is not exceeded for a $m_{bomb} = 1000lb$ when the bomb impacts the aft spar ($x = 0$).

Fig. 12 Forward spar with varying bomb mass m_{bomb} and y-coordinates ($F_s = 2000N$, $\delta = 1$, $x=0$).
