# Intersection control for cyclists with iSignum

At the signalized intersection Julianalaan-Nassaulaan in  
Delft

Civil Engineering Bachelor Thesis

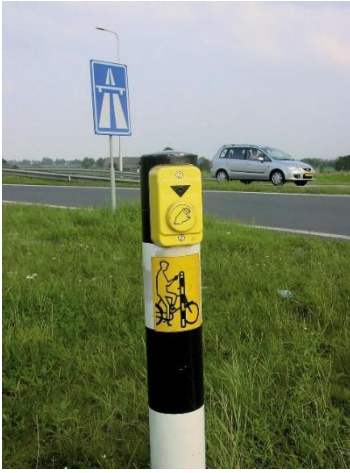
Figure 2: A inductive push button (CROW, 2014)

Shortly mentioned in the introduction, push buttons and inductive loop sensors are commonly used as cyclists detectors. These loop sensors work with an electromagnetic field, when a cyclist stops on a loop sensor or passes by, the magnetic field is disturbed and a cyclist is detected. However, the loop sensor does not always detect cyclists correctly. Especially when a bicycle made out of very little metal is used (Sterk, 2020). Therefore, the combination with push buttons is more sufficient in case such a situation occurs. However, during the time of research, a global pandemic COVID-19 is happening. With the consequence that people need to maintain distance or advised to keep distance from each other which may result in lower traffic volumes and fewer spikes in normal situations. As a result, the induction loop sensor can be treated as broken and is switched off (Salomons, 2020). Consequently, this particular combination of sensors then only relies on a push-button at that point which is only located at the stop line.

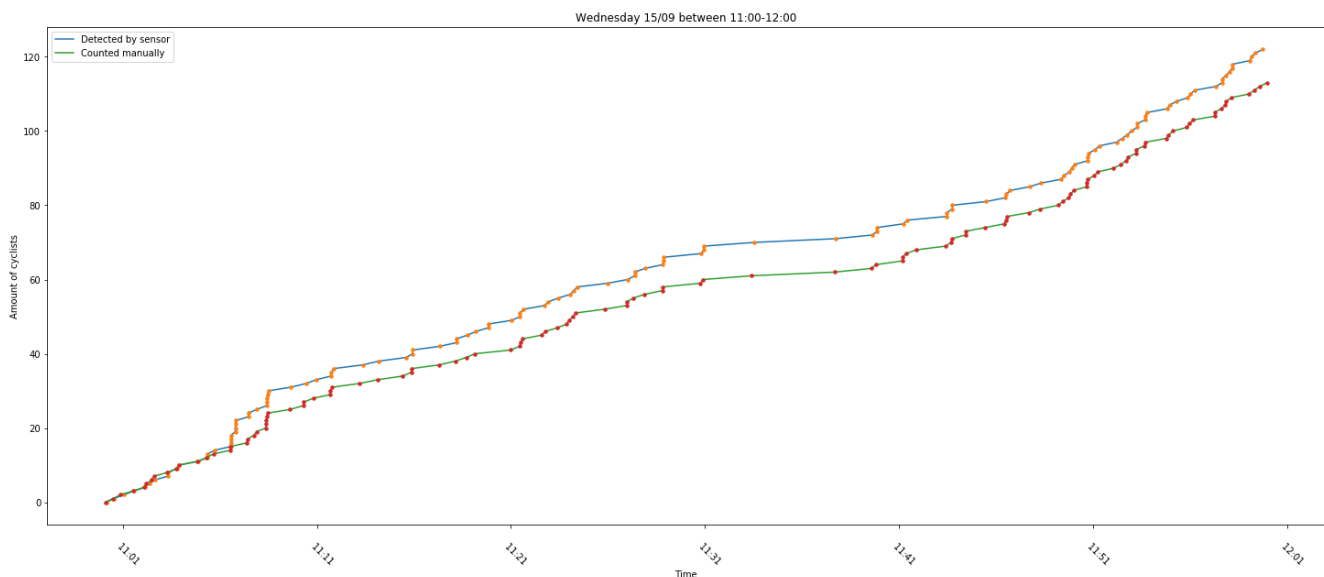
Figure 4: Comparison between manually counting and sensor detecting on 15/09 11:00-12:00.

As witnessed, the two graphs in all figures are not exactly on top of one another, meaning that the data does not match completely. To highlight the individual points, markers are used in all graphs except for Figures 5 & 6 due to the many markers the graph will become unclear and these graphs are elaborated on in the next section in more detail. Furthermore, it can be observed that the divergence is not constant over the course of the measurement from the sensor in comparison with the manual counting and therefore it is valuable to take a closer look at only the differences between the two. These are on display in Figures 7-9.

In Figures 4-6, it is witnessed that the graphs of manually and sensor measurements are not always exactly on top of each other. Additionally, Figures 7-9 that show the difference between the measurements are not constant at all. During real-time measurements, many factors contribute to the observed data. This also includes disturbances that oppose the objective of the iSignum and the company CycleData had intended for the sensor.

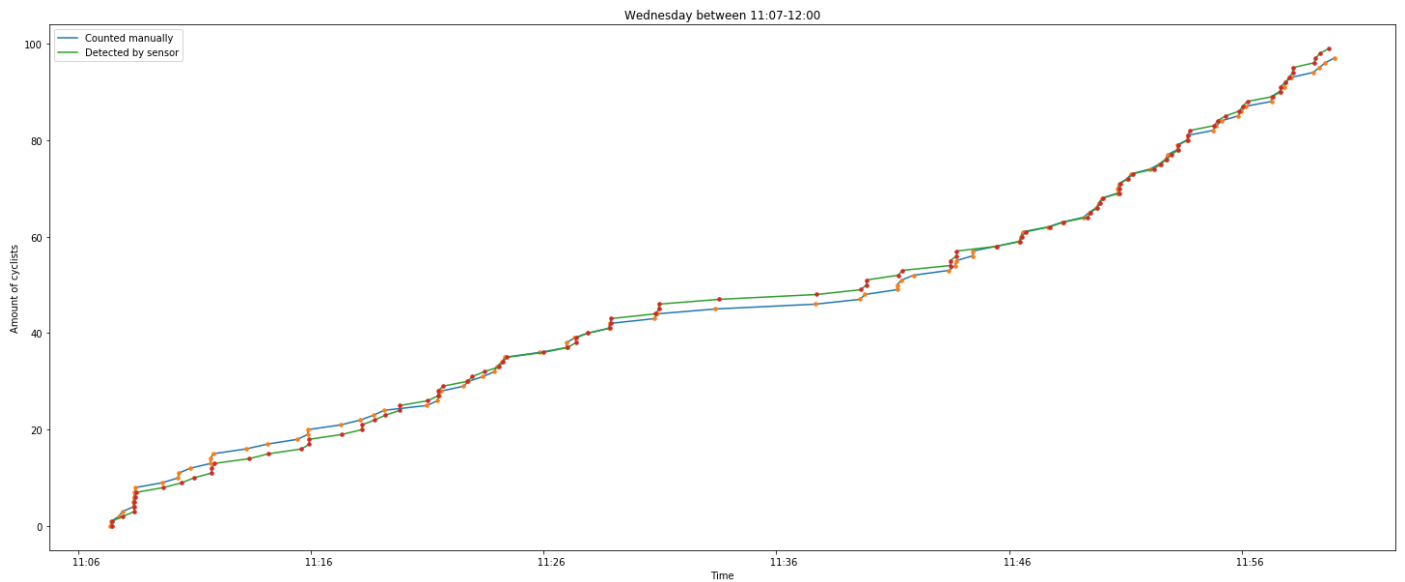
Figure 11: Comparison between manually counting and sensor detecting on 15/09 11:07-12:00.

Therefore, two new graphs are plotted in Figures 11 and 12 to illustrate the detection of cyclists from 11:07 onwards. The previously counted cyclists and falsely detected cars from that event are removed from the data list to show a better representative image over the course of the remaining time of measurement. In the graphs, it is noticeable that after the occurrence of a few cars driving over the bicycle path the sensor is not showing big errors in means of numbers of cyclists as before. The constant difference that was present in Figure 4 has disappeared mostly and was accountable towards one event of cars driving on the bicycle path and getting detected as a cyclist by the iSignalum. However, there are still fluctuations visible when it comes down to the comparison of measurement methods in Figure 12. These fluctuations are not all from the same kind of error type. Due to the graph going up and down multiple times, it can be seen that errors occur frequently but at the end balance each other out which is not particular what the goal is of the sensor. Computing the number of correct detected cyclists into a percentage expressed in the total scrutinized number of cyclists gives in this case for the shortened measurement, around 74.5% which is even lower than the overall percentage.

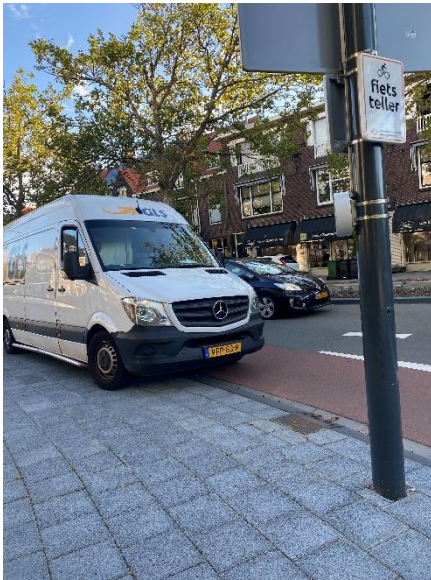
Figure 13: A delivery van partly blocking the bicycle path from 8:52-8:54 on 16/09.

Over the course of the measurement on Thursday 16/09 between the hours 8:15 and 9:15, the greatest part is within the rush hour limits. This was also remarkable in the difference in the number of cyclists with the previous measurement on Wednesday 15/09. During this analysis a problem as described on Wednesday 15/09 with cars driving on bicycle lanes is not present. Due to rush hours, many more cyclists were present and cars did not get the opportunity to make a manoeuvre to divert onto the bicycle lane without physically hitting a cyclist. However, during the time of observation two disturbances were present (Figures 13 & 14). At 8:52-8:54, a delivery van was partly blocking the bicycle lane causing the sensor to have trouble counting all the cyclists. Several cyclists that went around the van were not detected by the sensor since practically they were cycling on top of the car lane. During the time span, a total of 34 cyclists approached the

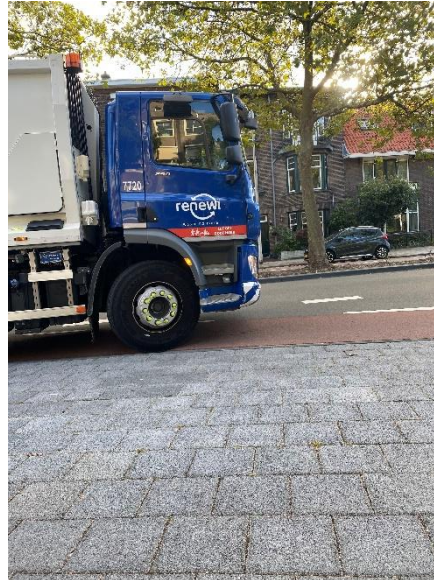
Figure 14: A garbage truck blocking the whole bicycle path from 9:12-9:15 on 16/09.

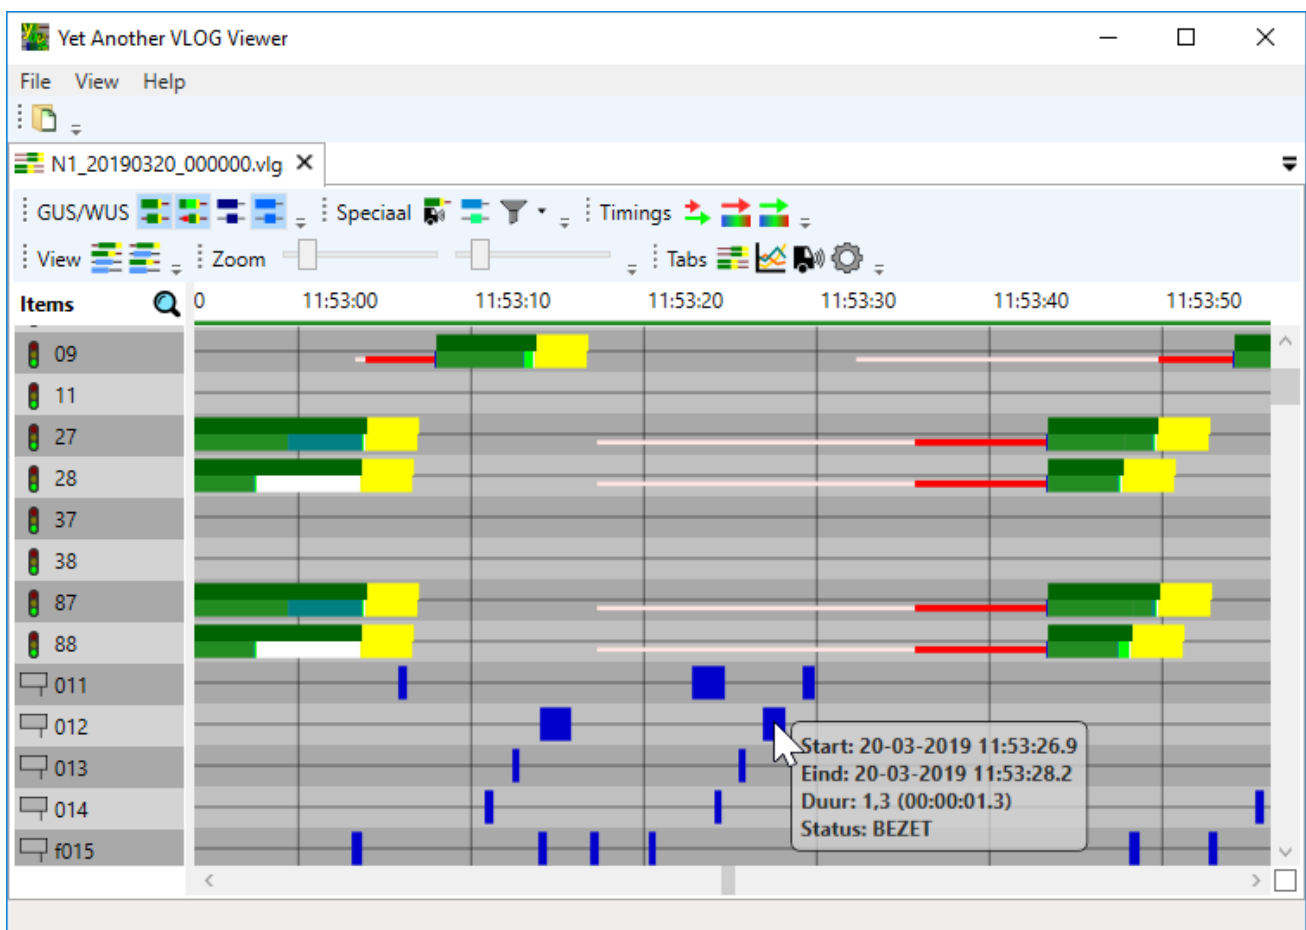
Figure 20: Example of V-log data in YAVV (CodingConnected e.U, 2019)

The V-log data that is used to compare the data set of the manual measurements are confidential, therefore no real representation can be given. However, in Figure 20 an example is displayed on how V-log data is shown in a VLOG Viewer application called YAVV. On the left side, the traffic light and sensors can be filtered such that only the relevant items regarding cyclists at the intersection are visible. Next to that, an item including public transport was kept to indicate if that has large influences on cyclists flow at the intersection. The blue colours represent the specific sensor to be occupied while the colours red, green, white and yellow represent the status of the traffic lights. During the comparison, the cyclists that are counted in

the manual measurements are paired with a cycle of the traffic light. Manual measurements were done with the same principles as the iSignum at this location, detecting cyclists without knowing whether the cyclists made a right turn or not. To have a clear overview of the data, the data set is modified when comparing with the V-log data and the modification can be seen in Appendix C. However, this is not the real data with the actual timestamps and are all made up but with a sense of plausibility. In the appendix, it can be observed that remarks about a specific cycle are made on the right side.

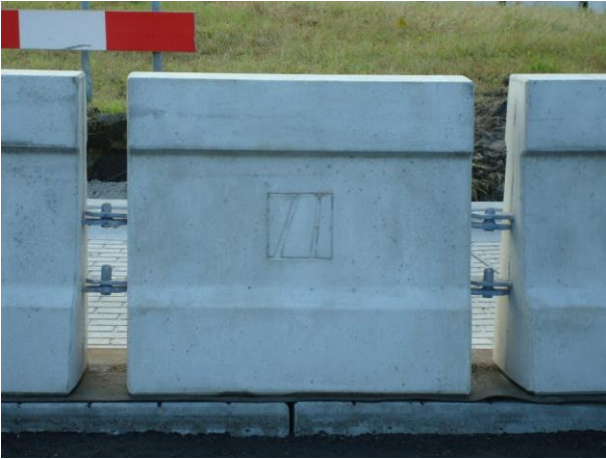
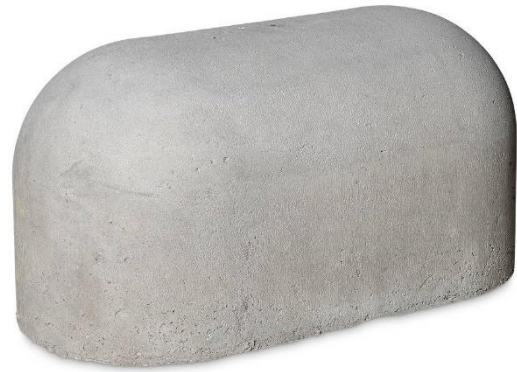
Figure 22: A Haisafe barrier (Traffic Service Nederland, 2020) Figure 23: A Jumbo block (Betondingen, n.d.)

Another option besides repositioning the sensor could be placing barriers near the iSignum location to block the bicycle path in such a way no disturbances can be present. Making it impossible for a vehicle to stop in front of the iSignum and forcing delivery vans and garbage trucks to stop at another location than in front of the sensor. This prevents cyclists to make a detour on the regular car lanes at precisely the height of where the sensor is aimed. Thus, in the end, cyclists that are actually present will not stay undetected by events as these anymore. With barriers, one can think of concrete blocks that are displayed in Figure 22 or 23 which are the Haisafe barrier and the Jumbo block. The first type of barrier is commonly used when construction is taking place and temporary barriers are needed and the latter functions as collision protection. Both of these barriers are able to function as barriers in this particular situation and location where the iSignum is installed

at the moment. Additionally, vehicles are not able to go through one of these and are forced to follow the prescribed lines on the ground and right-turning cars have to wait patiently until cars that are in front of them crossed the intersection before reaching the lane for right-turning cars without driving on top of the bicycle lane. With this prevention, one should keep in mind that barrier blocks make the lanes for cyclists and cars smaller than the current situation or the other prevention methods and can seem blunt when used for one spot in particular and not along the whole street of the Julianalaan. However, the municipality has stated not to actively prevent offences such as wrongly parked vehicles with concrete barriers near the iSignum location. Consequently, this prevention method is an option on paper but is not going to be realized by the municipality.
