## Overflow Tests on Grass-Covered Embankments at the Living Lab Hedwige-Prosperpolder

### An Overview

# Overflow Tests on Grass-Covered Embankments at the Living Lab Hedwige-Prosperpolder: An Overview

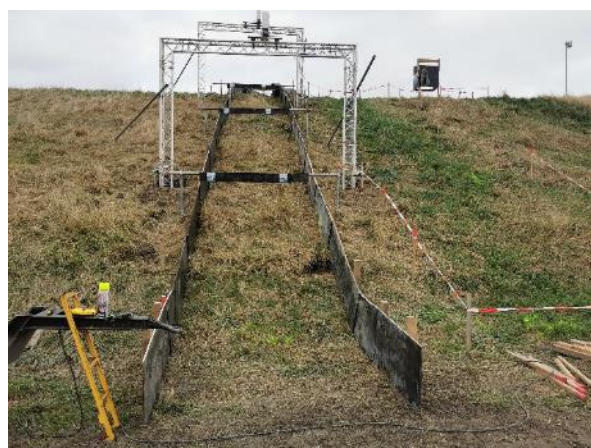
**Figure 2.** Standard setup of an overflow experiment, view from the landside dike toe. Camera and sensor frames are placed across the 2 m wide test section, prior to execution.

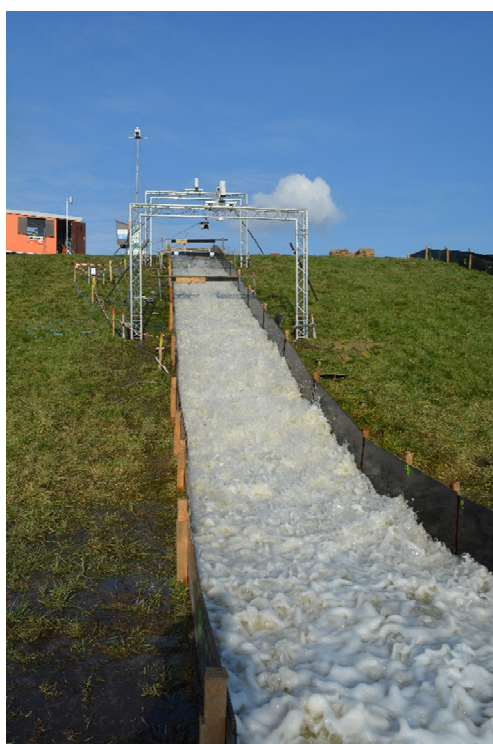
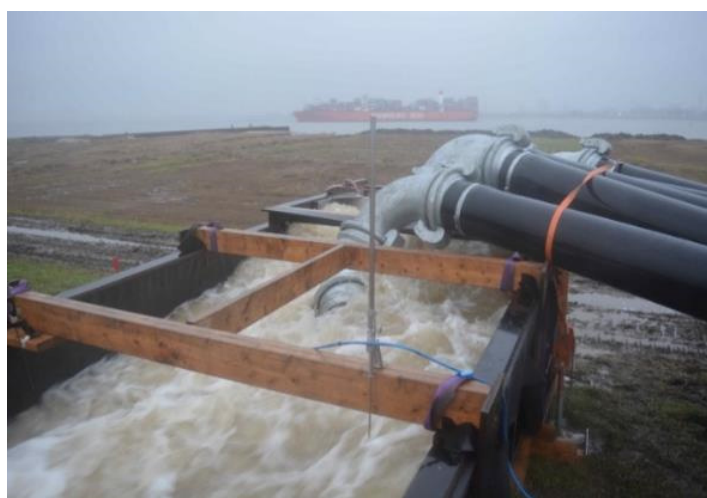
**Figure 3.** (a) Overflow in progress; (b) Overflow generator at maximum discharge of 1100 L/s.

The flow canal used for directing the water flow over the grass cover of the dike was 2 m wide. At the crest of the dike it was connected to the overflow generator. Both sides of the flow canal were made of coated hardboard plates of  $2 \times 0.7 \times 0.01$  m. The plates were hammered and sliced into the ground to a depth varying between 7 and 15 cm deep. The plates were screwed to wooden poles of a size of approximately 0.1–0.1–1.0 m with one pointed end. The poles were hammered into the ground to a depth of approximately 0.2–0.3 m. Figure 3a shows a typical flow canal that was realized on virtually every test section during the overflow experiment. Figure 3b shows the uppermost part at the maximum discharge.

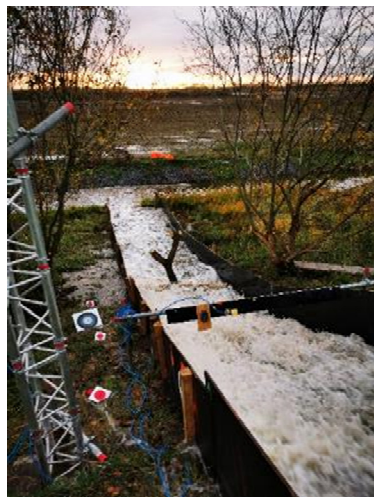
**Figure 4.** Anomaly test section with a tree trunk at the toe of the dike.

1. the presence of a tree at the toe of a dike in the test section (Figure 4);
2. a damaged dike profile at the toe, mimicking damage by animals like grazing sheep;
3. hard structures and transitions on the dike (e.g., concrete staircase).

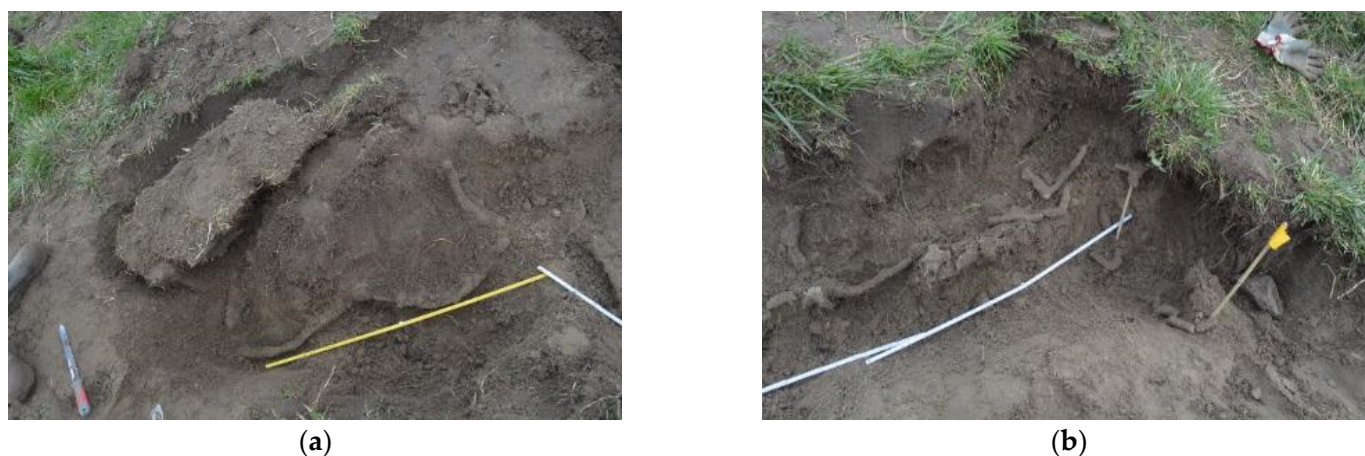
**Figure 10.** (a,b) Examples of excavated grouted animal burrows.

To learn more about the structure, dimensions and depth of animal burrows, some burrow systems were filled with grout and exposed (Figure 10). These activities led to an increased understanding of the processes at hand [16,18]. The critical factor in the damage to develop appears to be whether the burrows are in contact with the sand core and whether sand can be mobilized from within the core and exported to the outside of the dike. The requirements for this seems to be (1) a burrow system that is connected over meters to decameters distances; (2) a burrow system that reaches deep enough so that the dike clay cover is pierced and contact with the sand is made; (3) a flow of water through the burrow system is generated by the overflow process so that core sands are mobilized. Surprisingly, the artificially made holes, supposed to resemble animal burrows, were generally better resistant to flow, even if they were clearly connected to the sand core, with both an entry pipe and an exit pipe. In test B-11 for instance, the artificial hole was the very last part to collapse.
