CULTURAL VALUE

This document concerns an analysis and evaluation of the cultural value of architectural complex of the Katoenveem at the Keilestraat 39 in Rotterdam. In order to redevelop the area in the future this research is required to get a good understanding of the cultural values of the Katoenveem. This will give an insight in the aspects of building and its surroundings that need to be preserved, restored or redeveloped.

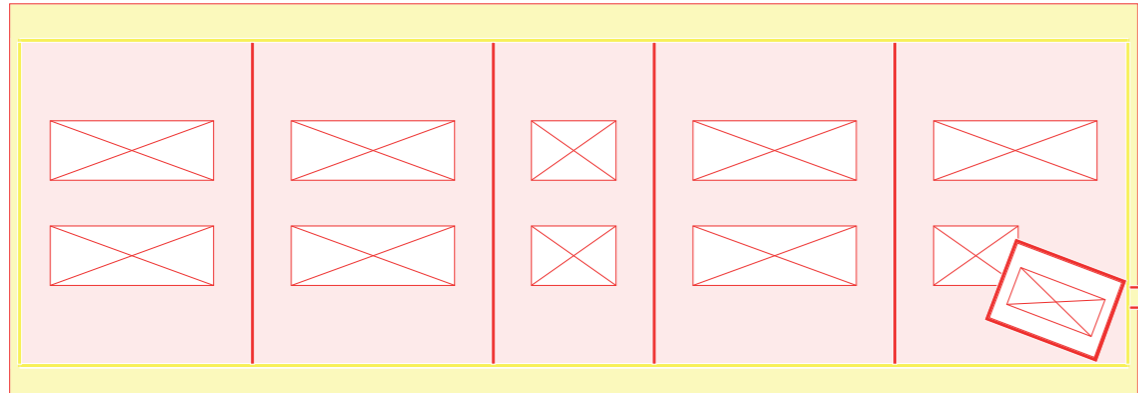
illustration 4a - stated value roofplan of main building by Audrey Loef
illustration 4b - stated value first floorplan of main building by Audrey Loef
illustration 4c - stated value ground floorplan of main building by Audrey Loef
(own illustrations)

High: The building in its contemporary original completeness is assigned high value because of the traces of intended functionality of the Katoenveem warehouse. The composition, shape and openings of the facades, compartment walls and floors are of highest importance because they represent the original functionality of the Katoenveem warehouse by its set up of spaces and structure.

Medium: In order to preserve the remaining original completeness of the building of today the layers of skin and surfaces of the facades, balustrades and galleries are of medium value as they are in need of treatment to maintain the assigned high value of being part of the intended functionality of Katoenveem warehouse.

Low: The added structures, like the interior walls and the replaced window frames hold no value and can be adjusted to strengthen the present high valued elements or to bring back the atmosphere or 'belevingswaarde' as they were not part of the original use and physical layout of Katoenveem (see illustration 4abc and 5abcd on the next page).

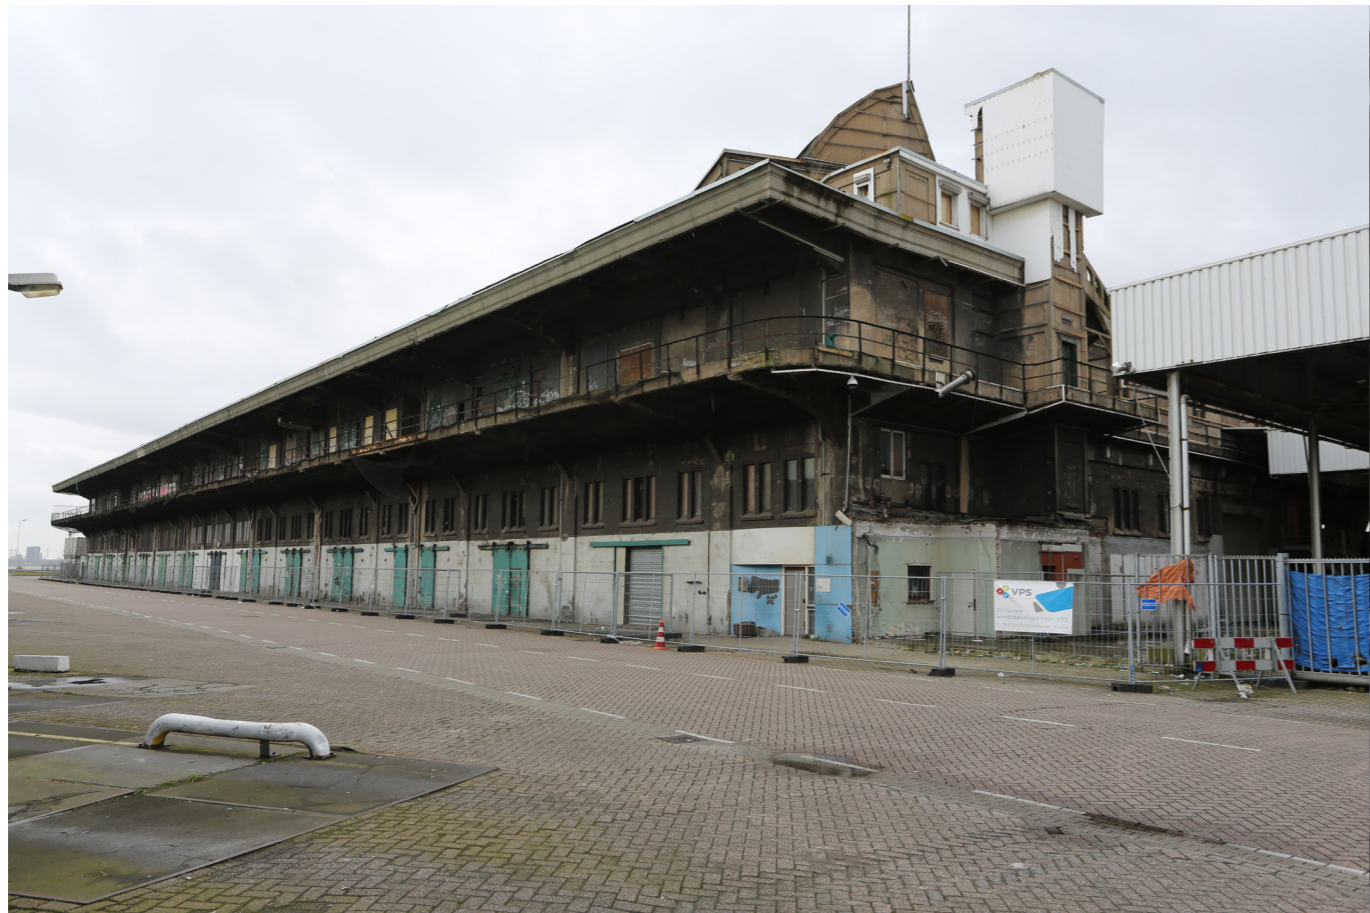
illustration 6 - katoenveem exterior south by Xihao Yi
(own photograph)

BUILDING DESCRIPTION Generally speaking, the original state (see illustration 6) and the functionality of the building complex are its primary features. The Katoenveem was built by the Dutch tradesmen of the New Maas in 1919 for the purpose of re-establishing the cotton trade after the WW1.³ Thanks to the cranes at the Lekhaven and the Keilehaven, the building complex had the ability to collect and store cotton bales from both sides of the pier that mainly arrived from England. Afterwards they would be redistributed to Germany and Belgium, either via ships from the harbours or via the railway at the south of the building.⁴ The building itself was specifically designed for the stor-

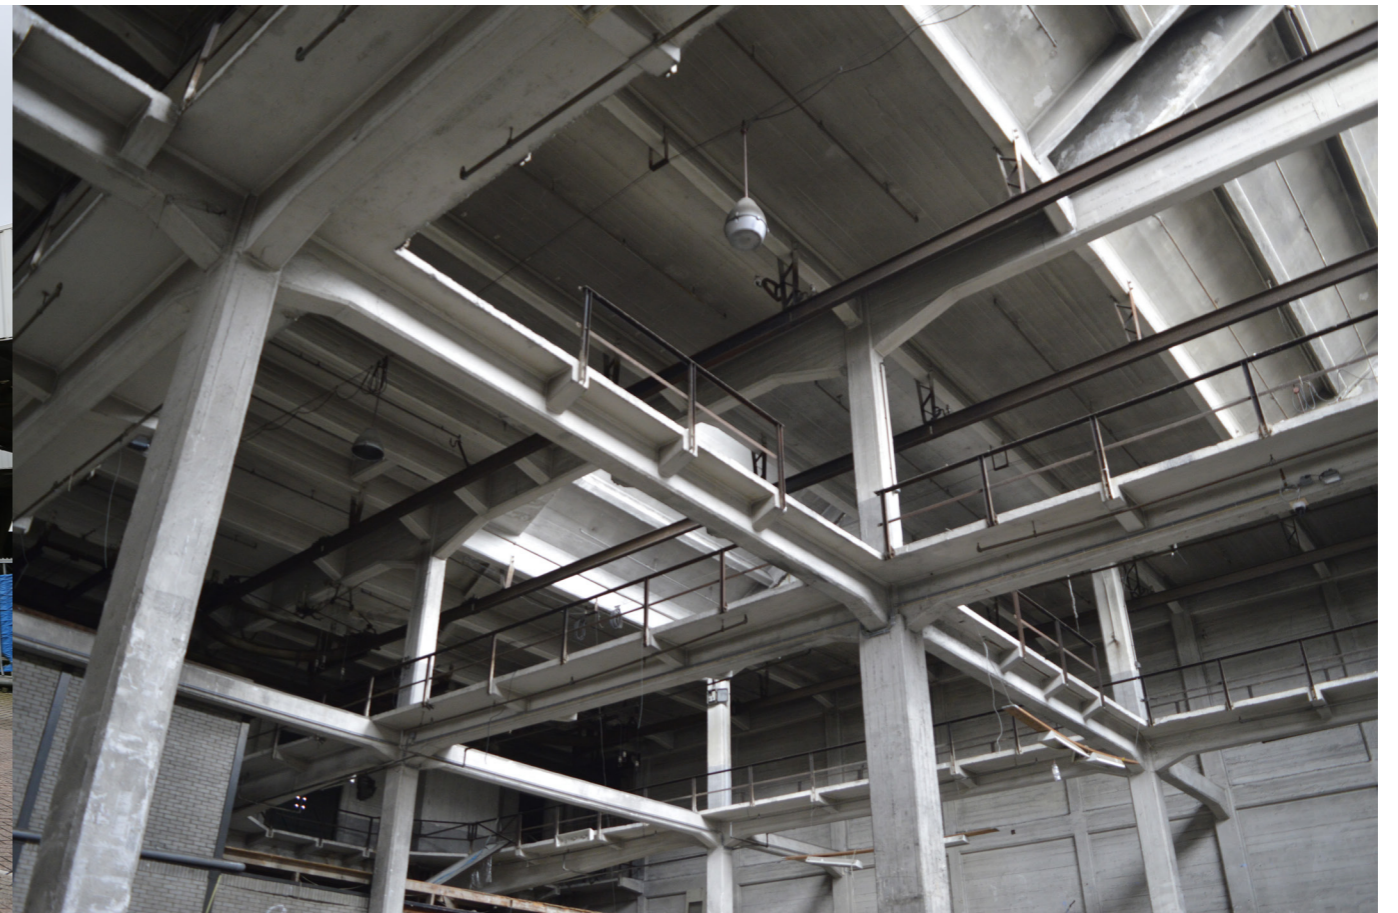
illustration 7 - katoenveem structure by Audrey Loef
(own photograph)

of indirect natural light. The natural light is brought in without overheating the cotton. The structure of the building is a monolithic reinforced concrete system that has been derived from the Hennebique construction system (see illustration 7). The architects understanding of the constructive materials resulted in slim profiling of the beams and columns, while the weight of the walkways, roof and conveyor system were distributed very well. Internal steel reinforcement is used to strengthen the structure.

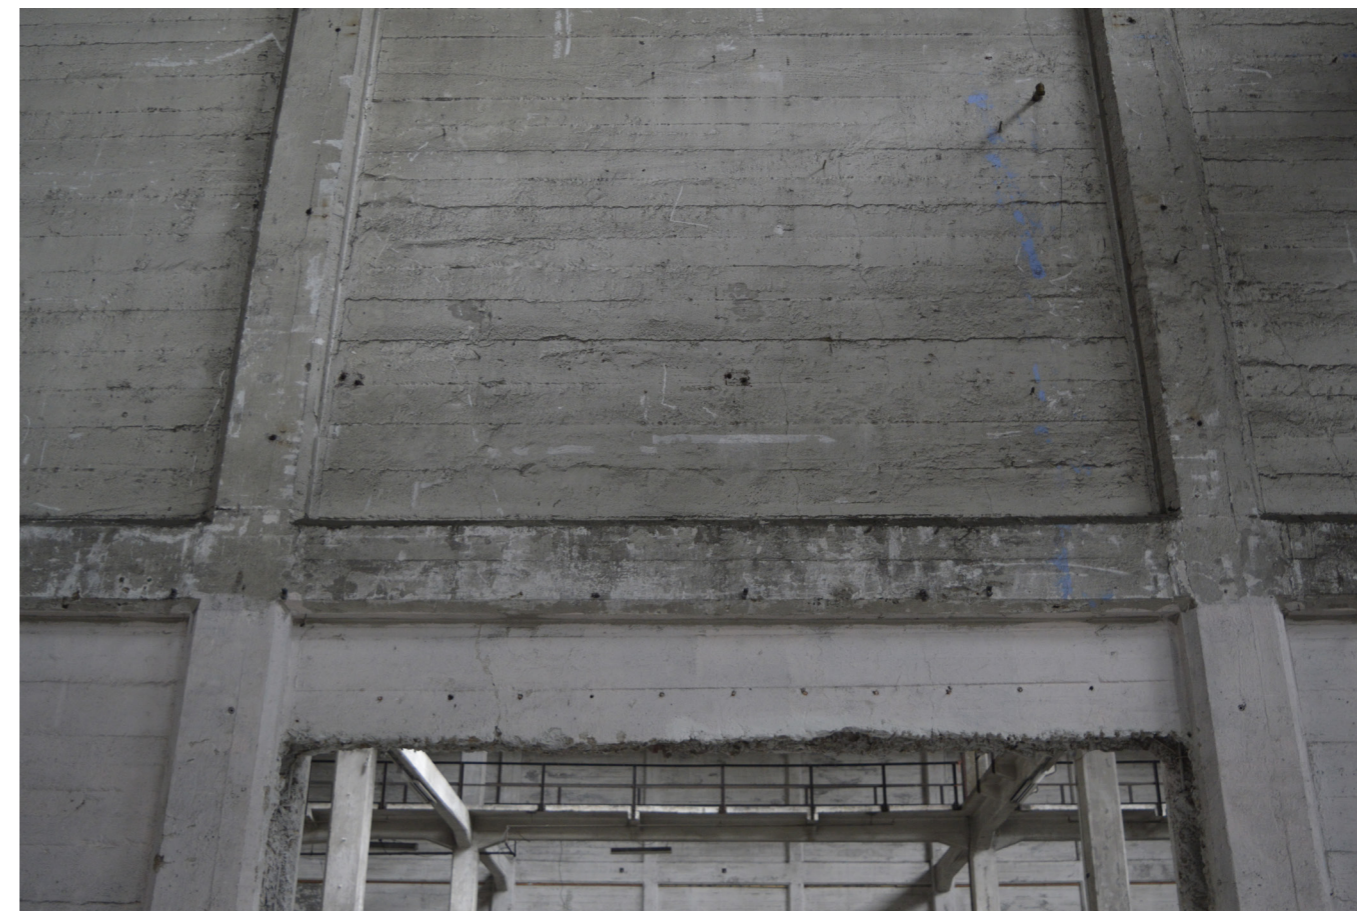
illustration 9 - interior surfaces katoenveem by Audrey Loef
(own photograph)

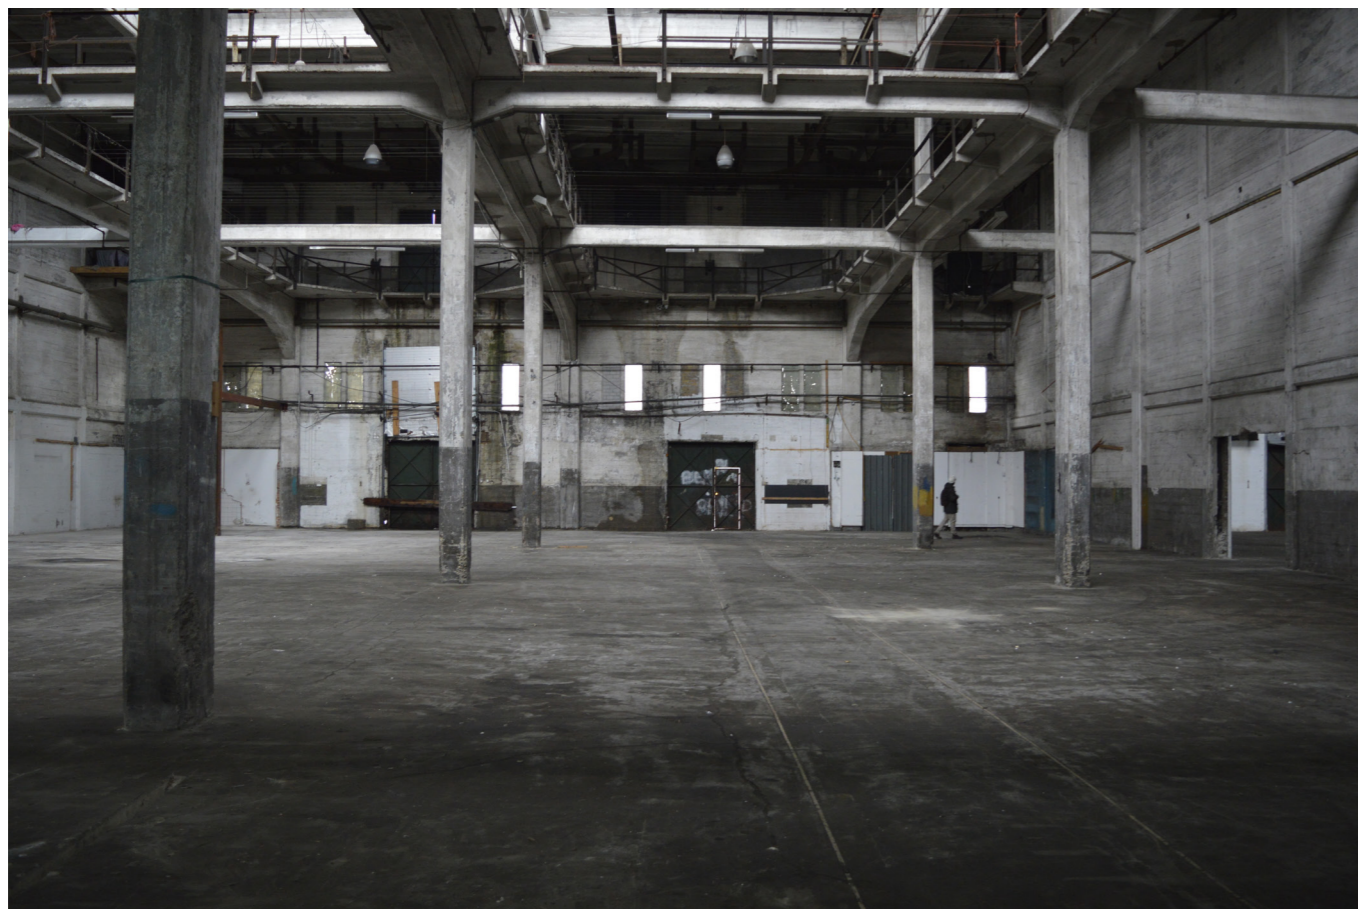
*illustration 10 - large, tall interior spaces by Audrey Loef
(own photograph)*

In the use value column, the highest rating has been assigned to the structure and the space plan. The structure of the skylights has been designed with an orientation to

the north because the cotton warehouse required indirect daylight. In the redevelopment this indirect daylight can be of high value if an appropriate function is assigned to the Katoenveem. The historic space plan with its large open spaces was designed specifically in accordance with the functionality of the building. With a little restoration, these large, tall spaces of the compartments have the potential to be used for many purposes (see illustration 10). For example as a warehouse, an art studio, a sports hall, and a church, as well as many others. The next column of the matrix that contains aspects of high value is rarity. The site and the space plan have been given a high value rating. The Katoenveem is the

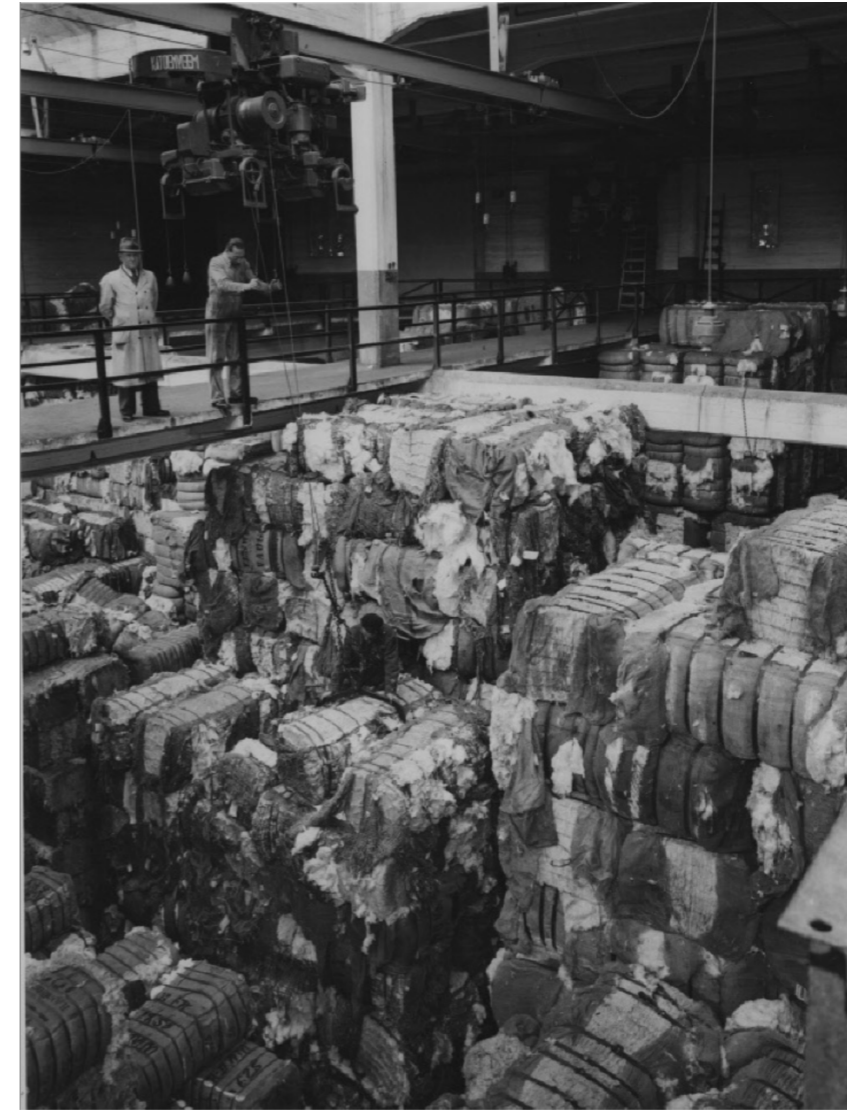
illustration 13 - Katoenveem interior image (1952)
(Dijk, F.H. van, image owned by Stadsarchief Rotterdam)

odd movement of a traveller as show on illustration 13. That sight is a stark contrast to the current situation in which the complex has been destroyed and only the empty halls of a warehouse of the once proud cotton industry remains.

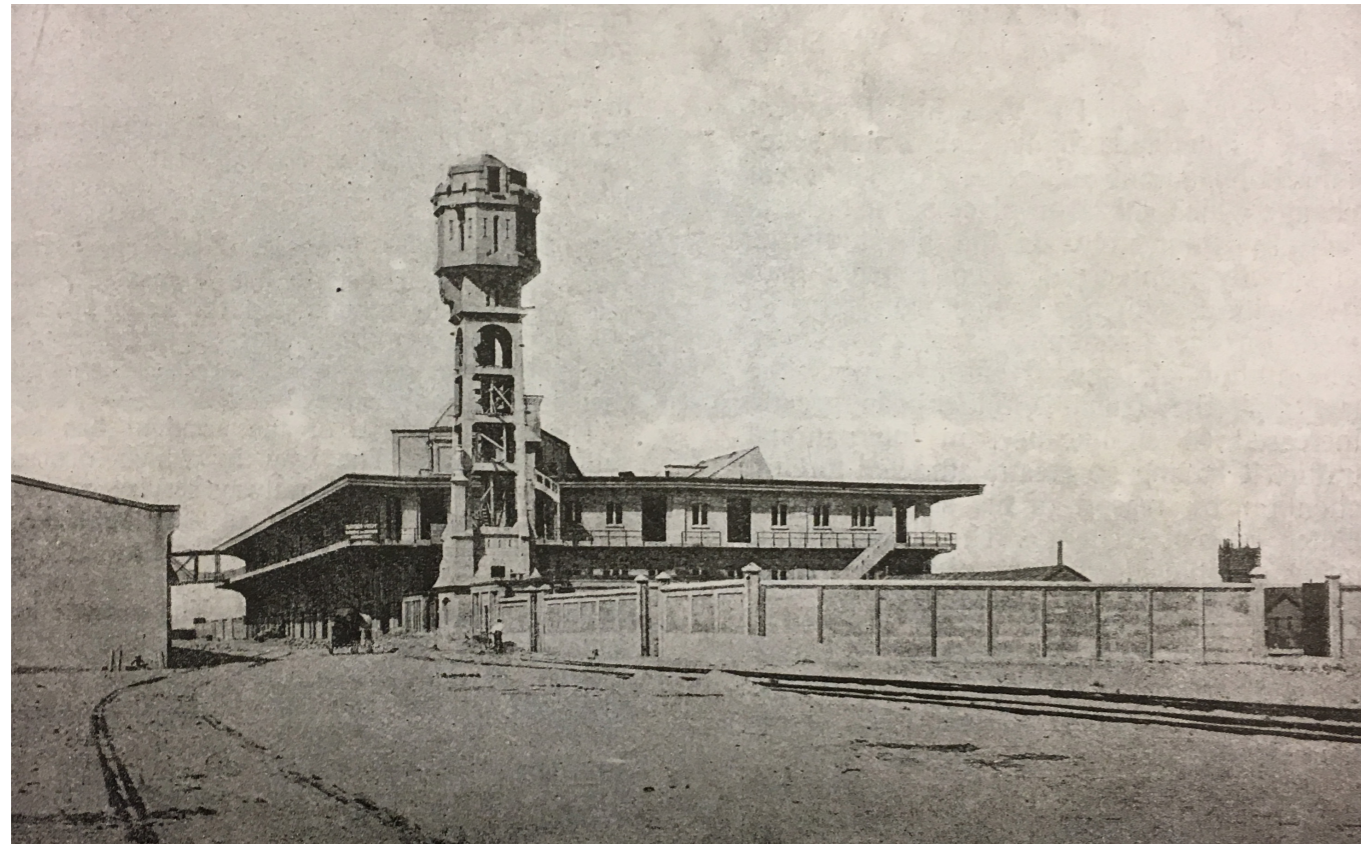
illustration 14 - Photograph of the Katoenveem in 1919
(*The Pioneer*, p69, Stadsarchief Rotterdam)

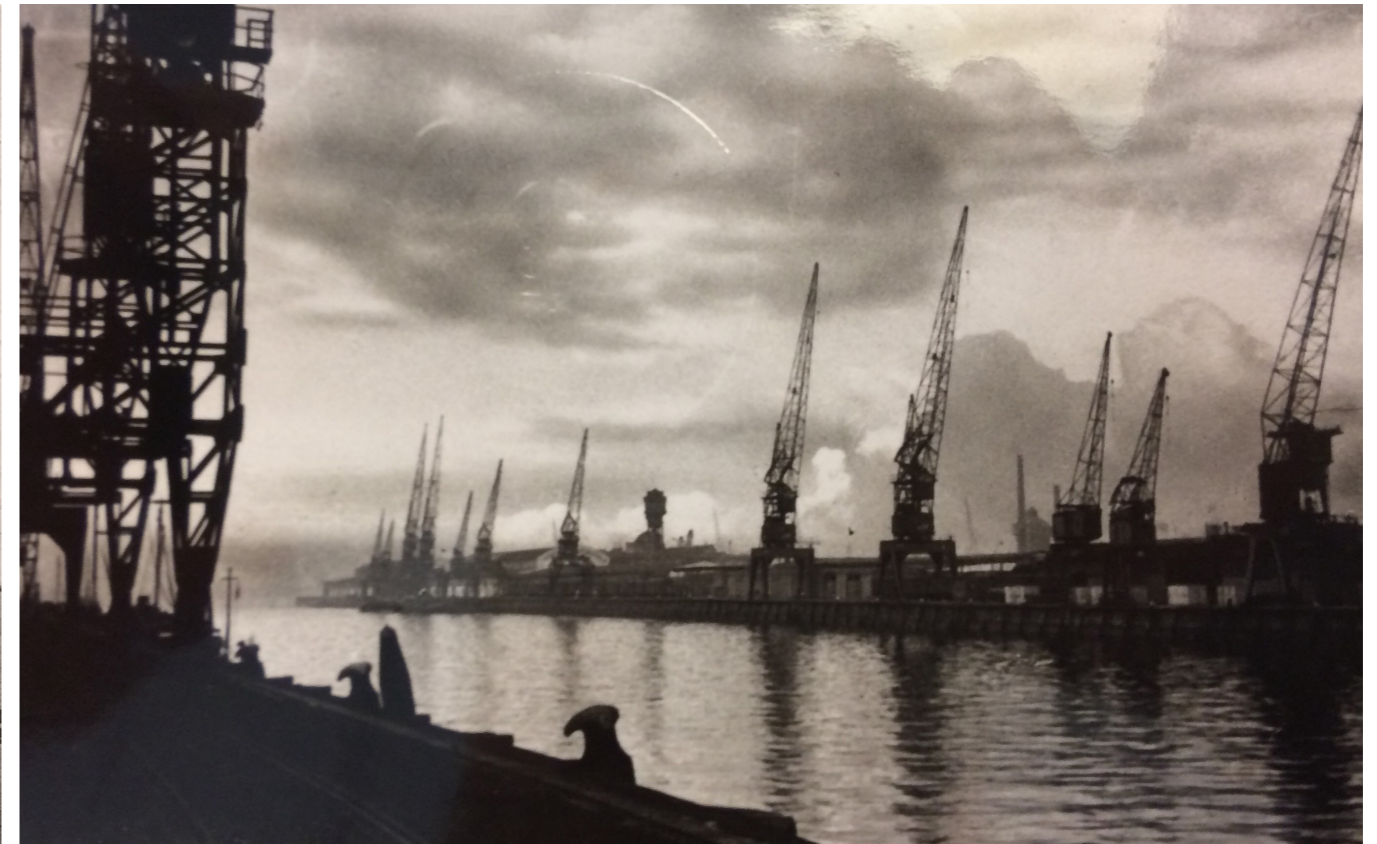
illustration 15 - Photograph of the Lekhaven in 1939 (water tower can be seen)
(Klaver, J., Stadsarchief Rotterdam)

But in between the structure saw a lot of change. For instance during the Second World War, the entire harbour area came to a stand still as can be seen in illustration 15. This picture was taken in 1939, one year before the invasion of the Netherlands by the Germans. As said before, the Katoenveem was spared in the bombings of Rotterdam. But in the following years

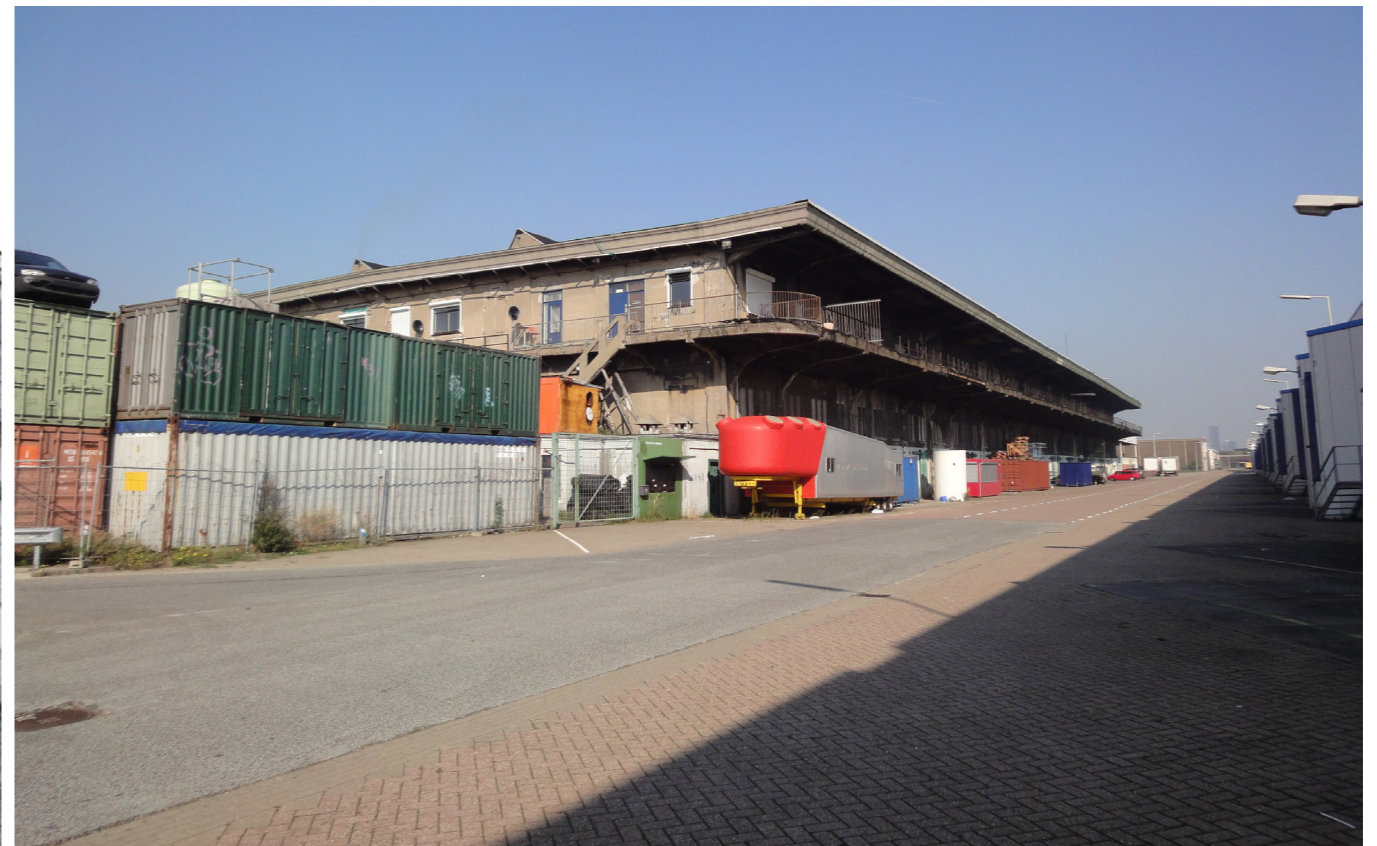
illustration 17 - Van Lieshout at Katoenveem (2011)
(Kok, V. de, via Rijksmonumenten.nl)

In 1995 a new chapter opened for the building, with Atelier van Lieshout or AVL. This Dutch studio used the most western compartment as its own studio up to 2011. After this period the studio resided in a building on the Keileweg 18. The containers that are visible on illustration 17 still remain, and were once used by Van Lieshout as a restaurant and an office (avlmundo.org).

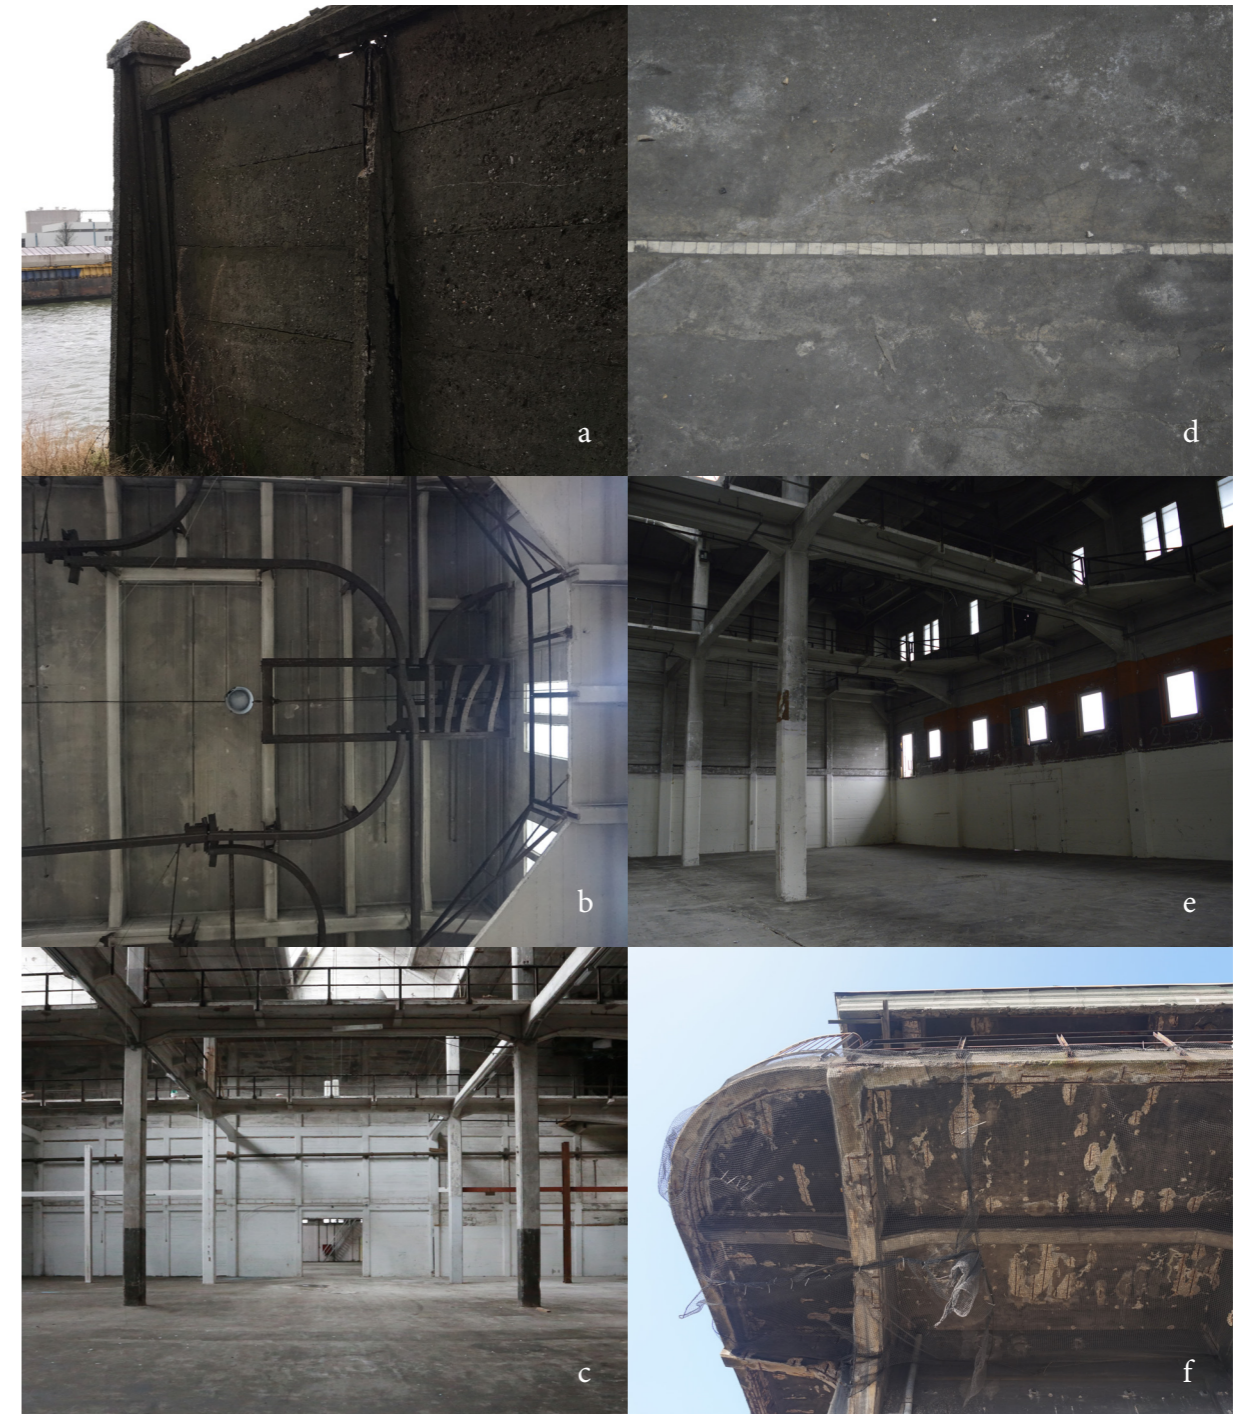
COMPLEX (I) Restore and show traces of former Katoenveem complex. In order to maintain the historical value of the site, the pieces of the complex that have prevailed over time need to be taken into consideration when starting to design. In order to maintain the value and integrity of the ensemble, from which a lot has been lost over time already, the aspect that are still present (e.g. parts of the wall, the railway and the crain foundation), as shown through high valued colouring in the matrix, need to be preserved. The traces are of significant value and therefore there is an obligation to rehabilitate them, as well as increasing their visibility.

SERVICES (II) Maintain the parts of original services (e.g. the sprinkler system and the conveyor system) in and around the building. The remaining fragments of original services like sprinklers, railways, conveyors and lights give an insight in the original use and purpose of the Katoenveem. Therefore these parts should be looked after when a new design is proposed, to maintain the historical value of the sprinkler- and the conveyor system. This does not mean nothing can be changed, but original services may never be removed completely.

ATMOSPHERE(V) Maintain the historical industrial atmosphere. In a new design the character and atmosphere, that can be found in the structure, skin and space plan of the original Katoenveem must still be present. Indirect daylight, materiality, proportionality and overall rawness are key aspects of the atmosphere. When adding new aspects to the Katoenveem it is obligatory to look for a balance between the old and the new to preserve aesthetic value or 'belevingswaarde'.

RESTORATION(VI) Repair and restore the Katoenveem. In order to create new use value in the building the Katoenveem needs to be renovated. Repairing and restoring would also help to retain the historic value of the building. It is therefore an obligation for anyone who starts redevelopment of the Katoenveem. (Roman numbers correspond to illustrations.)

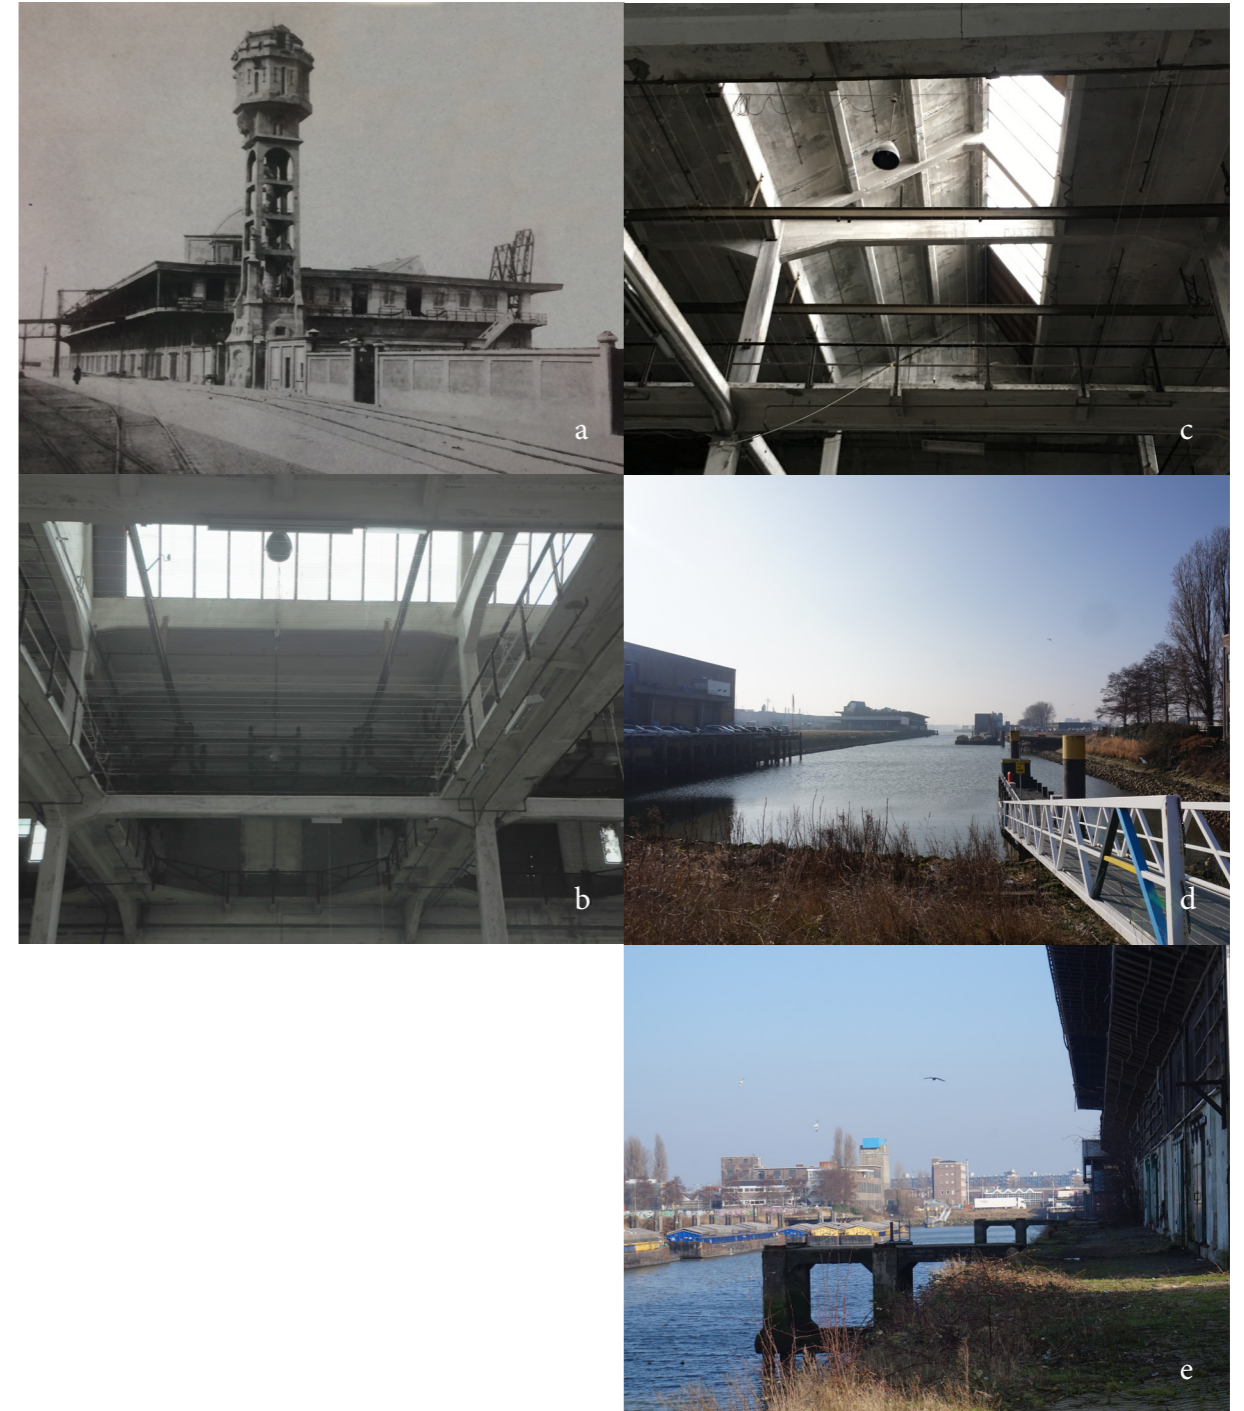
*illustration 18a - complex (I) by Joost van den Berge
illustration 18b - services (II) by Joost van den Berge
illustration 18c - skylights (III) by Xihao Yi
illustration 18d - neighbourhood (IV) by Elmer Pietersma
illustration 18e - water relationship (V) by Elmer Pietersma
(own illustration)*

COMPLEX (I) We as a group decided that the cultural value of the building should be improved by for example restoring the complex value, making it part of a whole instead of just a single building as it once was part of larger complex. In this case it could be interesting to show or rebuild the former concrete complex wall which bounded the Katoenveem complex or the revival of the watertower or a reference to it. This last example can highlight the site as a landmark and increase or strengthen the cultural and improve the historical value. It can even be restored in such a way it delivers water to the building once more. It is all a personal choice and discussable with the rights arguments and reasons.

SERVICES (II) Next to that the services that are still left in the building could be re-used. The walkways however cannot be built upon but they can be used to walk on if the railings would be repaired. The conveyor system with the I-beam running around the ceiling might or might not function anymore but these beams could at least be used for a new or other function. A lot of functions can be thought about as the conveyor system and the roof that carries the system were built for heavy loads. Moreover as the roof has been built especially to take heavy loads there are opportunities of using the roof and incorporate it into the design.

SKYLIGHTS (III) Another opportunity is using the skylights for more lighting but as they are directed to the north they won't serve functions that need much sun or daylight. Opening them up more can be a solution however this will be an intervention that has to be defended very well as it touches and changes much of the original design and functioning of the building.
