Experimental and Numerical Assessment of Historical Steel-Concrete Composite Bridge Decks Without Mechanical Connectors

Poliotti, Mauro; Yang, Yuguang; De Boer, Ane

Building for the Future: Durable, Sustainable, Resilient

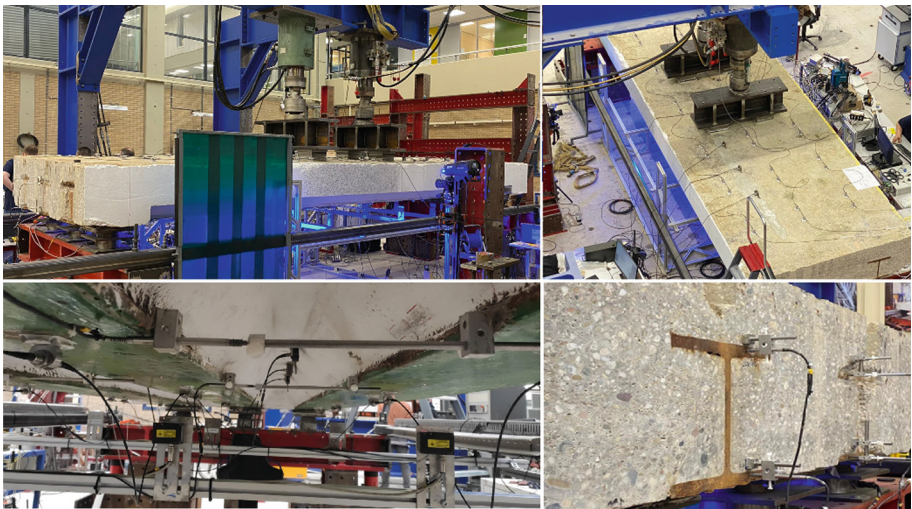
Fig. 5. Test and instrumentation. Top Left: side overview; Top Right: top view and optic fibers. Bottom Left: Bottom view transverse LVDTs; Bottom Right: Side view end LVDTs.

The sensor plan is designed to track several key parameters of the behaviour during testing. Reactions are monitored by 6 load cells placed under the steel beams. Vertical displacements are tracked by a grid of 12 laser sensors placed under the specimen. Strains on concrete deck and steel beams are measured by means of 42 discrete optical fiber sensors with a base length of 200 mm. Steel strains are measured on the bottom flange at the center line of each beam. Concrete strains are measured on the top layer aligned vertically with the steel measurements. The interface behaviour is monitored using 8 LVDTs at different locations. At the end of beams 4 LVDTs are placed to measure the total slip between concrete and steel. Moreover, relative longitudinal slip between the

bottom flange and the surrounding concrete are tracked at four different locations by means of 4 LVDTs. The relative transverse displacement between the central and outer beams is measured by 6 LVDTs attached to the bottom flanges of the steel beams. Finally, 2D and 3D DIC cameras are used to monitor cracking from the side and bottom of the specimen, respectively. See Fig. 5. Full details of the measurement plan can be found in [8].
