Rapid damage assessment caused by the flooding event 2021 in Limburg, Netherlands

Journal of Coastal and Riverine Flood Risk

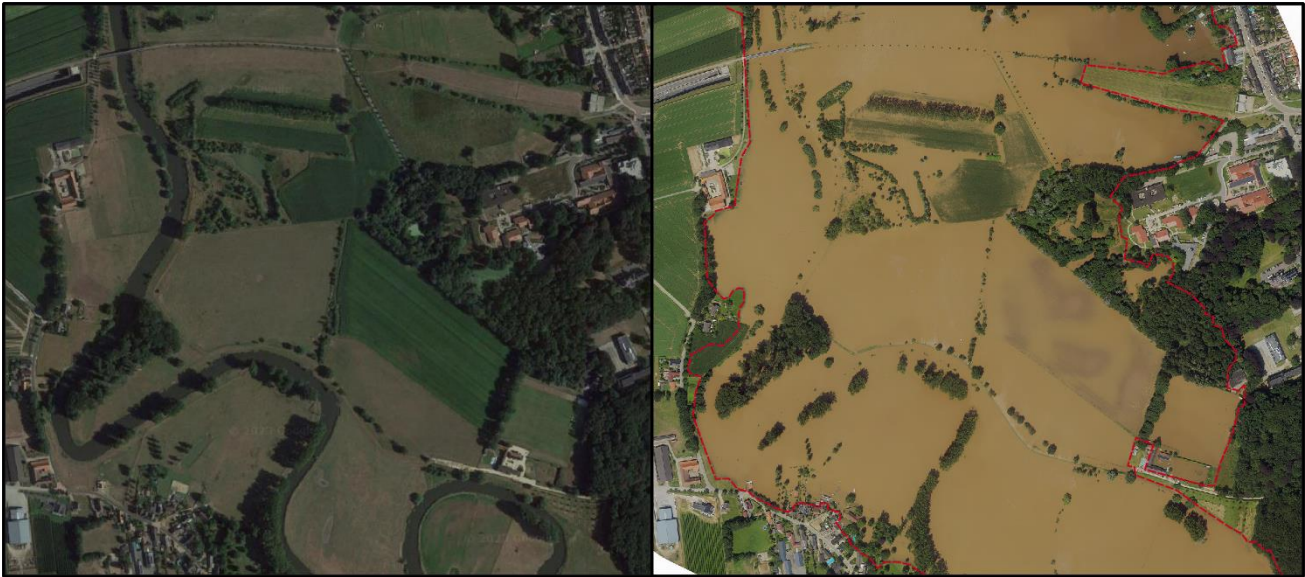
Figure 2: Example of the identification procedure of flood extents for damage assessment. The left picture shows a rural area along the Roer tributary in normal (dry) conditions (Source: ESRI). The right picture shows aerial photographs with retreating water after the flood event (Source: Het Waterschapshuis). Those pictures, together with existing model simulations (published on official government hazard maps – Source: Waterschap Limburg) are used to delineate the flood extent (red dotted line). Based on: <https://storymaps.arcgis.com/stories/7488a4903f47499a9f765a23619eb2f4>

In the direct aftermath of the flood, we made an initial damage assessment based on constructed flood maps and damage assessment models. Figure 2 presents an example of the maps used to assess the flooded area, and figure 3 shows an impression of flooding and damage to the city of Valkenburg.

We estimated the damage using the regional and flood plain module from the Standard Method 2017 (SSM2017) Flood Damage and Casualties (Slager & Wagenaar, 2017). SSM2017 requires at least a water depth grid, which was derived from flood extent observations (Figure 2) combined with existing flood hazard model runs. For the tributaries of the Roer, Geleenbeek and Geul, aerial photographs were taken (particularly of the Roer) during the event, showing inundation directly, or shortly after the event (one or two days) showing flood marks and reconstruction activities. Based on this imagery and aided by elevation data and existing model simulations (see LIWO, 2022) flood extents were digitized for these three tributaries. To construct an indicative water depth map, model simulations (with a return period of 1/1000 years) were used as water depth input for the damage estimation with SSM2017. We verified the flooded extent of the existing 1/1000 year modelled scenario (spatial resolution of 5x5 m) by visual inspection. To get a first estimate of the total damage, we manually adapted this input water depth map, by excluding small areas not being flooded in reality. On the other hand, small areas that were flooded in reality, but not as such in the model results, were added to the flood extent and maximum water depth. An indicative water depth value of 0.5 m was used for these areas. The peak discharge of the 2021 event was in the same order of magnitude as the discharge in the model simulation. Note that there are 4 rivers in the study area (Maas, Roer, Geleenbeek and Geul) which were modeled. For the main Meuse River flood extents, a similar

approach was used, although due to a delay in the availability of the photographs, first a set of model simulations was used for water depth estimation, later amended by a visual check on flood extents from the aerial photographs. The optional input for SSM2017, such as the flow velocity, arrival time, or the rate at which the water level rises become of relevance when casualties are also considered. Since this was beyond the scope of damage assessment, and this data unavailable, they have not been used in the assessment.

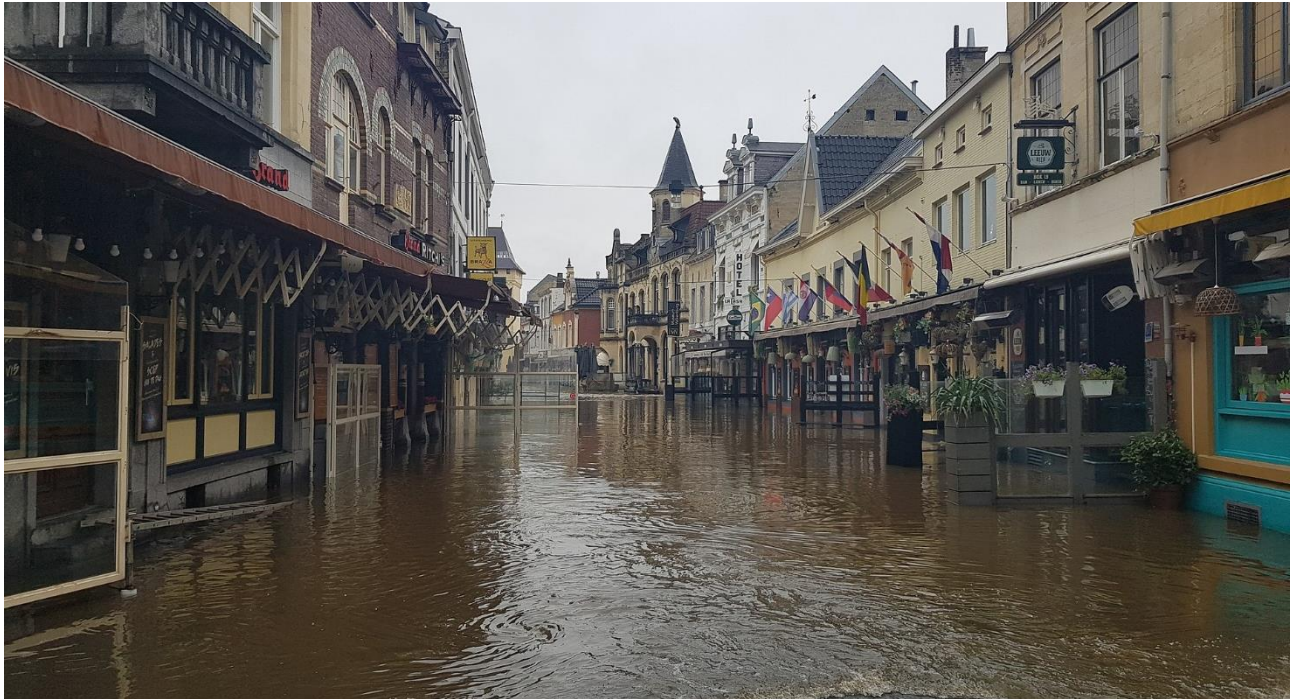
Figure 3: Impression of damage in the city of Valkenburg (source Wikimedia).
